CONTROL OF ALGAE AND BLACK FLY ATTACHMENT TO CONCRETE FLUMES

ALUMINUM MARKERS FOR TRANSMISSION TOWERS (Suggestion R2-57-116)

SPREADER BOX ON DOZER BLADE (Suggestion R2-57-9)

CONCRETE BONDING AGENTS

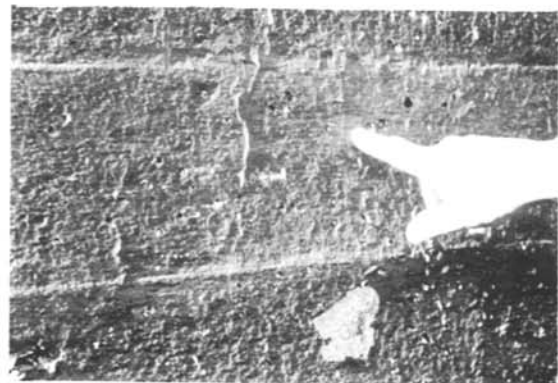
In the photographs above, the condition of the paint with and without the protection of the shed are illustrated. The smooth, adhering paint under the shed in the left photograph, that has been in service two irrigation seasons, is in sharp contrast to the scaling, peeling

and deteriorating surface shown at right that has been in service for a similar length of time, but exposed to the sunlight.

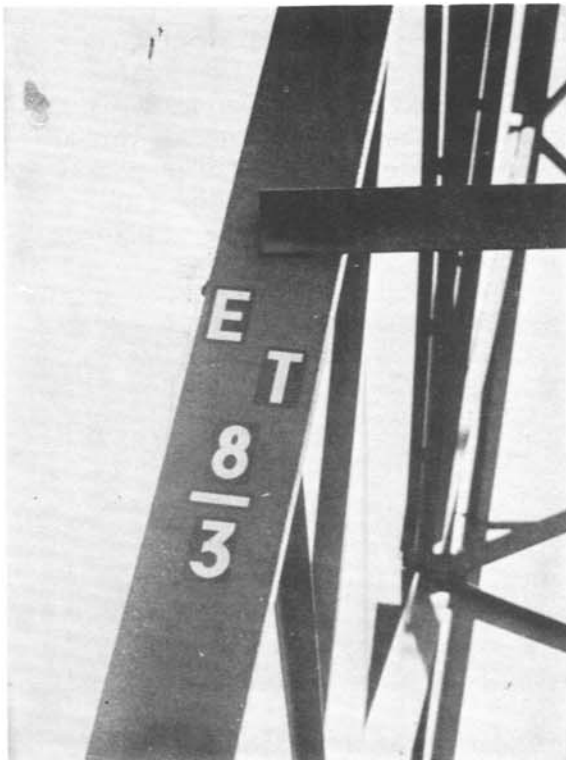
As a result of a suggestion of Electrical Engineer William Eckhoff, that aluminum decals be used in the marking of transmission line towers, automotive equipment and other property, the Bureau's Regional Office in Sacramento, California, decided to try the idea for a year in the marking of identification letters and numbers on transmission line towers, as shown at left.

Regional Supervisor of Irrigation and Power Martin Blote, has announced that the tests have proved the markers satisfactory and that this method of marking is now being used region-wide at a savings of some \$1,500 per year over the previous practice of stencilling the identifying letters and numbers.

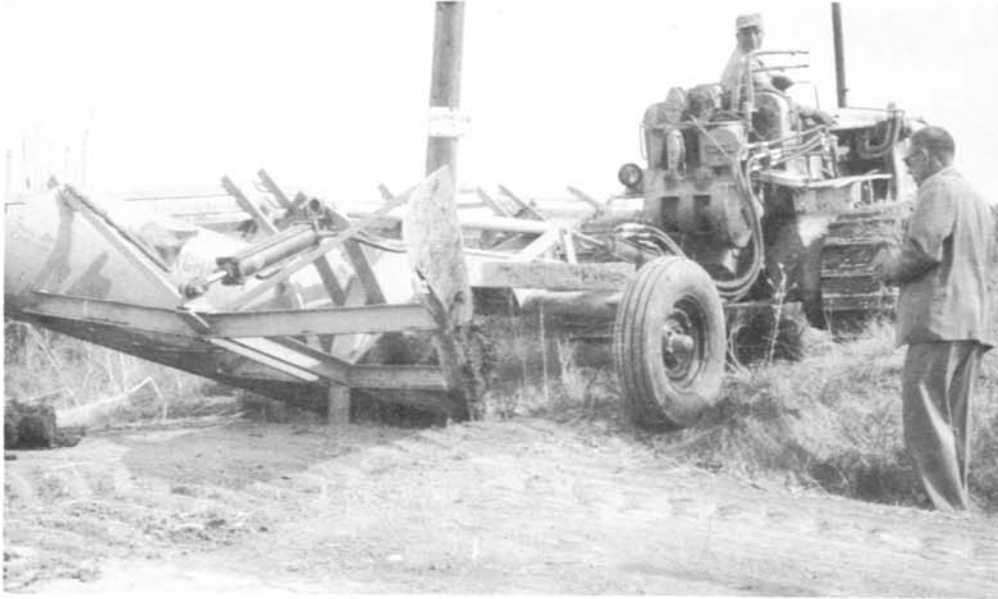
Mr. Axel Persson, retired manager, Lower Yellowstone Project, Sidney, Montana, states that one big advantage of the ditcher shown below and on the following page is that it is coupled directly to the power unit and hydraulically operated, making the work accomplished with the ditcher a one man operation.

The ditcher has two hydraulic controls; one on the plow and one on the traveling gear. The dimensions of the ditcher are: 10.6-foot blade, 10-foot wing spread, and 30-inch depth of blade. The ditcher can be adjusted to clean any size ditch from 1 foot to 4 feet in depth, and can be raised to clear the average structure or ditch bank that the power unit can clear. The ditcher shown in this article and in use on the Lower Yellowstone Project, is mounted on a crawler tractor. With the quick break-away hose connections and hitch, the ditching unit can be dismantled in two minutes.

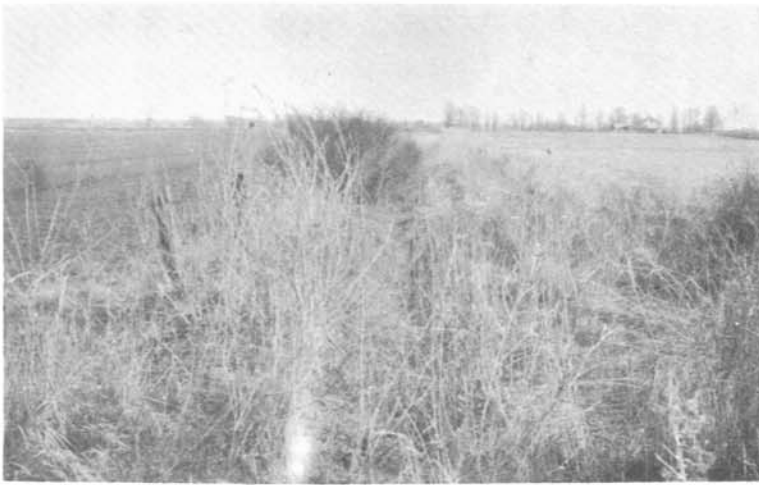
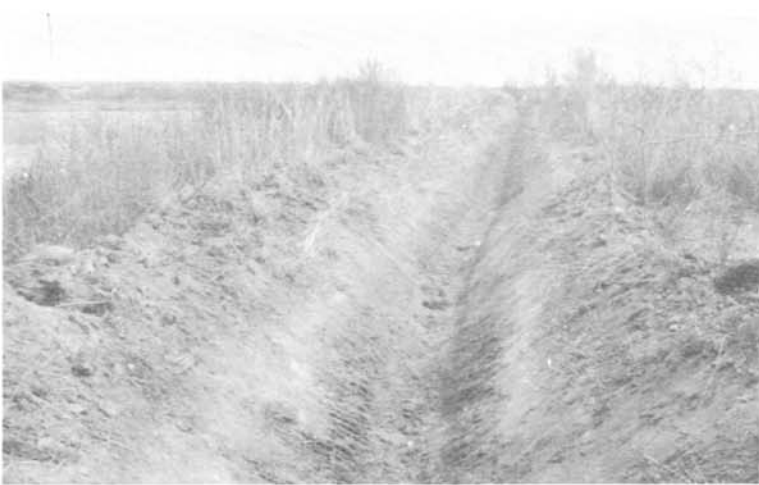
An example of the clean job performed by the piece of equipment is shown in the two lower photographs on this page.

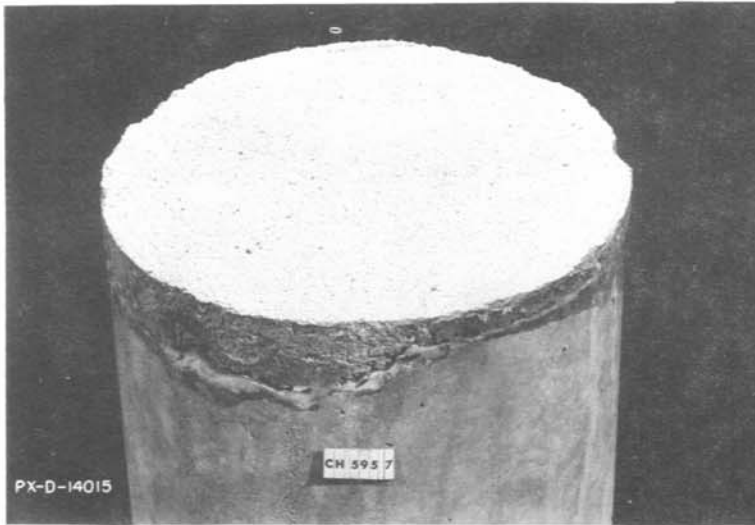
Two types of specimens were used in the tests, as shown at left, 6- by 12-inch cylinders and 3- by 3- by 1-1/2-inch mortar blocks. One half of the top surface of each cylinder was chipped; the other half was left as formed. The surfaces to be patched (capped) on all specimens were then etched with a 5 percent hydrochloric acid solution and rinsed.

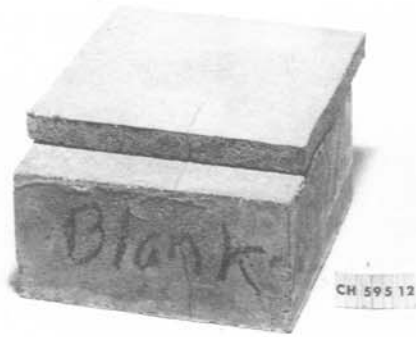
The patch applied to the control or blank block specimen is shown in the photograph at left on the following page. The patch was completely disbonded from the specimen on impact and it will be noted that a crack extends through the patch and block. The photograph at right, also on the following page, shows the result of impact on the block specimen the surface of which was treated with the bonding agent

prior to placement of the patch. The specimen broke cleanly through the patch and block. There was no evidence of disbonding in the adhesive layer or in the patch.

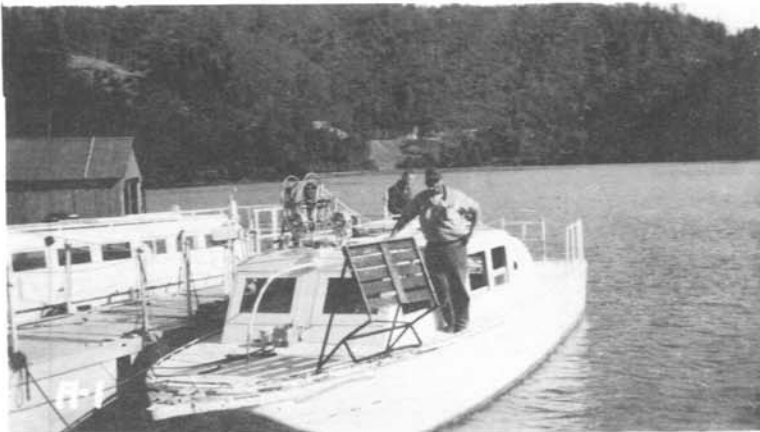
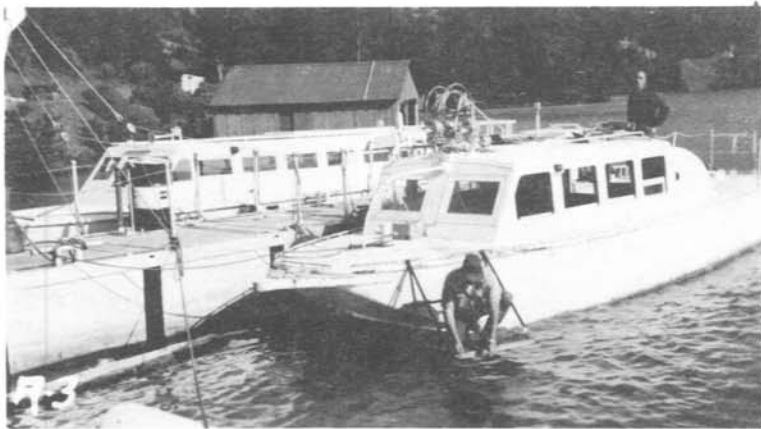
Water Level Working Platform

The working platform shown in the photograph at left swings over the side of the boat and provides a platform on which a crew member can stand while driving bolts or spikes into the logs for towing to shore, either one at a time or several fastened together. Without the platform, the whole operation would be extremely difficult and hazardous, because one could not reach the logs and drive the bolts from deck level.
