WATER OPERATION AND MAINTENANCE

BULLETIN NO. 142

December 1987

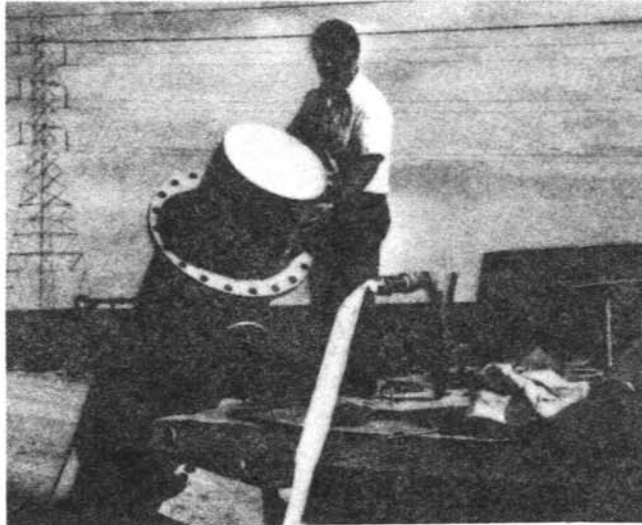
Introducing the "pig" into the irrigation line.

Flowline Services of Long Beach, California, was called in to assist. In this case, a total of five aqua-pigs was run. The first unit was a 20-inch (2-lb/ft³ density) bare type. Two 20-inch (5-lb/ft³ density) crisscross were pumped one at a time, followed by two 20-inch (5-lb/ft³ density) crisscross wire-brush types.

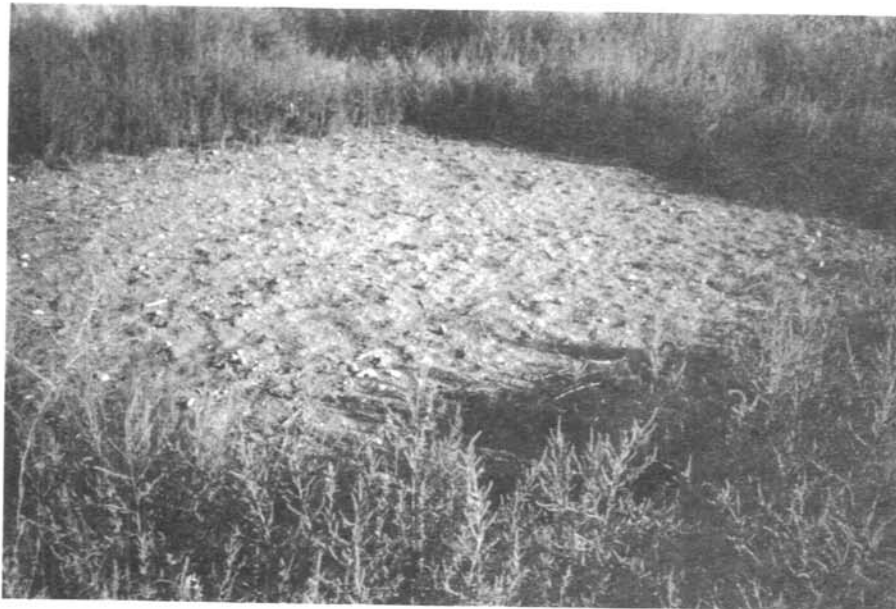
Figure 2. - Herbicide 1 treated in 1983.

Herbicide 1. — There is still complete control of the vegetation at all three rates with a very slight lateral movement beyond the area reached last year (fig. 2).

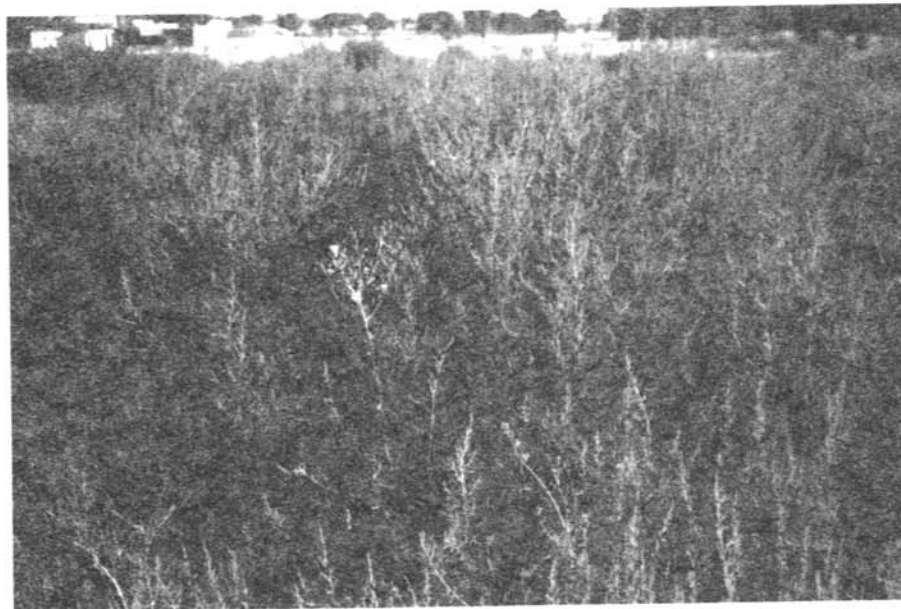
Figure 4. - Herbicide 3 treated in 1983.

Herbicide 3. — In April, only the high-rate plot showed some effect in controlling weeds; however, by August, even the high rate showed little effect on the weeds. As with the other herbicide plots, the herbicide moved very little beyond the area reached last year (fig. 4).

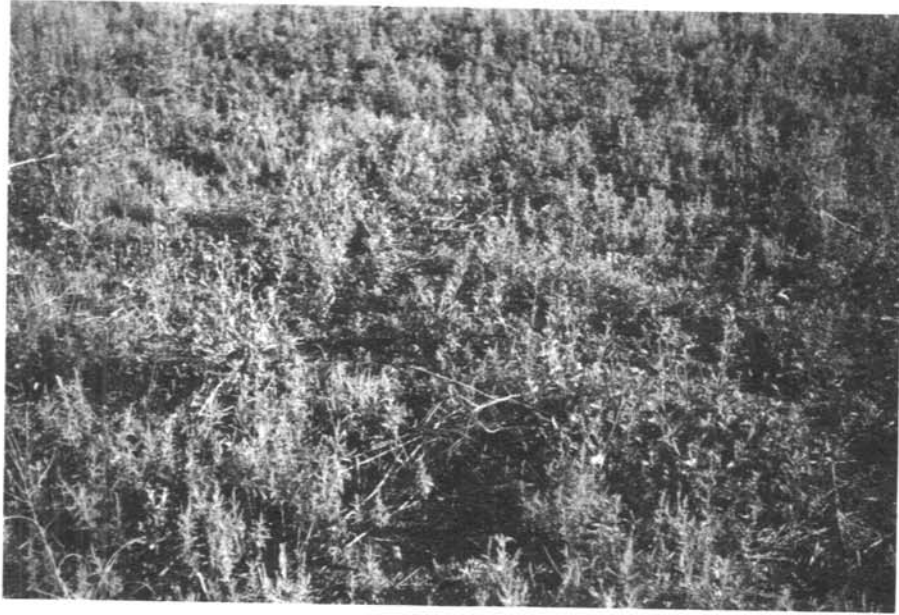
Figure 5. - Herbicide 4 treated in 1983.

Herbicide 4. — There was a dense stand of thistle in all the plots, including the high rate; but in late August, the thistle showed some injury (fig. 5).

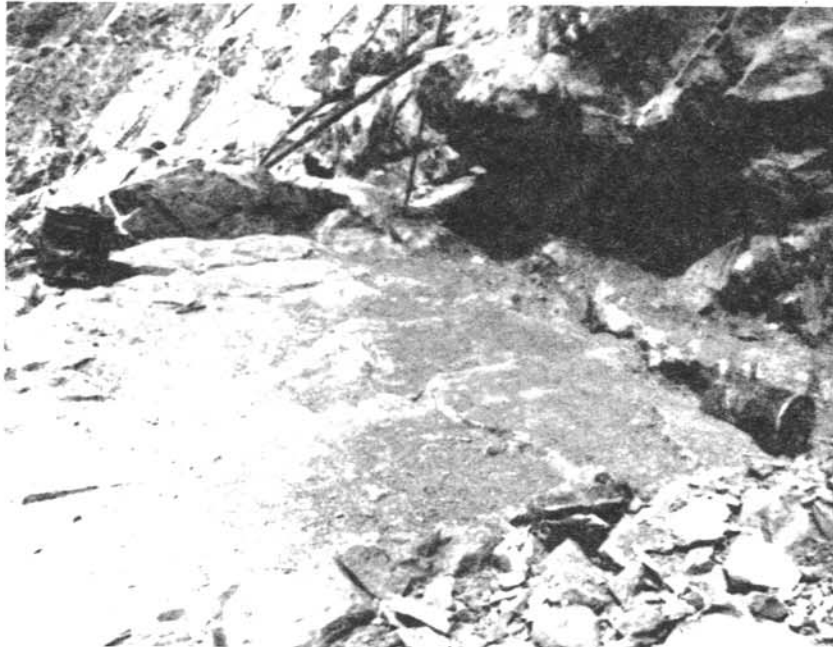
Figure 3. - Overhangs treated with pneumatically applied concrete for foundation shaping.

The A-joints strike nearly normal to the dam axis and dip steeply out of the left abutment into the right abutment. They predominate upstream of the dam axis in the lower left abutment and in the lower to mid-right abutment. The A-joints commonly created overhang irregularities ranging in height from 1 to 5 feet. These overhangs were treated with pneumatically applied concrete for foundation shaping (fig. 3).
