WATER OPERATION AND MAINTENANCE

BULLETIN NO. 143

March 1988

Reducing Maintenance Costs of Irrigation Systems
Yakima-Tieton Irrigation District Rehabilitation Program
Concrete Deterioration
Erosion Control Along the Rio Grande
Keep Fall Costs Down
Spotlight on Glen Canyon Dam
Policy for Safety Recommendations During RO&M (Review of Operation and Maintenance)
Examinations
Criteria for the Removal of Trees, Other Vegetative Growth, and Rodent Burrows From
Earth Dams, Dikes, and Conveyance Features
Root Characteristics of Common Woody Vegetation in the Western United States
Case Study - Lemon Dam - Concrete Spillway Inlet Wall Failure

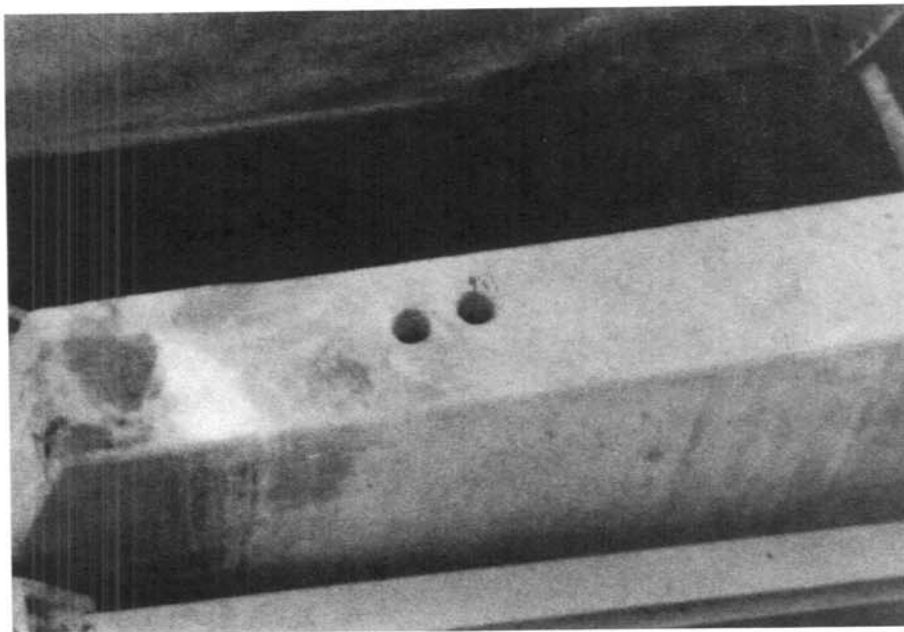
Figure 4. View of center wall from which core No. 4 was removed. Wall is 14 inches thick.

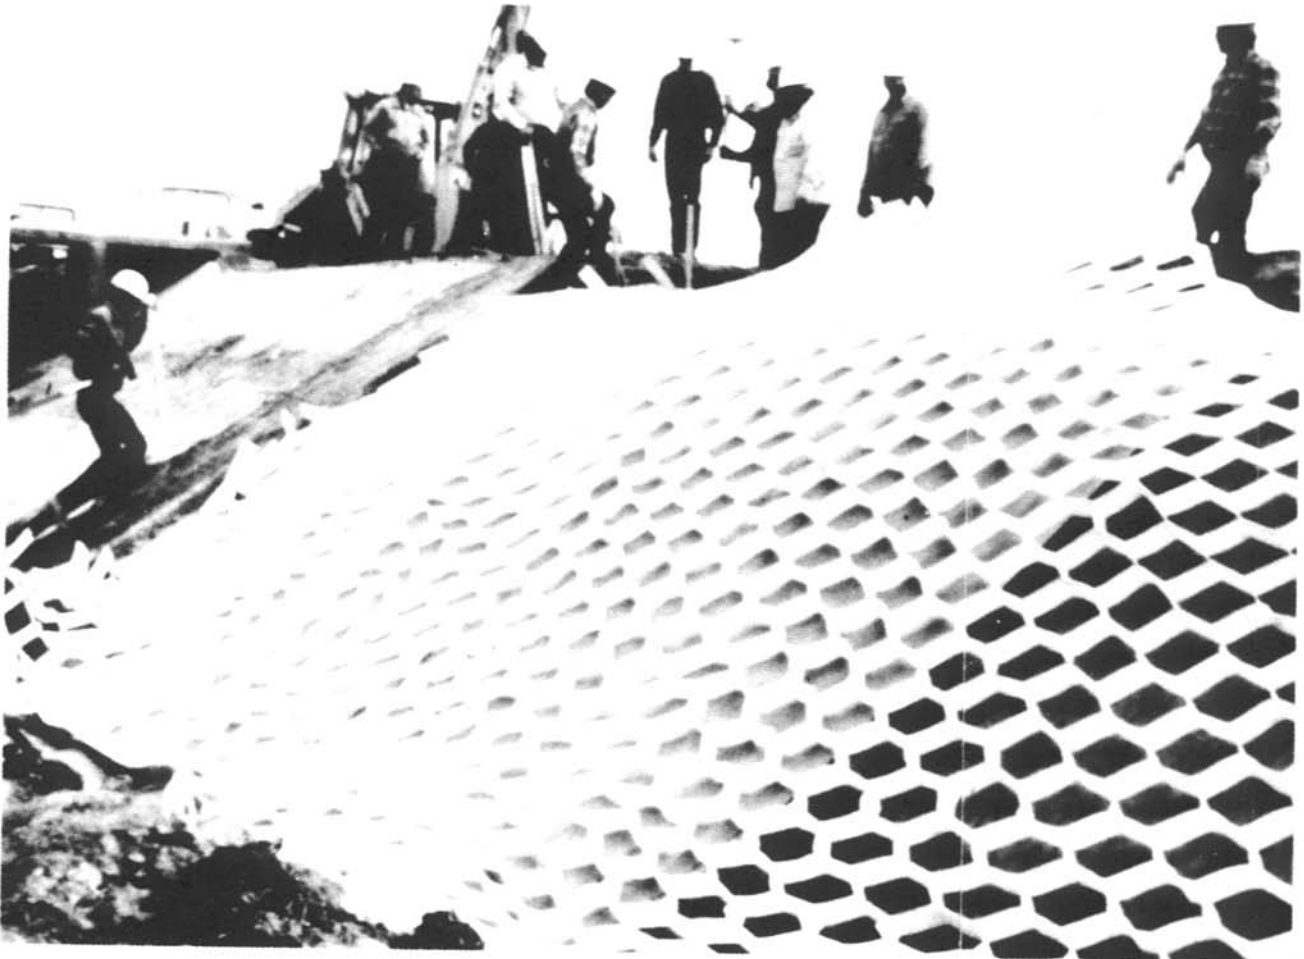
The Armater was spread out and anchored across a 2- to 4-foot flat ledge and down the slope.

Armater is a three-dimensional, semi-rigid geomatrix made of nonwoven, polyester fabric. It is permeable, lightweight and rot-proof, and provides virtually permanent erosion control, the manufacturer promises.

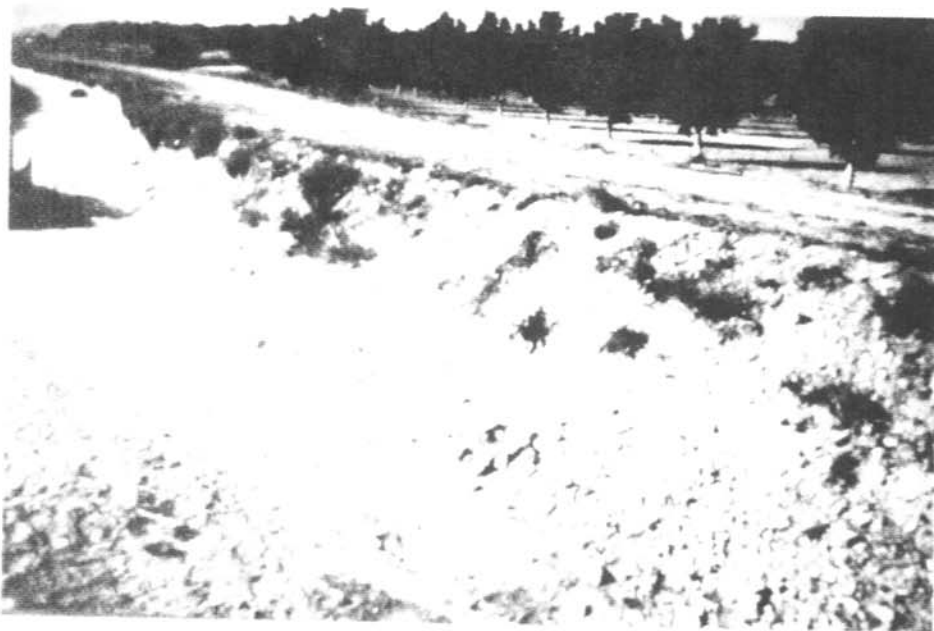
The Elephant Butte irrigation system consists almost entirely of earthen canals, laterals, and ditches.

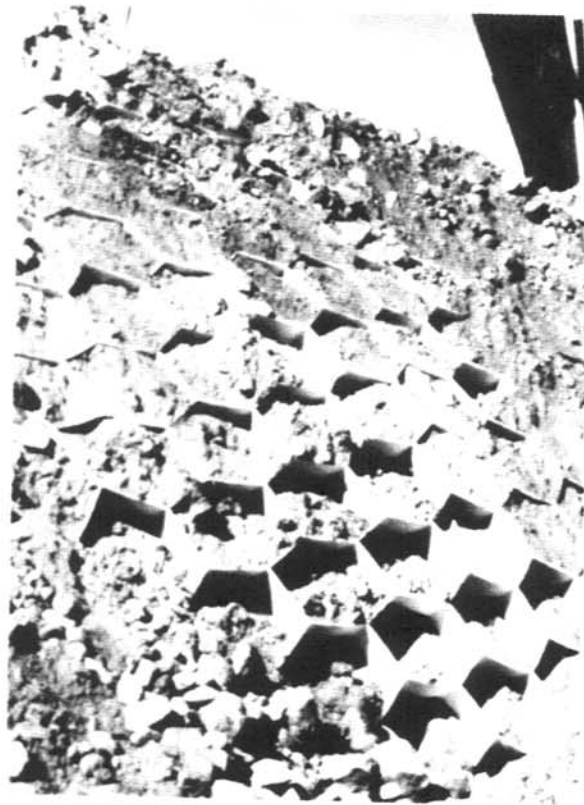
The honeycombs of the Armater were filled with a mixture of rock fine, consisting of baseball- to football-size rocks, and soil to keep the banks stable.

Esslinger is not critical of the Armater for the one failure. He explains, "There was so much turbulence and water interaction against the rock mixture that first the dirt was extracted, then the rock was put in a stress area and started to break the cones of the fabric, so that eventually the fabric started tearing away."

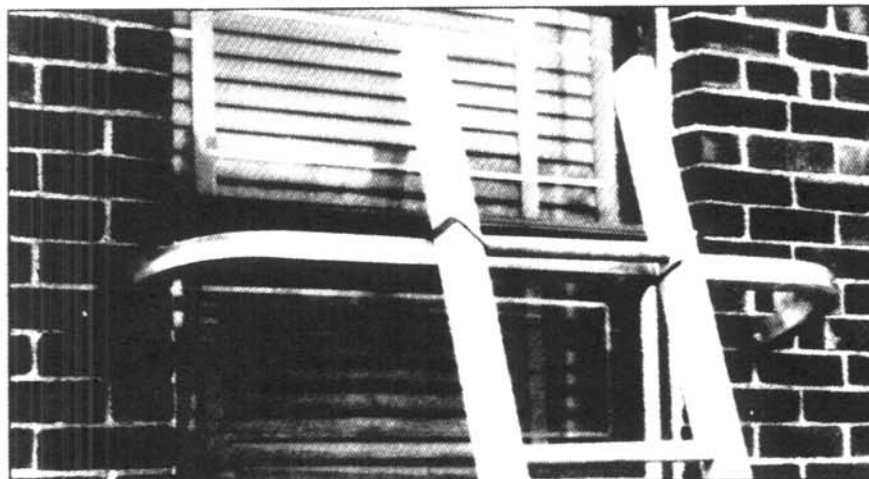
Ladders are a major contributor to industrial fall injuries. This metal bracket allows workers access to all points of this window without having to reach too far or extend the individual's center of gravity too far left or right.

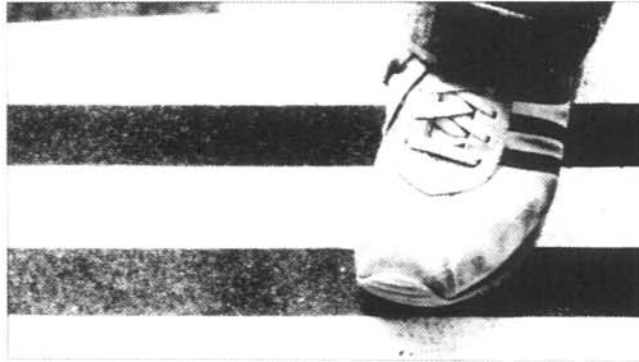
Adhesive-backed, anti-slip strips like these can be obtained in general purpose and conformance configurations. Thus, they are useful for reducing slip hazards on rungs, plant floors, shower rooms, and office-walking surfaces. (Photo courtesy of Direct Safety Company.)

A number of manufacturers offer a selection of strips and rolls of skid-resistant surfacing mounted on pressure-sensitive backings, or supplied with special mastic, that were designed to permit easy application to stair treads, gangplanks, and other potentially hazardous walking surfaces.
