# **WATER OPERATION AND MAINTENANCE**

**BULLETIN NO. 153**

September 1990

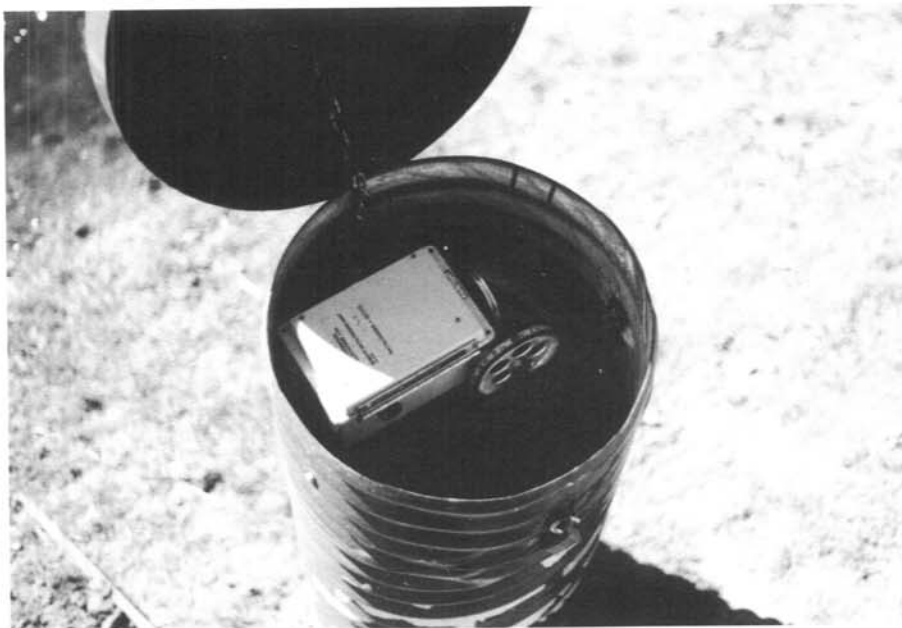
Alberta Agriculture has discontinued use of corrugated metal pipe and steel recording wells to house their electronic dataloggers.

During the summer of 1989, the staff of the irrigation branch of Alberta Agriculture noticed the repeated failure of their electronic dataloggers installed in corrugated metal pipe (CMP) and steel recording wells. Replacement instruments would record data for about 2 weeks and then fail again.

Brian Cook, an electronics technologist with the branch, believes "the problem occurred when the CMP or any other metal in contact with moist soil becomes a primitive battery or galvanic cell generating between 0.7 to 1.1 volts." This voltage, he says, along with the high humidity found in recording wells and manholes is enough to destroy most micro chip based instruments and computers. Where possible, he suggests electronic equipment should be installed in PVC, fiberglass, concrete, or other nonconductive recording wells and manholes.

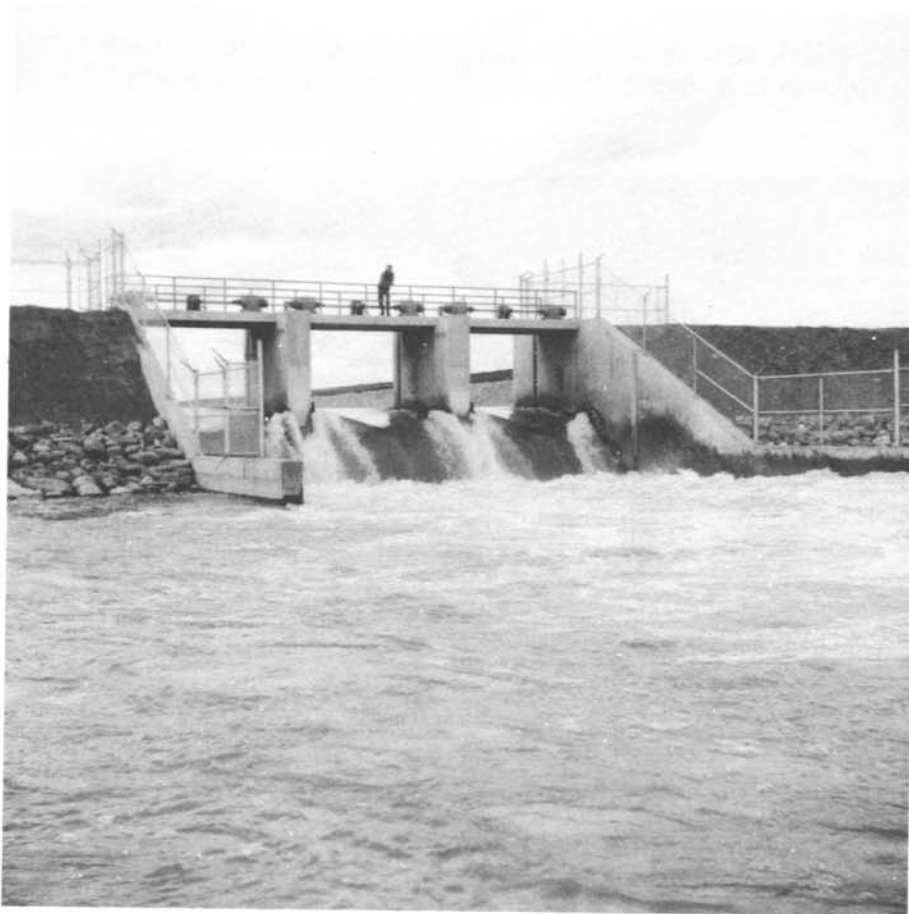
Drop No. 18 on the St. Mary Main Canal is a check drop structure with three Overshot Gates.

UMA countered the trend of half a century of hydraulic design work in arriving at this innovative design. The overshot gate is simple! It can best be described as: a rectangular panel, hinged across the bottom, that is raised and lowered by two cables attached to the upper corners. Stationary sidewalls guide the flow of water up and over the gate panel. Liken it to a drawbridge placed in a canal.

Hydraulically, the overshot gate is a moveable weir where flow over the gate varies as the three-halves power of the head, says UMA engineer Dale Miller. "This means that fluctuations in flow rate are reflected only as nominal fluctuations in water level. With water level held constant by the overshot gate, any diversions from the channel are assured of steady-state conditions. For a typical sluice gate diversion, the water manager needs to set his gate position only once with the knowledge that the flow through the gate will remain stable," says Miller.

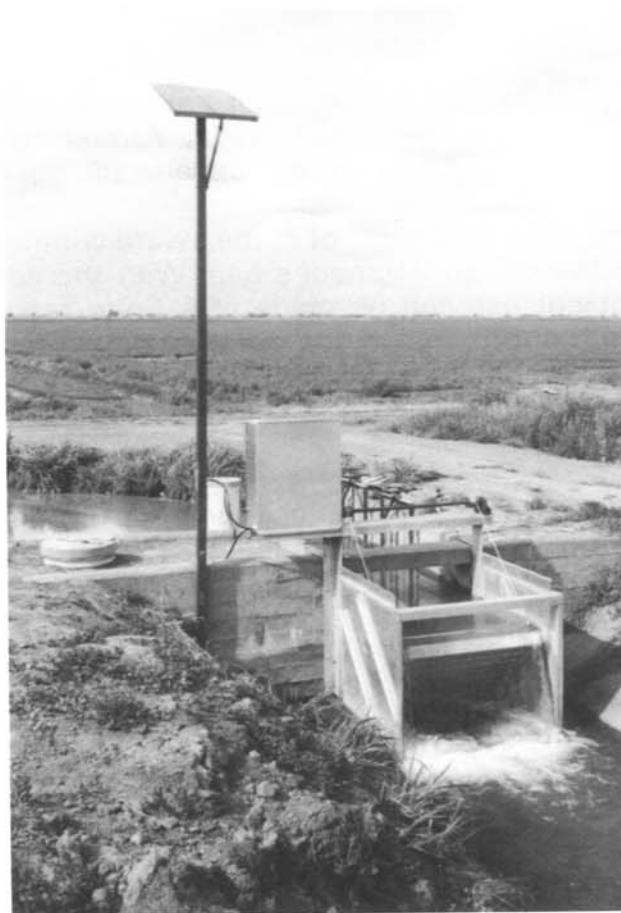
This smaller automated Overshot Gate is solar-powered, but these gates can also be connected to the local electrical grid system.

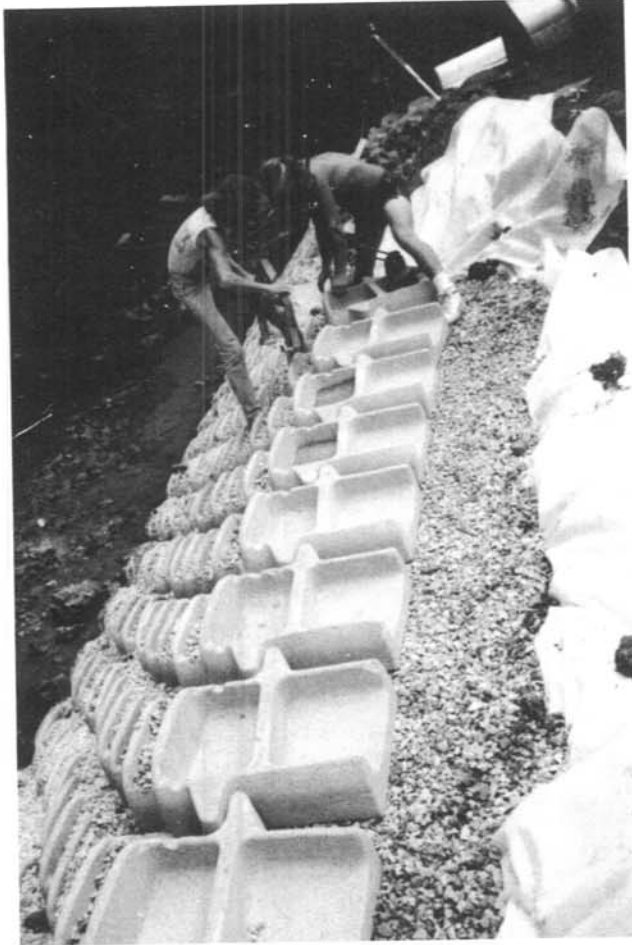
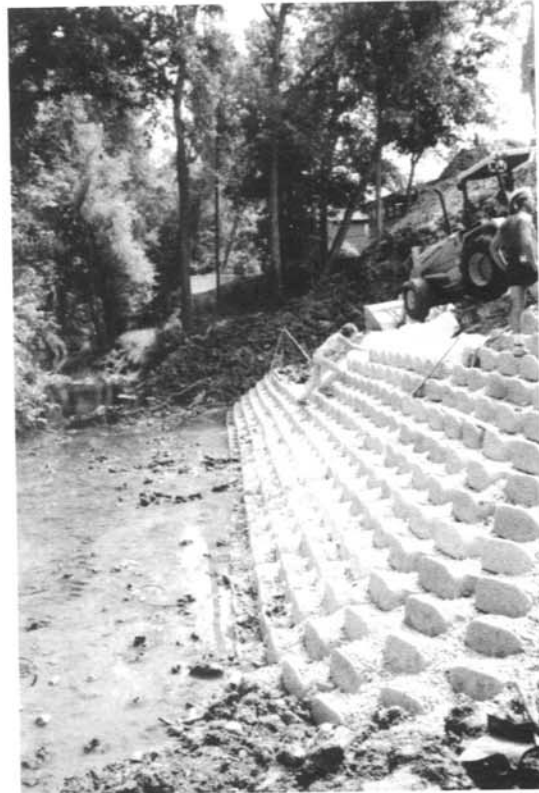
Creek bank stabilization system is built by placing layers of trough shaped modules on the steep slope. Interlocking wings tie units together, as shown in detail at left. Later a scour protection system was placed at the toe.

Construction of the Waterloffel retaining wall began with a 3-foot-thick footing located 1 foot below the creek bed. Poor soil conditions and sudden thunderstorms made construction of the footing difficult. During installation of the footing, the first layer of modules was embedded in the fresh concrete to ensure no slippage between the modules and the footing would occur. Construction of the wall progressed by setting the next layer of modules on the newly completed layer. Each layer of modules was set back approximately 8 inches to create a 40° slope from the vertical.

After completion of the first six or seven layers, a scour protection system was installed. This system, consisting of concrete-filled grid confinement system, was constructed at the toe of the retaining wall. The scour protection system was designed to help prevent scour along the footing.

To ensure positive drainage through the wall, a 1-foot-thick layer of clean rock was placed behind the wall and the troughs of the modules were filled with clean rock. A filter fabric was placed between the rock layer and the excavated creek bank to reduce contamination of the clean rock.

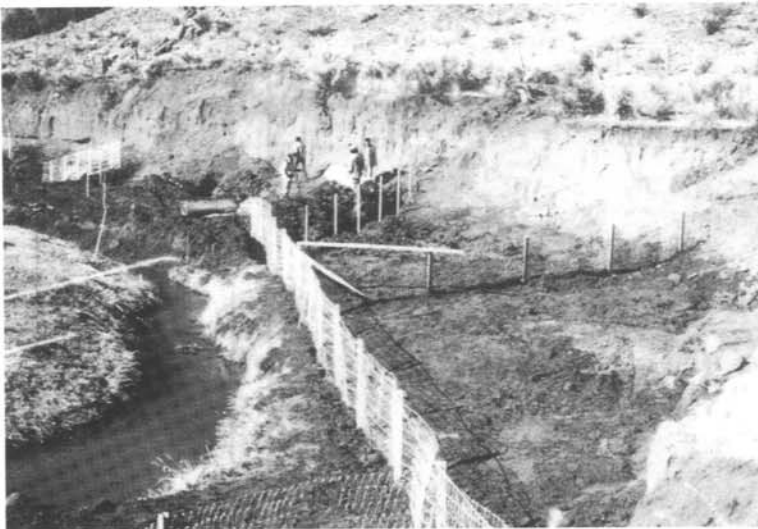
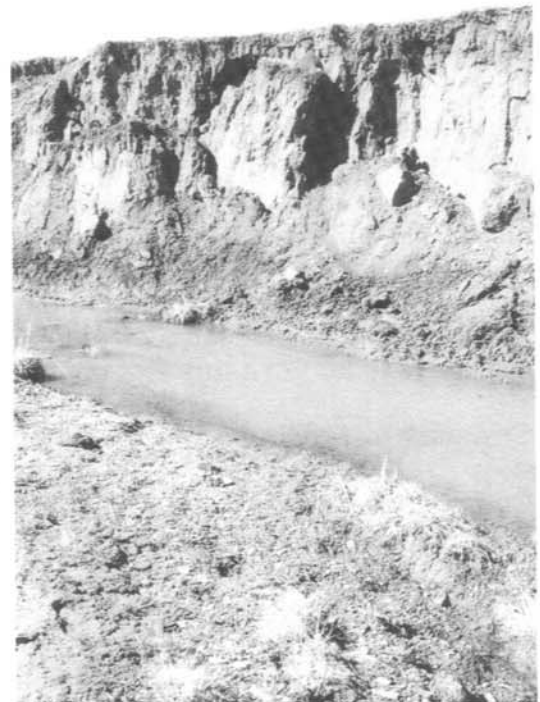
Construction view of revetment shows main baffle segment parallel to flow, one perpendicular baffle, and posts in place for a second. At right, bank slumping along the main stem of Bluewater Creek prior to the project.

The revetment section consists of two elements: one or more main segments aligned parallel to flow, and a series of baffles oriented perpendicular to flow, extending from the main segments back into the streambank. Main segments and baffles are faced with the fence material, attached so that water and debris will force the fence material against the posts. Galvanized wire rope extends along the top of the main segments, held at tension and secured in the ground via deadmen made of post segments. Wire rope is similarly attached along the top of the baffle posts and secured in the banks. Fence material is secured to the posts and wire rope by 12-gauge galvanized tie wire and galvanized U-bolts.

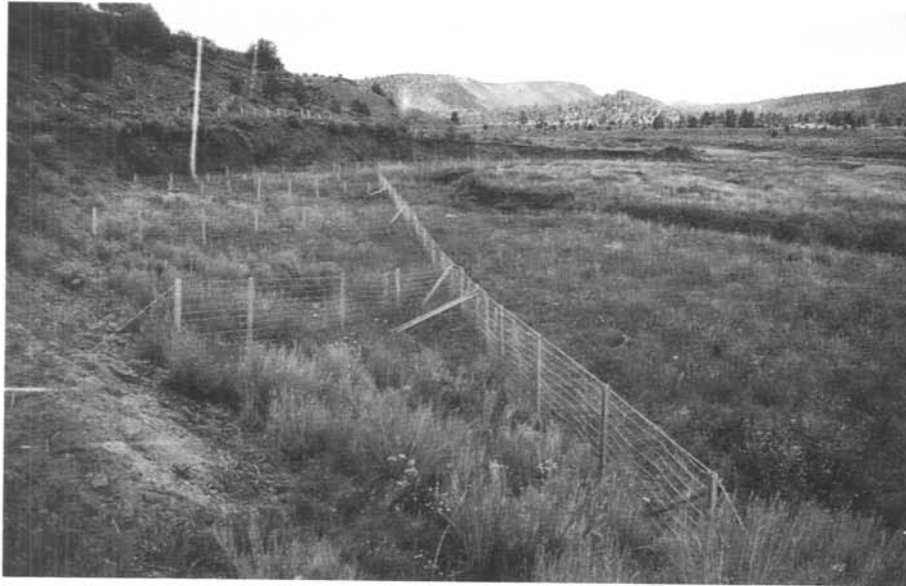
Excellent cover was established less than a year after revetment installation.

Vegetation growth in and around the structures did well during 1987, providing additional flow roughness to enhance sediment capture and provide ground and bank cover. Willow cuttings were planted on several occasions by various volunteer groups and cottonwood poles were also put in place. The second winter saw little snow and little spring flow but significant summer thunderstorm runoff. Plant growth in and around the revetments was excellent. Willow plantings were partially successful. Most cottonwood poles lost their top vegetation but sprouted from the root collar in summer 1988.
