WATER OPERATION AND MAINTENANCE

BULLETIN NO. 151

March 1990

Experience With Cavitation in High-Pressure Slide Gates
Bureau of Reclamation-Corps of Engineers Research Effort Results in High-Resolution
Acoustic Mapping System
Hydrodemolition Speeds Aqueduct Tunnel Repair
Pipercleaning With Pigs
Pipeline Settling Ponds
Spotlight on Jackson Lake Dam

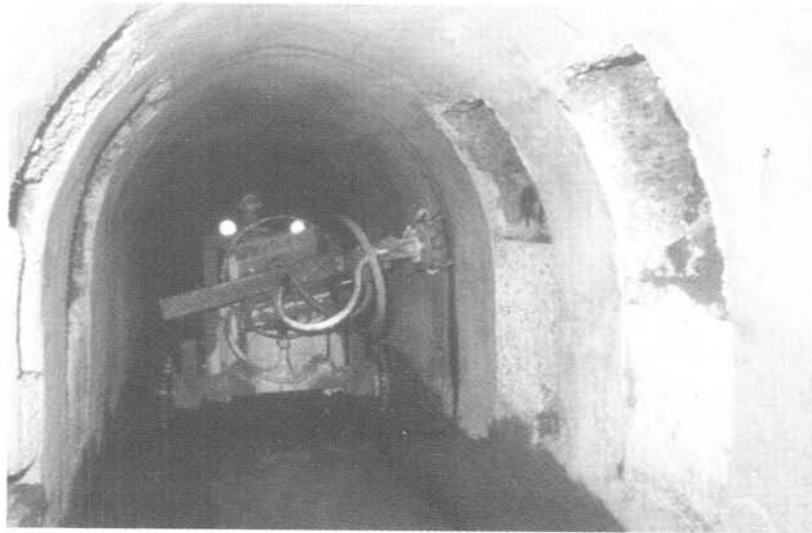
At each pass the Conjet unit removes deteriorated concrete from a 30-inch-wide section; then moves on leaving a 30-inch "rib" before cutting out the next section.

The Conjet arm was programmed to make its 30-inch-wide pass starting at 14 inches up from the tunnel floor and proceeding up to the water line. This is the area where the deterioration had taken place. (Repairs to the floor of the tunnel were made in 1938, and the floor was found to be in good shape.) Water was sprayed through two 1.5-mm nozzles (occasionally 1.1-mm nozzles) under 17,000 lb/in² pressure on both an up and down pass of the rotating arm. The two passes succeeded in removing the deteriorated concrete.

After each 30-inch-wide section was removed, the unit was then moved forward, skipping a 30-inch section, to begin removal of deteriorated concrete on another section, leaving behind a 30-inch supporting "rib" for shoring. After the areas where the removed concrete was filled in with new reinforced concrete, the unit returned to remove the ribs and complete the repair job.

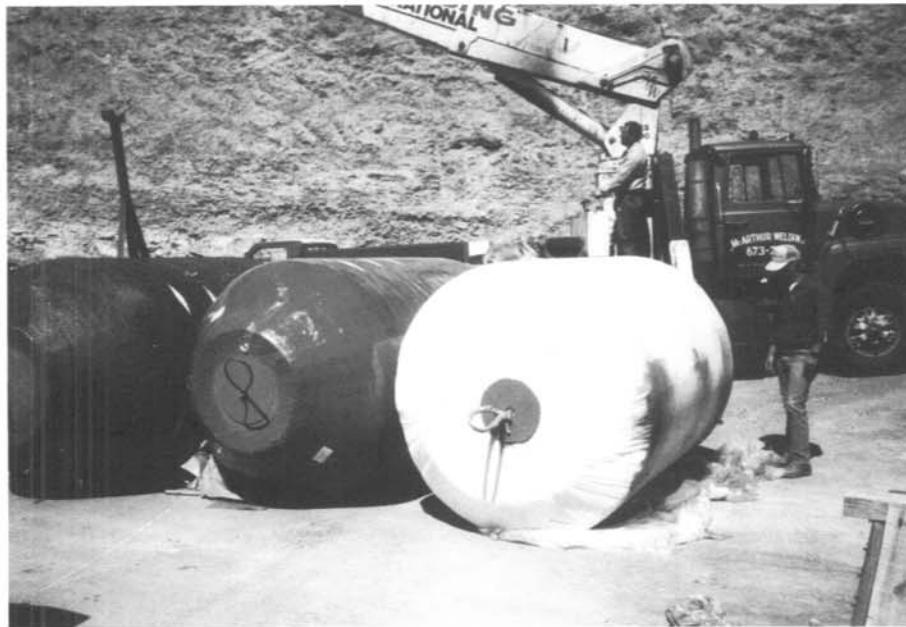
Left to right, 66-inch pigs: (1) pig with urethane coating embedded with carbide chips, (2) pig with urethane coating only, (3) lightweight foam pig.

We were referred to Flowmore Services, Houston, Texas, by our engineers. Flowmore usually handles the cleaning for oil pipelines. They recommended three different types of foam pigs to clean the pipeline. The pigs resemble large bullets, approximately 6 feet long. The first pig was soft foam, 2 lb/ft³. A 5-lb/ft³ urethane covered pig to remove scale was next. The last pig also weighed 5 lb/ft³ with carbide chips imbedded in a urethane coating to remove the hardest scale.

It was necessary to pass the pigs through both 66- and 48-inch pipe. The foam construction allowed the pig to be "squashed" through the smaller pipe.

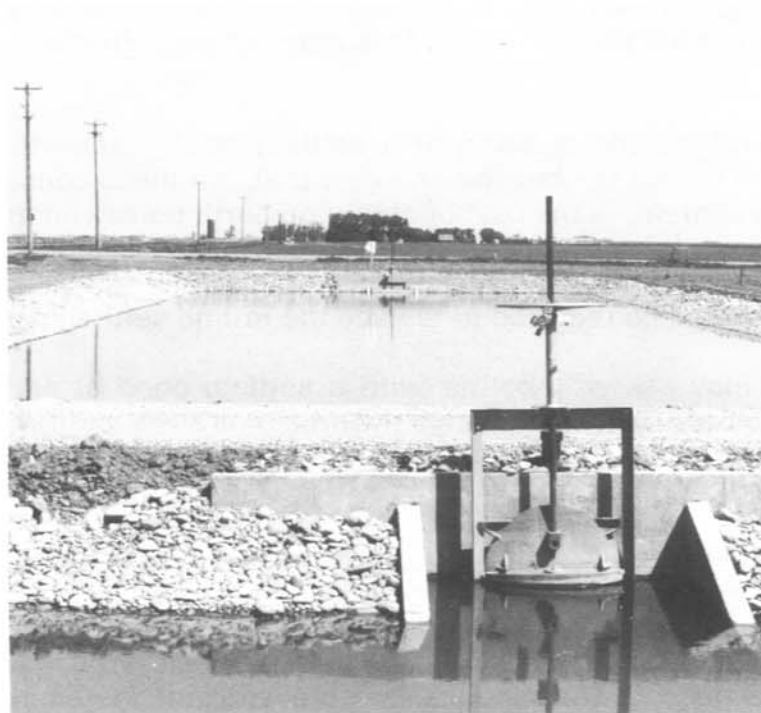
The settling pond constructed in 1989 on the SMRID's Coaldale Lateral is lined and gravel armored.

Their ponds are constructed approximately 40 m (131 feet) long by 5 m (16 feet) wide at the bottom with 2.5:1 side slopes and range from 2 m (6 feet) to 4.5 m (15 feet) deep. They consist of inlet and outlet structures with an inlet trashrack having 25-mm (1-inch) clear openings. A precast concrete baffle is usually placed near the downstream end of the pipe entering the pond to slow down the velocity of the water flowing through the pond. The ponds are usually plastic lined and gravel armored on their interior slopes.

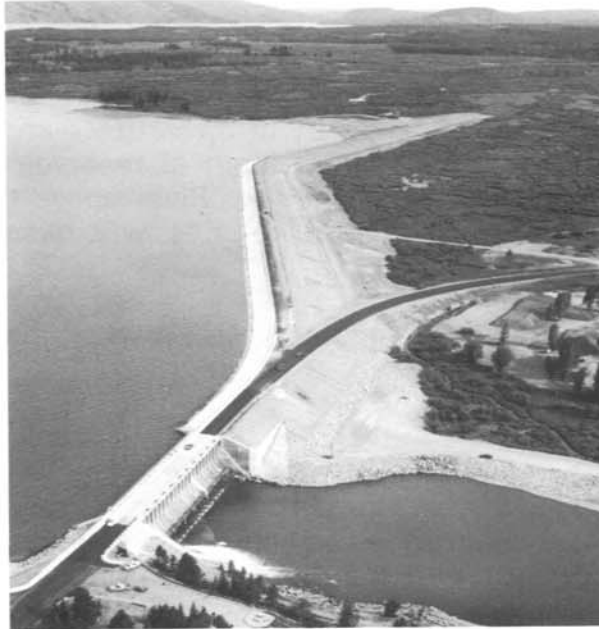
Photo 1. - Aerial view of Jackson Lake Dam looking north from south side of river showing completed dam and progress of reservoir filling. Reservoir is at elevation 6765.4 (maximum elevation is 6769.0). — Bureau of Reclamation photo by G. Walker. 6/20/89

SOD (safety of dams) modifications were performed from 1986 to 1989 to make the dam safe for earthquakes up to the maximum credible earthquake (MCE). The modifications performed were removal and replacement of the existing north embankment, densification of the north embankment foundation, treatment of the concrete dam foundation to provide stability, modifications to the outlet works, and modifications to the spillway piers. Jackson Lake Dam was rededicated July 17, 1989, following completion of the SOD modifications.

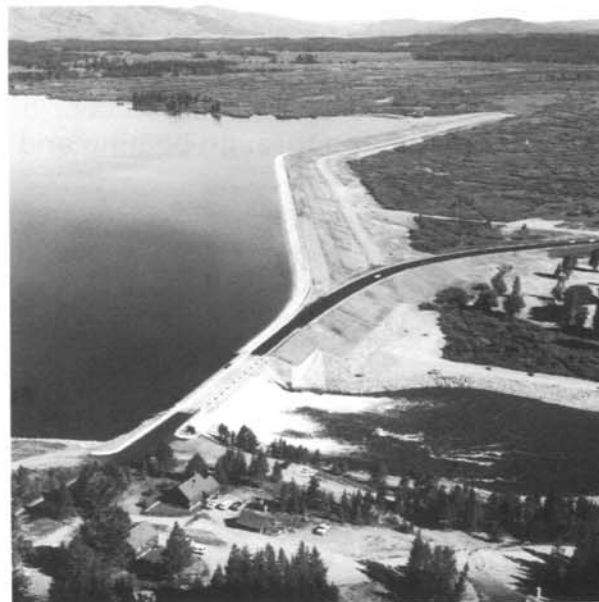
Photo 2. - Aerial view looking north showing general view of Jackson Lake Dam with a full reservoir elevation 6769.0. Releases from the reservoir were 1700 ft³/s at time photo was taken. — Bureau of Reclamation photo by Glade Walker. 7/17/89

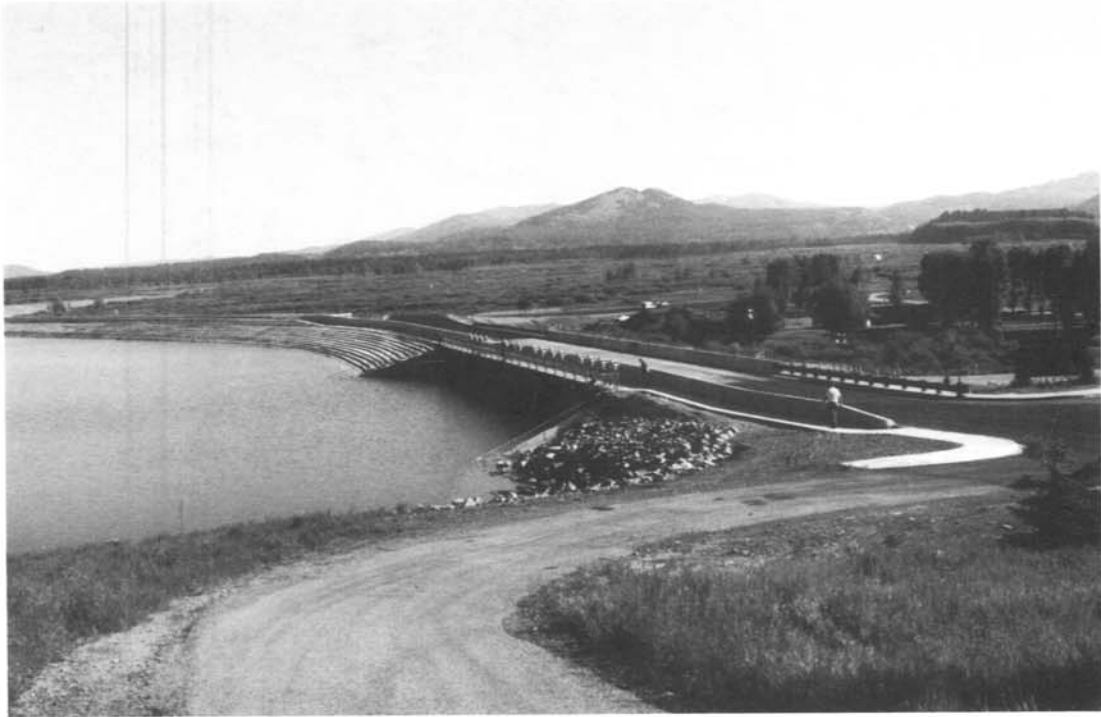
Photo 3. - View of Jackson Lake Dam and Reservoir at water surface elevation 6766.8. — Bureau of Reclamation photo by S. Bareis. 6/27/89

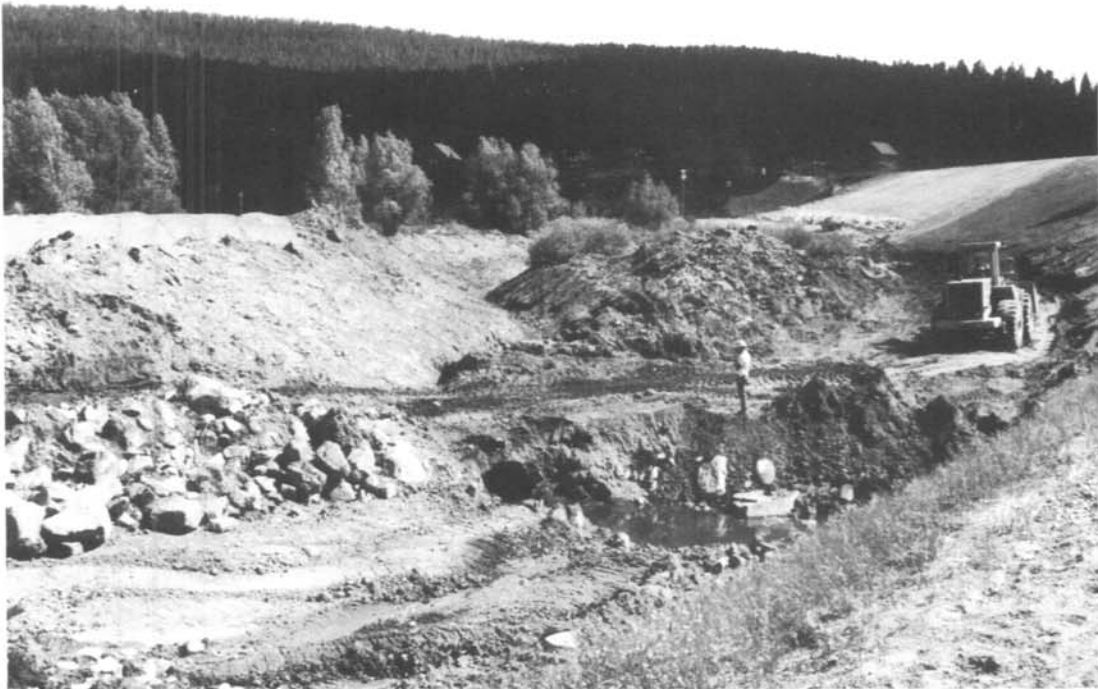
Photo 4. - The photo shows subcontractor constructing a new drainage ditch and rebuilding the embankment of the Teton Park Road to a 2.5:1 slope. Stockpiled fill material is at left, new ditch and temporary CMP at center, and alignment of old ditch (beneath loader) is at right. — Bureau of Reclamation photo by S. Bareis. 6/29/89

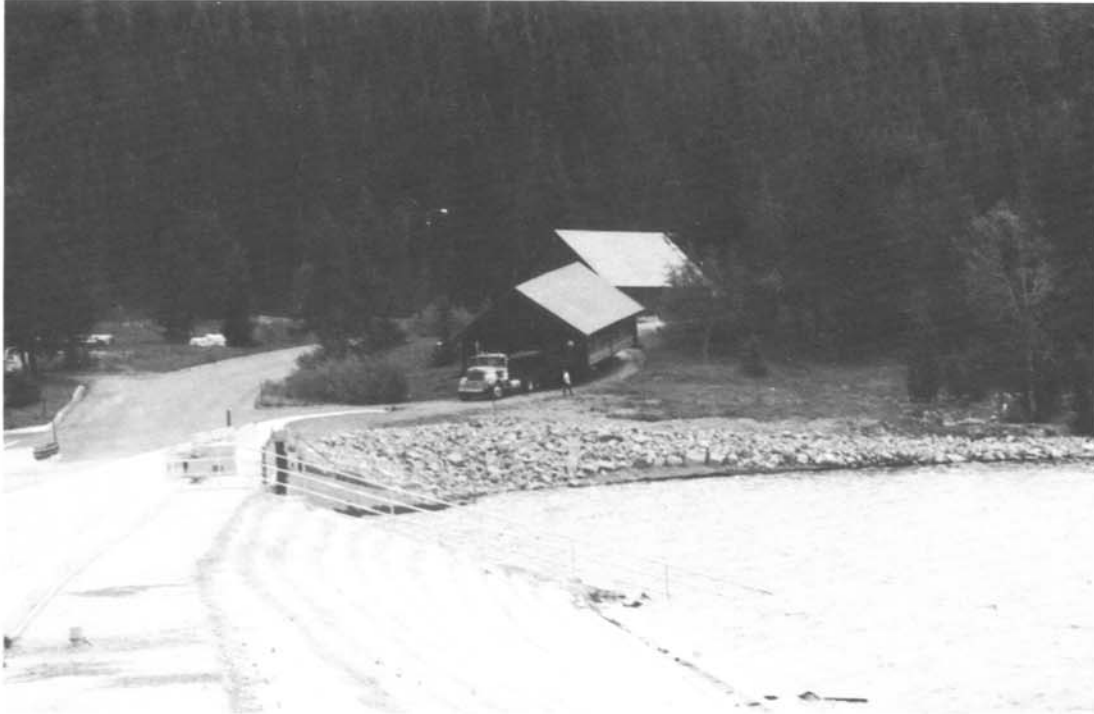
Photo 5. - View of warehouse building being moved from the old Reclamation maintenance area. This area will be turned into a parking lot, and the building will store boats at Colter Bay. — Bureau of Reclamation photo by S. Bareis. 6/26/89

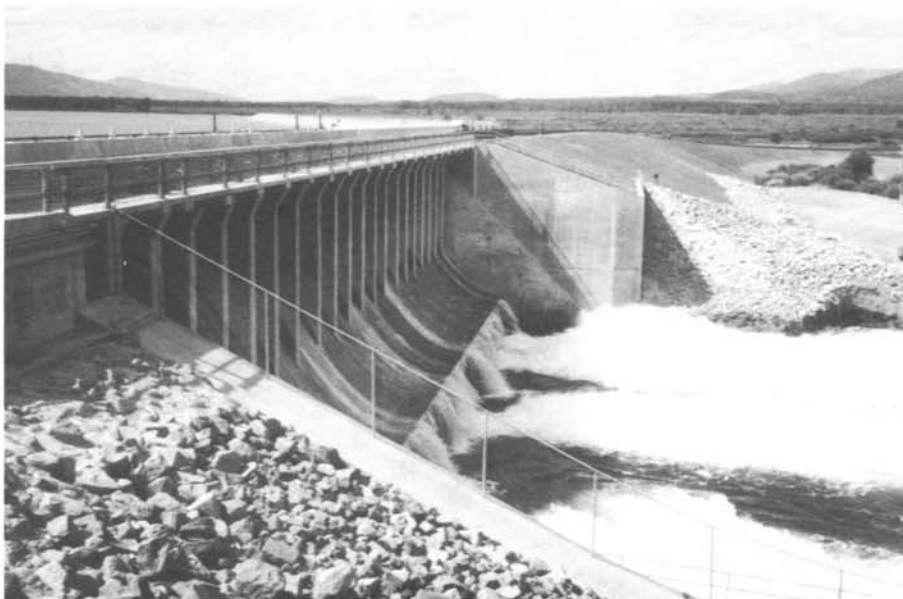
Photo 6. - Jackson Lake Dam discharging about 1,610 ft³/s through the outlet works. — Bureau of Reclamation photo by Bill Bouley. 7/27/89

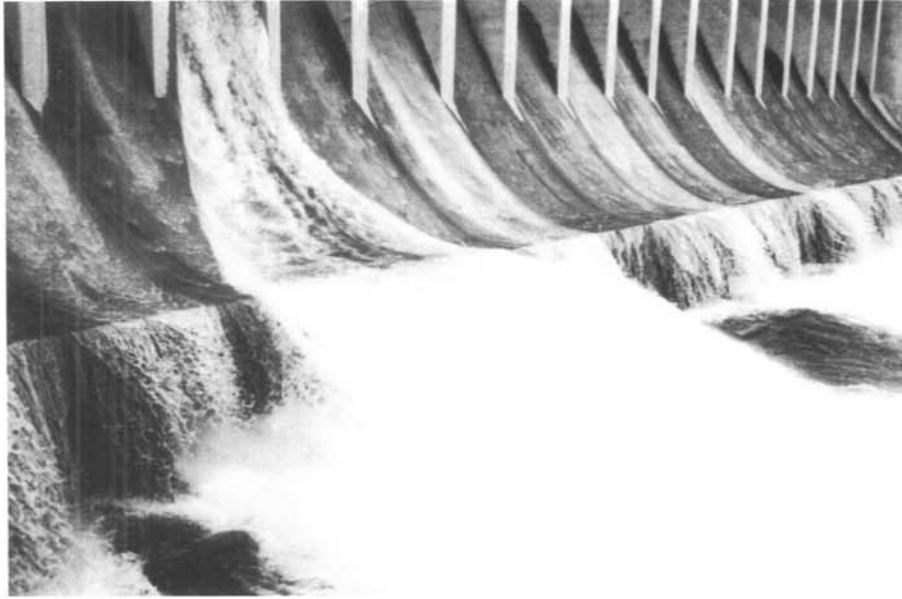
Photo 7. - Jackson Lake Dam spillway radial gate discharge.
— Bureau of Reclamation photo by Bill Bouley. 7/27/89
