# WATER OPERATION AND MAINTENANCE

BULLETIN NO. 174

December 1995

## LABORATORY AND FIELD EVALUATION OF ACOUSTIC VELOCITY METERS AT HOOVER, DAVIS, AND PARKER DAMS

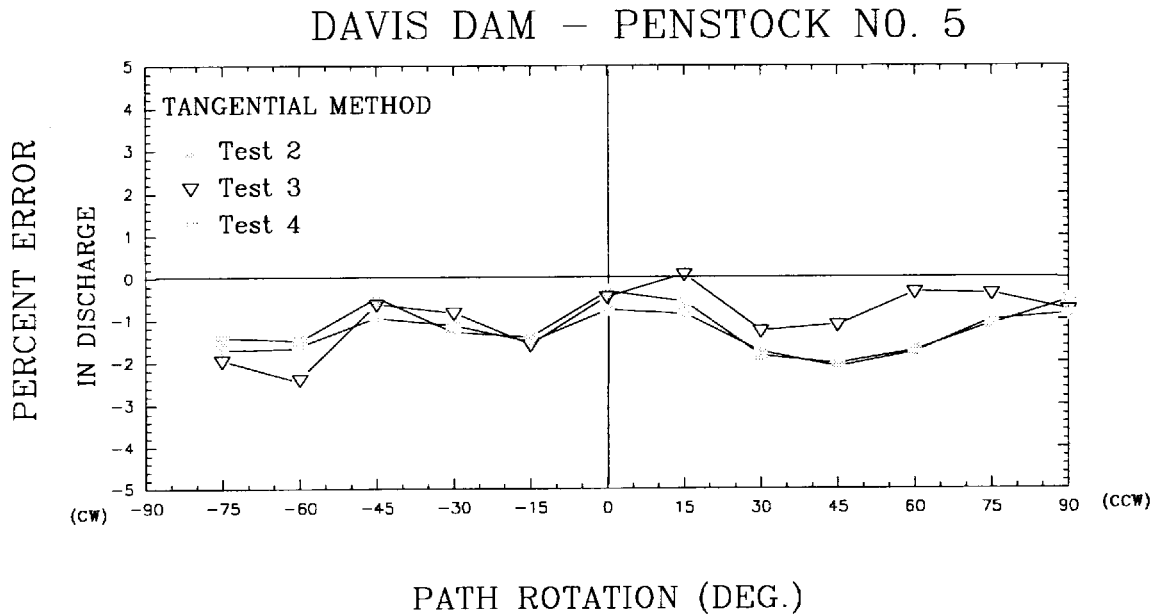
Figure 2.—Percent error in discharge measurement as a function of path rotation. This plot indicates the best transducer configuration is the existing horizontal acoustic paths.

measurement errors as large as 2 percent were measured. An analysis to determine the optimum path orientation (with respect to rotation around the pipe axis) showed the existing condition, horizontal acoustic paths, is optimum (figure 2). For a horizontal path orientation, integration errors in Accusonic's discharge measurement calculations for model tests 2 through 4 were found to be -0.31, -0.44, and -0.75 percent, respectively.

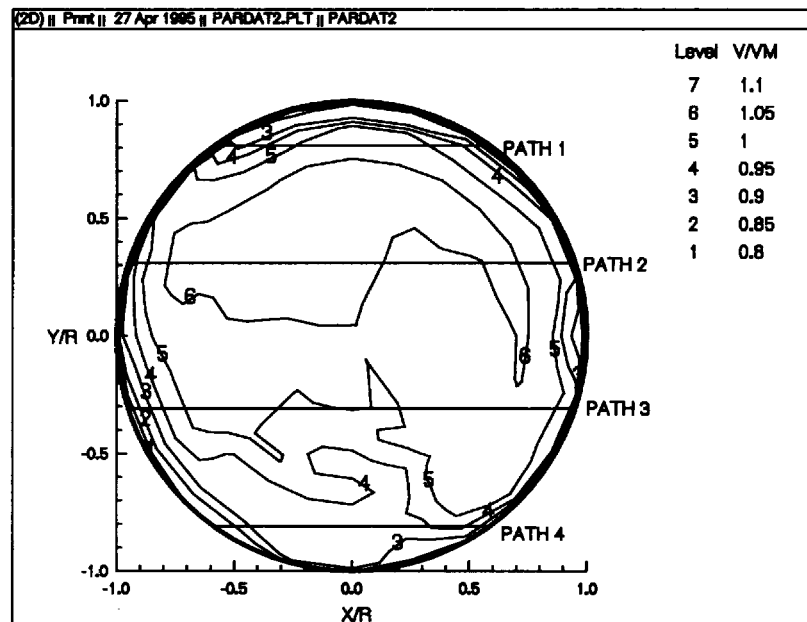
Figure 3.—Parker penstock No. 1 nondimensional velocity distribution (looking downstream) for a prototype discharge of 4,736 cubic feet per second and reservoir elevation 449 feet. The AVM computed flow was biased -0.18 percent from the actual flow.

A nearly symmetrical velocity distribution was identified for Parker penstock No. 1 for all discharges tested (figure 3). A combined bend upstream from the AVM measurement cross section creates a slightly skewed velocity distribution and lower velocities near the pipe invert. Data analysis showed that for this particular velocity distribution, velocities measured along the four acoustic paths are very similar, and path velocities are essentially independent of path orientation.

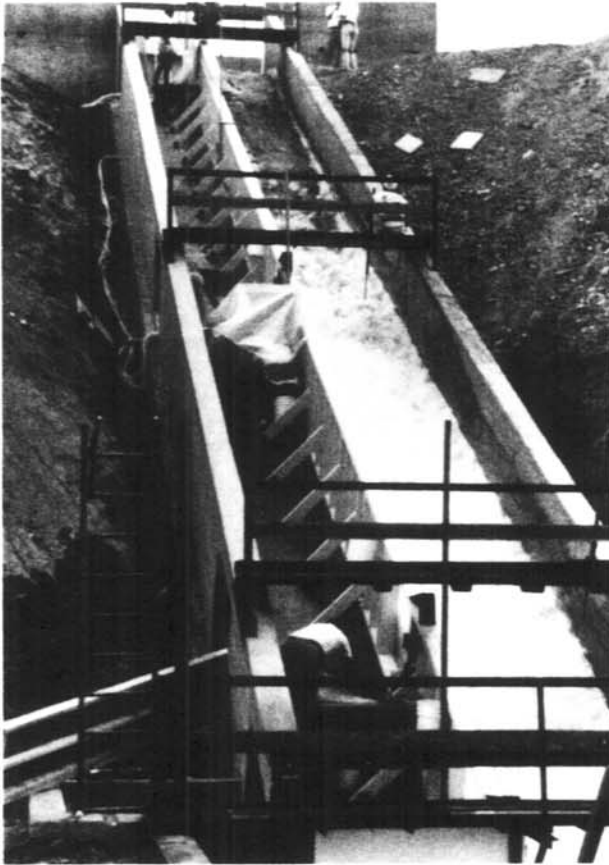
Figure 9.—Large-scale, 15-meter- (50-foot-) high dam overtopping test facility,  $q = 3$  cubic meters/second/meter (32 cubic feet/second/foot).

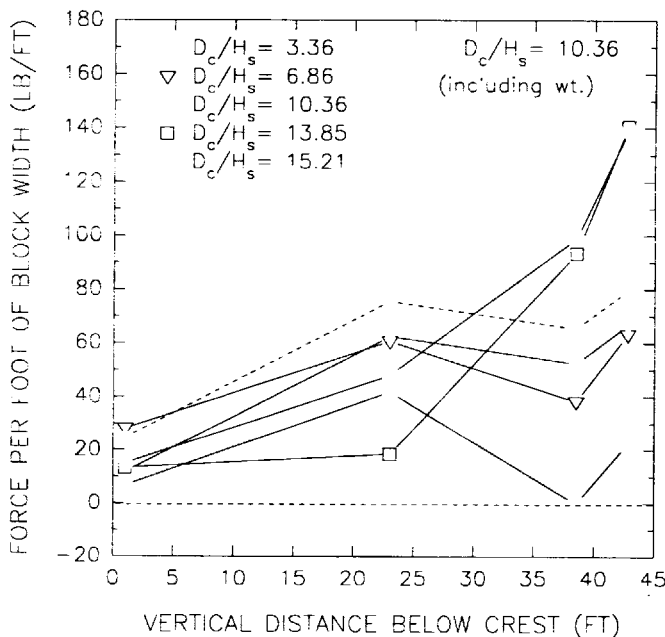
Figure 12.—Net force acting on the block versus distance below the crest.

The stability of the block system has been analyzed as a function of the total forces acting on individual blocks down the slope. Block weight and pressure yield a net downward or positive force normal to the slope. The uplift pressure in the filter material underneath the block and the low pressure zone created by the block offset act in an upward (negative) direction, tending to lift the blocks from the embankment surface (figure 11). Aspiration ports in the vertical face of the block limit the uplift forces by venting the filter layer to the low pressure separation zone. The gradation of the filter must be designed to prevent the filter material from being transported through the aspiration ports. In the analysis, a net positive force indicates a stable block.

The block geometry optimizes the hydraulic forces to produce downward impact pressure and aspiration of subgrade pressures. The stability of the block system is quantified in the graph showing the net force per foot of block width versus the vertical distance below the crest (figure 12). This graph shows the sum of the forces normal to the slope, including integration of the pressure profile on the step tread and the measured filter layer pressure (uplift). The sum of the forces is positive for this block shape and filter, indicating a stable overlay for a 2:1 slope for the range of critical depth ( $D_c$ ) to step height ( $H_s$ ) ratios tested. The submerged block weight of about 6 kilograms (13 pounds) has been added to the forces in the curve formed by the dashed line for  $D_c/H_s = 10.36$  to show the additional stability added by a block of minimal thickness. Not included in the analysis is the additional stability provided by the block overlap, which creates an interlocking affect. These results indicate no decrease in block system stability with unit discharge.

not be a concern. As a result, a free-draining gravel filter underneath the block system will be adequate, and stability may be predicted from figure 12. A dam height,  $H_{dam}$ , of 8 meters (27 feet) and  $D_c/H_s = 15.21$  gives a total positive force of about 89 kilograms/meter (60 pounds/foot) acting to hold the block on the surface. Therefore, a minimal block thickness at the upstream end of the block of 51 millimeters (2 inches) and appropriate aspiration port area will produce a stable block (figure 15).

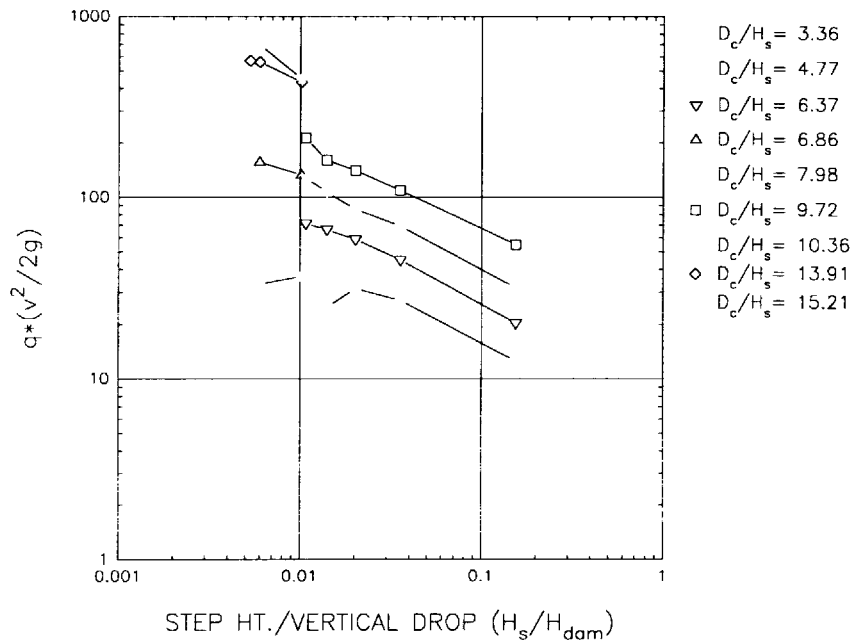
Figure 13.—Graph used to determine the velocity remaining in the flow after traveling down a stepped spillway with 15° tapered overlapping blocks on a 2:1 slope.

From the graph, the larger the step height for a given dam height, the less the energy remaining in the flow at the toe of the dam. Conversely, as the ratio of the step height to dam height decreases, the energy in the flow increases. The energy remaining in the flow is also a function of the critical flow depth to step height ratio. This graph includes a range of critical depths to step height ratios of 3.36 to 15.21. A designer should attempt to remain within this range if possible. At some point for all flow rates, uniform flow is attained and the energy per foot of width remains constant. This equilibrium is shown by the indication of the leveling off of the curves

as the step height to dam height ratio decreases. When uniform flow is reached, then the velocity and depth will remain constant regardless of the dam height. (We are currently working to provide extrapolation of these curves to higher flow rates and to dams of other slopes.)

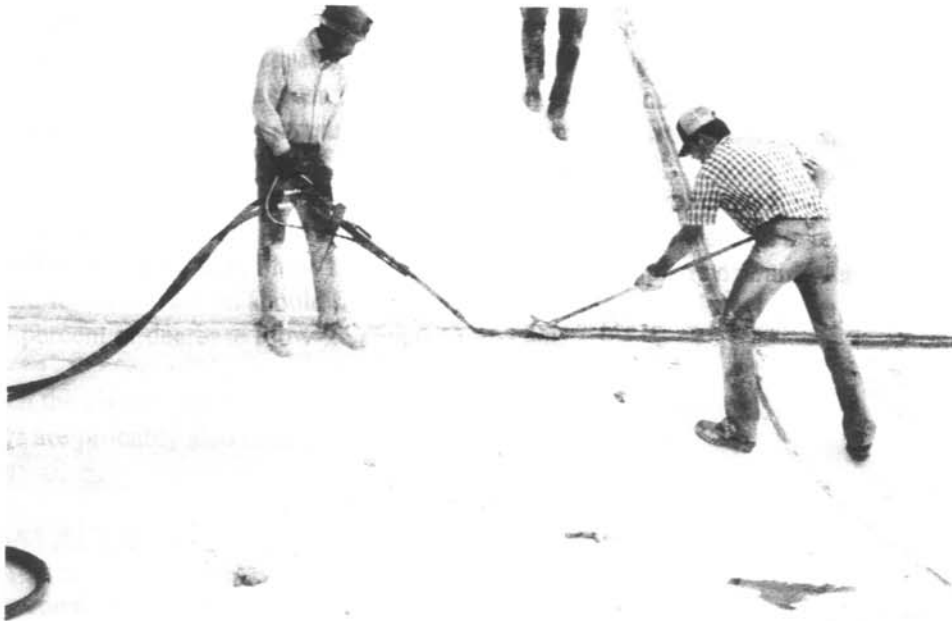
Flexible sealants are used to seal joints in concrete-lined canals to minimize water loss through seepage (see photo below). Sealant manufacturers typically require that the concrete be fully cured (28 days minimum) prior to application of the joint sealant. Otherwise, moisture vapor escaping from the "green" concrete can interfere with the bond between the concrete and the sealant. For concrete less than 28 days old, sealant manufacturers may recommend either a 4-percent maximum concrete moisture content, as determined with a Delmhorst moisture meter, or the absence of any moisture vapor drive as indicated by a "mat test" per ASTM D 4263 "Moisture in Concrete by the Plastic Sheet Method." The mat test consists of taping an 18-inch square of clear plastic to the concrete. The plastic is left in place overnight and then checked the next day for the presence of moisture beneath the mat.

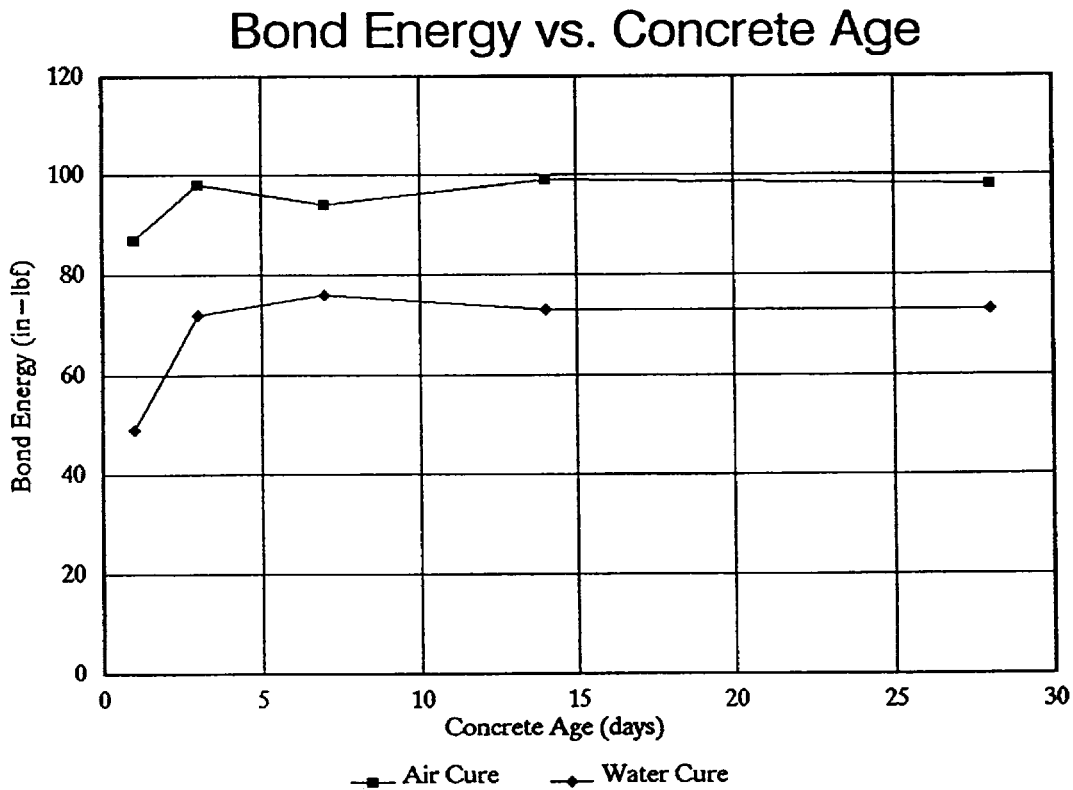
Using Water Technology and Environmental Research funds, the Denver Technical Service Center performed laboratory testing on seven promising canal sealants. The sealants were applied to "green" concrete ranging in age from 1 to 28 days. To simulate field conditions, the sealant specimens were then cured for 35 days in two different environments. The first set of specimens was cured for 35 days in air at 70 °F and 50-percent relative humidity. The second set was cured for 7 days in air, followed by a 28-day water-immersion cure. The water cure more closely simulates field conditions where the concrete structure and sealant are returned to service as soon as possible. After curing, triplicate specimens were tested for modulus, ultimate strength, elongation, and bond energy (area under the stress-strain curve). Of the seven sealants tested, three sealants demonstrated good bond to 1-day-old concrete and full bond to 3- to 7-day-old concrete. Typical results are shown in the graph below.

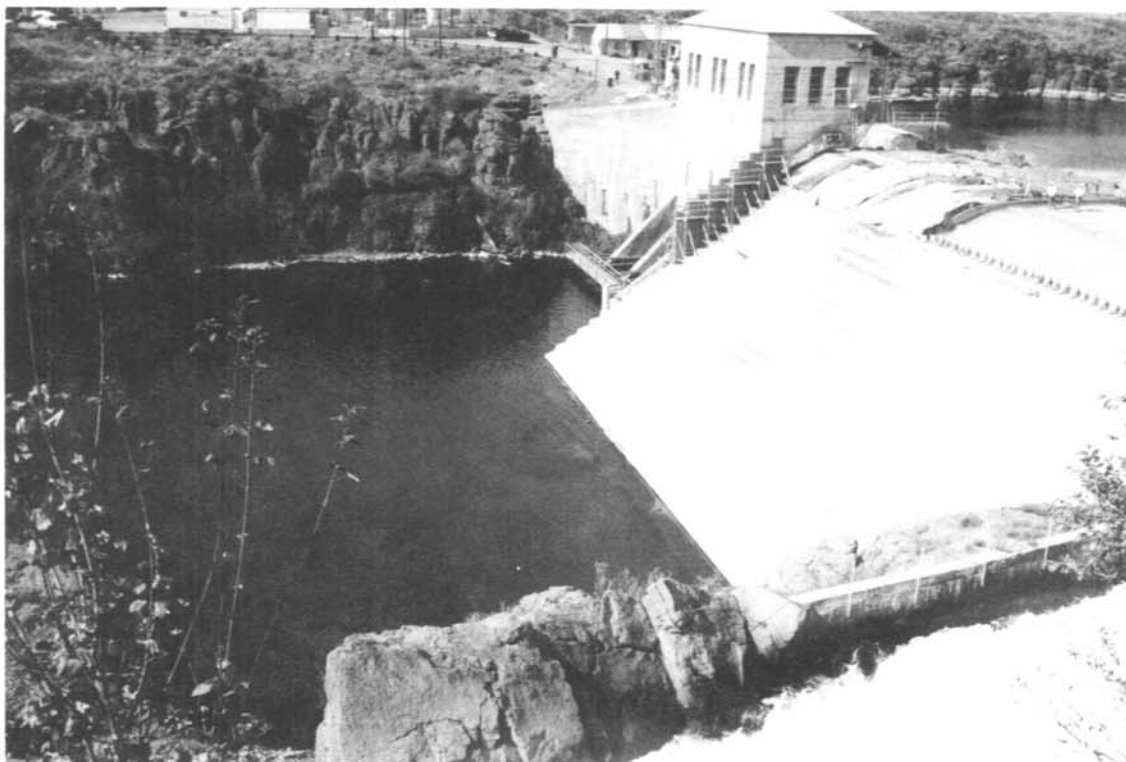
Figure 17.—Ashton Dam in Idaho.

Some recent overtopping protection projects have incorporated formed steps of RCC on the downstream slope. The steps are relatively easy to construct because of the horizontal nature of the RCC construction process. The steps are intended to take energy out of the overtopping flow step by step and thus minimize the need for energy dissipation at the downstream toe of the embankment. Formed 600-meter steps of RCC were used for Ashton Dam in Idaho as shown in figure 17. The RCC for this hydroelectric dam was designed to accommodate a maximum overtopping of 3.6 meters and also served as a zone to improve the structural stability of the steep 1.5H:1.0V downstream embankment slope.

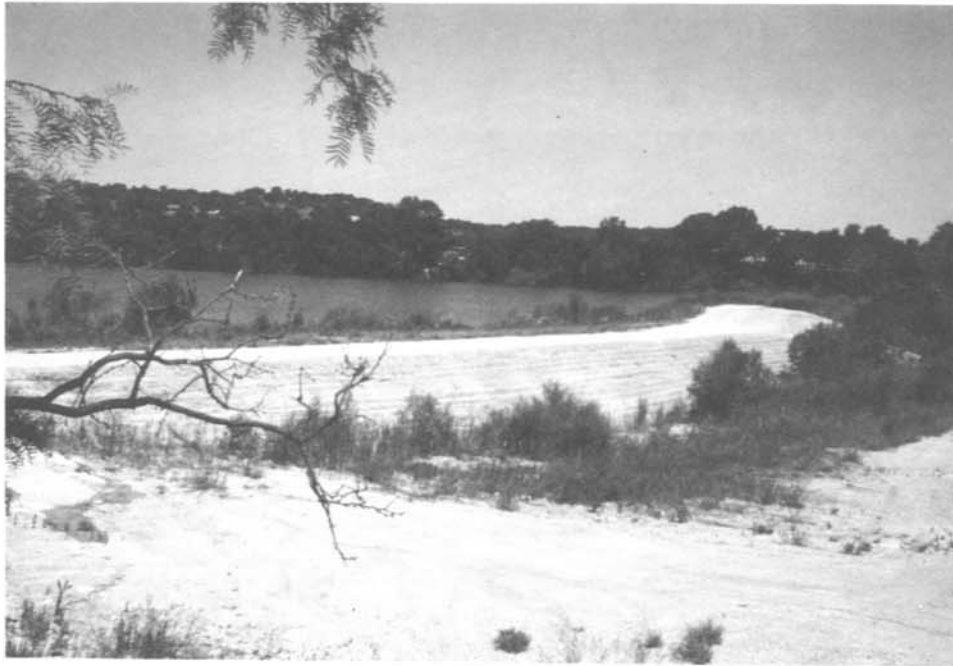
Figure 18.—Brownwood Country Club Dam.

The RCC for the 5.8-meter-high embankment in Texas has experienced at least 6 overtoppings up to 300 millimeters in depth because of floods since its completion in 1982. The uncompacted RCC edges for the Brownwood Country Club Dam are shown in figure 18 following the flows over the RCC protected embankment. Therefore, experience to date has demonstrated satisfactory hydraulic performance and durability of RCC overlays during overtopping flows.
