Pressure Tank Car Crashworthiness

- **Catastrophic tank shell failures**
- **Failure mode and fracture toughness**
- **Reducing risks from pre-1989 tank cars**

Anhydrous Ammonia Loading/Shipping

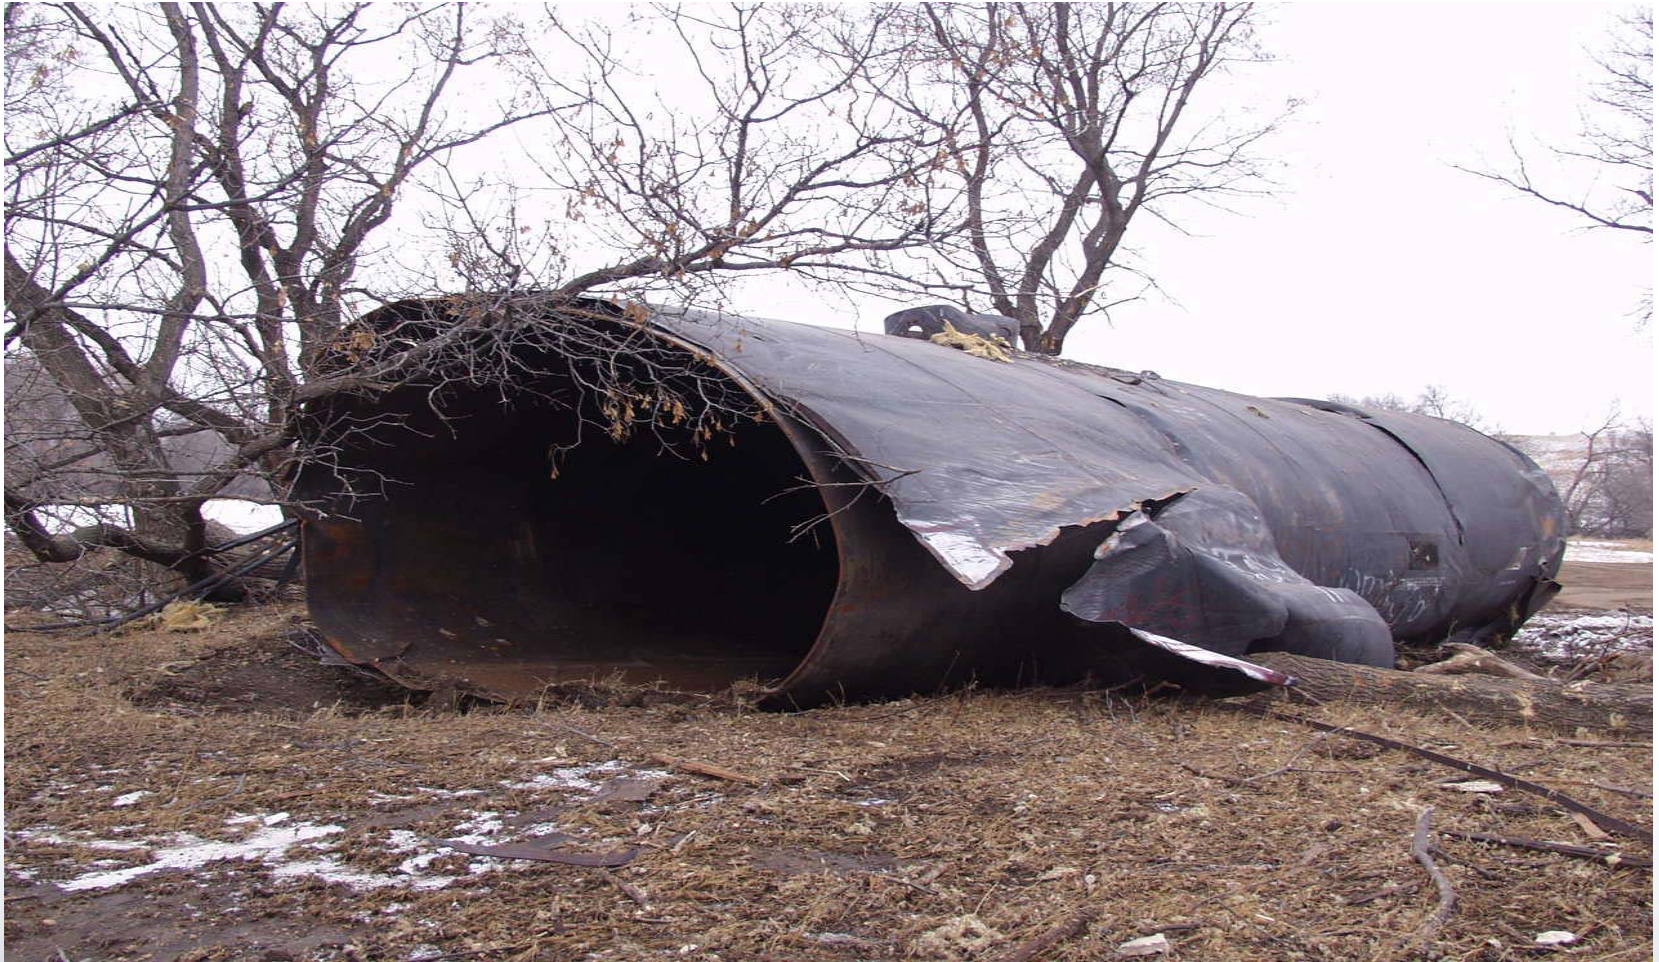
Car #19 - GATX 47814

Tank Car Position in Train – ID #	Ammonia Loaded	Damages	Product Lost
18 – PLMX 4644	29,776 gal	Puncture and tear	100% (leak)
19 – GATX 47814	29,528 gal	Catastrophic rupture	100%
20 – GATX 47837	29,473 gal	Catastrophic rupture	100%
21 – GATX 49248	29,447 gal	Puncture	100% (leak)
22 – GATX 47982	29,481 gal	Catastrophic rupture	100%
23 – GATX 48081	29,213 gal	Catastrophic rupture	100%
24 – PLMX 4504	29,006 gal	Catastrophic rupture	100%

The catastrophic fracture of five tank cars increased the severity of the accident by exposing residents to high concentrations of toxic vapors from the instantaneous release of 146,700 gallons of anhydrous ammonia and to the rocketing of portions of tank cars.
