NATIONAL TRANSPORTATION SAFETY BOARD  
WASHINGTON, D.C.

SAFETY RECOMMENDATION(S)

R-77-19

About 3:51 p.m., on April 10, 1977, a Chicago Transit Authority rapid transit train ran over and killed a passenger who fell from the train as it was leaving the Clinton station in Chicago, Illinois.

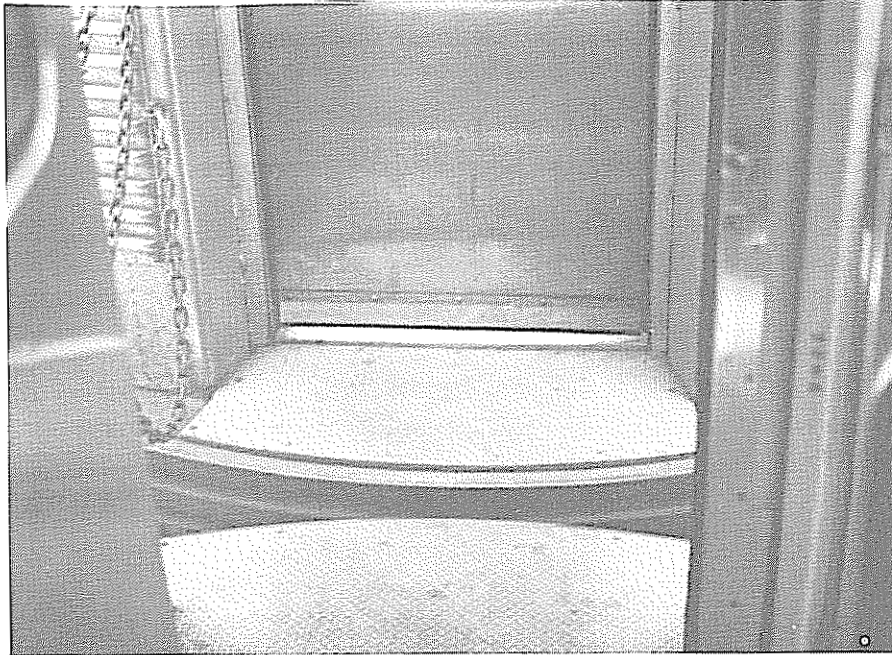
The semicircular end castings of the cars are used as the walkway between the cars when assembled in a train. There is a 3-inch space between the castings at the closest point. As the cars move around a curve the opening widens between the center of the end castings. A plate is not used to bridge the space between the end castings. Three loosely hanging chains secured to each car are intended to provide protection along each side of the walkway. However, they do not prevent someone from falling between or under the chains to the track; this does not provide a safe passageway for persons that move between cars. (See attachment.)

View of end platforms from the interior of a CTA rapid-transit car.

Provide a safe passageway between rapid transit cars when passengers are permitted or required to move from one car to another. (Class II, Priority Followup) (R-77-19)

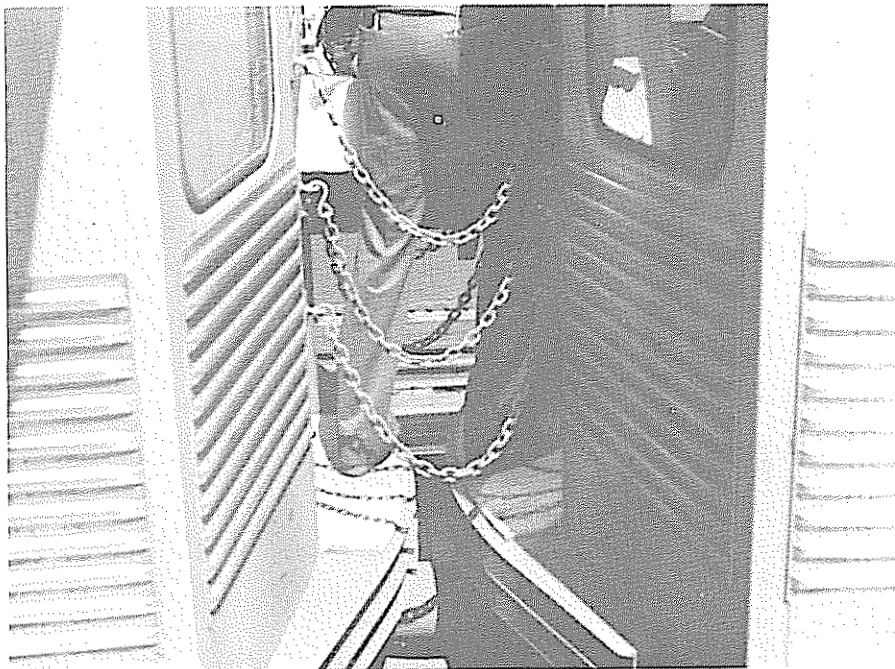
The accident occurred while a woman and two small children were moving from the overcrowded rear car to another car of a four-car train. As the woman stepped across the gap between the two cars, she lost her grip on her 2-year-old girl. The child slipped from the walkway and fell through the side chains to the track.

View of area between two rapid-transit cars. The lowest point of the top chain is about 26 inches above the platform. A 3-inch gap separates the platforms.
