## Runaway Train at the Nevada Test Site

### Introduction

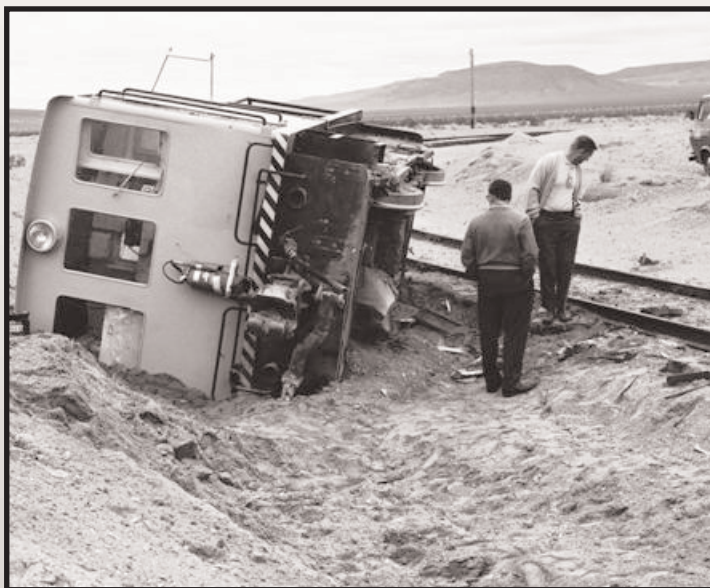
*The derailed locomotive lies 180 degrees from its direction of travel as investigators inspect the site.*

Careful examination of the runaway train's wheels found that all four wheels had flat spots on one side as a result of brake locking.

The final investigation report concluded that the accident was caused by too great a load for the locomotive. Grease and moisture on the tracks, lack of sanding equipment on the locomotive, and no brakes on the flatcar were all contributing factors to the wreck.
