CHAPTER 2.0

EXISTING CONDITIONS

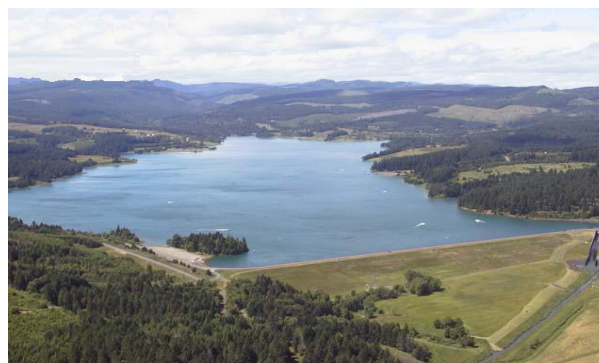
Photo 2-1. Aerial view of Henry Hagg Lake and surrounding foothills and Coastal Mountain Range.

Much of the land surrounding the reservoir is hilly and has slopes of 20 percent or greater (Figure 2.1-1) (Reclamation 1994). Elevations within the park range between 180 and 450 feet but adjacent features extend to above 1,000 feet. Level areas can be found adjacent to the reservoir particularly between Scoggins and Tanner Creeks and north of the Sain Creek cove. In many areas moderate slopes lead from the reservoir edge at full pool (Photo 2-1).

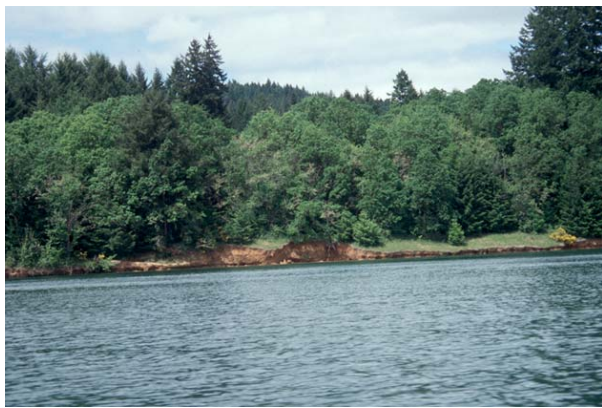
Photo 2-2. Shoreline erosion near Elks Picnic Area.

Soil erosion in surrounding lands and the resulting deposition of sediments into Henry Hagg Lake have been long-standing concerns of land managers (Photos 2-2 and 2-3). In planning for park development prior to the construction of Scoggins Dam, potential sediment yield and lost reservoir capacity

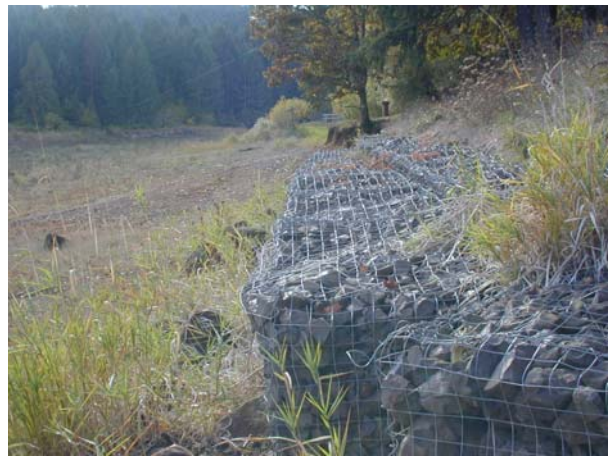
Photo 2-3. Shoreline erosion control structure at Sain Creek Picnic Area (at low pool).

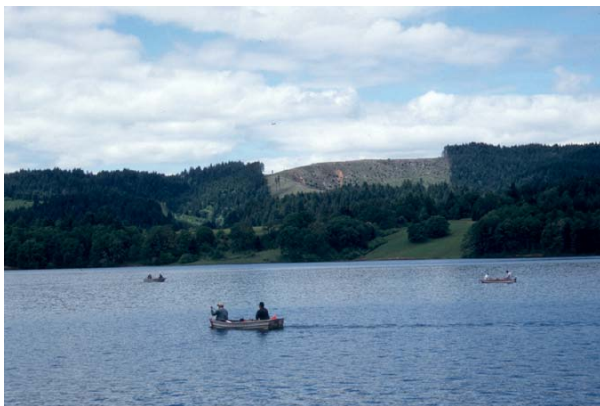
Photo 2-4. Grasslands, mixed forest, coniferous forest, and clearcuts as seen from Henry Hagg Lake.

Forested areas account for more than 70% of the upland habitat in the RMP study area and include: conifer forest, mixed (coniferous/deciduous) forest, clearcuts less than 1 year old, clearcuts 1 to 5 years old, and managed tree farms (Photo 2-4). Grassland areas in the vicinity of Henry Hagg Lake include: general upland grassland (typically used for agriculture), upland grassland with mixed shrub, and those grassland areas designated as elk mitigation meadows. The following narrative describes the primary components of each vegetation category. Vegetation association acreages are listed in Table 2.1-6.
