Comparison of Ceramic and Polymer Crevice Formers on the Crevice Corrosion Behavior of Ni-Cr-Mo Alloy C-22

Xi Shan, Joe H. Payer
Department of Materials Science and Engineering
Case Western Reserve University, 10900 Euclid Ave, Cleveland, OH 44106
Contact author: 216-368-4218, joe.payer@case.edu

Abstract:

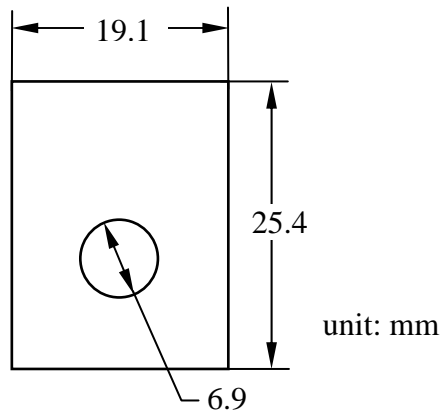
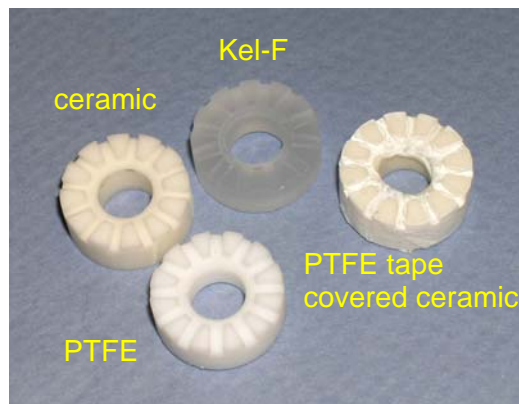
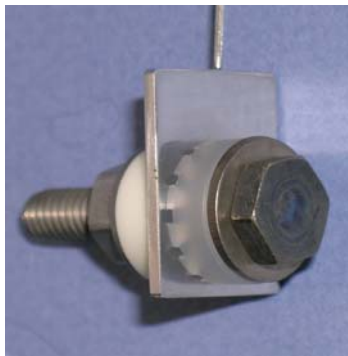
Figure 1 MCA crevice test specimen

(a) test specimen

(b) crevice formers

(c) MCA assembly with Kel-F and ceramic crevice formers

The alloy C-22 (N06022) Multiple Crevice Assembly (MCA) [15] specimens used in this study were fabricated from ~ 2mm thick wrought plate, which was obtained from Haynes International, Inc. The chemical composition is shown in table 1. The shape and dimension of the MCA specimen are shown in figure 1a. The crevice formers used in this study were: obtained from Metal Sample Inc., PTFE Teflon crevice former, Kel-F (PCTFE) crevice former and PTFE Teflon tape covered ceramic crevice former. The shape and dimensions of the crevice formers are shown in figure 1b after specification ASTM G48 [15].

minutes. The ceramic crevice formers were used in the as-fabricated condition, while the Kel-F and PTFE Teflon crevice formers were ground with 1200 grit SiC sand paper. The crevice formers were also cleaned with methanol. After grinding and cleaning, the specimen and two crevice formers were assembled together with grade 2 titanium bolts, nuts and washers that were electrically isolated from the metal specimen. Figure 1c shows the MCA assembly of SS316 with two crevice formers.

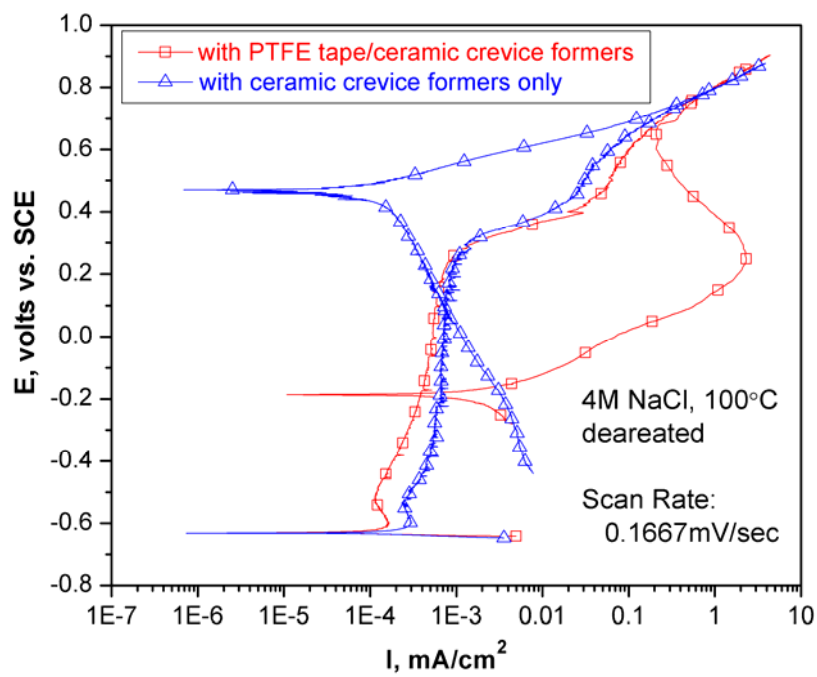
Figure 2 Cyclic polarization curves of alloy C-22 with PTFE tape covered ceramic crevice formers and ceramic crevice formers, 4M NaCl, 100°C, scan rate = 0.1667mV/sec

Figure 2 shows the cyclic potentiodynamic polarization curves of alloy C-22 with (a) PTFE tape covered ceramic crevice formers and (b) ceramic crevice formers in de-aerated 4M NaCl at 100°C. In the forward scan, these two samples showed similar behavior. Both samples had a corrosion potential of -0.629 V-SCE and a breakdown potential at +0.240 V-SCE. The crevice formers had no effect on the corrosion and breakdown potentials of alloy C-22. While in the reverse scan, there is a difference in the curves obtained with these two crevice formers. There is a large hysteresis loop during the reverse scan of the sample with PTFE tape covered ceramic crevice formers. The repassivation potential for the sample with PTFE tape covered crevice formers was -0.182 V-SCE. This value is in fair agreement with the -0.195 V-SCE result obtained by Ilevbare [9]. A potential of -0.150 V-SCE was applied in the potentiostatic tests, i.e. a potential 30 to 50 mV more positive than the repassivation potential.

Crevice corrosion and corrosion products were found under the crevice feet of the PTFE tape covered ceramic crevice formers sample. During the reverse scan of the sample with the ceramic crevice formers, the sample repassivated easily, and no crevice corrosion or corrosion products were found under the crevice feet. These results indicate that the crevice corrosion, where observed, initiated after the specimen was polarized beyond the

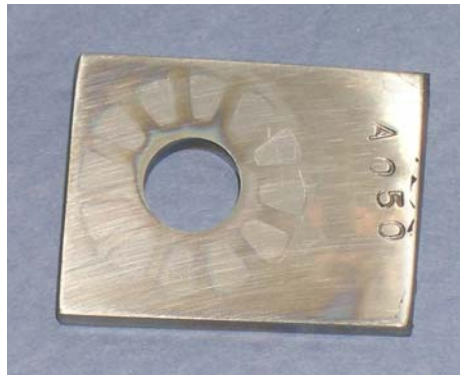
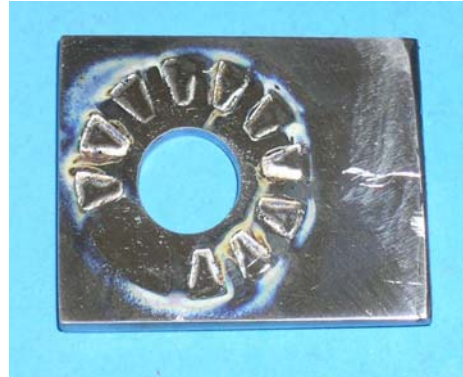
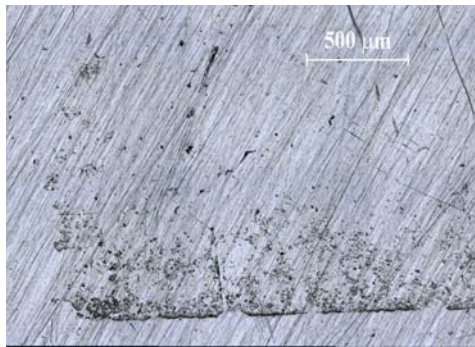
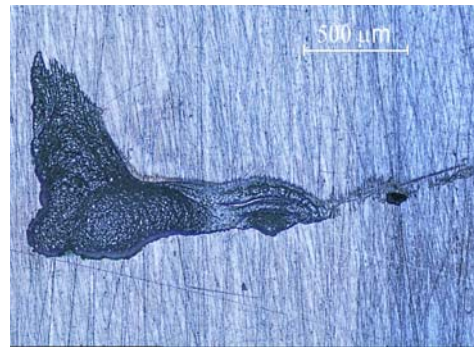
Figure 3 Crevice corrosion morphology with ceramic crevice former and PTFE tape covered ceramic crevice former on alloy C-22 and SS316, (a) alloy C-22, ceramic side (b) alloy C-22, PTFE tape covered ceramic side (c) SS316, ceramic side (d) SS316 PTFE tape covered ceramic side

Figures 3a and 3b show the potentiostatic test results of alloy C-22 in 4M NaCl at 100°C with ceramic crevice former and PTFE tape covered ceramic crevice former. The charge of the sample during the 67 hour test was 10 coulombs. The test protocol was to initiate crevice corrosion and to stop the test after 10 coulombs of corrosion current, and for this test 10 C was reached after 67 hours exposure. This was one of a series of tests to examine the crevice corrosion damage after controlled amounts of total coulombs had passed.

Figure 3a shows the morphology on the side with the ceramic crevice former, while figure 3b shows the morphology on the side with PTFE tape covered ceramic former. Localized corrosion and corrosion products were not observed under the ceramic crevice former feet however superficial mechanical damage was observed. The damage was attributed to the high torque during assembly.

, Green-black corrosion products were observed outside the crevice former on the side with PTFE tape covered ceramic crevice former during the test. The crevice former was removed at the end of the test, and crevice corrosion was found under the crevice former feet. Black, loose corrosion products were found in the corroded regions of the crevice.

Similar results were obtained on SS316 as for alloy C22. Figures 3c and 3d show the morphology of the SS316 specimen after being tested with ceramic crevice former and PTFE tape covered ceramic crevice former on each side of the specimen. The specimen was held under +0.100 V-SCE in 0.5M NaCl solution for 2.5 hours at room temperature. Severe corrosion with a depth up to 200 μm was found under the crevice former on the side with PTFE tape covered ceramic, while on the side with ceramic crevice former, only mechanical damage caused by the compression of the ceramic crevice former was found.

Crevice corrosion on alloy C-22 and SS316 was not found on the side with ceramic crevice former, and only superficial mechanical damage under the ceramic crevice formers was found as shown in figures 3a and 3c. To confirm that the damage on the ceramic crevice former side is mechanical damage, a 20 day test using two ceramic crevice formers was performed on alloy C-22 under -0.150 V-SCE potential in the 4M NaCl solution at 100°C. Post test examination with SEM shows no crevice corrosion under the crevice former. Figures 5a and 5b show SEM pictures of the alloy C-22 sample after 20 days of testing with two ceramic crevice formers. For comparison, a sample assembled with two ceramic crevice formers in air to the same torque and held for 2 hours without any corrosion exposure was also prepared and examined with SEM. The morphology under the crevice former is shown in figures 5c and 5d. No apparent differences can be found between the morphologies obtained under these two conditions. The damage depths of these two samples are similar at less than 3 μm . A similar result was obtained on SS316. The depth of the damage in figure 3c is less than 3 μm , and the morphology is similar to the one without corrosion exposure testing. The conclusion is that the damages under the ceramic crevice former in figures 3a and 3c are mechanical damages caused by the compression of the ceramic crevice former. Localized corrosion did not occur.

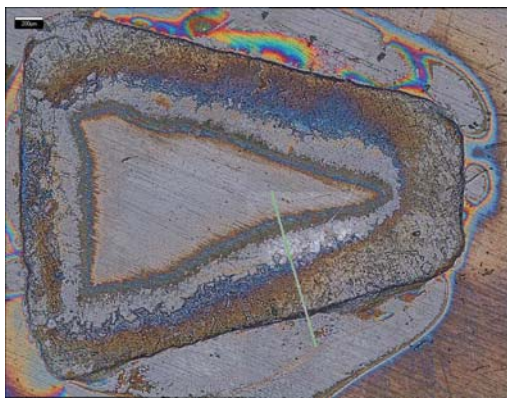
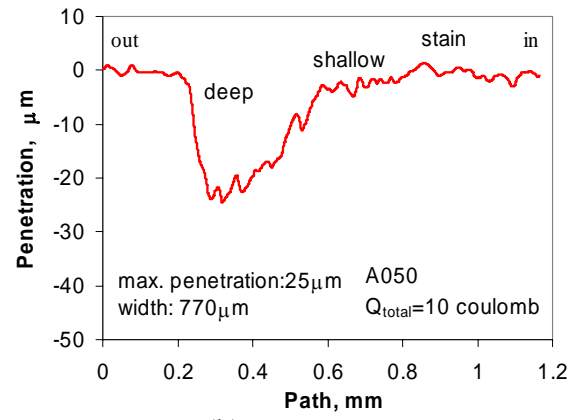
Figure 4 Corrosion morphology of alloy C-22 under PTFE tape covered ceramic crevice former, $Q=10$ coulomb, number of feet corroded = 10

Corrosion depth profiles after the tests measure the amount and distribution of the corrosion damage. Figure 4a shows a corrosion site beneath a contact foot of the crevice former on the alloy C-22, PTFE tape covered ceramic specimen shown in figure 3b. Figure 4b shows the corrosion depth profile across the damaged area along the line in figure 4a. Note the dimensional scale on the depth of the penetration scale is nearly 1000 times that of the width. The horizontal penetration is about 770 μm wide and the maximum depth is about 25 μm . Based on the depth of damage profile, the corroded area can be divided into three regions. The penetration is observed near the edge of the crevice foot, then there is a deeper corrosion region that has the maximum corrosion depth. The corrosion depth profile changes faster in this deeper corrosion region than in the other regions. Following the deeper corrosion region there is a plateau region, where the corrosion depth is shallower and the depth of penetration decreases slowly. Next is a stained region between the corroded and uncorroded areas. In the stained region, the surface is covered with a thin

layer of tenacious corrosion products. The central region of the crevice foot contact is uncorroded.

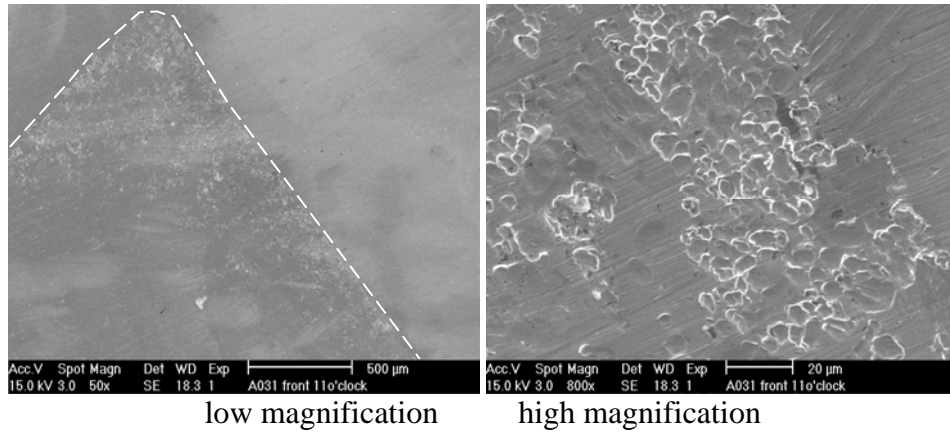
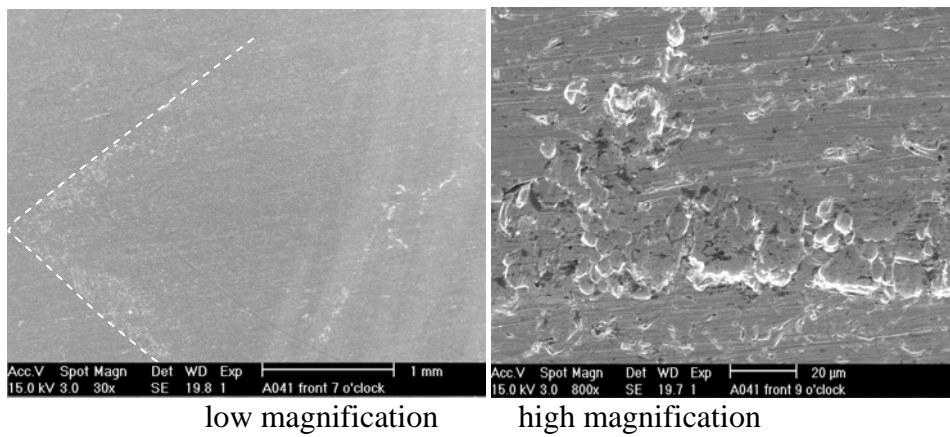
(a) tested for 20 days

(b) assembly only sample without test

Figure 5 Damage morphology of alloy C-22 under ceramic crevice former, the dash line shows the outline of the crevice former foot

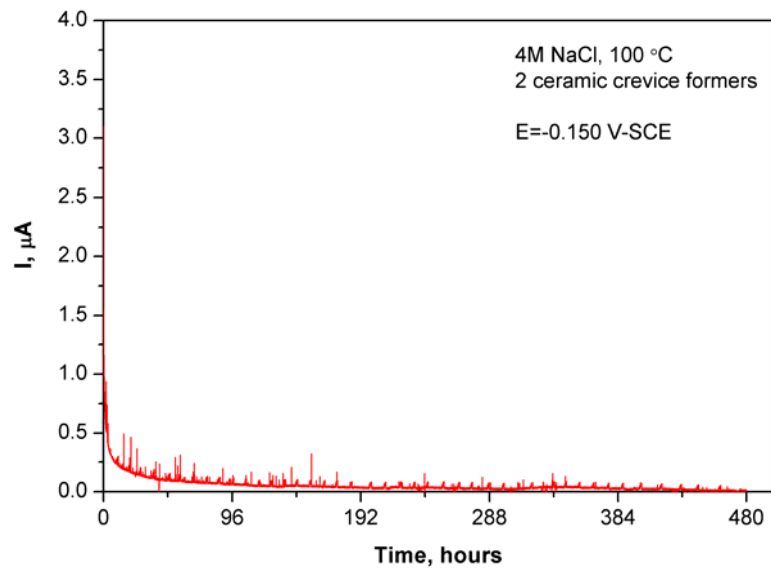
Figure 6 Current vs. time changes of alloy C-22 during the test with two ceramic crevice formers, 4M NaCl, 100°C, E=-0.150 V-SCE

The magnitude of the corrosion current during the constant potential exposure is an indication of the corrosion rate during the test. Figure 6 shows the current vs. time changes

during the test with two ceramic crevice formers. Overall the corrosion current decreases with increasing test time. The initial current of about $3\mu\text{A}$ decreased to $1\mu\text{A}$ after 30 minutes. The corrosion current decreased further to approximately $0.1\mu\text{A}$ after about 100 hours. The final corrosion current was $0.04\mu\text{A}$ after 20 days of testing. The total surface area of the specimen was 10cm^2 , and the corrosion current density was $0.004\mu\text{A}/\text{cm}^2$ based on the total specimen area. The corrosion current showed no initiation of crevice corrosion, and the alloy stayed in the passive state during the whole test period. This is further substantiation that the damages under the ceramic crevice former in figure 3a are mechanical damages caused by the compression of the ceramic crevice former.

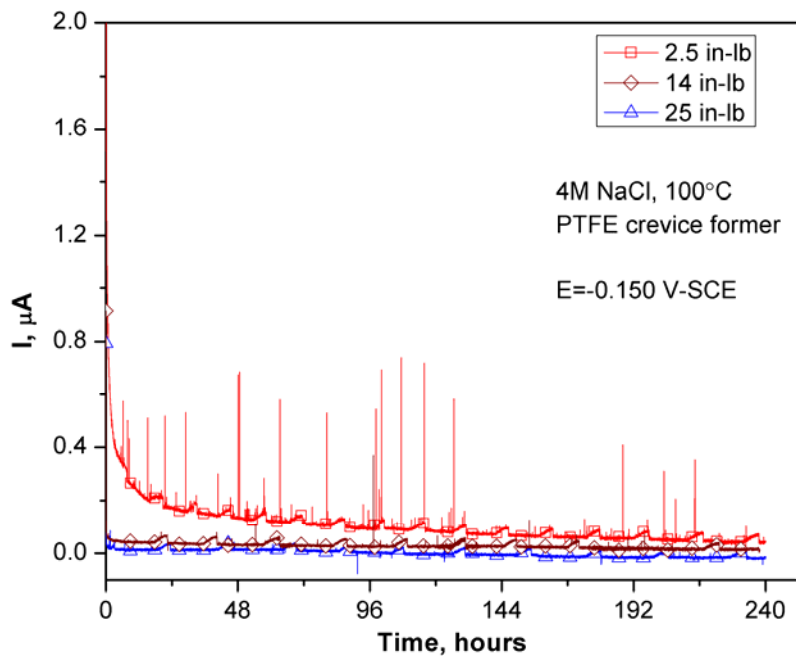
Figure 7 Current vs. time changes during the test of alloy C-22 with ceramic crevice former and PTFE crevice former, 4M NaCl, 100°C, E=-0.150 V-SCE

The current vs. time curve for the test with PTFE crevice former/PTFE tape covered ceramic crevice former is shown in figure 7. The current vs. time curves for PTFE/ceramic and PTFE/Kel-F (not shown) combinations are similar. The current decreased to low values and remained low throughout the tests. The specimens stayed in passive states during the whole test period. No corrosion damage was observed after the tests were completed.

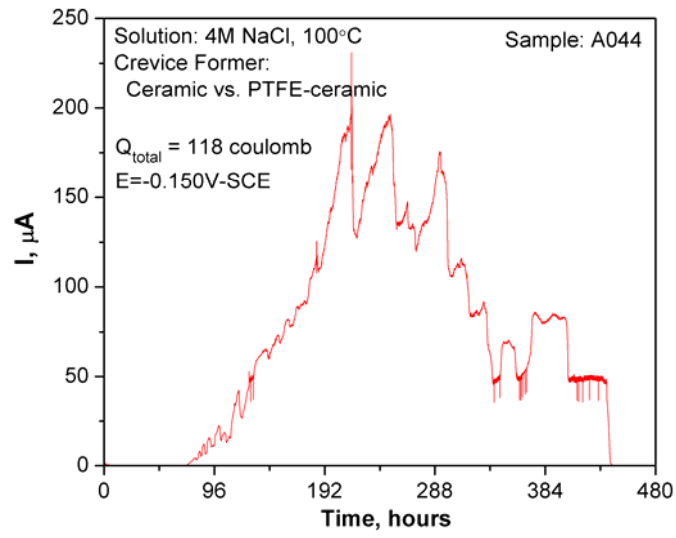
Figure 8 Current vs. time changes of alloy C-22 for test with PTFE tape covered ceramic crevice former, total feet corroded = 9, $Q = 118$ coulomb

Figure 8 shows the corrosion current vs. time curve for the test with ceramic crevice former vs. PTFE tape covered ceramic crevice former in 4M NaCl at 100°C. The test duration was 442.6 hours., Three different stages are shown on the corrosion current vs. time curve. During the initiation stage, the corrosion current was small and on the order of 0.13 μA . There was an increase in the corrosion current after about 71 hours, which corresponds to the initiation of the crevice corrosion. During the propagation stage, multiple initiation and arrest events were observed as serrations on the current vs. time curve. When the current reached a maximum value of about 200 μA , the overall current started to decrease. When the total charge reached 118 coulombs, the current decreased to lower than 1 μA , and the sample became repassivated. At the end of the test, the corrosion current was less than 0.3 μA and showed a tendency to continue decreasing.

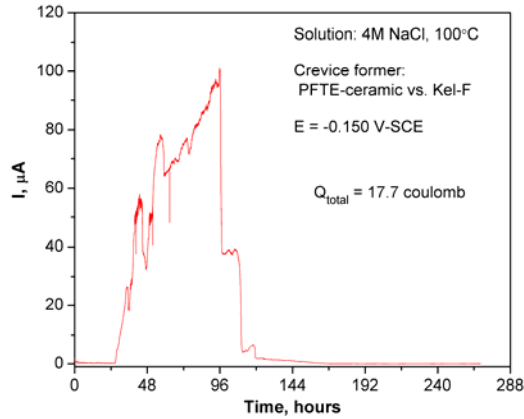
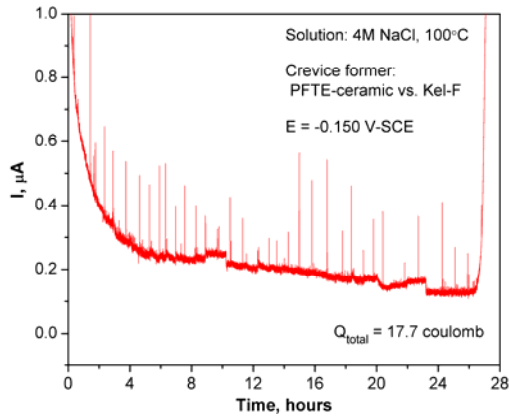
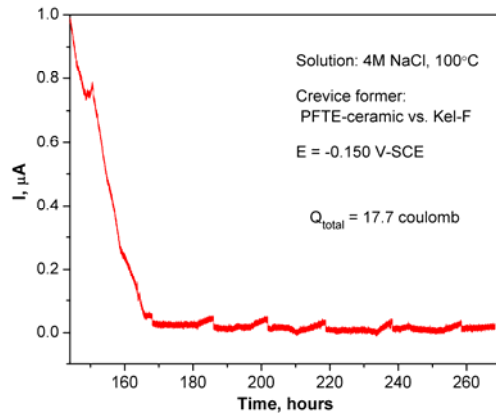
(a) Current vs. time

(b) initiation

(c) repassivation

Figure 9 Initiation and repassivation events in the crevice corrosion process of alloy C-22, PTFE tape covered ceramic/Kel-F, feet corroded = 10, Q= 37 coulomb

Other specimens where crevice corrosion initiated on the PTFE tape covered ceramic showed similar current vs. time behavior with multiple propagation, stifling and arrest events. Figures 9a, 9b and 9c show the current vs. time behavior of a sample with PTFE tape covered ceramic crevice former and Kel-F crevice former tested in 4M NaCl at 100°C. The crevice corrosion occurred on the side with PTFE tape covered ceramic crevice former during the test. In the incubation period, the corrosion current decreased

with increasing exposure time, and the current was $0.13 \mu\text{A}$ before the initiation of the crevice corrosion. 26 hours into the incubation period, crevice corrosion initiated as indicated by the sharp increase of the corrosion current, and the crevice corrosion changed to the propagation period. During the propagation period, corrosion current initiation and arrest events occurred several times. After reaching a maximum current of $100 \mu\text{A}$, the overall corrosion current started to decrease, and the sample gradually became repassivated. The sample stayed in the repassivation state for more than 100 hours until the test was stopped. No indication of the re-initiation of crevice corrosion was observed. The corrosion current was only $0.04\mu\text{A}$ at the end of the test.
