Hurricane Katrina Rapid Response Wind Water Line Report – Mississippi

Task Order 416

June 9, 2006 (*Final Report*)

Hazard Mitigation Technical Assistance Program
Contract No. EMW-2000-CO-0247
Task Order 416
Hurricane Katrina Rapid Response
Wind Water Line (WWL) Data Collection – Mississippi
FEMA-1604-DR-MS

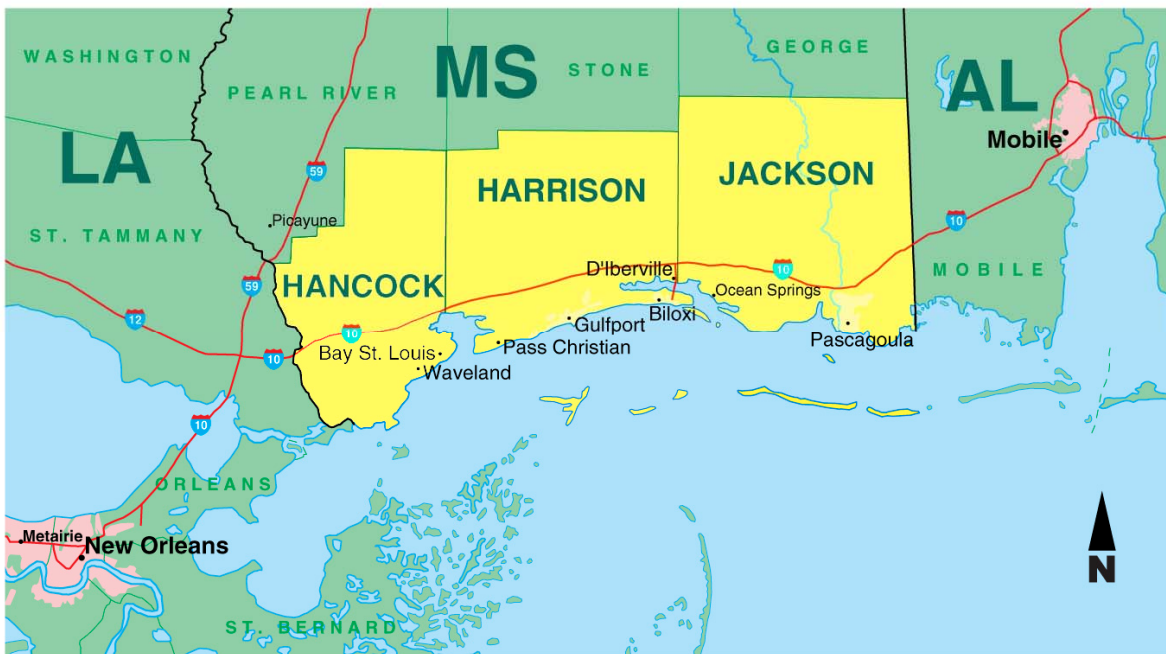
Figure 5: WWL Study Area within Mississippi

The entire Katrina WWL study area extended from southwest Alabama west through coastal Mississippi and southeastern Louisiana. This report focuses on the results of data collected in Mississippi to determine the WWL. In Mississippi the entire coastline was studied to identify areas where wind and water damages occurred and inland areas where damages were caused primarily by wind. Figure 5 shows the study area within Mississippi, with the coastal counties highlighted in yellow.

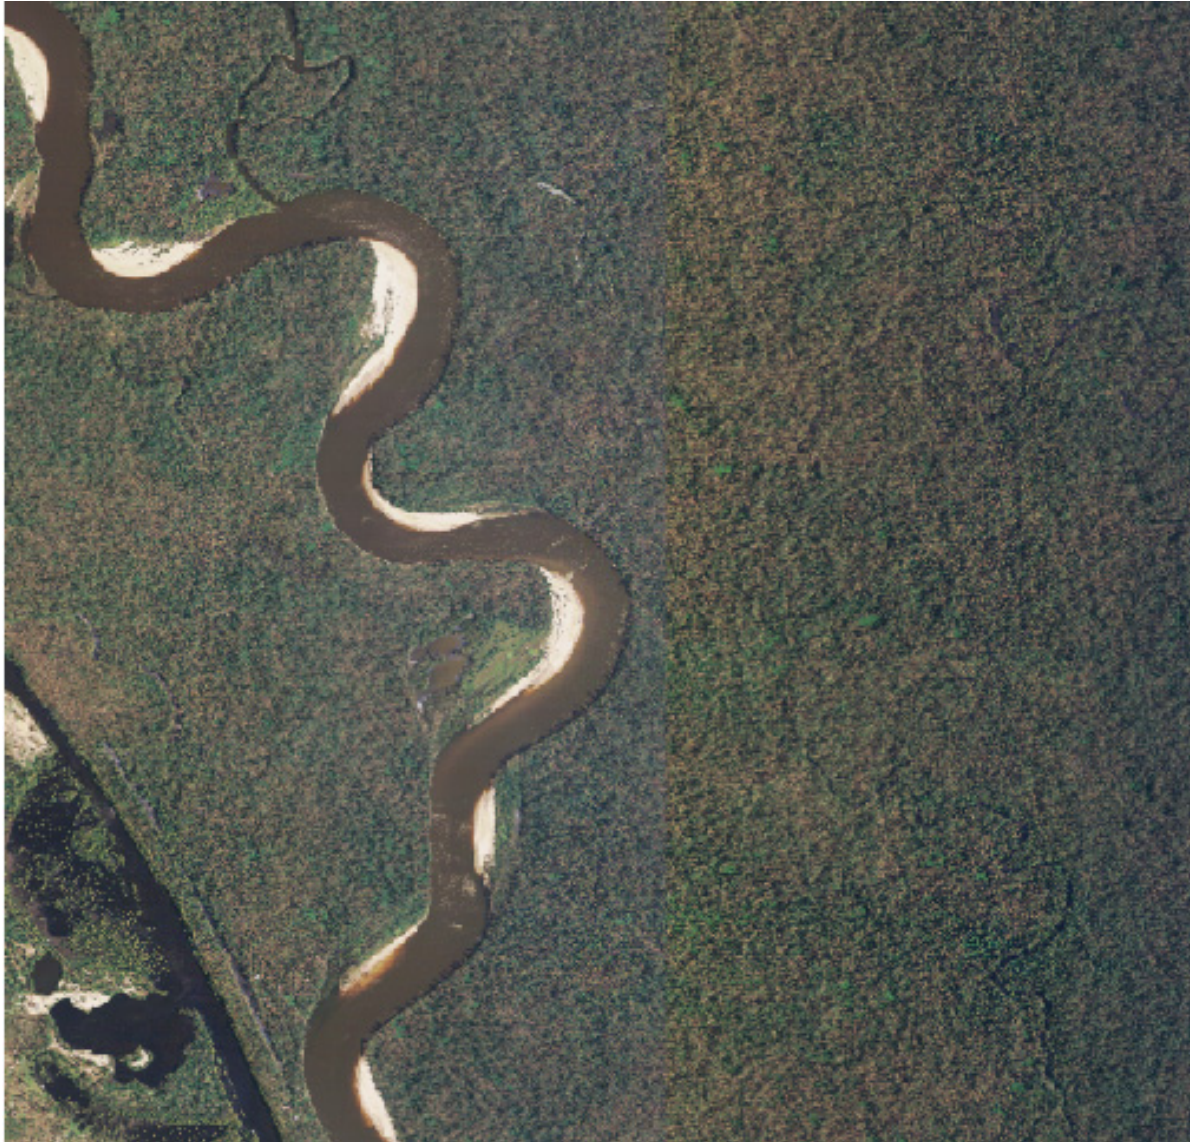
Figure 1 shows a case of inland flooding along a river, where the high water had partially receded by the time the photograph was taken. In such cases, analysts designated any areas covered with mud, sand, or silt, as well as areas where the color of the ground or vegetation indicated a high level of moisture due to recent inundation, as “flooded.”

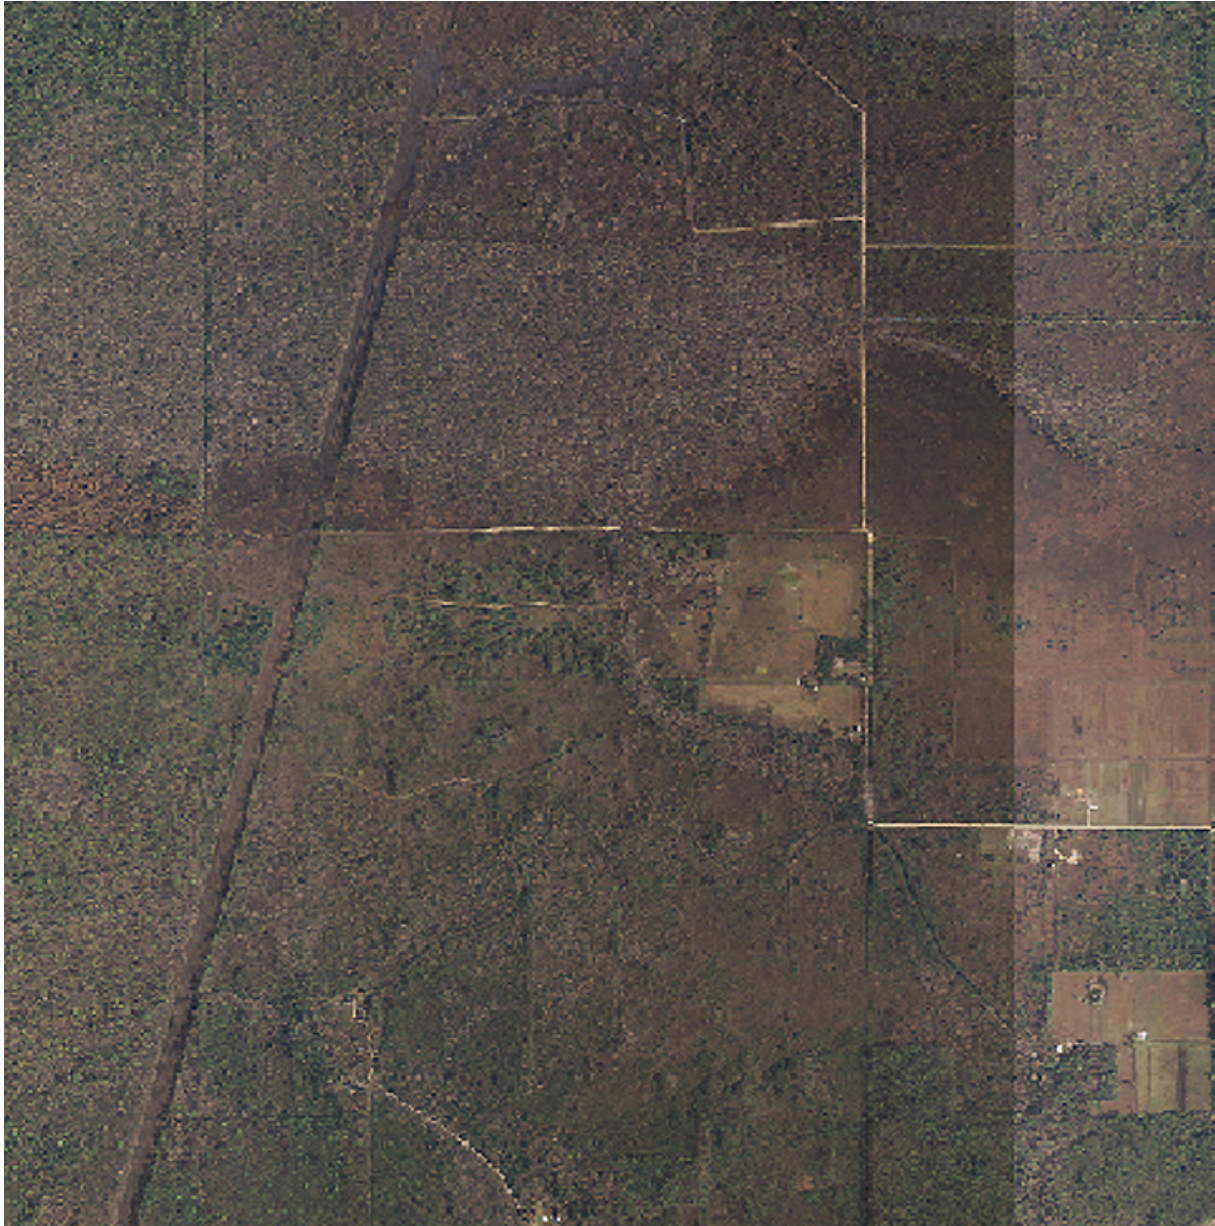
When flood waters recede quickly before the photographs are taken, analysts are confronted with a more complex interpretation assessment. In these cases, analysts look for signatures in the photographs, such as leaning trees, standing water, deposited debris (mud, silt, vegetation, etc.) and other features, that indicate the presence of inland flood waters. Figure 2 depicts an area which was interpreted to have been entirely inundated with water that receded before the photo was taken. This was determined by the presence of mud, fallen trees and saturated ground indicated by brown coloration throughout the image.

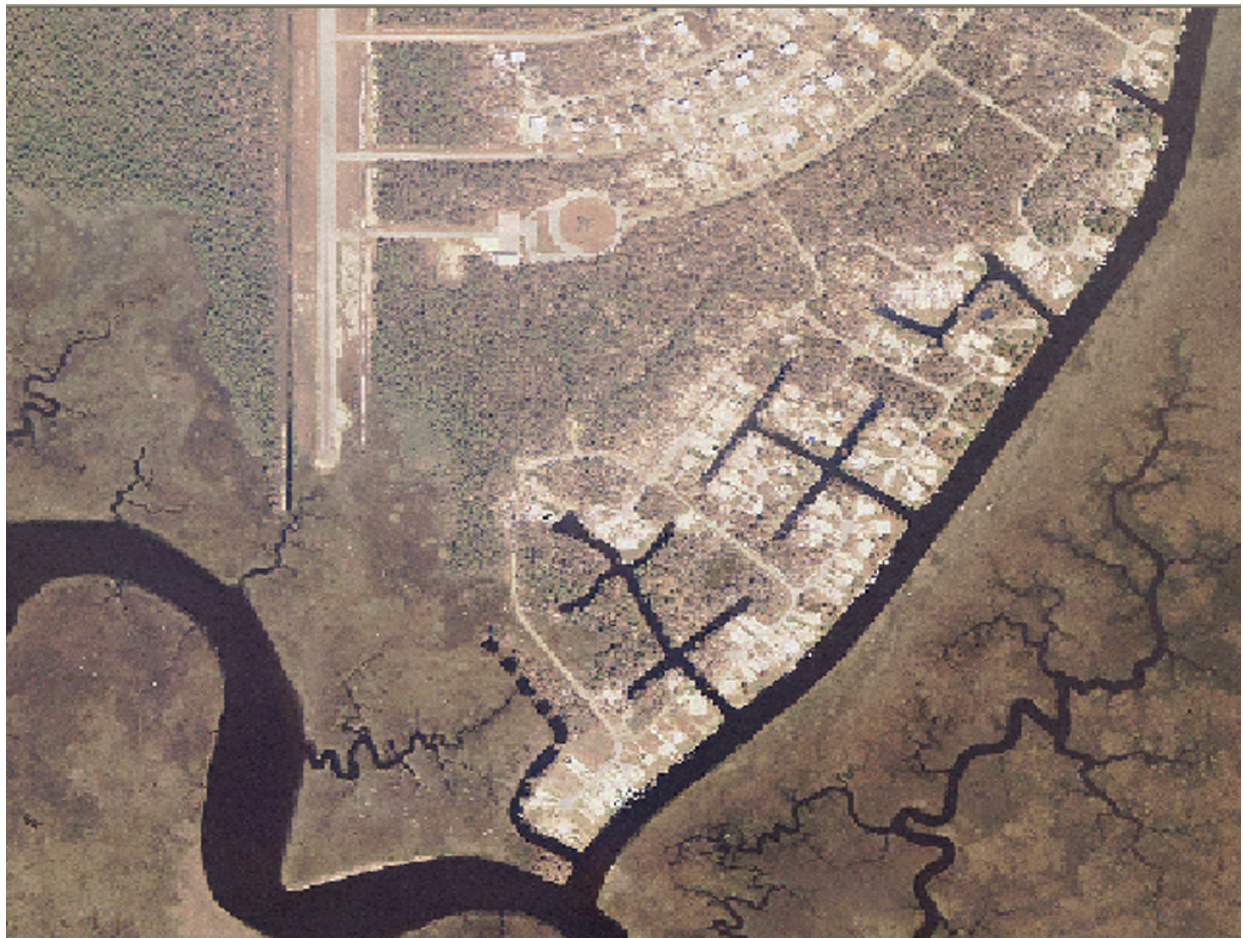
Figure 3 represents an area where the presence of marsh results in a unique situation whereby debris no longer collects as it would typically do on dry land. What is normally a visible debris line on dry land becomes less obvious for photo-interpretation when over marsh and other standing water bodies. In such cases, analysts may use contour lines, the presence of high water marks, deposited mud and silt, and/or any damage to vegetation that has been submerged by flood waters. The marsh in Figure 3 is evident in the lower left and lower right sectors of the image. URS engineers judged final placement of the wind/water line in such areas where photo interpretation alone was not conclusive.

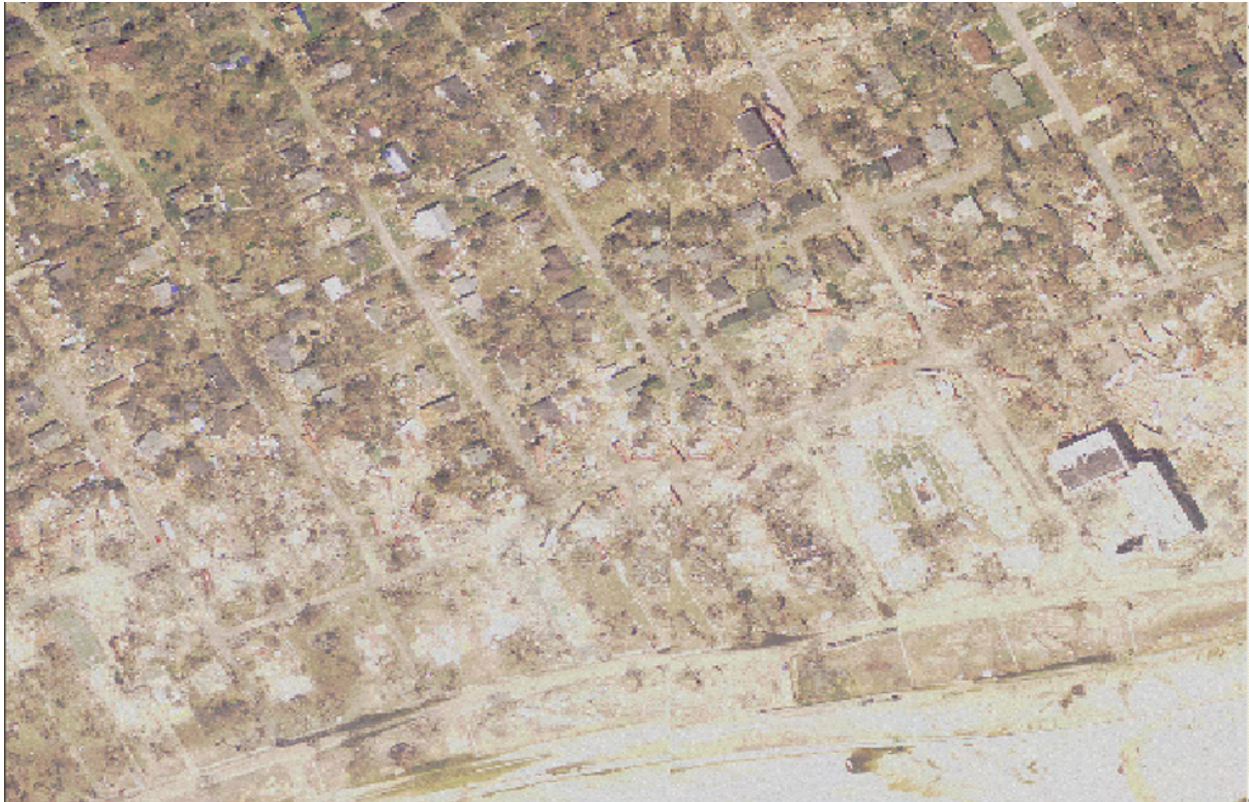
Figure 4 depicts the presence of multiple debris lines. In such cases, the analyst must decide whether all debris was deposited by the ocean surge or some debris was later swept up by inland flooding caused by heavy rain. If tide waters are present along the coast, it can result in multiple debris lines being left behind. Typically, the analyst will place the debris line at the most evident and consistent debris line or along the furthest inland point (high water mark).

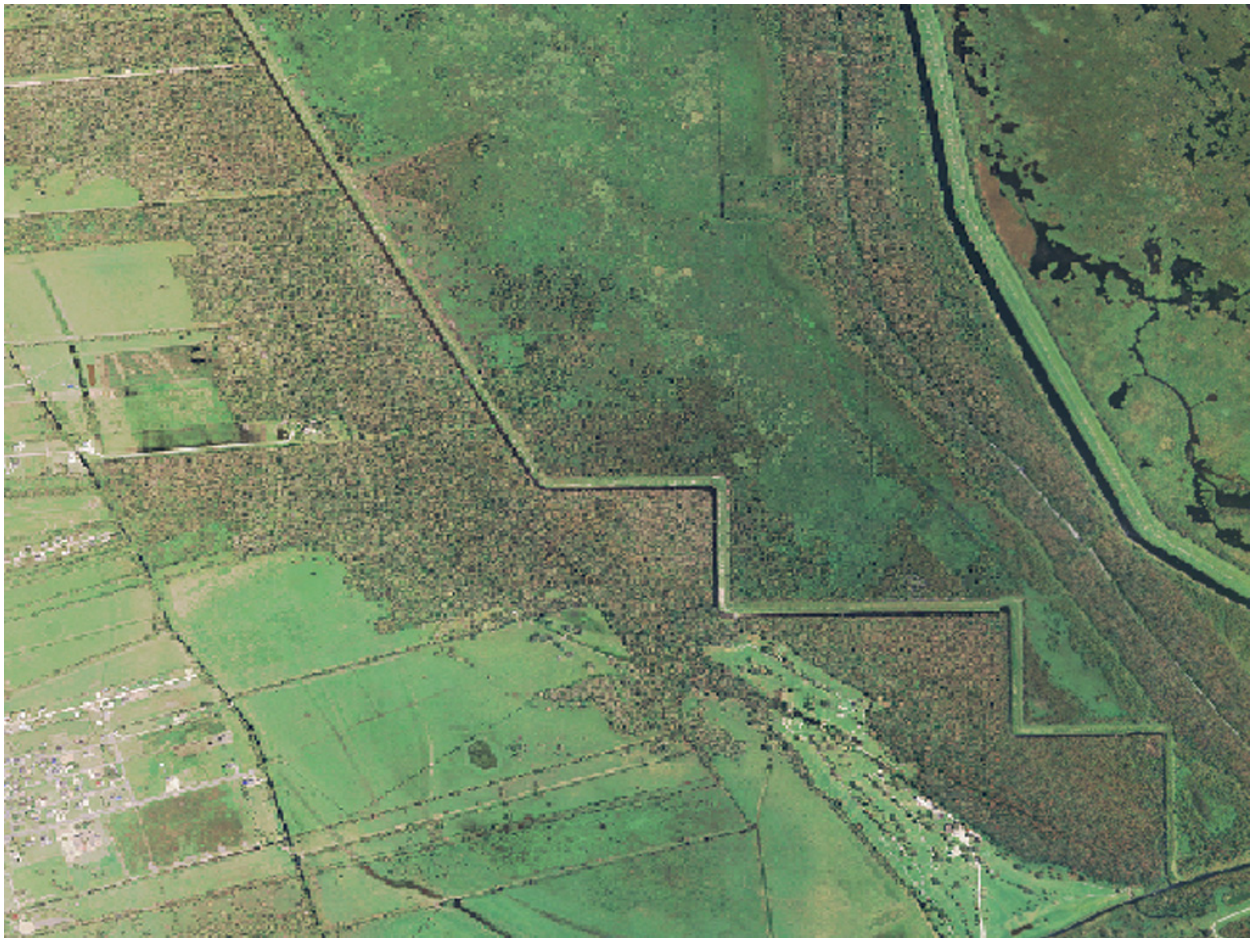
Coastal areas containing salt marshes and other low-lying areas such as that represented in Figure 5 can pose a challenge to photo-interpreters delineating flood waters. An analyst must determine whether or not to represent an area as flooded. There are many cases in which land appears to be flooded, but the area is really a marsh and always has saturated characteristics. In these cases analysts often review other sources such as secondary maps, historical data, and field surveyed conditions. Analysts also look for deposited mud and the condition of nearby vegetation to determine whether an area has been flooded or whether it is simply a marsh.
