1.0 INTRODUCTION

1.1 Background Leading up to the Limit State Test

Sandia National Laboratories (SNL) is conducting a research program to investigate the integrity of nuclear containment structures. This program is cosponsored by the Nuclear Power Engineering Corporation (NUPEC) of Japan and the U.S. Nuclear Regulatory Commission (NRC). As part of the program, NUPEC constructed a 1:4 scale model of the prestressed concrete containment vessel (PCCV) of a Japanese pressurized water reactor (PWR) plant at SNL's Containment Technology Test Facility in Albuquerque, NM. The model is shown in Figures 1-1 and 1-2. SNL designed and installed an extensive suite of instrumentation during and after the construction of the model and conducted a series of overpressurization model tests leading to both functional and structural failure. One of the key program objectives was to validate methods for predicting structural performance of containment vessels when subjected to beyond-design-basis loadings, such as very high internal pressurization. The NRC-sponsored analysis effort to achieve this objective included 2D and 3D nonlinear finite element modeling of the PCCV model. Such analyses were per

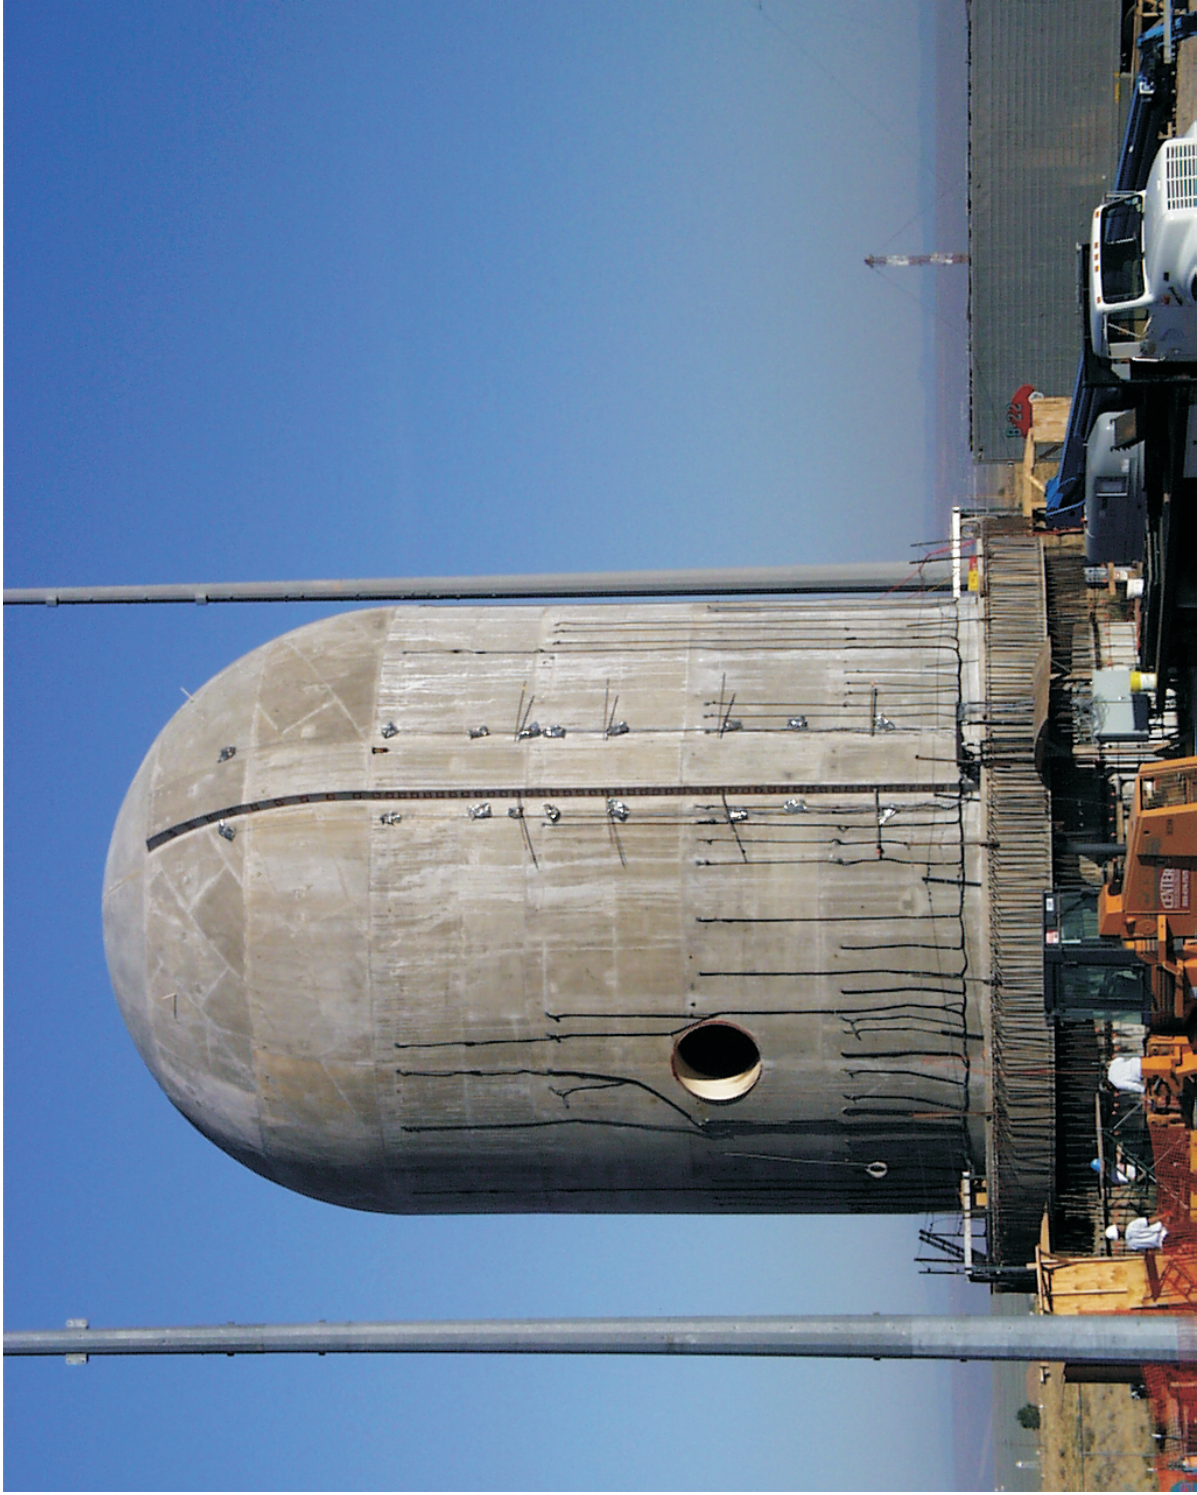
Figure 1-1. NUPEC/NRC 1:4 Scale PCCV Model Built at Sandia National Laboratories

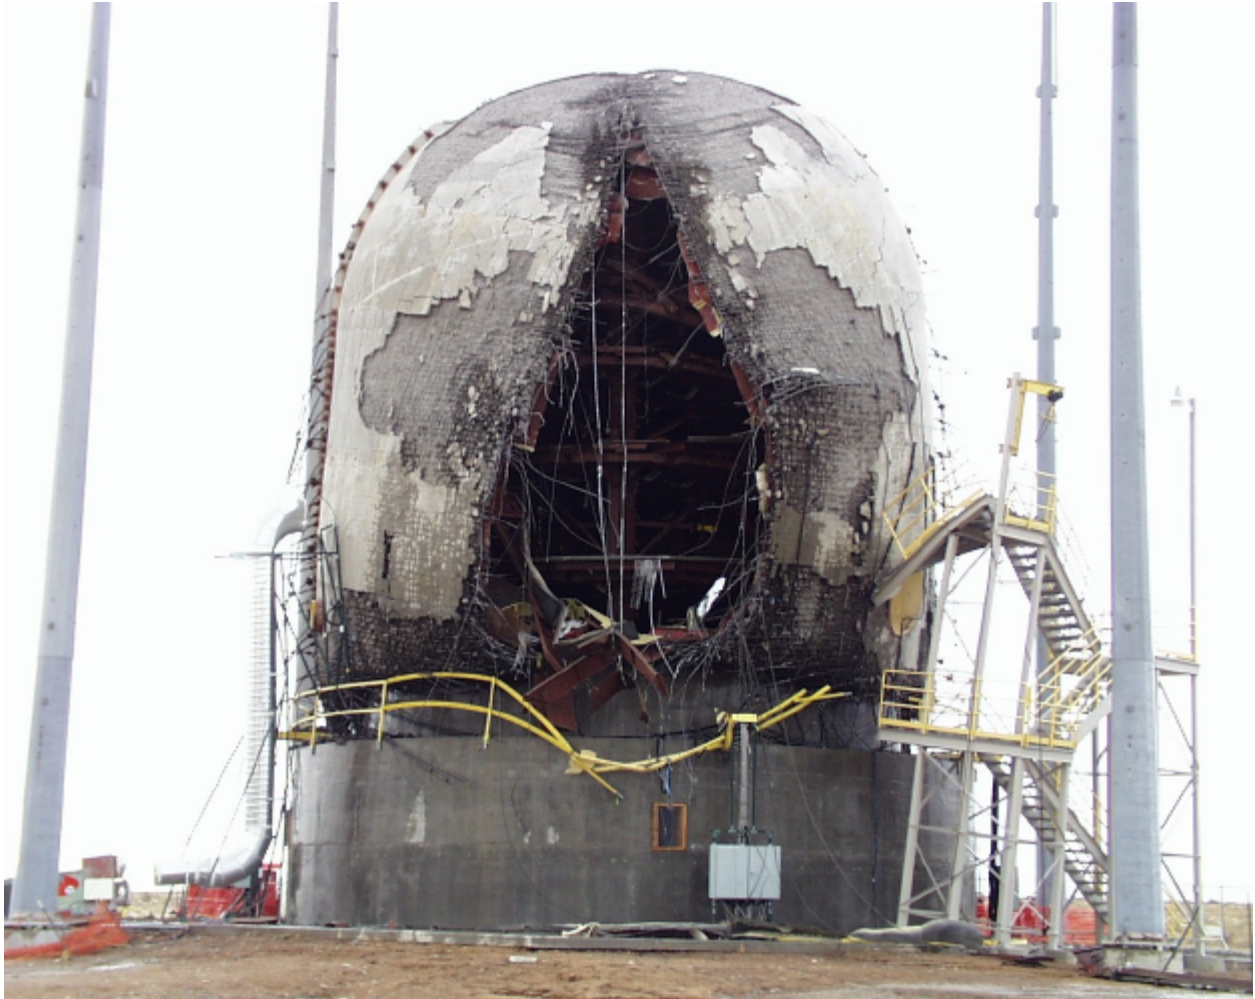
Figure 1-6. PCCV Model after Structural Failure Mode Test

Following the LST and post-LST inspection of the model and the data, it became clear that the objectives of the test program were not fully satisfied. Other than concrete cracking, liner tearing, and leakage, the LST did not cause any significant structural damage in the model, and overall structural response (displacements, rebar and tendon strains, etc.) was only slightly beyond the elastic range. In order to provide additional structural response data to compare with inelastic response conditions, the PCCV model was resealed, filled nearly full with water, and repressurized during the Structural Failure Mode Test (SFMT). A maximum pressure of 3.6 Pd was reached when a catastrophic rupture occurred. This was preceded only briefly by tensile failure of several hoop tendons. The condition of the model immediately after the SFMT is shown in Figure 1-6.
