Drop Test Results for the Combustion Engineering Model No. ABB-2901 Fuel Pellet Shipping Package

Lawrence Livermore National Laboratory

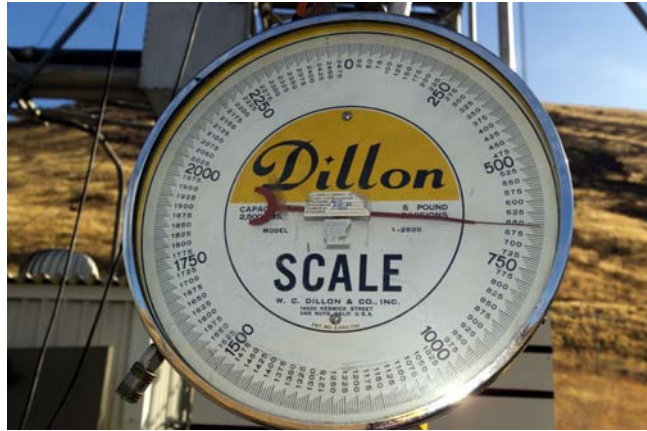
Figure 14. Packaging Weighing, Bldg. 858

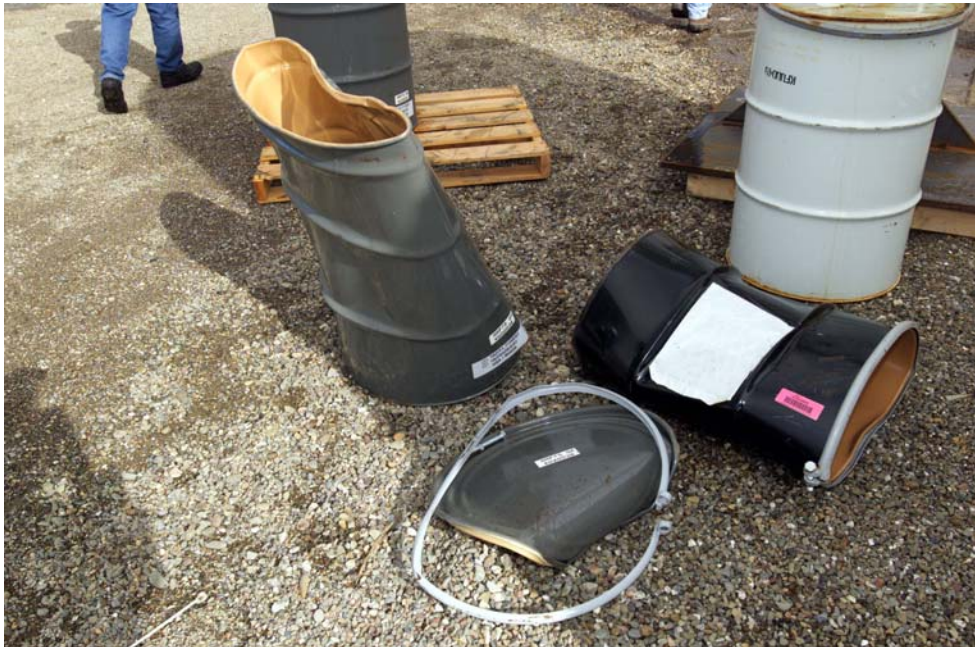
Figure 20. Damage to Lid, Closure Ring and Drum Along Side of Damage to Previously Dropped 133-l (35-gal), Water-Filled Drum

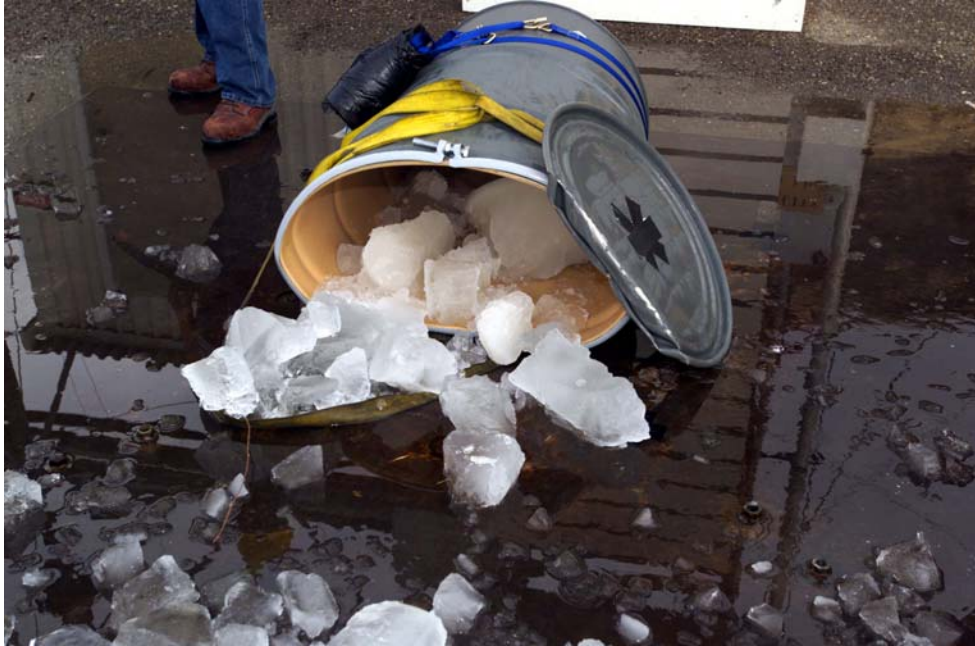
Figure 21. Damage to Drum and Lid after Ice-Filled Drop (Close-Up)

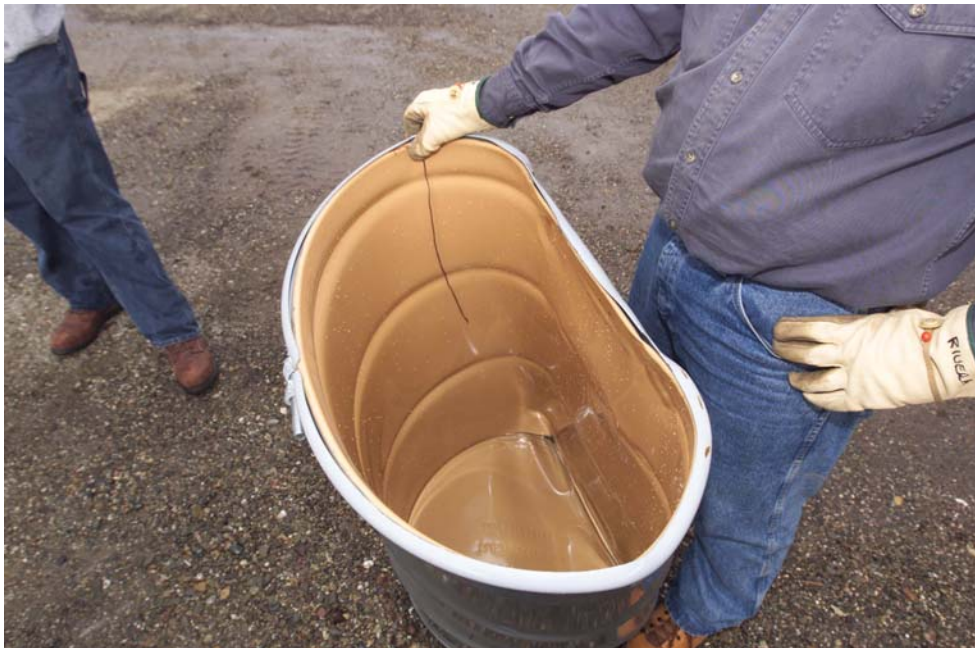
**Figure 22. Damage to Drum (Ice-Filled Drop)
Rich Villafana (LLNL) and Jesse Rivera (LLNL)**

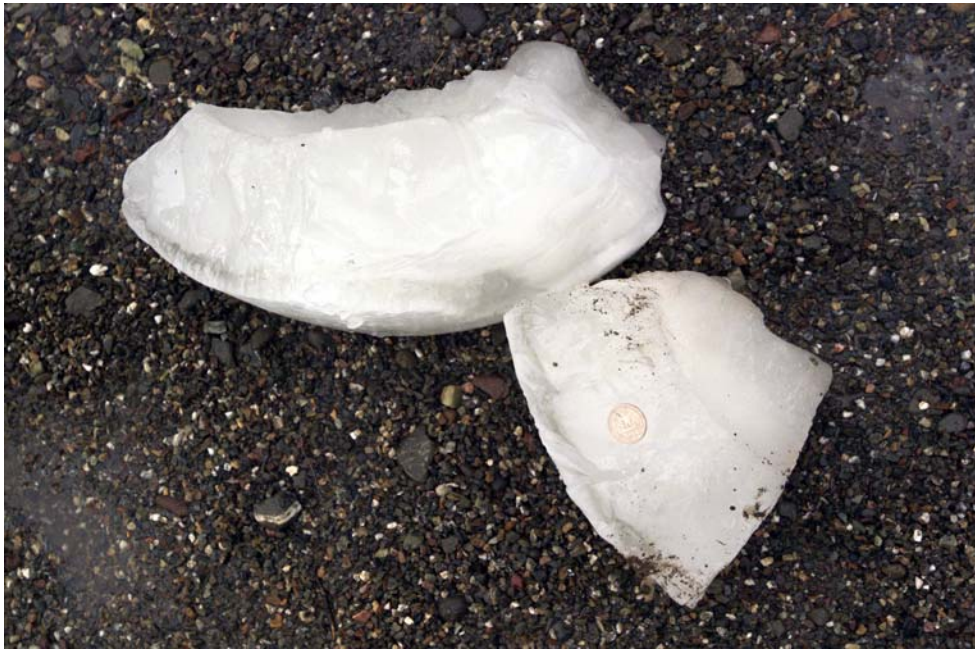
Figure 23. Close-Up of Ice Fragments from Bottom of Drum with a Quarter to Show Relative Size

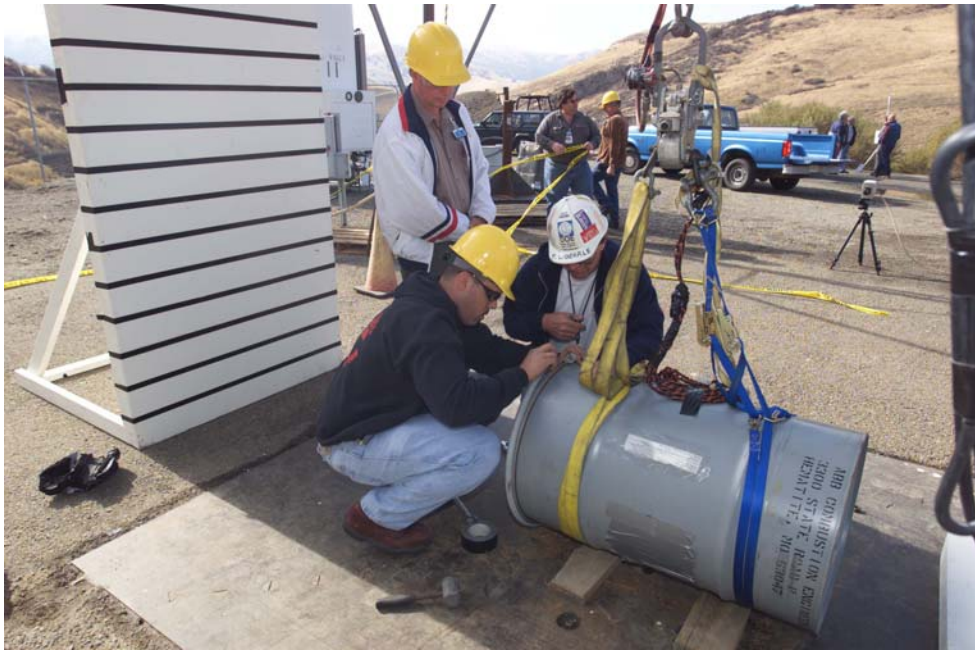
Figure 24. Packaging Closure, Bldg. 858
Foreground: Paul McMahon (WEC-SC) (Standing), Rich Villafana (LLNL), and Tom Woehrle (LLNL) Background: Lisle Hagler (LLNL), Bruce Clegg (LLNL), Ron Parkhill (USNRC), Ron Hafner (LLNL), Brian Hempy (WEC-SC) and Alan Brooks (LLNL)

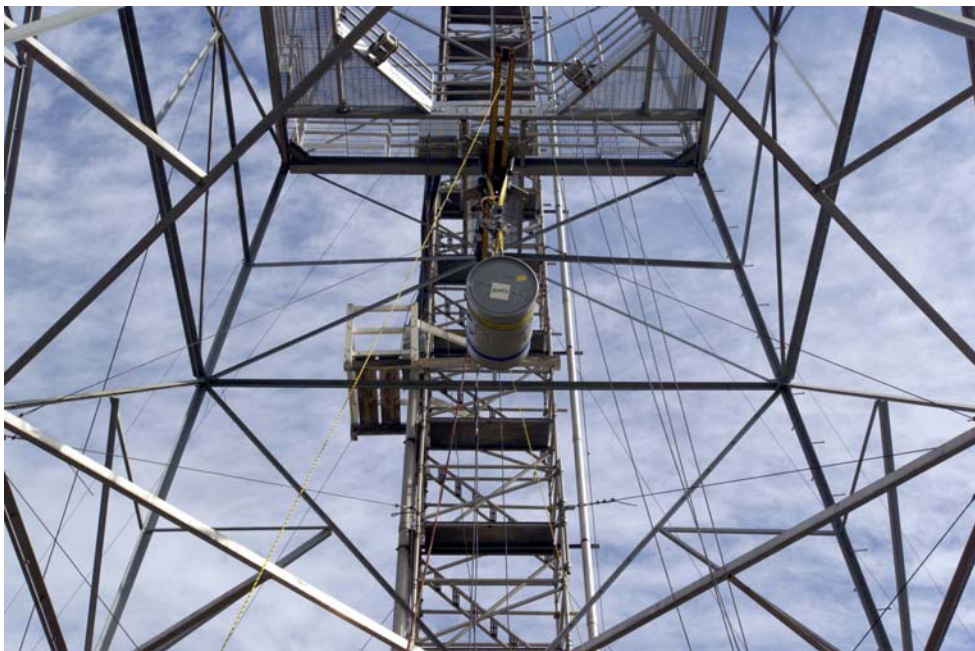
Figure 26. Packaging in Position, Close-up, Bldg. 858

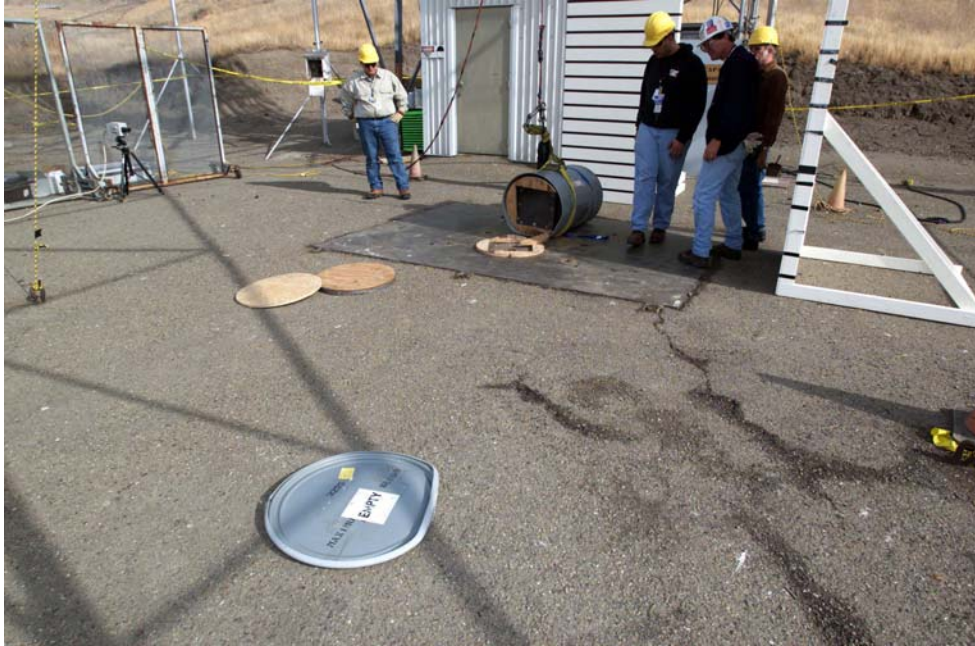
Figure 27. Post-test Component Orientation (Wide-Angle View)
From left, Jesse Rivera (LLNL), Rich Villafana (LLNL), Tom Woehrle (LLNL), and Bruce Clegg (LLNL)

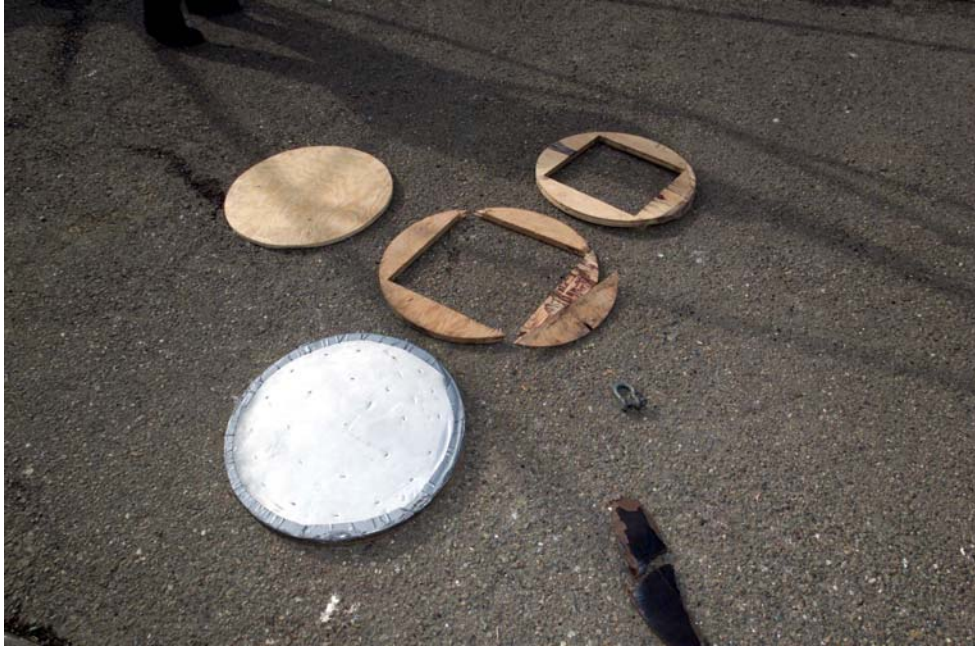
Figure 29. Insulated Plywood and Plywood Spacers

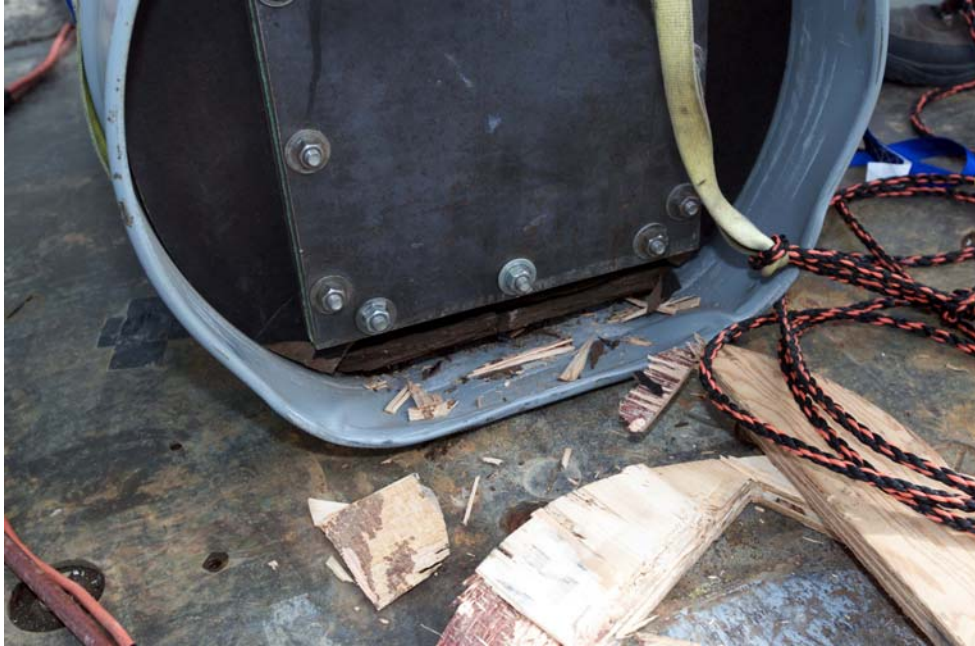
Figure 30. Post-Test Upper Drum-Body Close-Up; End-On View

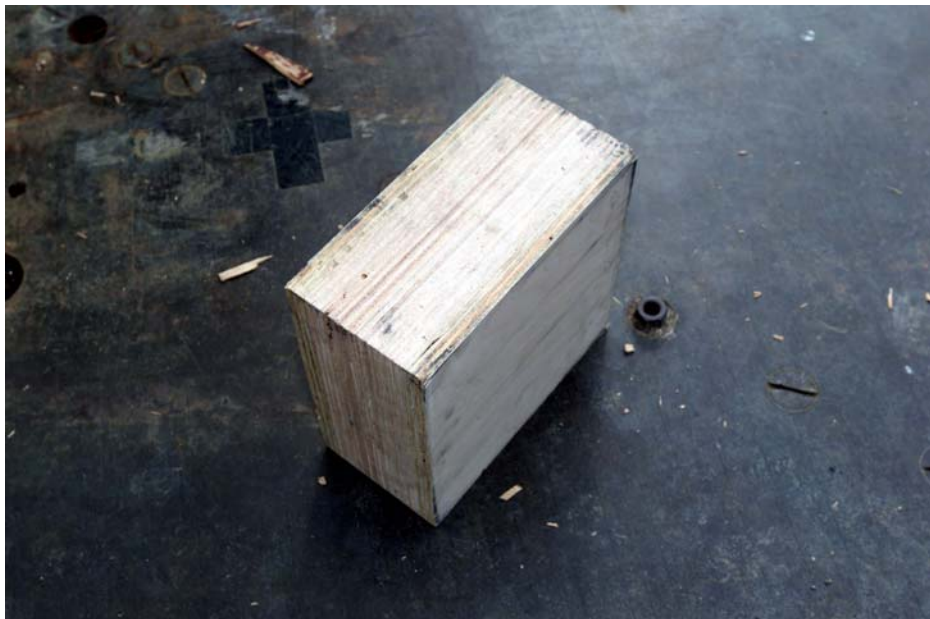
Figure 33. Upper Inner-Compartment Spacer Block

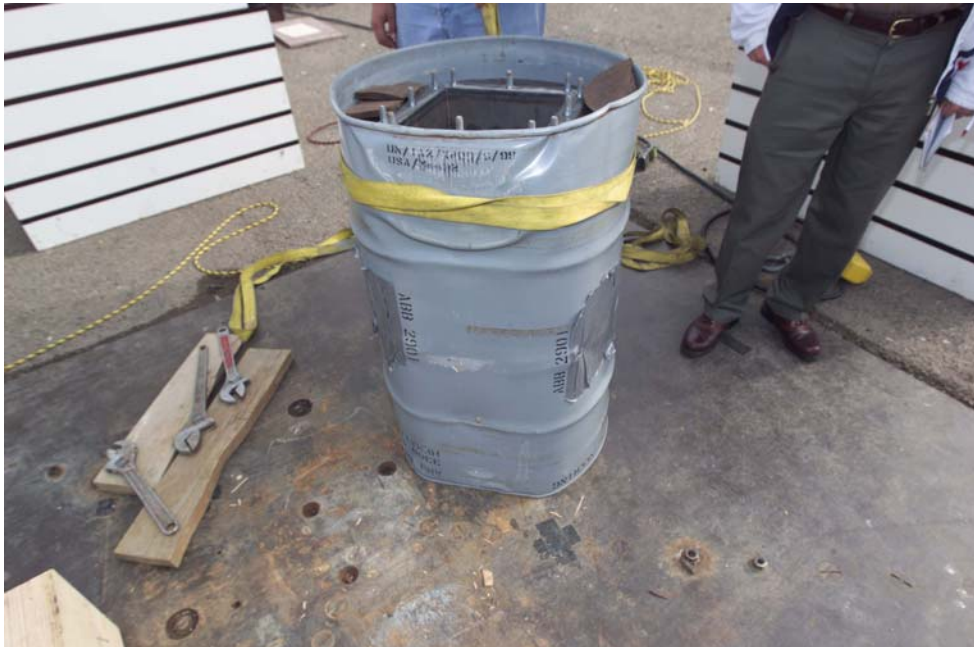
Figure 38. Damage to Open Drum, Side View

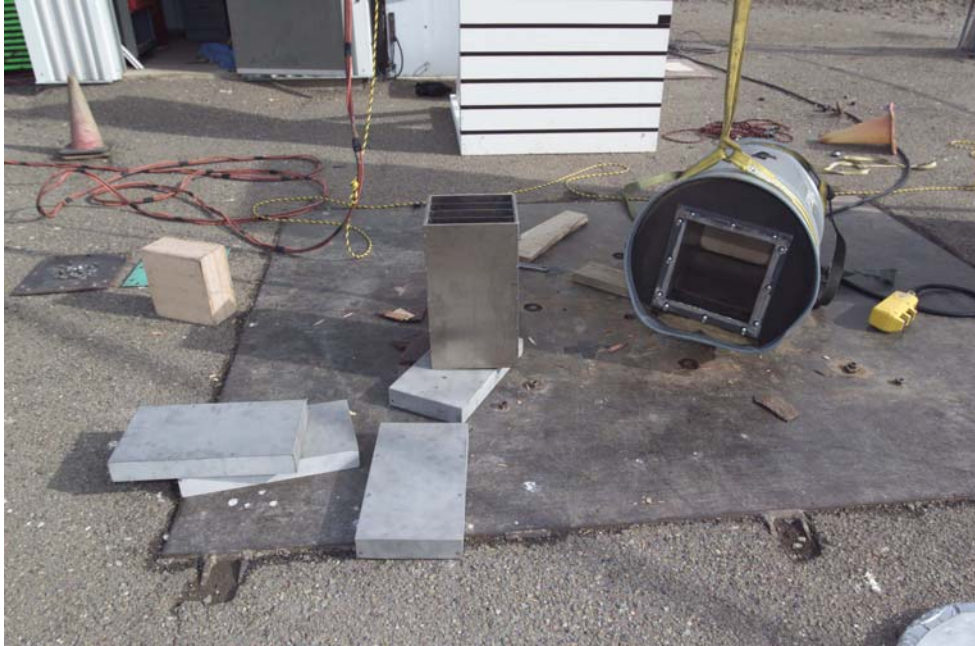
Figure 39. Upper Inner-Compartment Spacer Block, Pellet Trays, Pellet Tray Box, and Drum

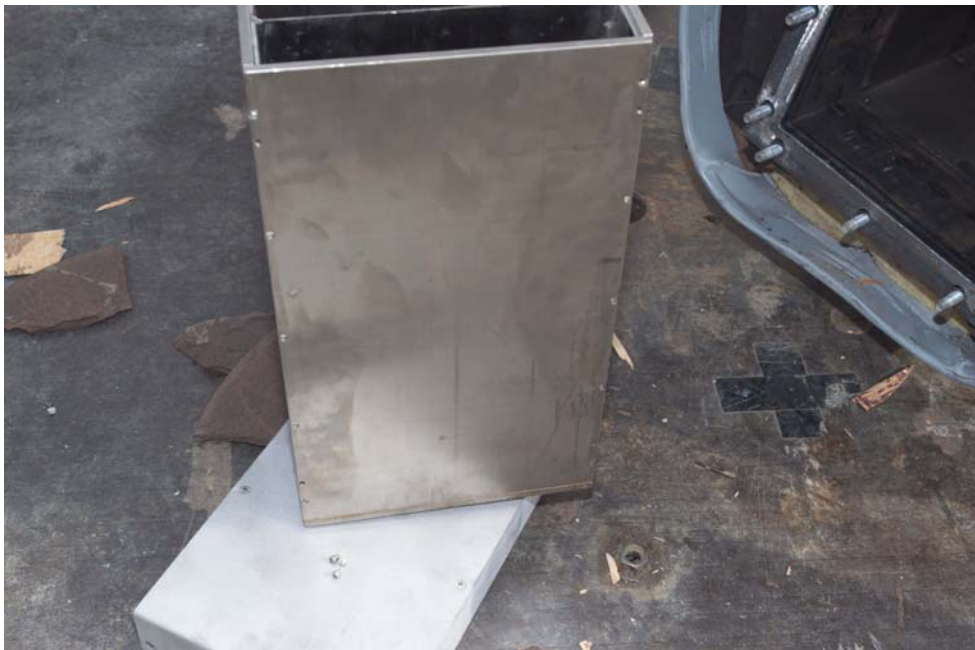
Figure 40. Close-Up of Pellet Tray Box, Side View

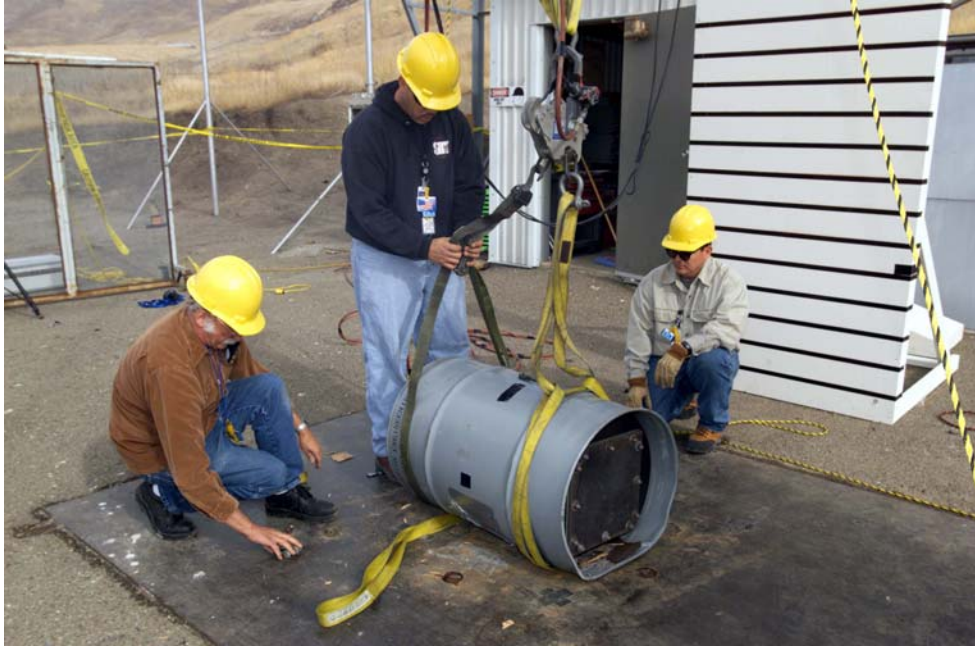
Figure 41. Drum Damage
From left, Bruce Clegg (LLNL), Rich Villafana (LLNL), and Jesse Rivera (LLNL)

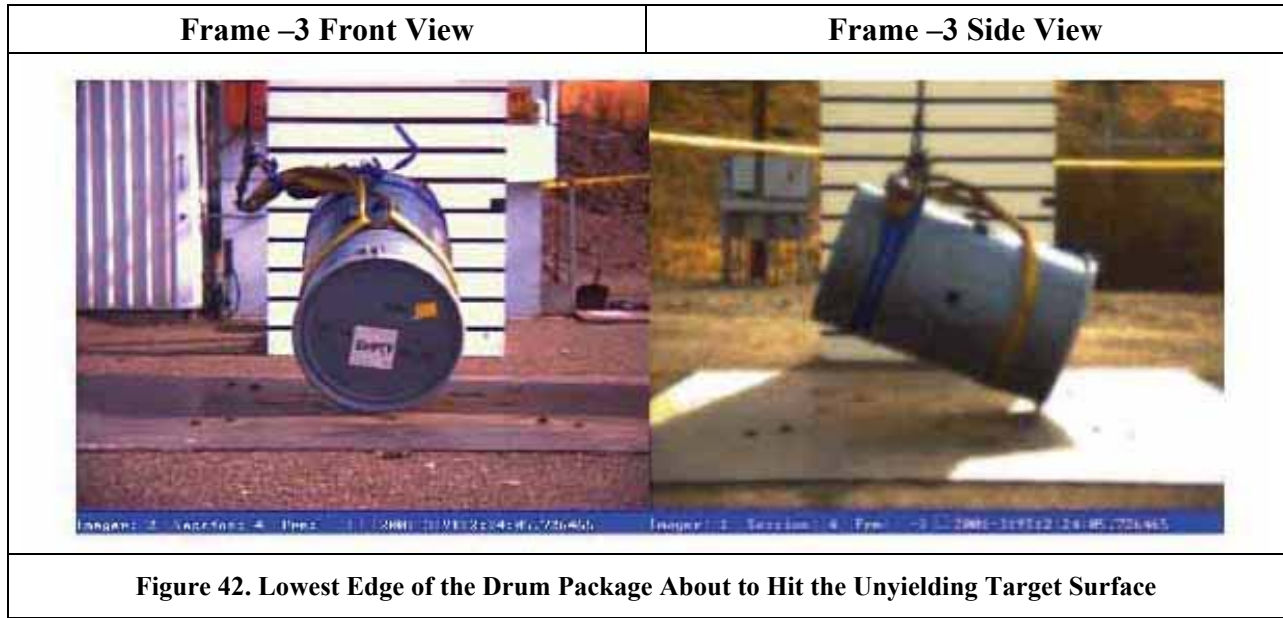
The impact had already caused some slight deformation in the drum body, the lid, and the closure ring as seen in Figure 43.

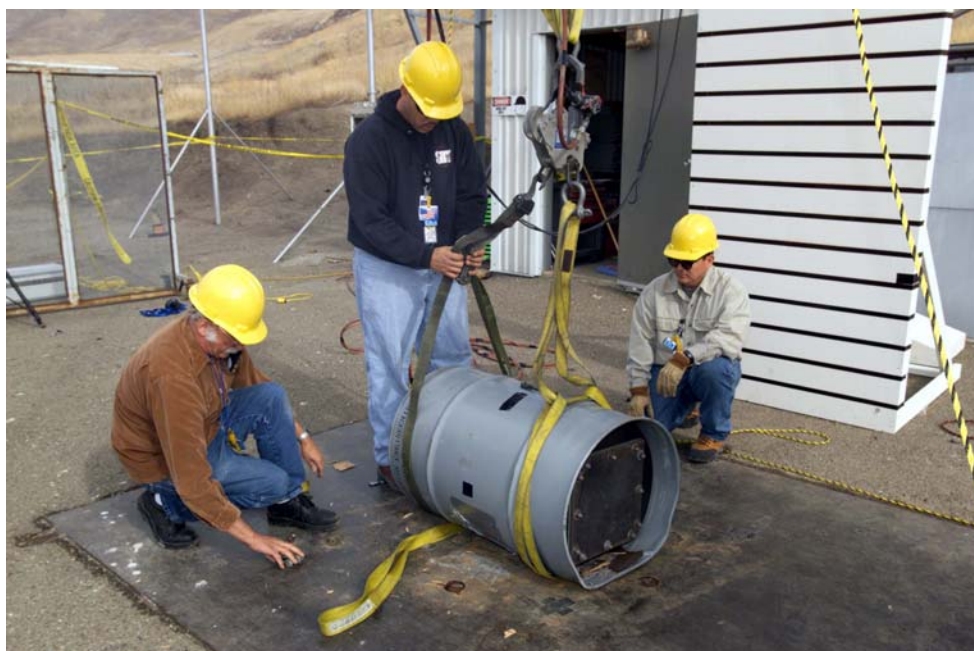
Figure 50. Drum Damage
From left, Bruce Clegg (LLNL), Rich Villafana (LLNL), and Jesse Rivera (LLNL)
