3 Results – Effect of Heat Treatment on Fatigue Life

3.1 Fatigue ϵ -N Behavior

3.2 Fatigue Crack and Fracture Surface Morphology

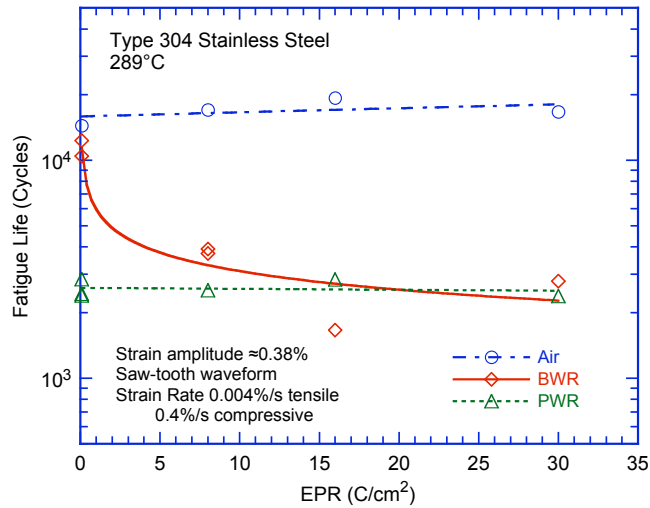
Figure 5. The effect of material heat treatment on fatigue life of Type 304 stainless steel in air, BWR, and PWR environments at 289°C, $\approx 0.38\%$ strain amplitude, sawtooth waveform, and 0.004%/s tensile strain rate.

The effect of heat treatment on the fatigue life of Type 304 SS in air, BWR, and PWR environments is shown in Fig. 5. Fatigue life is plotted as a function of the EPR value for the various material conditions. The results indicate that heat treatment has little or no effect on the fatigue life of Type 304 SS in air and PWR environments. In a BWR environment, fatigue life is lower for the sensitized SSs. The decrease in life seems to increase with increasing EPR value.

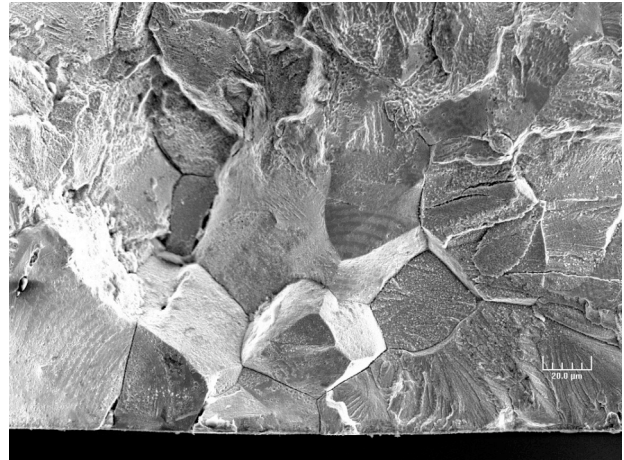
Figure 8. Photomicrographs showing sites of crack initiation on fracture surfaces of Type 304 SS specimens tested in simulated BWR environment: (a), (c), (e), (g) low magnification; (b), (d), (f), (h) high magnification.

An effect of a simulated normal-water chemistry BWR environment, Fig. 8, was to cause intergranular (IG) crack initiation, implying a weakening of the grain boundaries. In the BWR environment, the initial crack appeared IG under all heat-treated conditions. Photomicrographs of the fracture surface of the more heavily sensitized steel, e.g., Heat 30956 MA + 24 h at 700°C (Figs. 8g and h) and especially Heat 10285 MA + 24 h at 600°C (Figs. 8e and f), are good examples of smooth IG fracture. Furthermore, by comparing the four material conditions, it appears that the extent of IG fracture increases with the degree of sensitization, at least through the MA + 24 h at 600°C condition, whereas MA + 24 h at 700°C appears to have a somewhat more mixed IG and TG morphology. Also, one effect of the BWR environment (Figs. 8a–h) was to cause IG crack initiation, implying a weakening of the grain boundaries. Nevertheless, for all four conditions tested, initial IG mode transformed within $<200\ \mu\text{m}$ into a TG mode with cleavage-like features. By contrast, for all samples of Type 304 SS tested in PWR environments (Fig. 9), cracks initiated and propagated in a TG mode irrespective of the degree of sensitization. Prominent features of all fracture surfaces are highly angular, cleavage-like fracture facets that exhibit well-defined “river” patterns. Intergranular facets were rarely observed, mostly in the more heavily sensitized alloys. These observations suggest brittle behavior throughout the testing period.

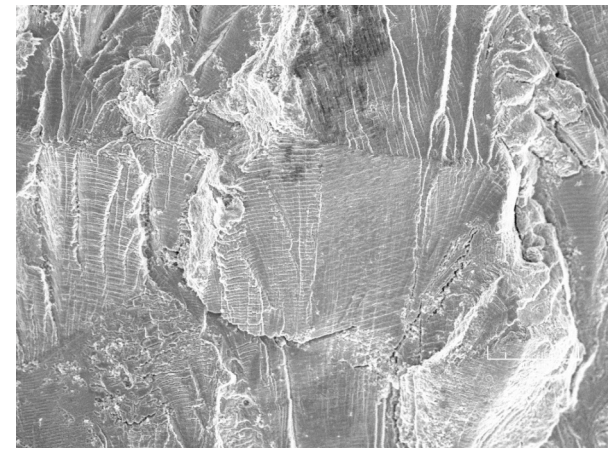
Figure 11. Low- (a), (c), (e) and high-magnification (b), (d), (f) photomicrographs showing striations at select locations on fracture surfaces of MA specimens of Heat 30956 heat-treated for 0.67 h at 700°C in air, BWR, and PWR environments.

Fatigue striations normal to the crack advance direction were clearly visible beyond $\approx 200\ \mu\text{m}$ on the fracture surfaces of all materials under all environmental conditions, as documented in Figs. 10–13. For example, for the MA Heat 30956 samples tested in BWR water (Fig. 10), striations were easily discernible on the facets irrespective of the steps, cleavage-like features, or river patterns. Similar striations were also observed on the fracture surface of MA Heat 30956 heat-treated 0.67 h at 700°C irrespective of the testing environment (Fig. 11). Striations were found on both the TG and IG facets of the samples tested under BWR conditions, or co-existing with the “river” patterns specific to the samples tested in the PWR environment. Evidence of extensive rubbing due to repeated contact between the two mating surfaces (Figs. 11a and b) was also found.
