University Contributions To The Effective Use of Thermal Barrier Coatings in ATS Engines

95-01-SR030

Eric Jordan and Maurice Gell
University of Connecticut

David Clarke
University of California, Santa Barbara

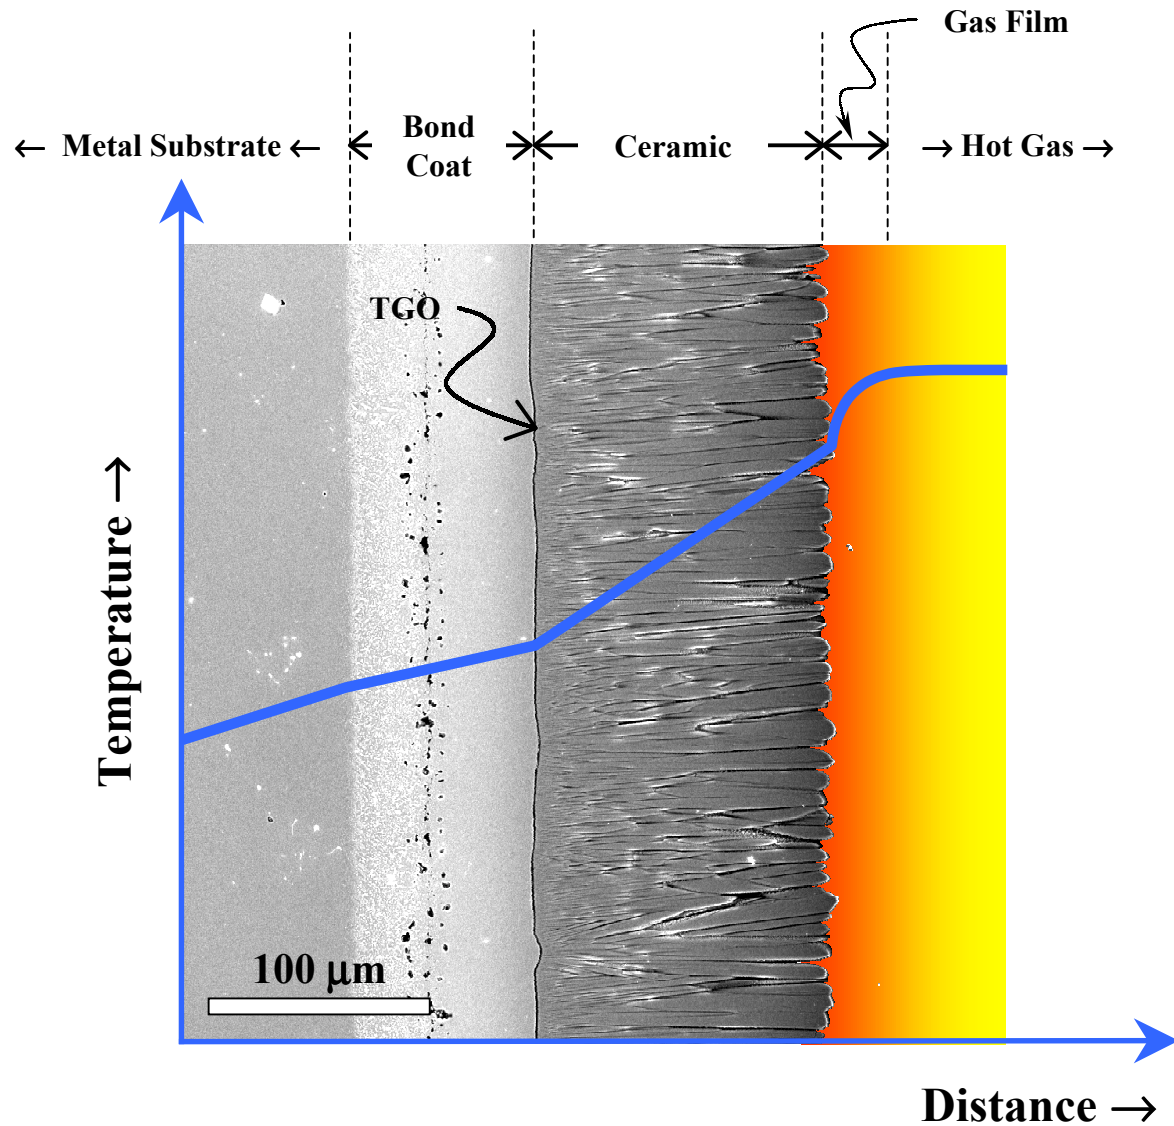
Temperature Profile Across TBC

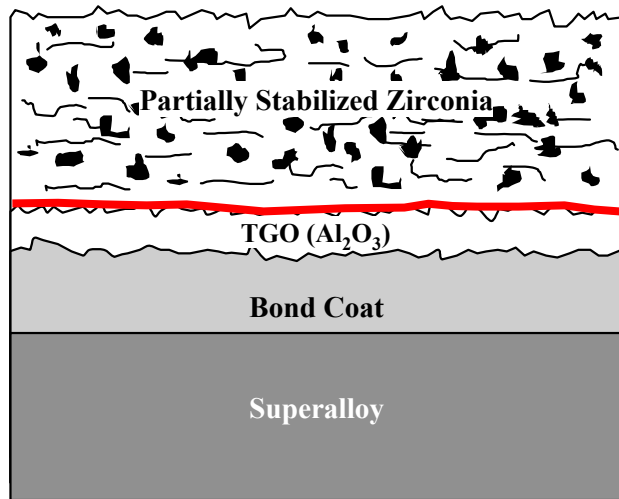
Plasma Sprayed TBC

Microstructure and Spallation Failure Location of TBCs

← **Failure** →

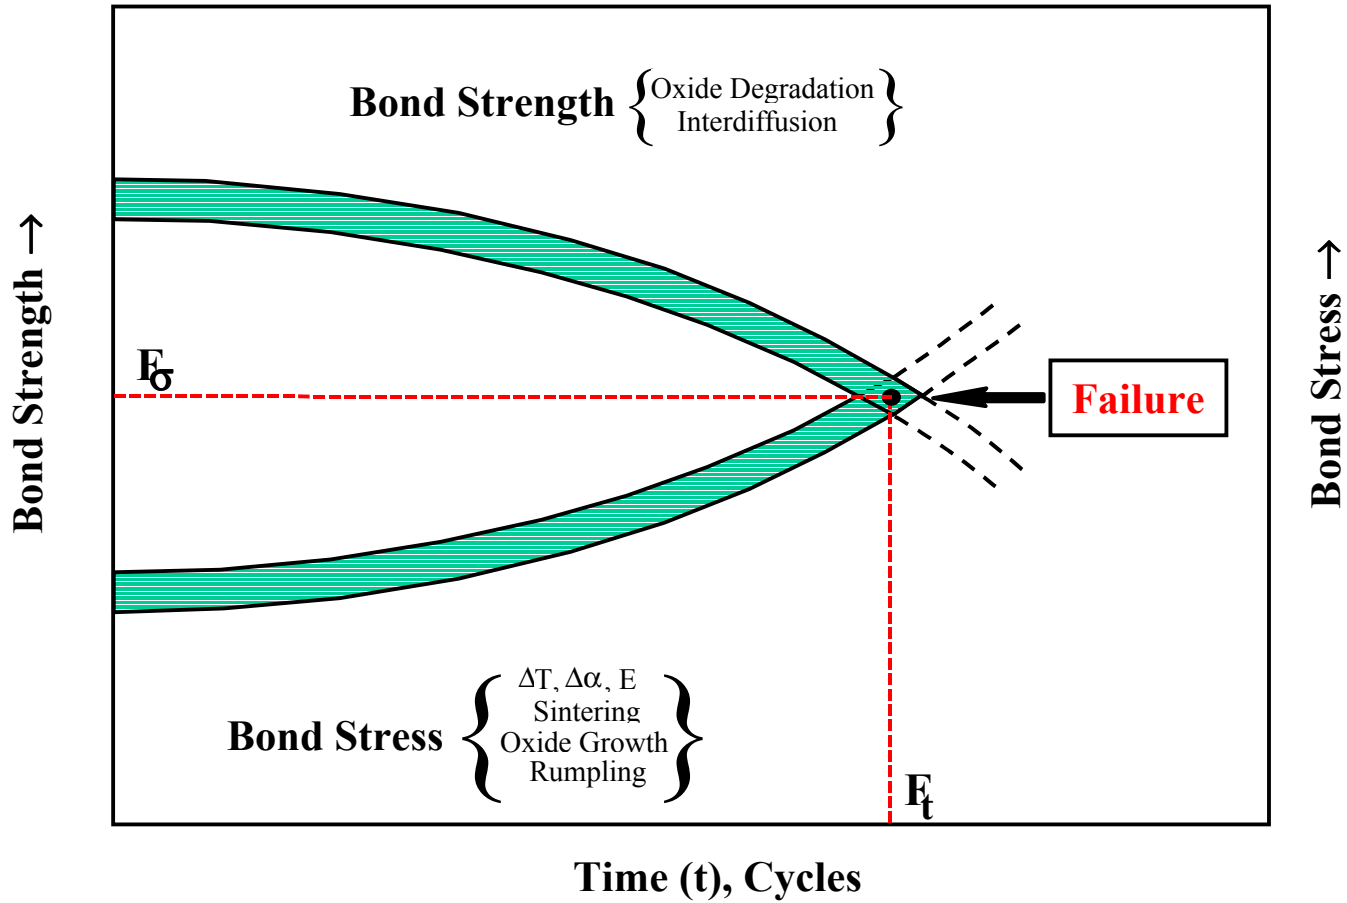
Spallation Model

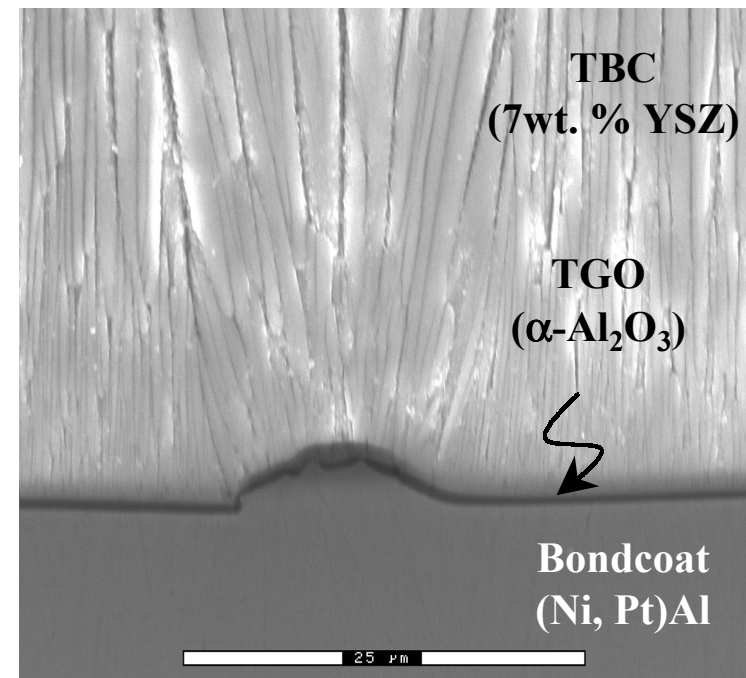
Five Bill of Materials Systems Studied Supplied by Commercial Vendors

- **Failure - System Specific**
- **Defects Play a Key Roll**

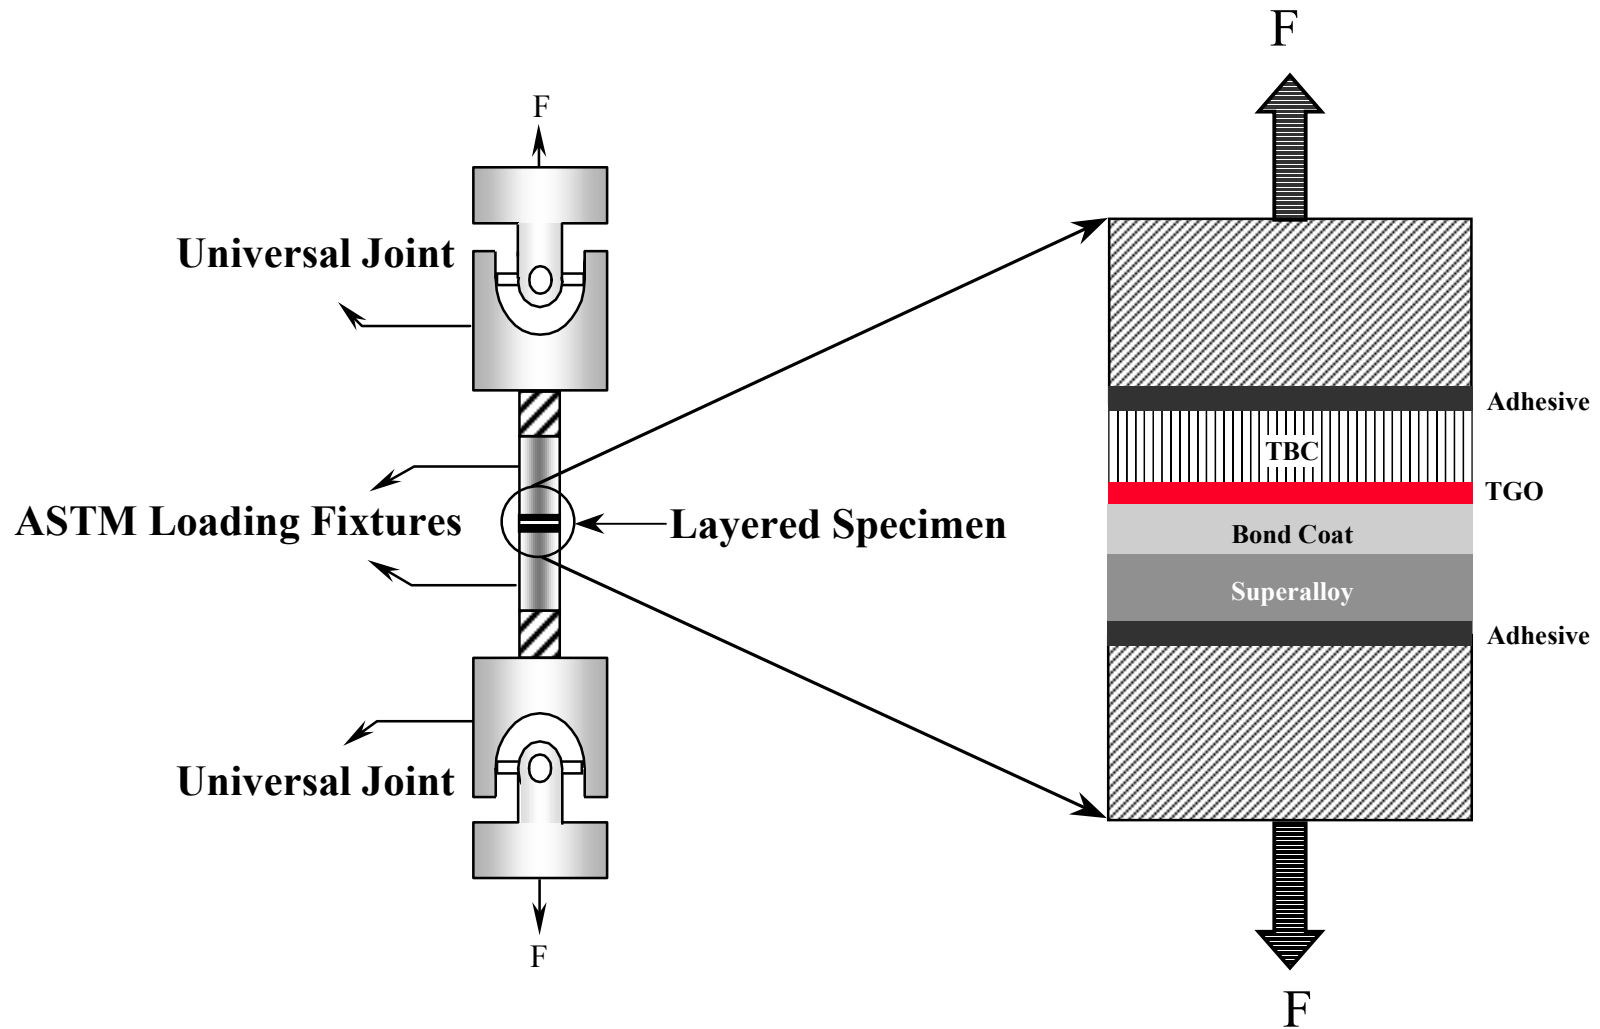
Modified ASTM Direct Pull Test

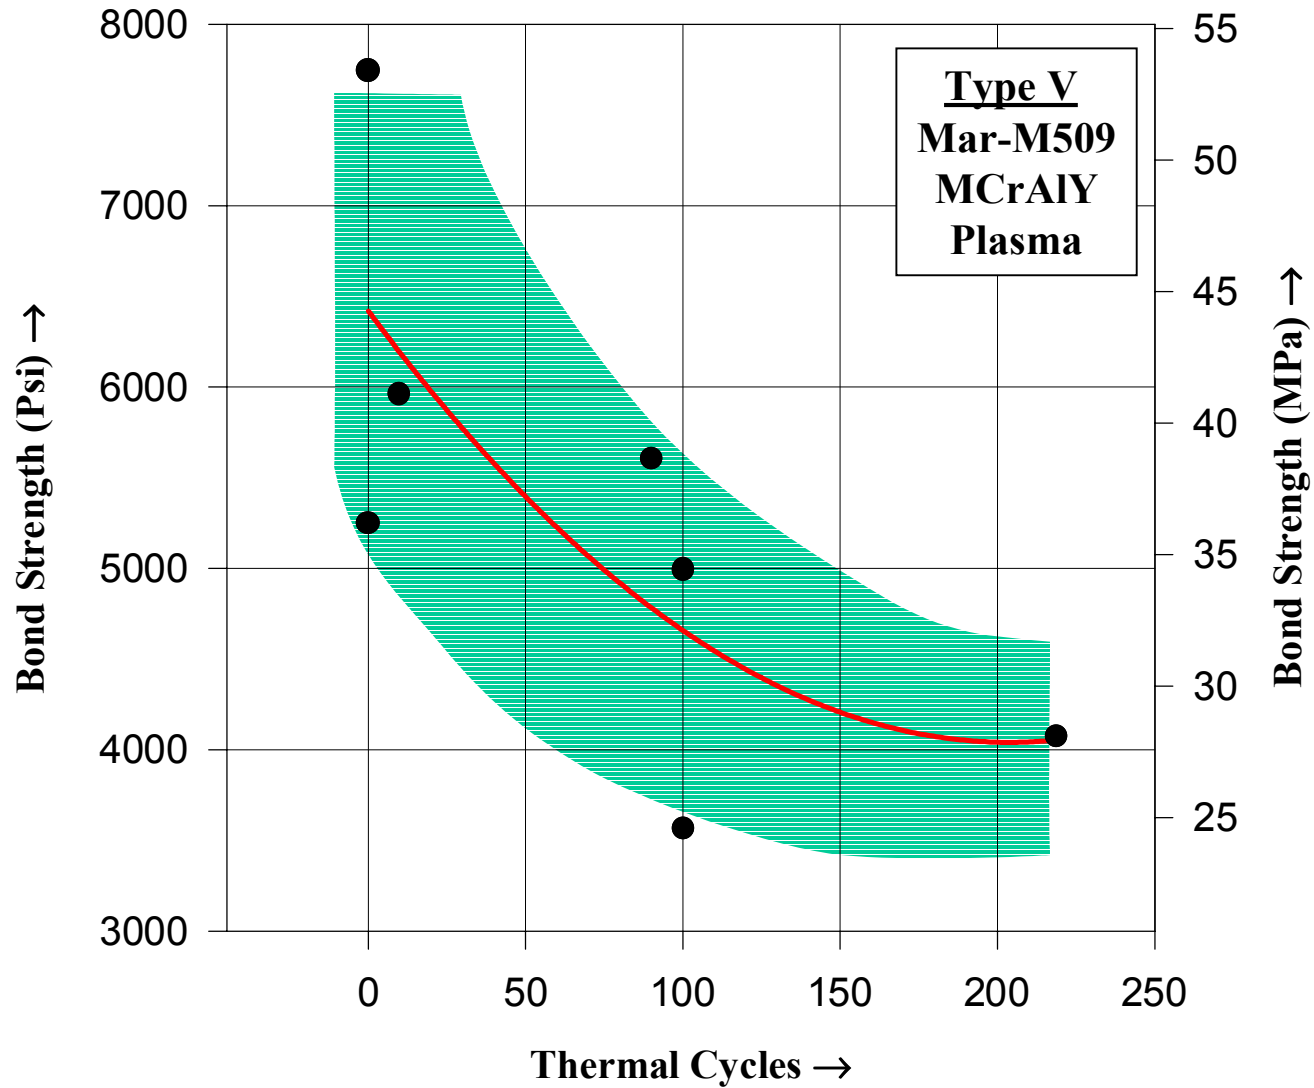
Bond Strength of Type V Coating

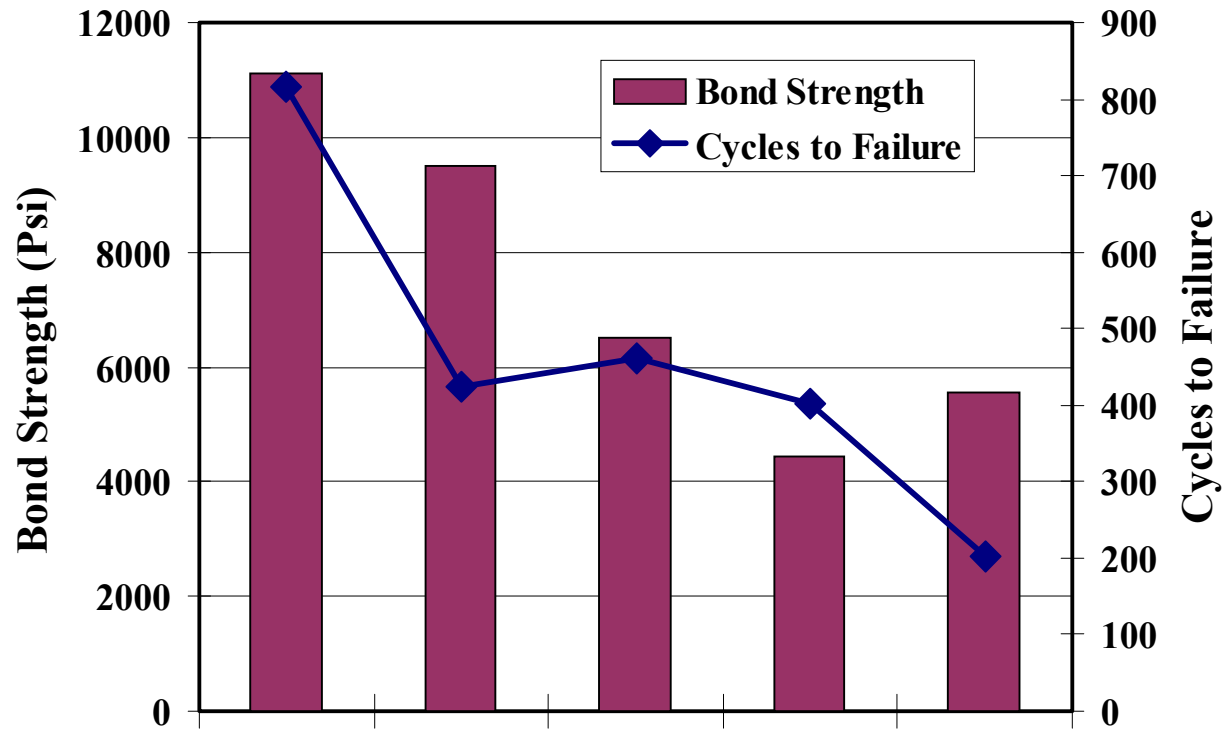
Initial Bond Strength Vs. Cycles to Failure

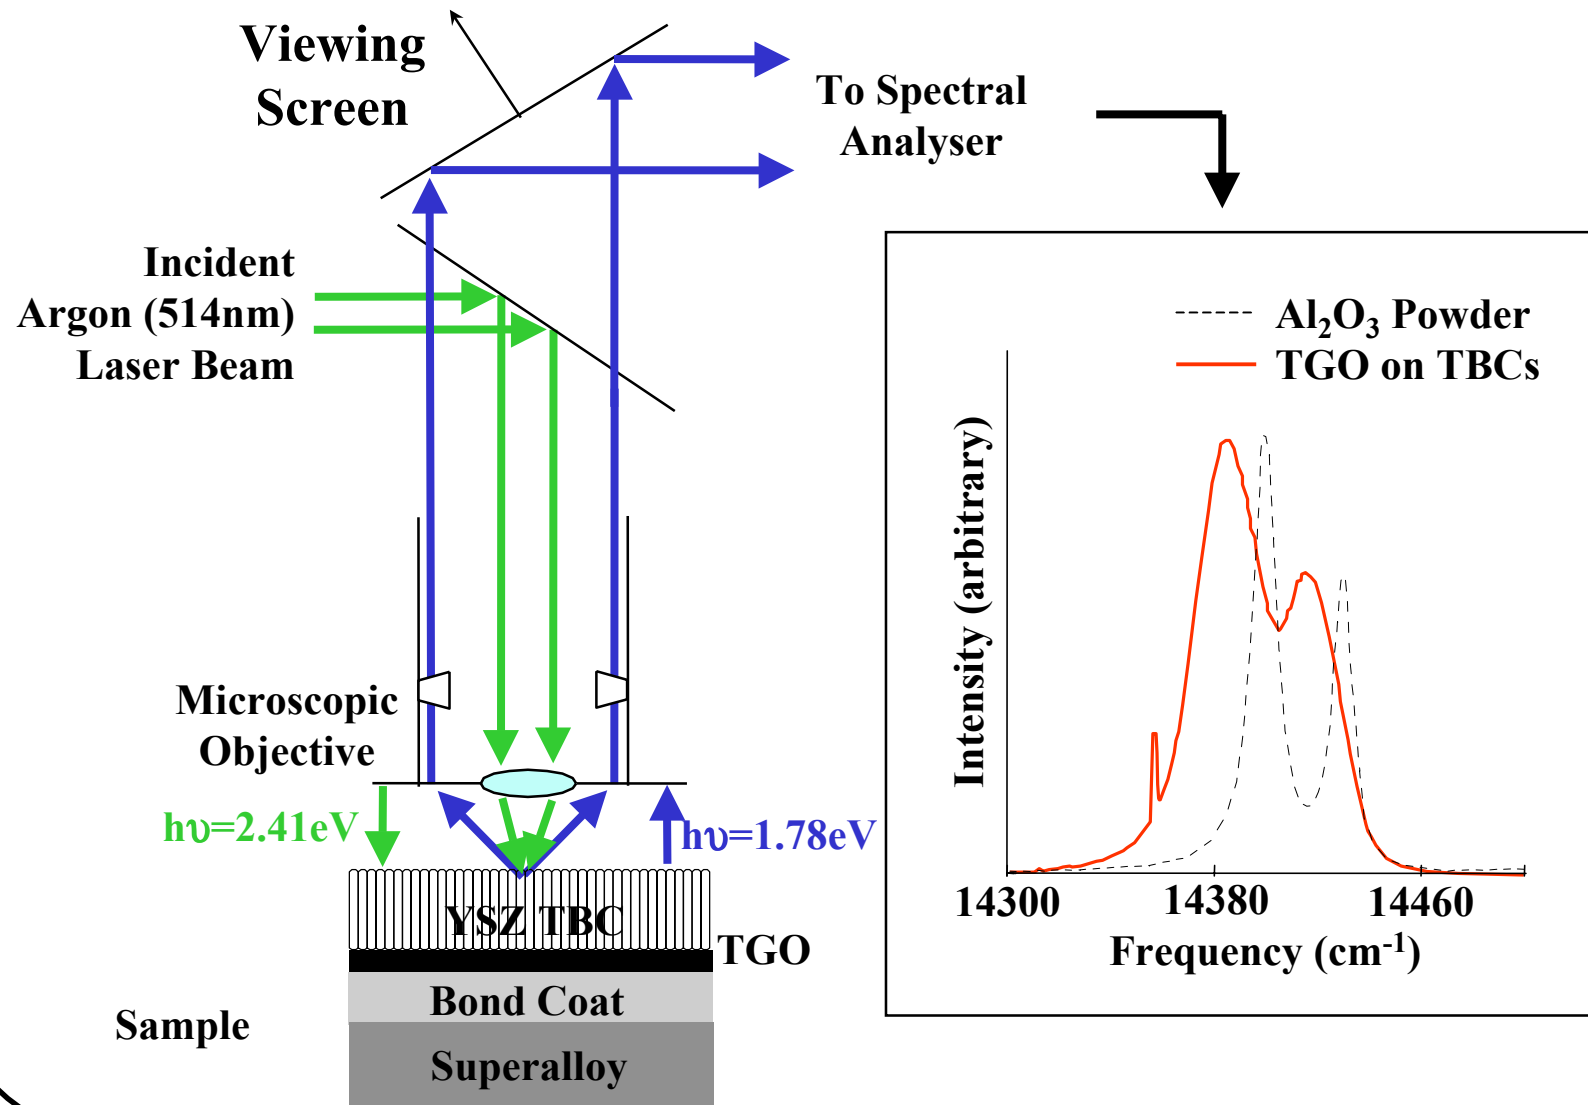
Laser Fluorescence Technique

Applications of Laser Fluorescence for Thermal Barrier Coatings

- **Assessment of Life Remaining**
- **Input for Lifetime Prediction Methods**
- **Quality Control**
- **Coating Development**

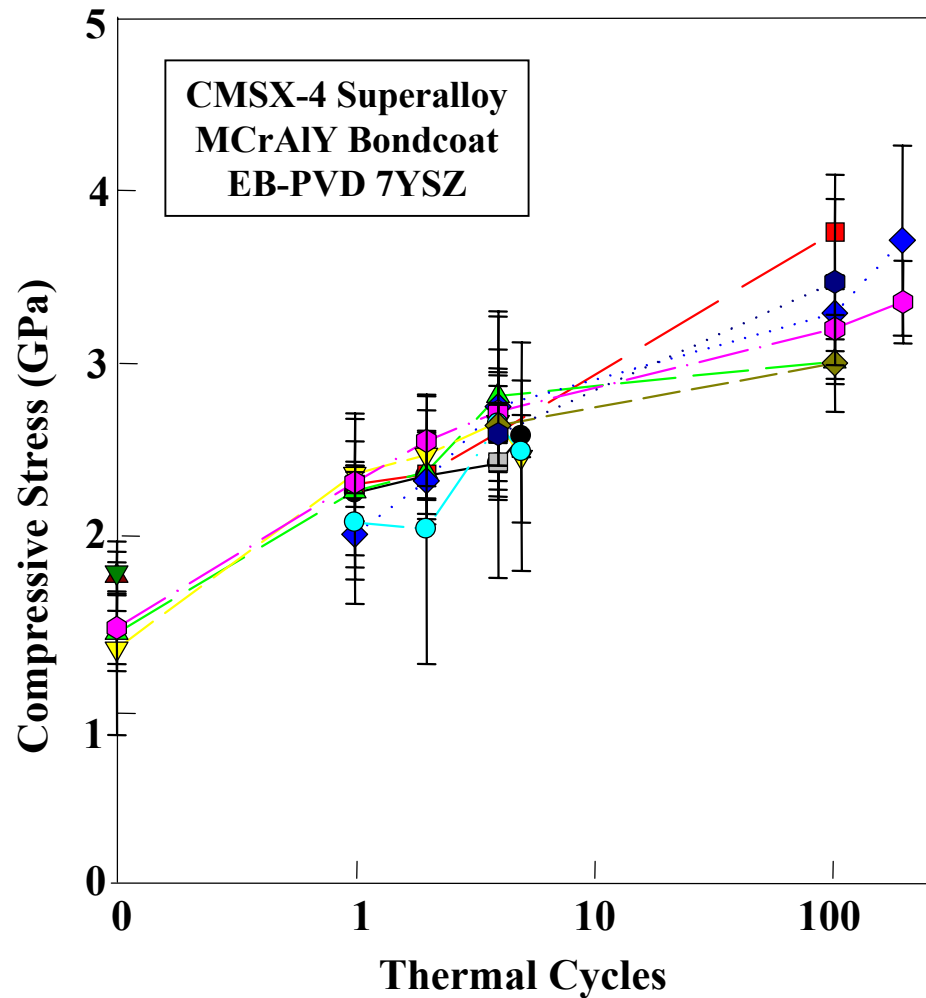
Evolution of Compressive Stress in TGO with Thermal Cycling for TBCs

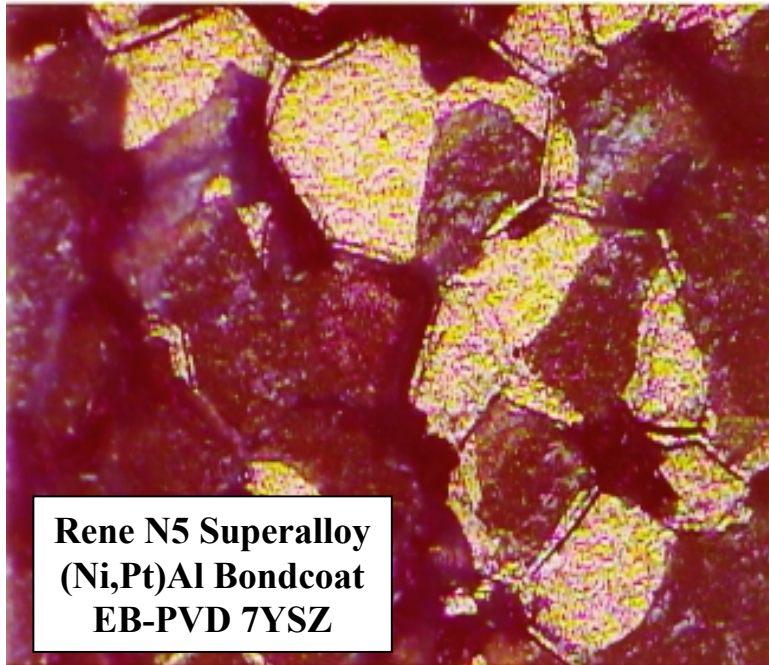
Optical Micrograph

Fracture Surface of TBC After 400 Cycles

**Fracture Surface Exposed by Modified Direct-Pull Test (ASTM)
After Vacuum Infiltration of Fluorescence Dye.**

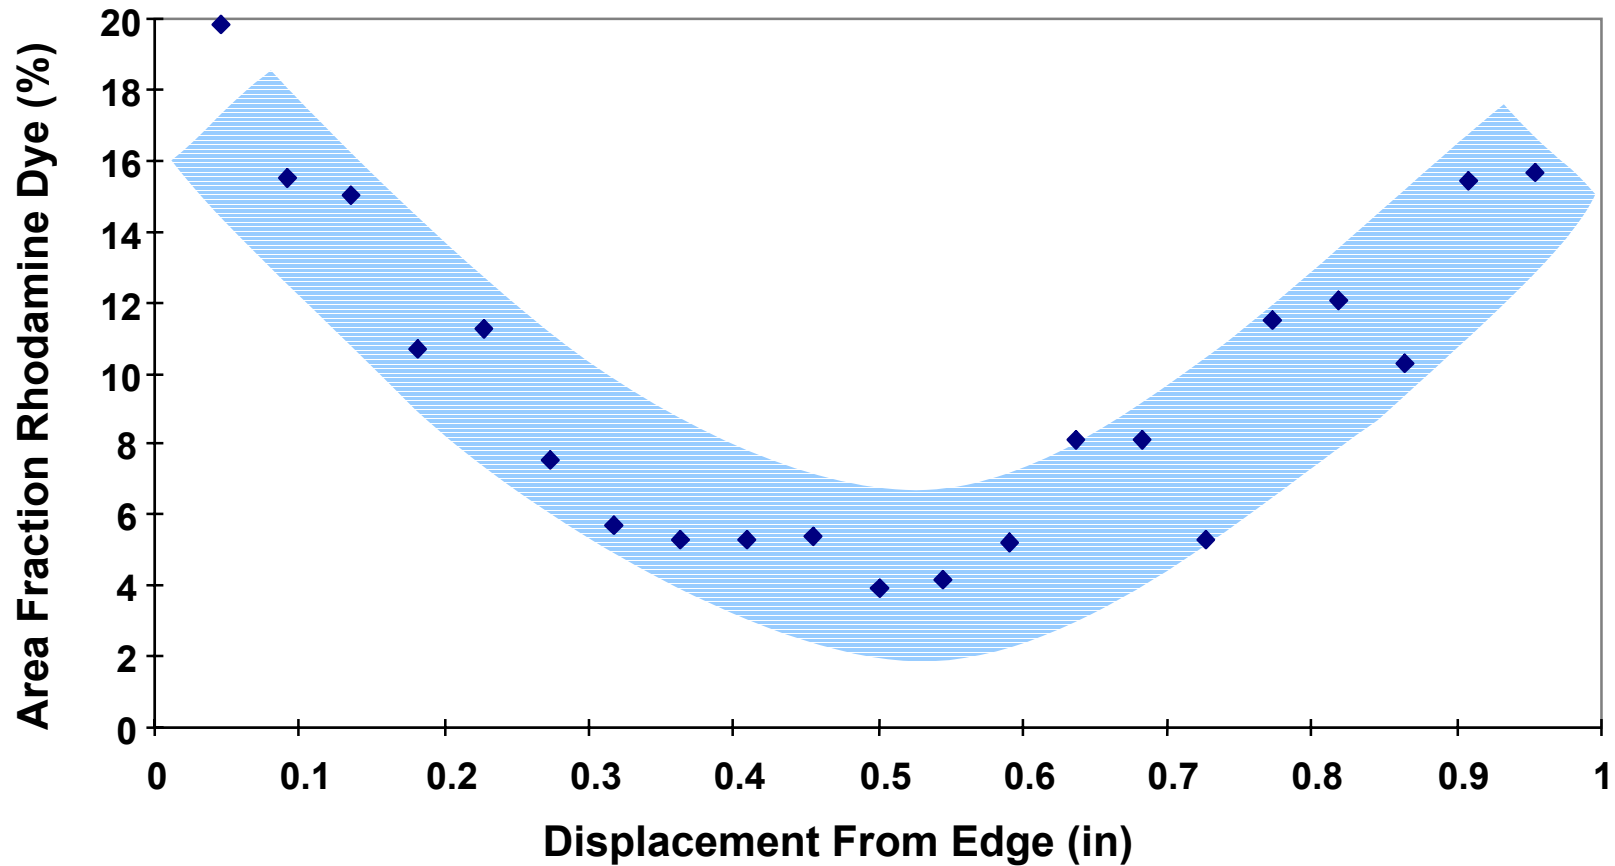
Damage Accumulation Across Disk Specimen

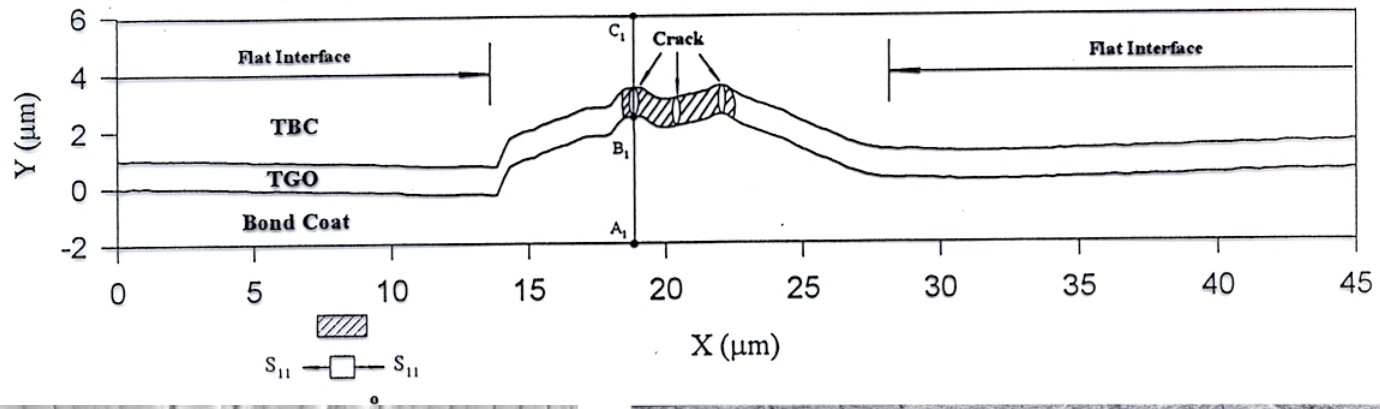
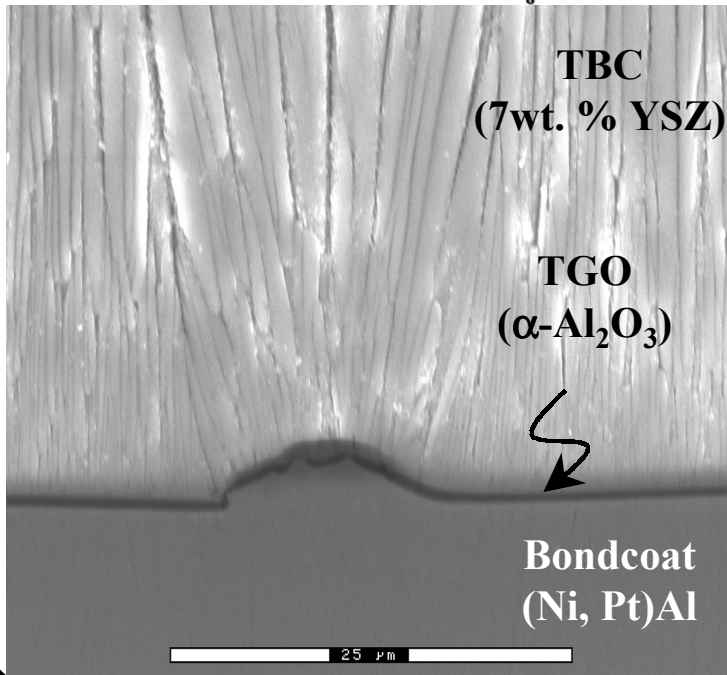
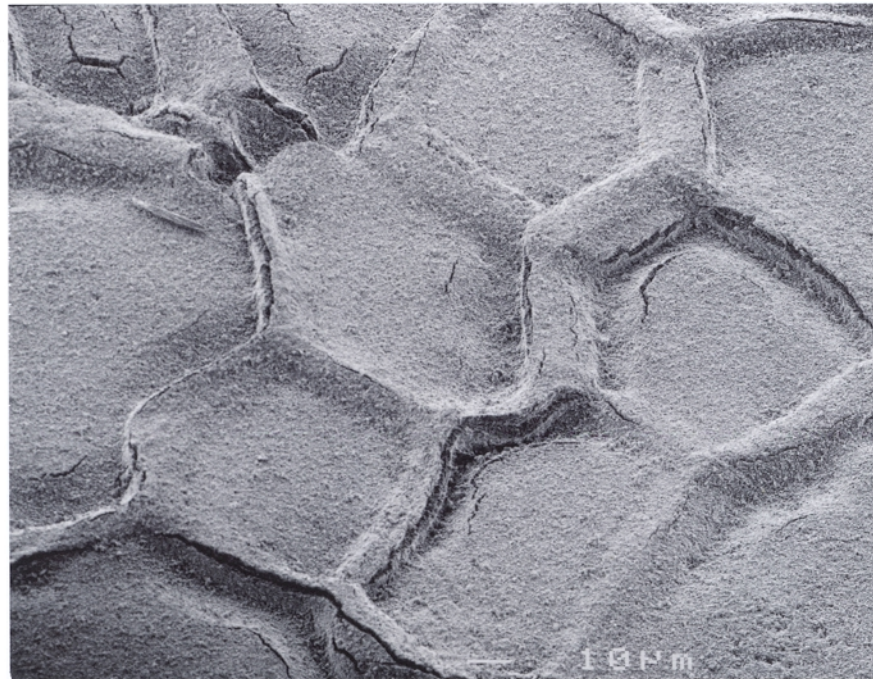
Cross-Section of a Bondcoat Ridge

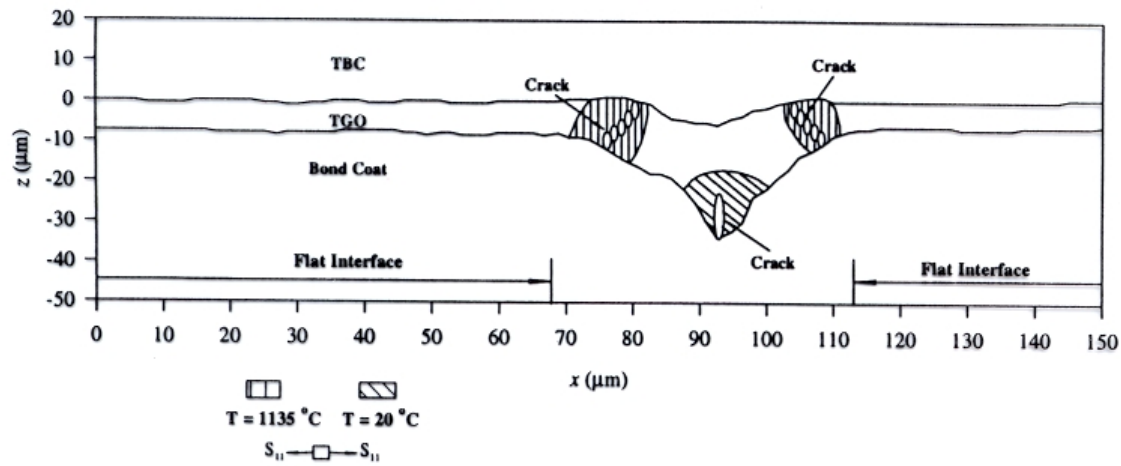
Calculation vs. Observation

Predicted tensile stress zone (shadowed region)
at the cavity tip and transition shoulder

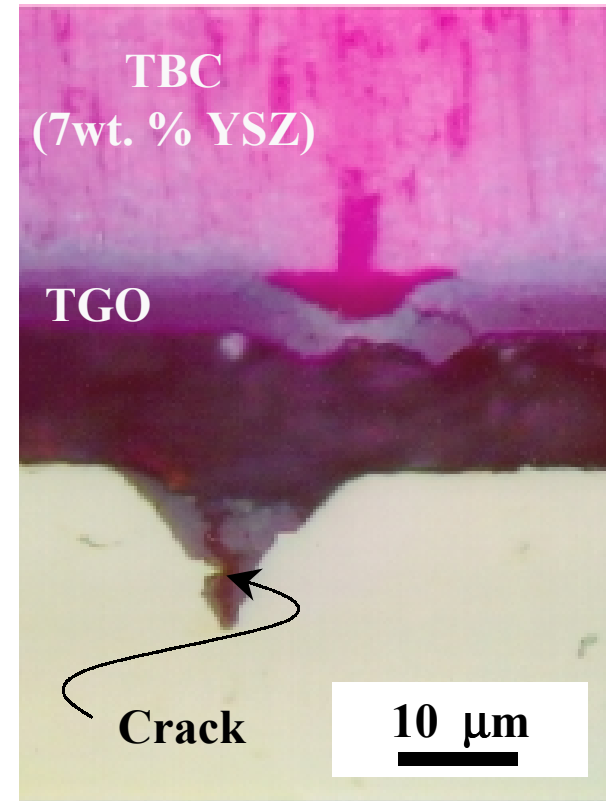
Observed cracking
at the cavity tip and shoulder

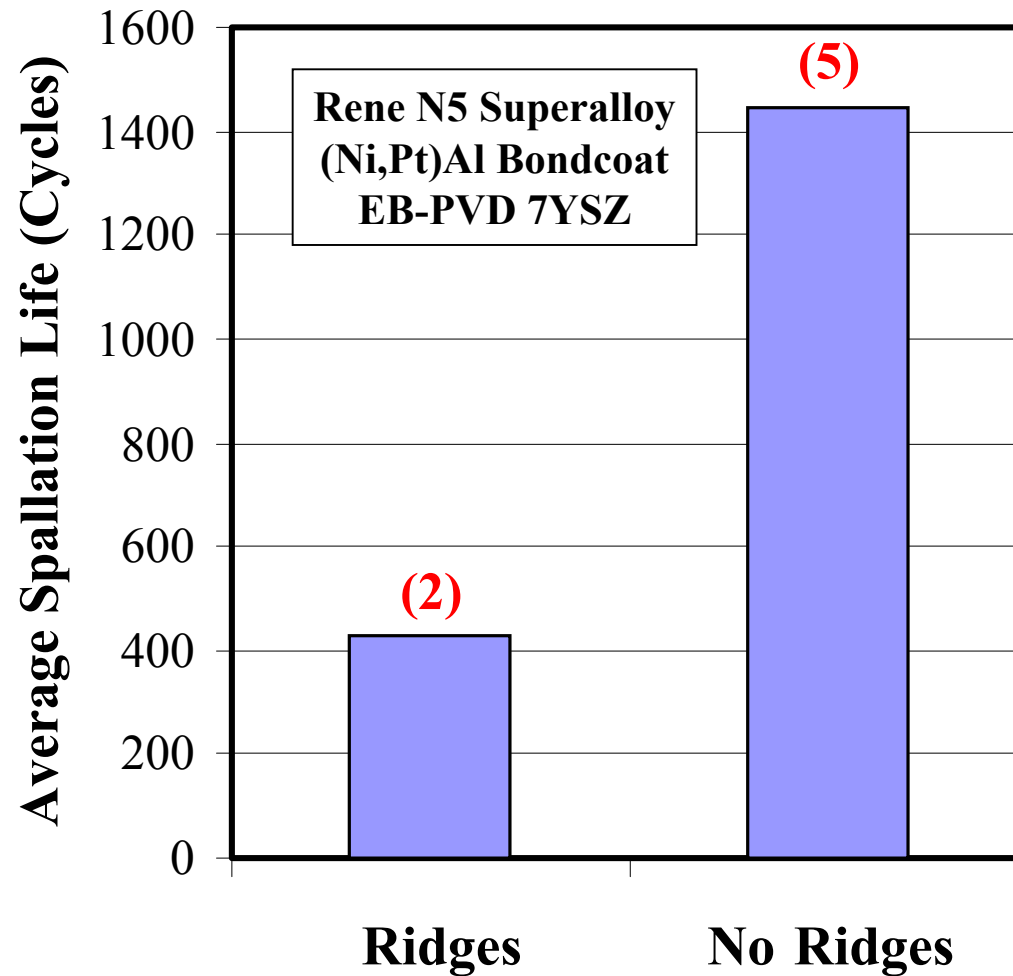
Effect of Ridges on Spallation Life

- **Mechanisms of Spallation Determined.**
- **For EB-PVD TBC, Damage Initiation Occurs at Bond Coat Defects.**
- **When Defects are Removed, 3X Improvement in Life is Obtained.**
- **Good Correlation Between Finite Element Analysis and Observed Cracking.**
- **Quantitative Assessment of Damage Developed Using Fluorescence Dye Technique.**
- **Mechanism-Based Models Should be Defined for Each TBC.**
- **Development of Accurate Lifetime Prediction Systems Now Possible.**

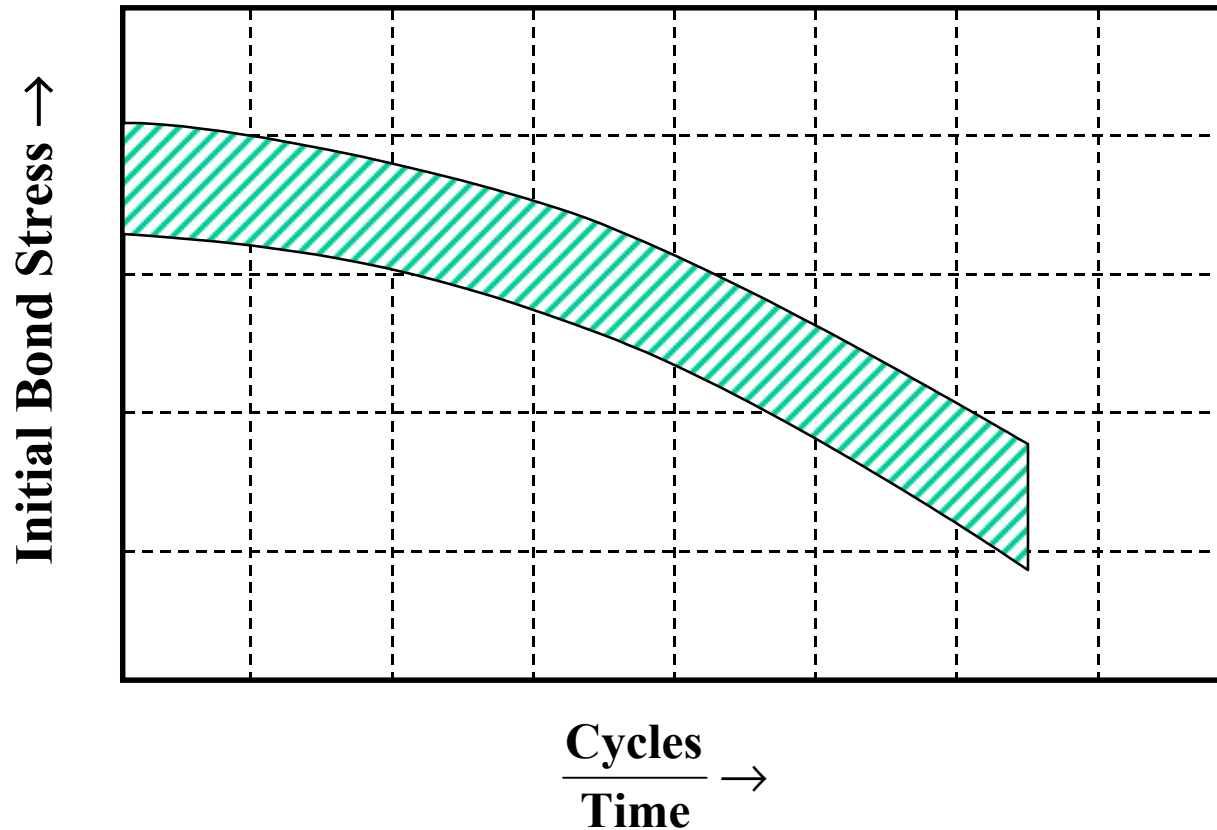
Laser Fluorescence as NDI Technique

- Measure initial bond stress in critical regions of component
- Measure same area after service
- Use calibration curve to assess life remaining

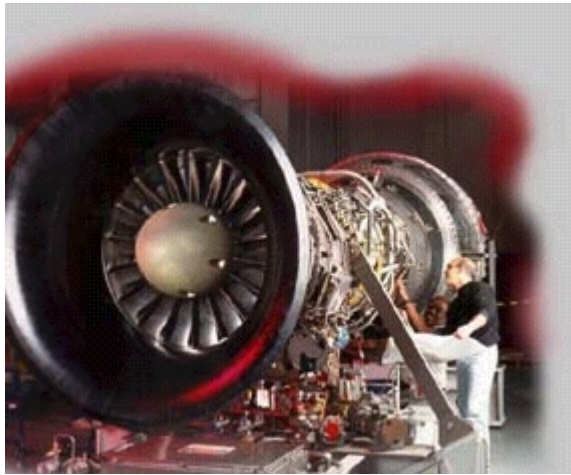
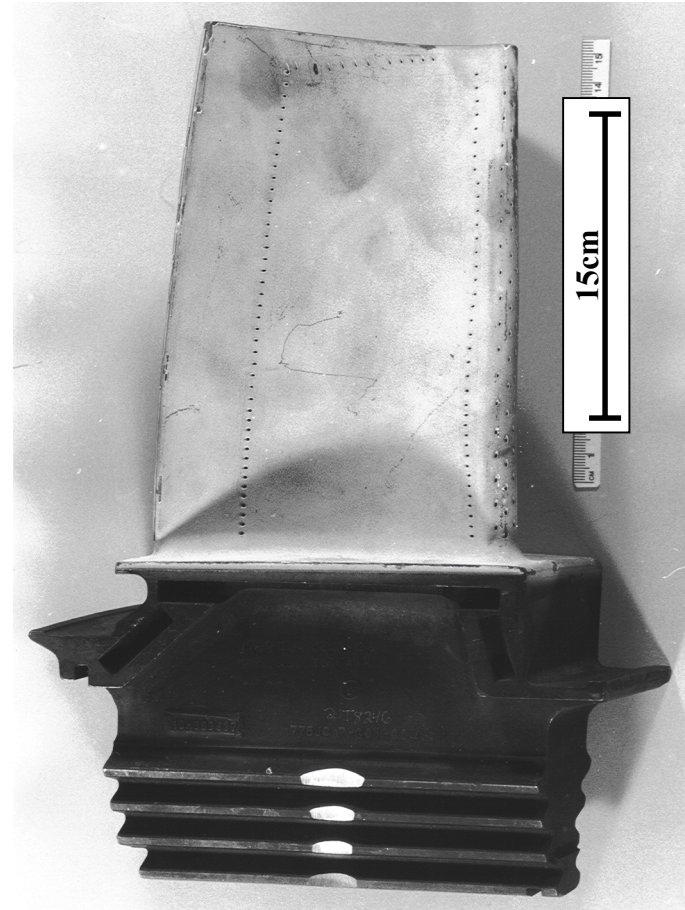
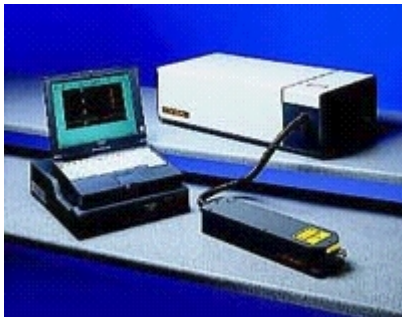
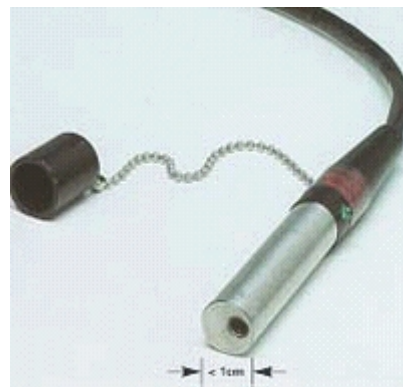
Portable Laser Fluorescence NDI Technique for TBCs Demonstrated

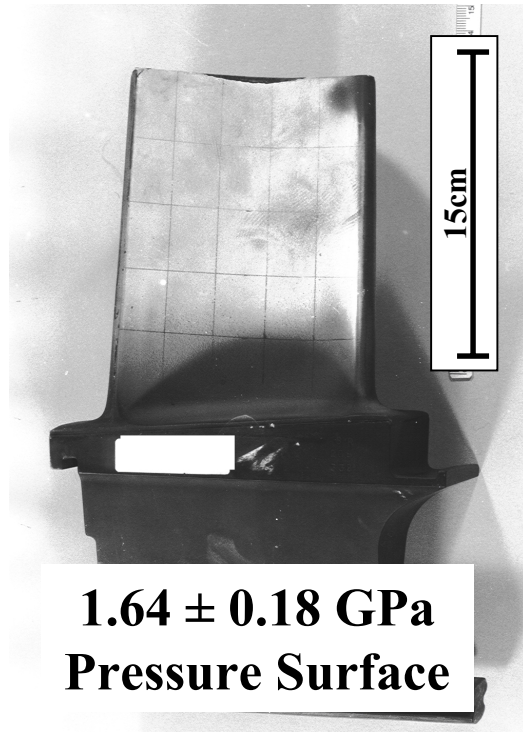
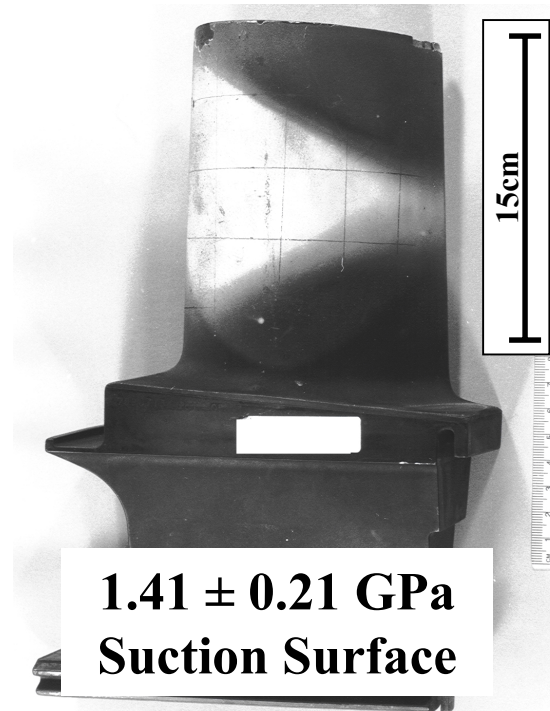
Application of Laser Fluorescence on Thermal Barrier Coated Turbine Blades

27000 Service Hours

- **Five Production Coatings Tested and Showed Characteristic As-Coated TGO Stress and Bond Strength.**
- **Quality of Coating and Spallation Life Related to TGO Stress and Bond Strength.**
- **Laser Fluorescence Measurement of TGO Stress Demonstrated on As-Coated and Engine Run Turbine Blades.**
- **Laser Fluorescence Has Potential for Being Used as Technique for (1) NDI, (2) Life Remaining Assessment, (3) Quality Control and (4) Coating Development.**
