A MECHANISM-BASED APPROACH TO LIFE PREDICTION AND NON-DESTRUCTIVE EVALUATION FOR THERMAL BARRIER COATINGS

Anthony G. Evans, David R. Clarke, and Carlos G. Levi

Materials Department, University of California, Santa Barbara, CA 93106-5050

Sponsored by the Advanced Gas Turbine System Research Program

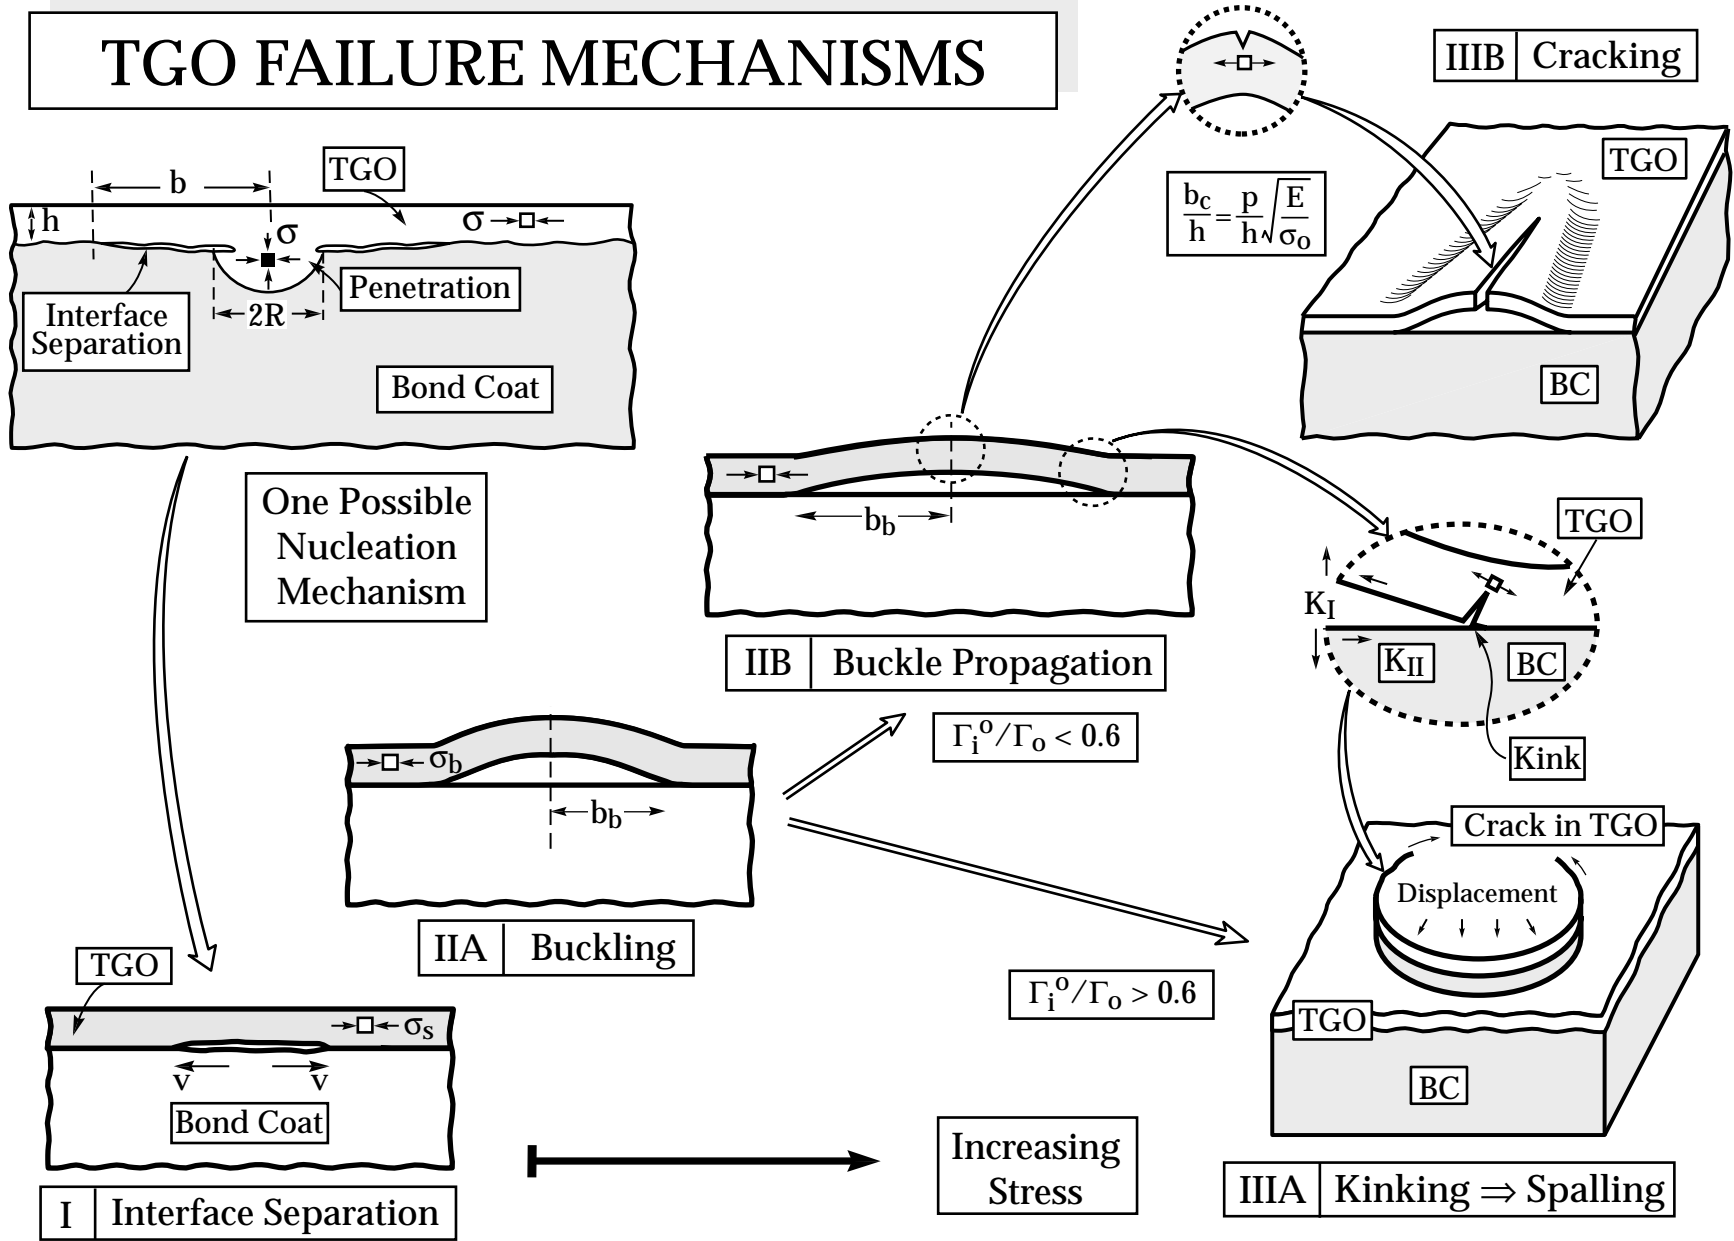
TGO FAILURE MECHANISMS

FAILURE MECHANISMS IN THE THERMALLY GROWN OXIDE

- Predominant failure mechanism is spalling driven by residual compressions ($\sim 4\text{GPa}$) in the TGO.
- Spalling initiates by the nucleation of interface separations (I), typically at defects in the TGO and assisted by impurity segregation. Nucleation requires normal stresses along the interface which arise from the redistribution of the residual compression due to the non-planarities in the TGO. Likely nucleation sites are provided by oxide penetrations which represent local sources of dilatation.

- The separation thus formed grows until it meets a buckling criterion (IIA). The buckle expands (IIB) until the associated increase in the mode mixity angle causes the interface crack to kink into the TGO (IIIA), whereupon a spall develops and detaches a region of the TGO.

- Bending within the buckle induces tensile stresses in the TGO upper surface. In some cases, e.g. highly elliptical buckles, these stresses can cause cracking before the onset of spalling (IIIB). Cracks allow rapid oxygen ingress and the evolution of locally thick oxide layers. These defective regions then degrade the entire system.

- Buckle propagation is motivated by the strain energy density in the TGO and resisted by the fracture toughness of the TGO/BC interface. The extent of propagation before failure depends on the relative toughnesses of the TGO (Γ_o) and the interface (Γ_i^o).

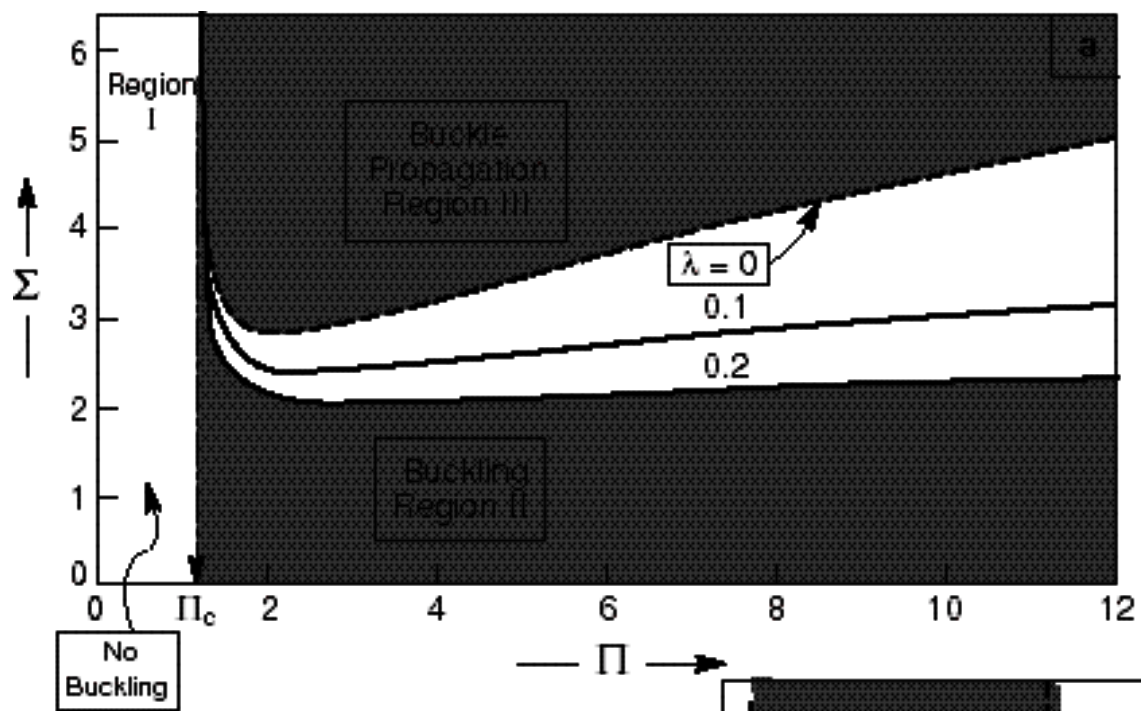
Buckling Maps

(Critical Conditions for TGO Buckling)

$$\Sigma = \sigma_N \sqrt{(1-\nu)h / (E_f \Gamma_i^0)}$$

$$\Pi = (1-\nu^2)(\sigma / E_f)(b/h)^2$$

$$\lambda = 1 - \psi^{-1} \arctan \sqrt{\Gamma_i / \Gamma_i^0 - 1}$$

BUCKLING MAPS

- Established mechanics of compressed thin films can be used to calculate buckling maps. The behavior is represented in terms of three dimensionless indices: an adhesion index Σ , a buckling index Π , and a mode mixity index λ (see figure). In these indices σ is the residual compression in the TGO, h its thickness, E_f its Young's modulus, ν its Poisson ratio, b the separation (buckle) radius, Γ_i^0 the mode I adhesion energy, Γ_i the mixed mode interfacial toughness and ψ is the mixity angle,

- The buckling map for separations in a planar interface identifies three regions:
 - ⇒Region I: stable separations exist because the buckling condition is not satisfied.

- ⇒Region II: the buckling condition is satisfied, but the energy release rate is too low to cause additional buckle propagation.
 - ⇒Region III: the energy release rate exceeds the interface fracture energy. At fixed mode mixity, the buckle enlarges stably as the adhesion index increases.

- For non-planar interfaces the buckling condition is satisfied at lower stresses and/or separation sizes.

- Buckling maps have been developed and used to experimentally assess the role of non-planar features at the interface in accelerating the buckling process. These maps depict the combinations of residual stress, thickness and size of the interfacial separation, and interfacial toughness that are needed for nucleation as well as for stable or unstable propagation of the buckle.

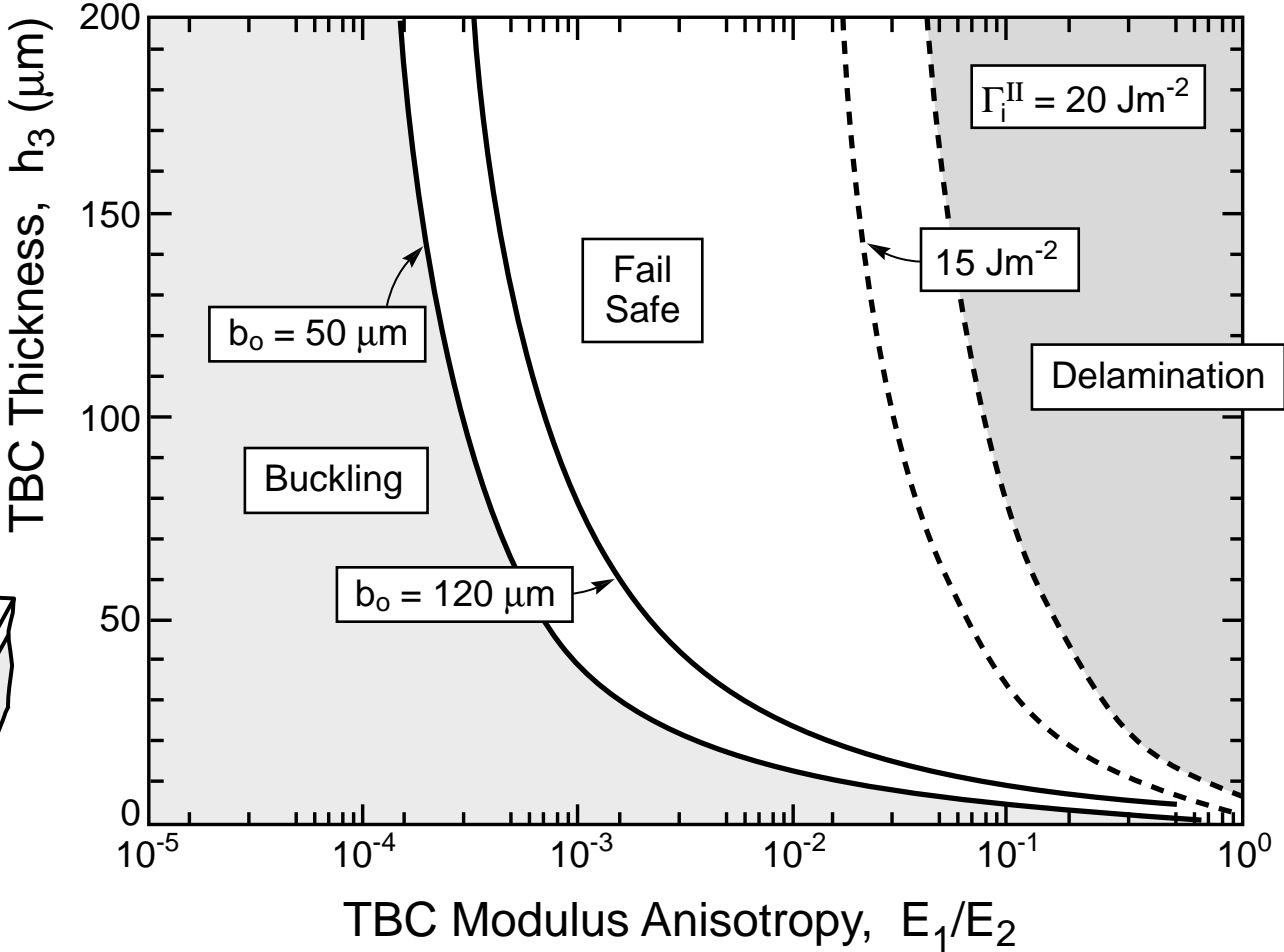
Failure Mode Competition in TBC Systems

(based on work by Choi and Hutchinson)

FAILURE MECHANISMS IN THE TBC

- The starting hypothesis is that TBC systems fail by a similar sequence of events as the uncoated TGO, albeit with key differences introduced by the presence of the TBC.

- The residual stress in the TGO and the associated strain energy density are still considered as the primary driving potential for failure.
- The stiffness of the superposed TBC suppresses wrinkling and buckling of the TGO. A high area density of separations and microcracks develop around the TGO well before actual TBC failure, forming preferentially at imperfections such as oxide heterogeneities. The interface remains attached at regions between separations until the latter merge and produce a sufficiently large detached area to induce spall failure. Accordingly, unlike TGO failure, TBC life is dominated by considerations of crack growth and coalescence rather than nucleation.

- As buckling is suppressed competing mechanisms emerge, notably edge delamination. In EB-PVD systems, where the compliance varies through the thickness, the dominant mechanism is determined by the relative magnitudes of the in-plane modulus of the columnar structure and the modulus of the denser layer near the substrate.

- Modeling scenarios suggest that there is a fail-safe region against spalling by either mechanism for combinations of the TBC thickness and the modulus anisotropy ratio (see figure above).

- Edge delamination has emerged as a potential failure mechanism for TBC systems. Modeling suggests the existence of a fail-safe regime—for certain combinations of TBC thickness and elastic anisotropy —between the buckling and edge delamination conditions.

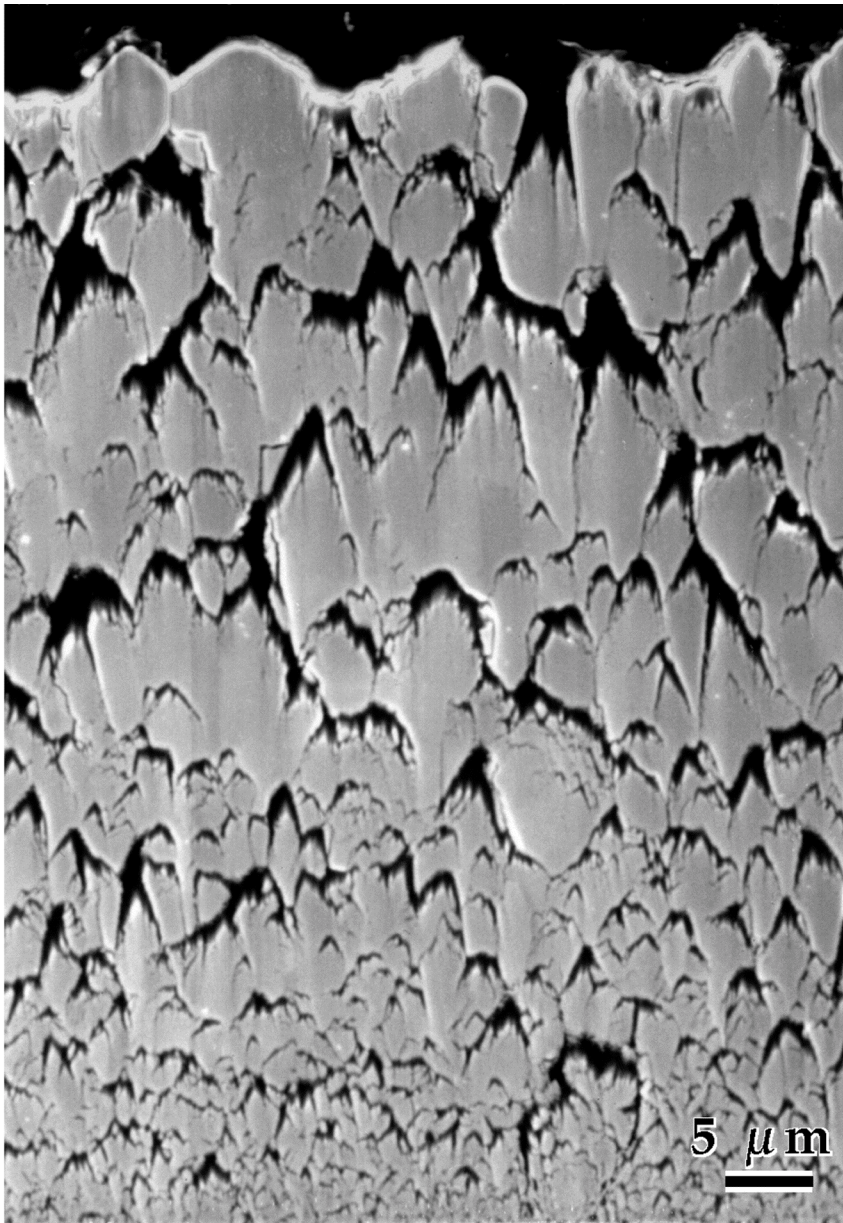
TBC Cross Section across Columns

EFFECT OF TBC STRUCTURE ON COMPLIANCE

- EB-PVD TBCs are naturally graded structures, with a compliance that increases with deposition thickness. This structure can be used advantageously to tailor the coating anisotropy to optimize its role in avoiding spalling failures.

- Studies are underway to characterize the variation of compliance with thickness. The figure above shows microstructures for EB-PVD TBCs deposited at 1100°C on stationary FeCrAlY substrates with different vapor incidence angles (VIA).

- The image on the left shows the strong change in porosity scale (and probably volume fraction) with distance away from the substrate. The effect is enhanced because the coating was deposited without rotation but at a high VIA (45°). It is also noted that the distribution of porosity, and hence the compliance, is anisotropic. This is a result of shadowing of the vapor flux by the column tips in only one direction.
