# Ramsey Creek Watershed Restoration Accomplishment Report

Barlow Ranger District  
Mt. Hood National Forest

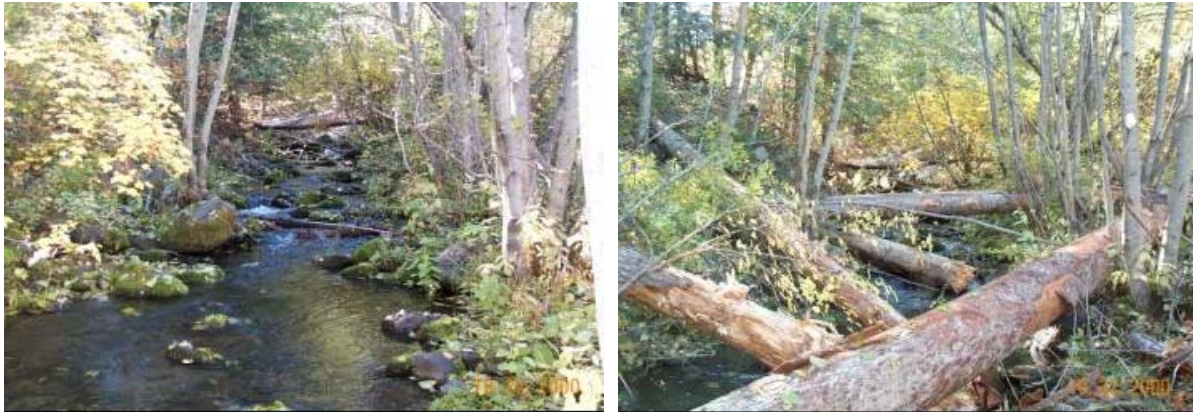
*Figure 2. The photos above illustrate one work site in Ramsey Creek before and after log placement. Logs placed in the stream channel improve fish habitat and increase the number of times high stream flows spill over the banks onto the floodplain, thus improving riparian area health.*

We placed approximately 1,400 logs within and adjacent to the stream channel in a three mile project reach. Logs placed in the channel will provide cover for fish, create pool habitat, and ultimately increase the number of times higher stream flows spill over banks onto the floodplain (Figure 2). More frequent over bank spilling is desirable because it actually reduces erosion of stream banks plus recharges the riparian area with water and sediment, improving vegetation growth.

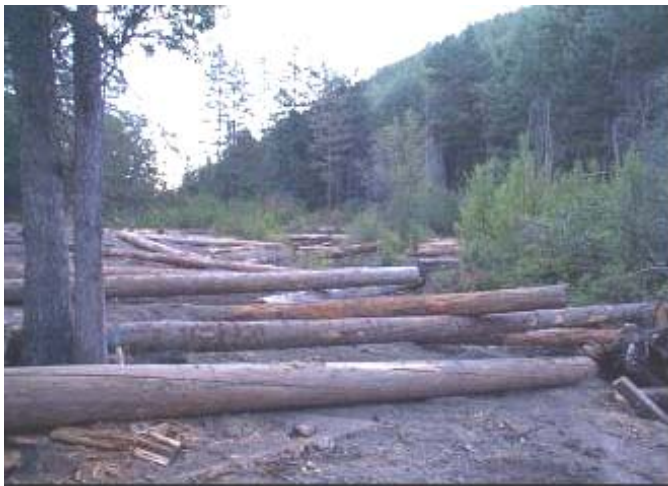
*Figure 3. The photo at left shows a typical floodplain wood placement site. A large logjam placed in the channel downstream will likely cause the stream to shift into the area illustrated in this photograph. The logs will help reduce the erosion when that happens plus provide future fish habitat.*

The majority of wood (60-70%) was placed in the floodplain because we anticipate the stream to shift course due to in-channel wood placement (Figure 3). The wood placed in the floodplain will help regulate the rate of stream channel shifting, reduce erosion when it does shift, and become new in-channel habitat when the stream shifts course. Large wood on the floodplain also reduces the amount of erosion during flood events.

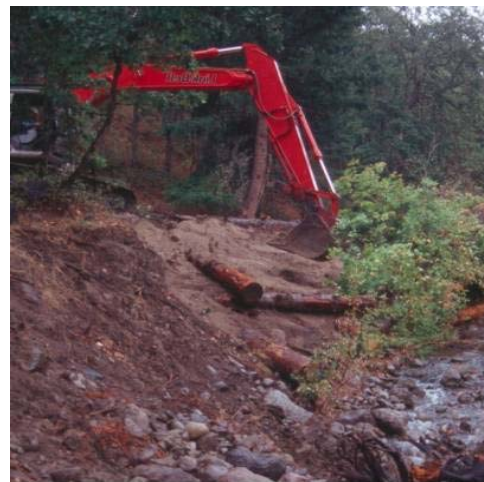
*Figure 4. At many sites, logs were placed in and along stream banks not only to reduce erosion but also to prevent the stream from shifting into the new trail. At these locations, the excavator was often able to work from the bank to place and bury logs.*

We placed logs in specific locations along stream margins to reduce the amount of bank erosion (Figure 4). Most of these sites were located adjacent to the decommissioned road and were designed, in part, to prevent the creek from shifting into the new trail.

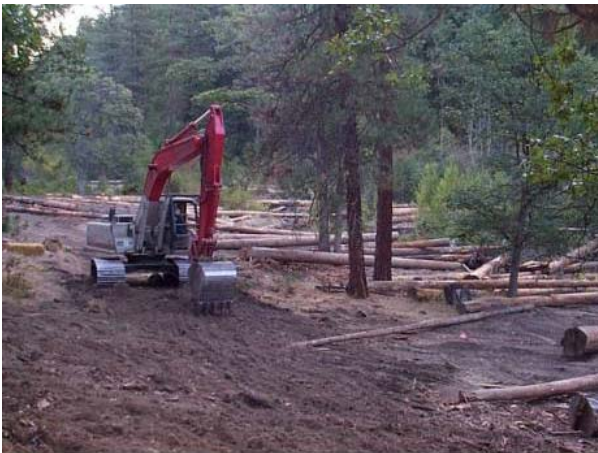
*Figure 5. This section of road was completely removed from the landscape by digging it up and restoring the natural contour of the land. We spread native grass seed and straw mulch and now the area is covered with grass.*

Actual decommissioning was begun in fall 2000 and completed in 2001. The upper 1.5 miles of road was fully obliterated. Road fill was pulled up the slope and shaped to match the natural contour of the slope. A small bench was left at the top for the trail. Other short sections of road leading down to the creek were also obliterated (Figure 5). The lower 1.5 miles were sloped away from the hillside and scarified to improve drainage and increase water infiltration (Figure 6). About 1/3 of the road surface was left as trail. The constructed drain dips, which had been armored with rock, were left in place. Treated areas were planted with native grass seed and mulched with straw. A small parking lot/trailhead was constructed at the MHNF boundary in 2001.

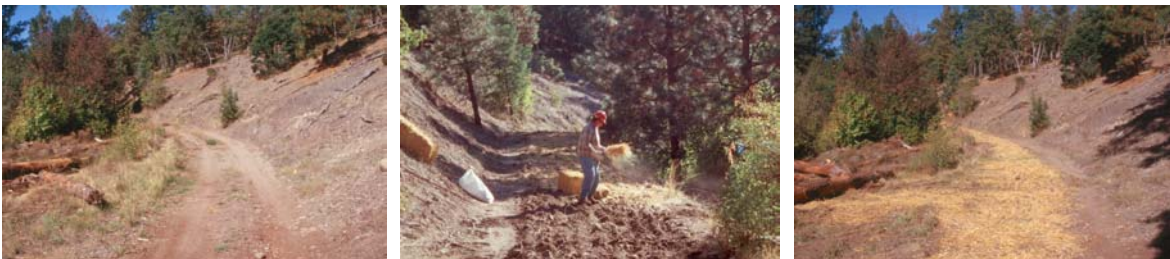
*Figure 6. Example of a section where the road was sloped away from the hillside, scarified except for the trail area, seeded with native grass seed, and mulched. The left and right photographs are before and after photos of the same location.*

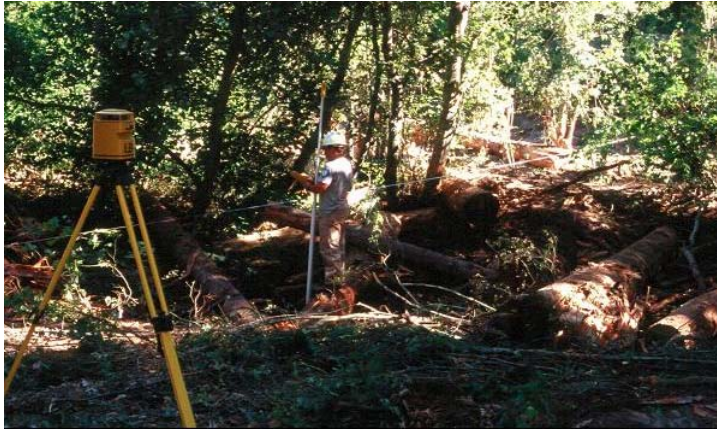
*Figure 8. Among other things, field crews measured the shape of the floodplain and stream channel at 24 sites within the treatment reach. This information will help document and describe stream channel shifts resulting from large wood placement.*

Pre-project monitoring within the project area occurred between 1997 and 2000. This monitoring focused on stream habitat that we expected to change because of project activities, including stream shape (Figure 8), amount of large wood, number and size of pools, amount of shade, and bank stability. Post-project monitoring is ongoing and a detailed monitoring report is in preparation.
