South Texas Project Electric Generating Station P.O. Box 289 Wadsworth, Texas 77483

South Texas Project
Units 1 & 2
Docket Nos. STN 50-498, STN 50-499
Responses to NRC Questions Regarding
Bottom Mounted Instrumentation Penetration Indications

Responses to NRC Questions

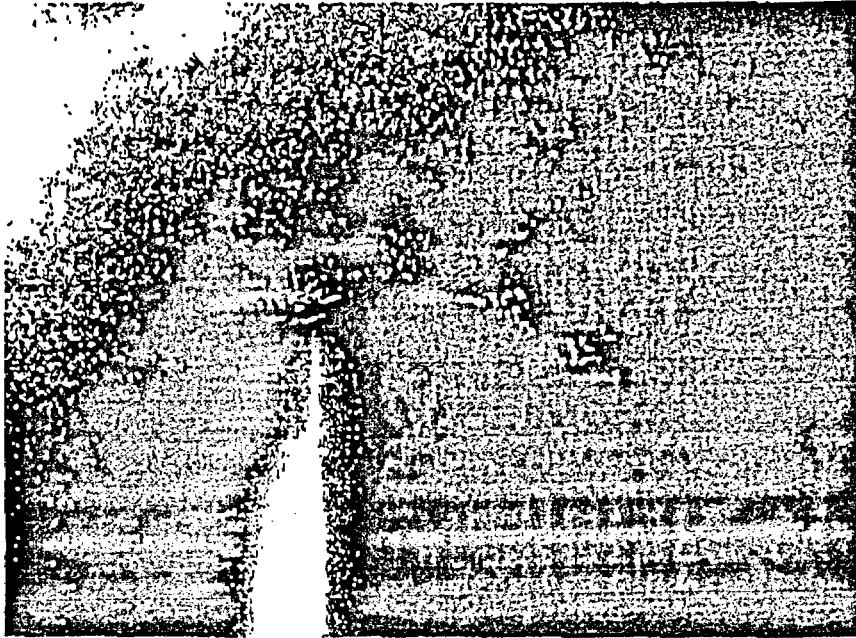
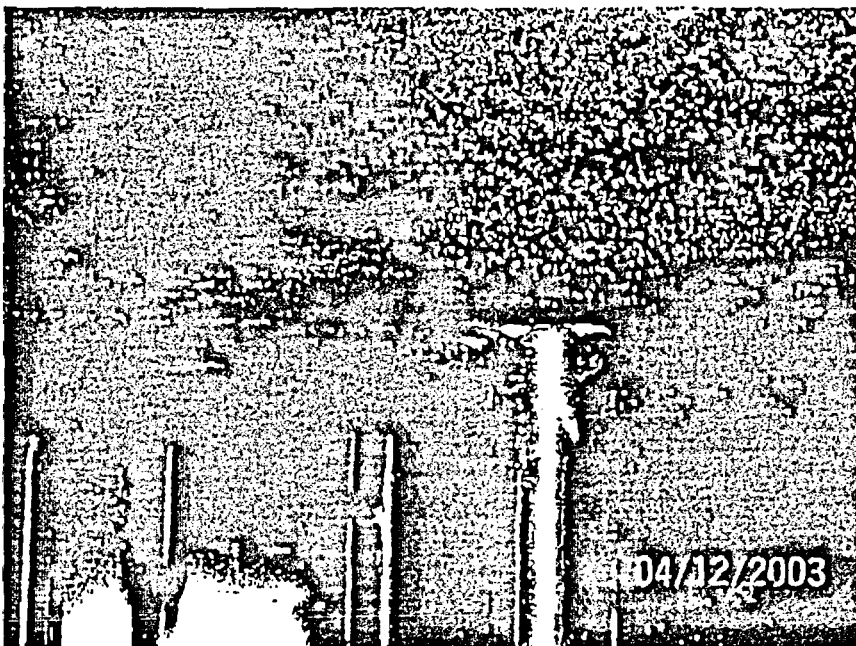
9. Please explain the apparent groove or gap in the photograph of Penetration 1.

There is no groove or gap. A closeup photo from a video taken after the residue was removed shows a better view of Penetration 1. The penetration openings are chamfered. This photograph shows that the chamfer is still clearly defined. A photograph of Penetration 1 prior to cleaning is provided for comparison.
