Addendum to
OST Long-Term Testing Report

FULL-SCALE DEMONSTRATION OF LOW-NO_x CELL™ BURNER RETROFIT

September 1994 Outage:
Examination of Corrosion Test Panel
and UT Survey in DP&L Unit #4

June 1995

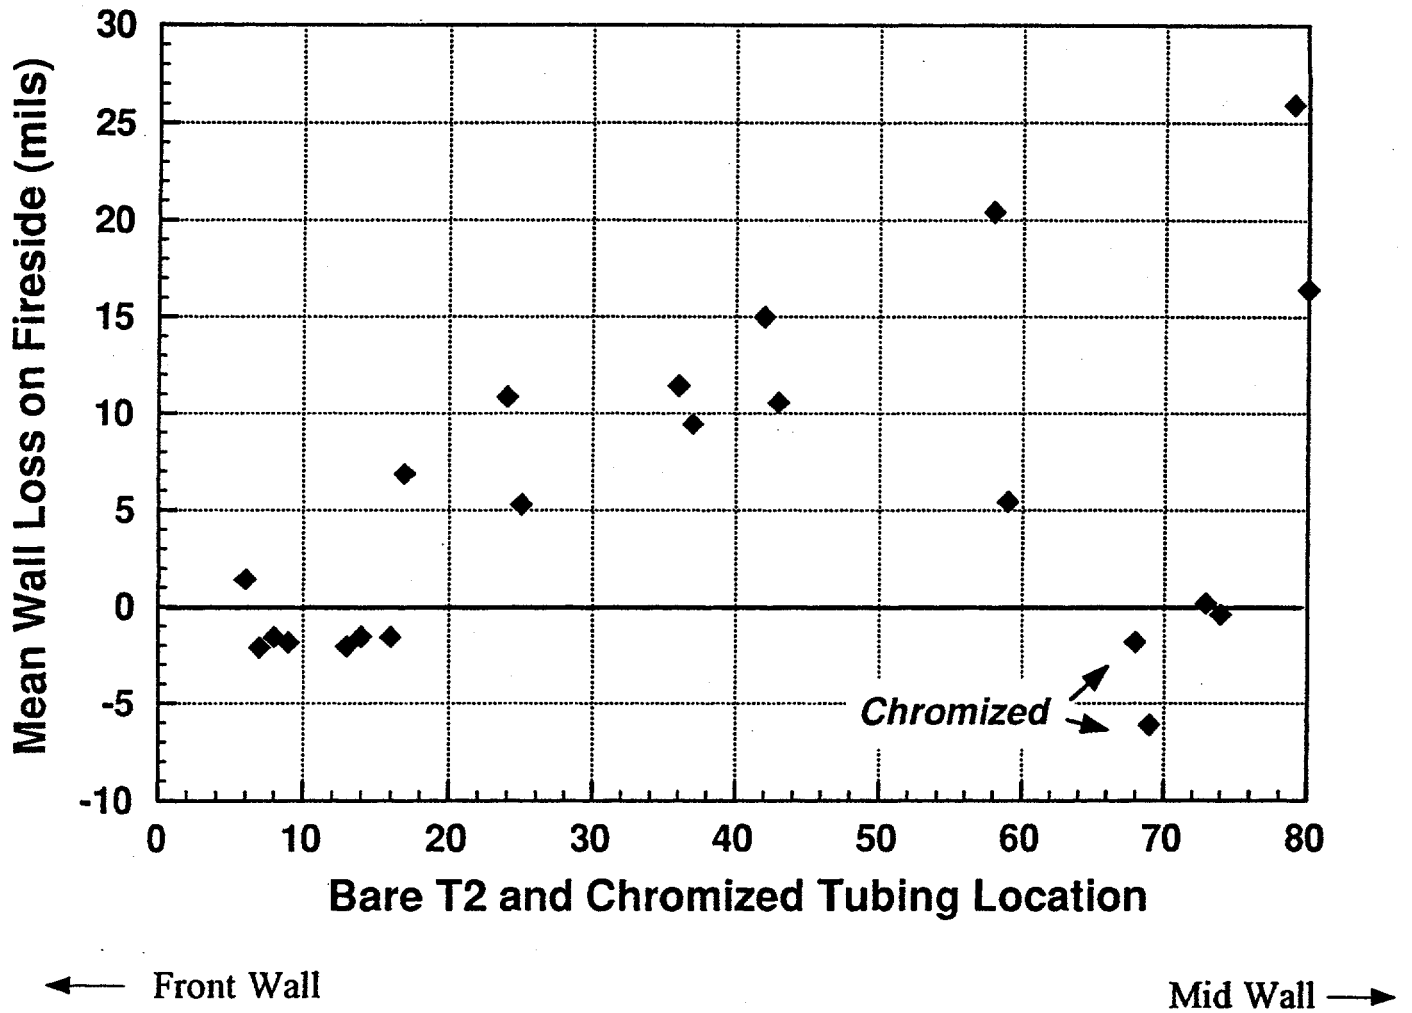
Figure 3 displays the mean wall losses (in mils) of the test panel on the fireside. The measurements indicate that the corrosion wastage of bare T2 increases with increasing tube number, with the highest tube loss being ~26 mils on Tube #79. This trend is consistent with the previous results from the April 1993 outage documented in the Long-Term Testing Report.¹ That is, higher corrosion wastage on the bare T2 was found near the center line of the west sidewall at the bottom elevation of the test panel.

It is also noted that the wall losses of each adjacent pair of bare T2 tubes are noticeably different, with one being higher than the other. Such a variation is again consistent with the corrosion results obtained from the April 1993 outage. It has been interpreted in the Long-Term Test Report that such variations were caused by an appreciable difference in the metal temperatures between each pair of tubing, as JMSS4 consists of two-pass furnace walls. Consequently, the metal

Figure 3 - Measured "mean" wall losses of the bare and chromized T2 tubes at the bottom elevation of the corrosion test panel.

Relating the wall-loss data in Figure 3 to the tube pass identifications in Table 1, the second-pass tubes indeed show higher corrosion wastage than their neighboring first-pass tubes. Therefore, this correlation agrees well with the previous interpretation, i.e., differences in the corrosion wastage of two adjacent tubes were primarily caused by their tube metal temperatures.

The measured metal wastage in Figure 3 for the bare T2 with tube numbers less than 15 scatters along the original OD thickness. Again, a similar observation was found on these tubes from the results of April 1993 outage (i.e., after the first 15-month exposure in JMSS4). Considering the standard deviation of the measurements, the scattering of wastage data signifies that negligible fireside corrosion has occurred on these bare T2 tubes at the bottom elevation of the test panel close to the front wall. The range of data scattering suggests that the standard deviation is approximately ± 2 mils.

Data of the chromized T2 tubes in Figure 3 also show no sign of wall losses at the bottom elevation of the test panel, even though they were located near the center line of the west sidewall where the corrosion attack on bare T2 was more severe. In fact, these coated tubes show "negative" wall losses compared to the archived samples. As discussed in the Long-Term Testing Report, the

negative tube losses were primarily caused by non-uniformity of the initial coating thickness on the as-chromized product. The coating thickness produced on the ends of an as-chromized tube panel, from which the archived samples were taken, was usually the thinnest. As a result, the OD thicknesses of the exposed chromized tubes which suffered negligible metal losses may appear to have increased when compared to the archived tube-end samples.

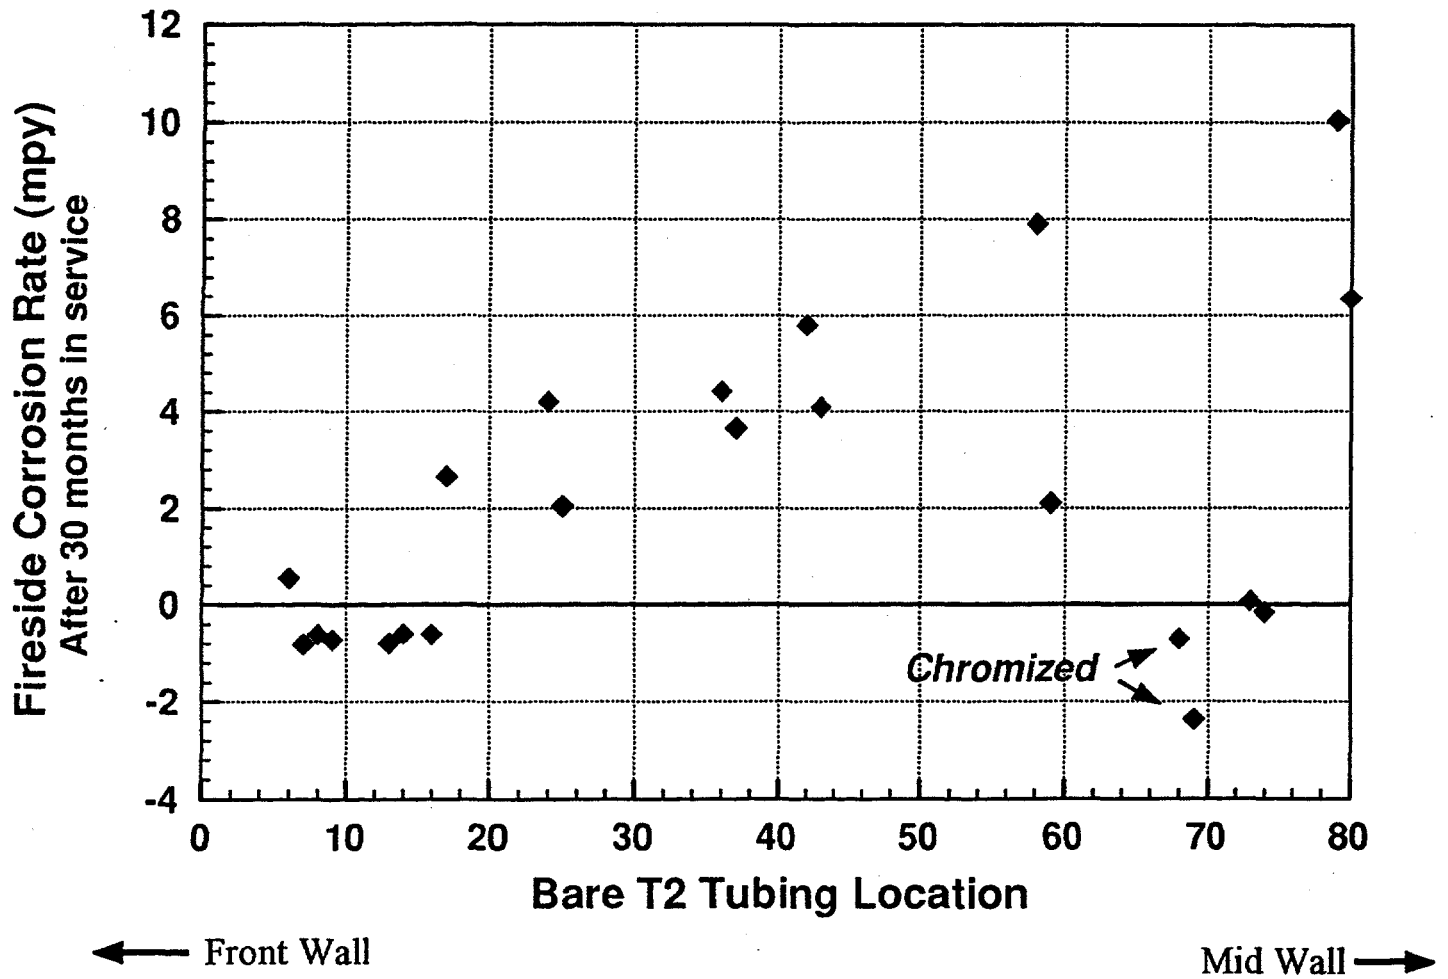
Figure 5 illustrates the variation of corrosion rates in mil per year (mpy) with tube location for the bare T2 and chromized tubing. The corrosion rates were derived by linearly extrapolating the 31-month corrosion data (in Figure 3) to one year. As expected, the highest corrosion rate, ~10 mpy, occurs on the bare T2 tube of #79 at the bottom elevation of the test panel. The corrosion rate on the chromized T2 is negligible (the negative data points were caused by reasons discussed previously).

Figure 5 - Variation of corrosion rates of bare T2 and chromized tubes with the tube location at the bottom elevation of the corrosion test panel.
