Report DOE/PC/90545-1
(Babcock & Wilcox Report RDD:94:40090-030-036:01)

TASK REPORT

FULL-SCALE DEMONSTRATION OF LOW-NO_x CELL™ BURNER RETROFIT

Long-Term Testing

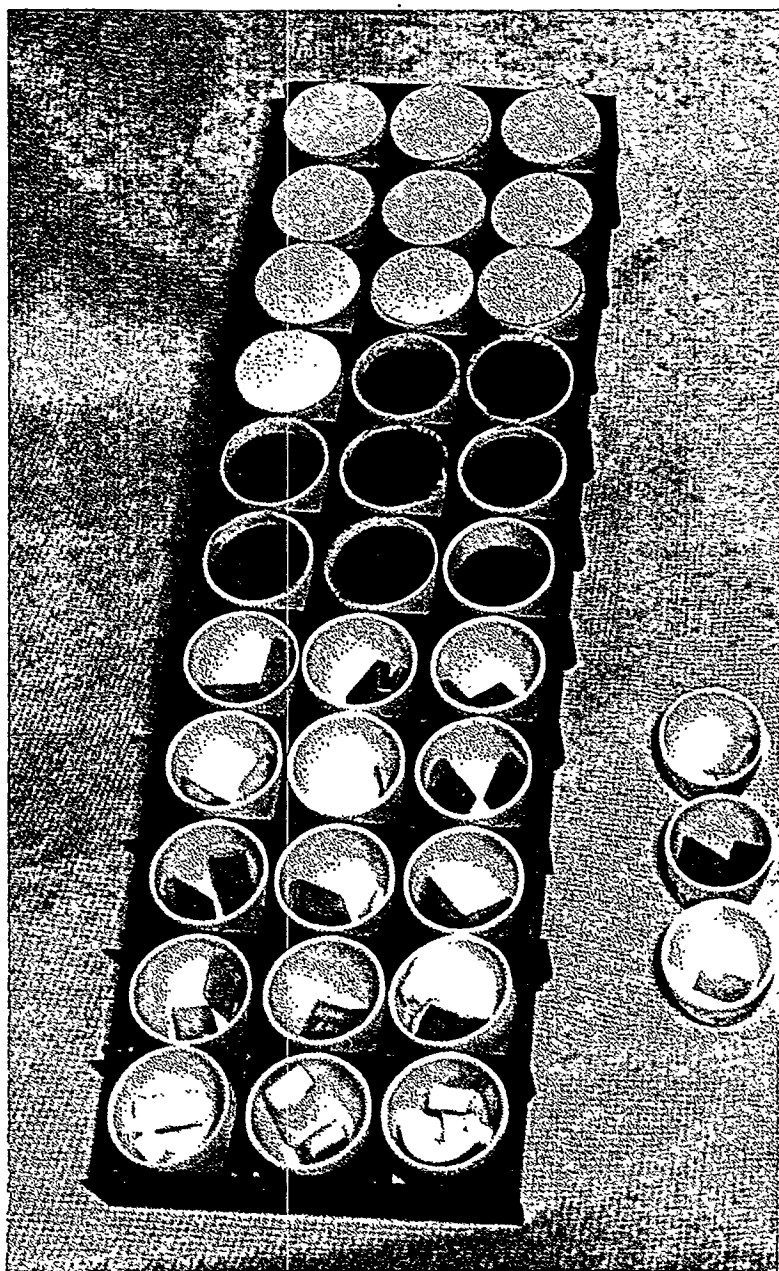
Figure 2-2 Photograph of an assembled steel rack containing alumina crucibles prior to the retort exposure

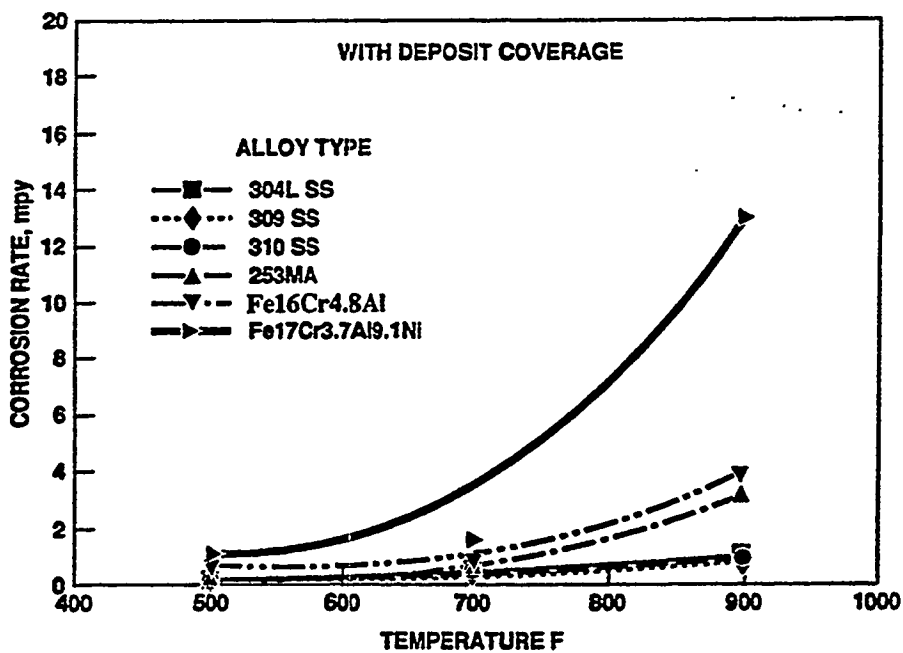
Figure 3-6 Variation of the corrosion rates with temperature for Group-II alloys with the coverage of simulated ash deposit

However, the corrosion rates of these free-standing coating materials in Figures 3-5 and 3-6 are relatively high compared to those of the other Group-II alloys. To understand the cause of this behavior, the exposed coating materials were carefully examined under SEM/EDX. Figure 3-9 shows a cross-sectional SEM micrograph of an FeCrNiAl sample after exposure in Test #2. In general, the corrosion products on the outer surface were very thin, despite the detection of some iron sulfide by EDX. The thin corrosion products formed on the surfaces indicate that the inherent compositions of these coating materials are quite resistant to the simulated reducing combustion gases.

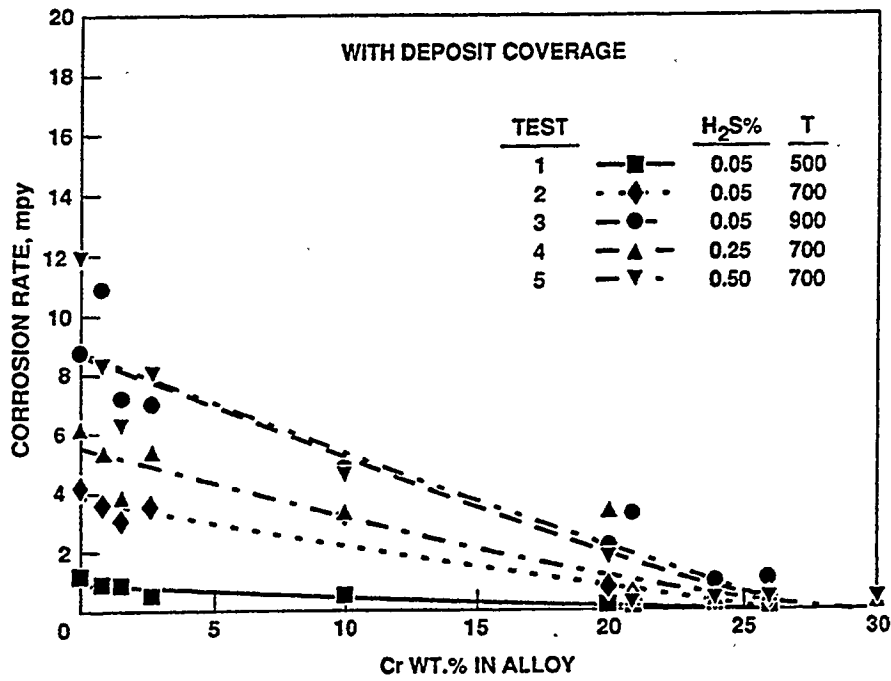
Figure 3-15 Variation of the corrosion rates with Cr concentration in alloys with the coverage of simulated ash deposit

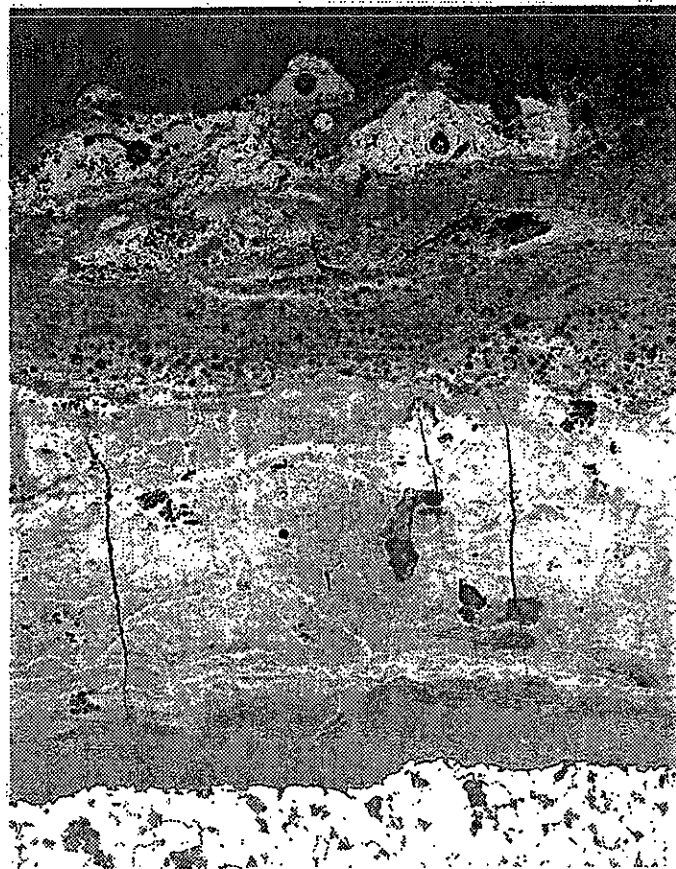
Figure 3-28 Cross-sectional SEM micrograph of a T2 tube sample from the corrosion test panel

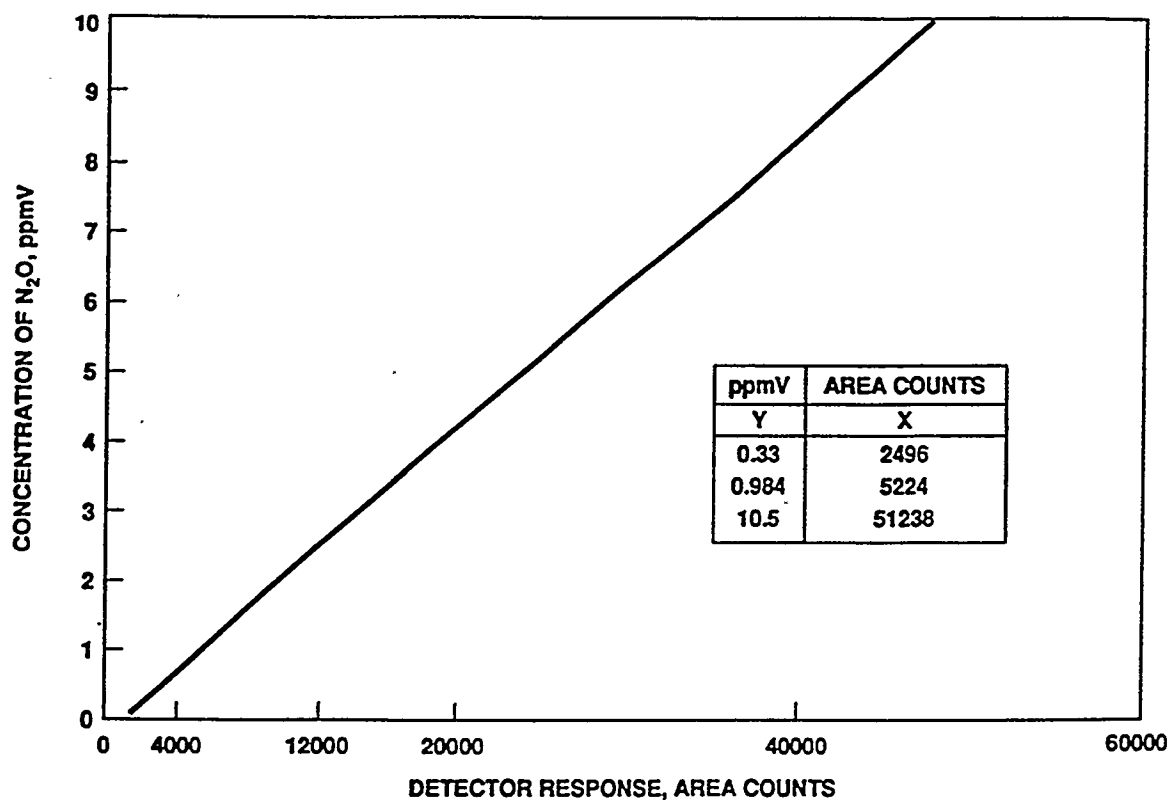
Figure 3-37 Graph of concentration of nitrous oxide against peak area (Data points = 3, correlation coefficient = 0.999; intercept = -0.1465; and slope = 0.0002)
