**SPILL RESPONSE, CLEANUP AND
ENVIRONMENTAL ISSUES ASSOCIATED WITH A
METHANOL SPILL IN ALASKA**

**Linda Laubenheimer
Jacqueline Ayer
Timothy Hofseth**

March 29, 1991

**California Energy Commission
1516 Ninth Street
Sacramento, CA 95814
(Contract 500-88-003, Work Authorization 4-PVEA)**

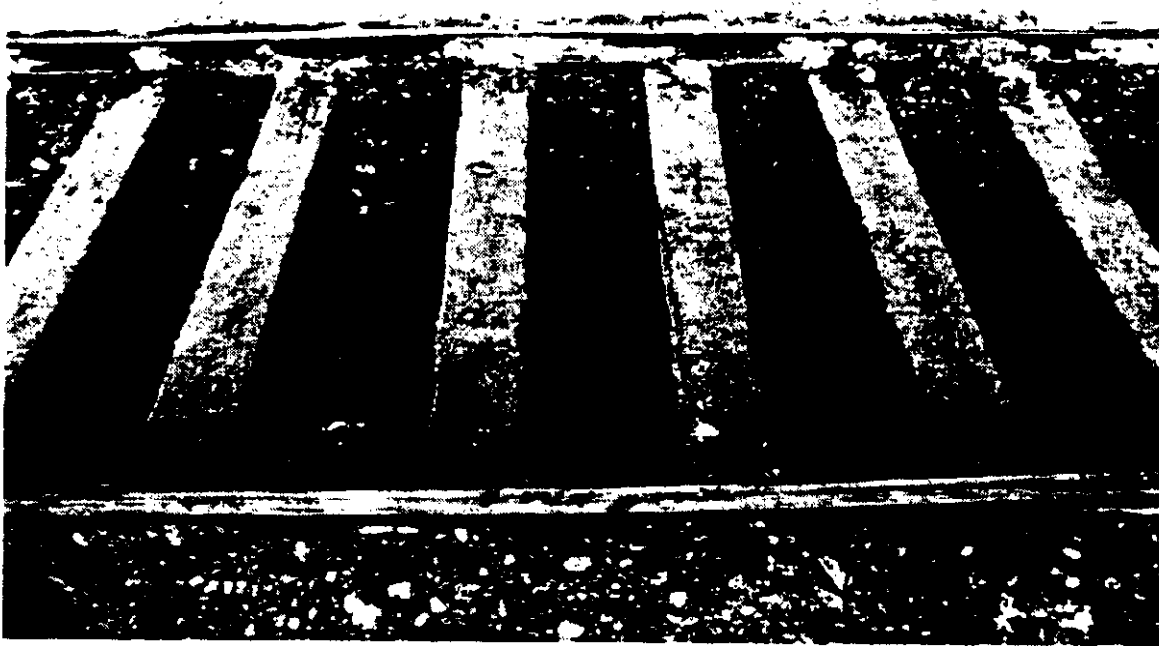
PHOTOGRAPH 5. Close-up view of the railroad bed after some of the contaminated gravel was removed.
