Slipstream Heat Pipe Air Heater Tests

**MILLIKEN CLEAN COAL TECHNOLOGY
DEMONSTRATION PROJECT**

**MILLIKEN UNIT 2 SLIPSTREAM HEAT PIPE TESTS
October 27, 1993 to May 21, 1994
Final Report**

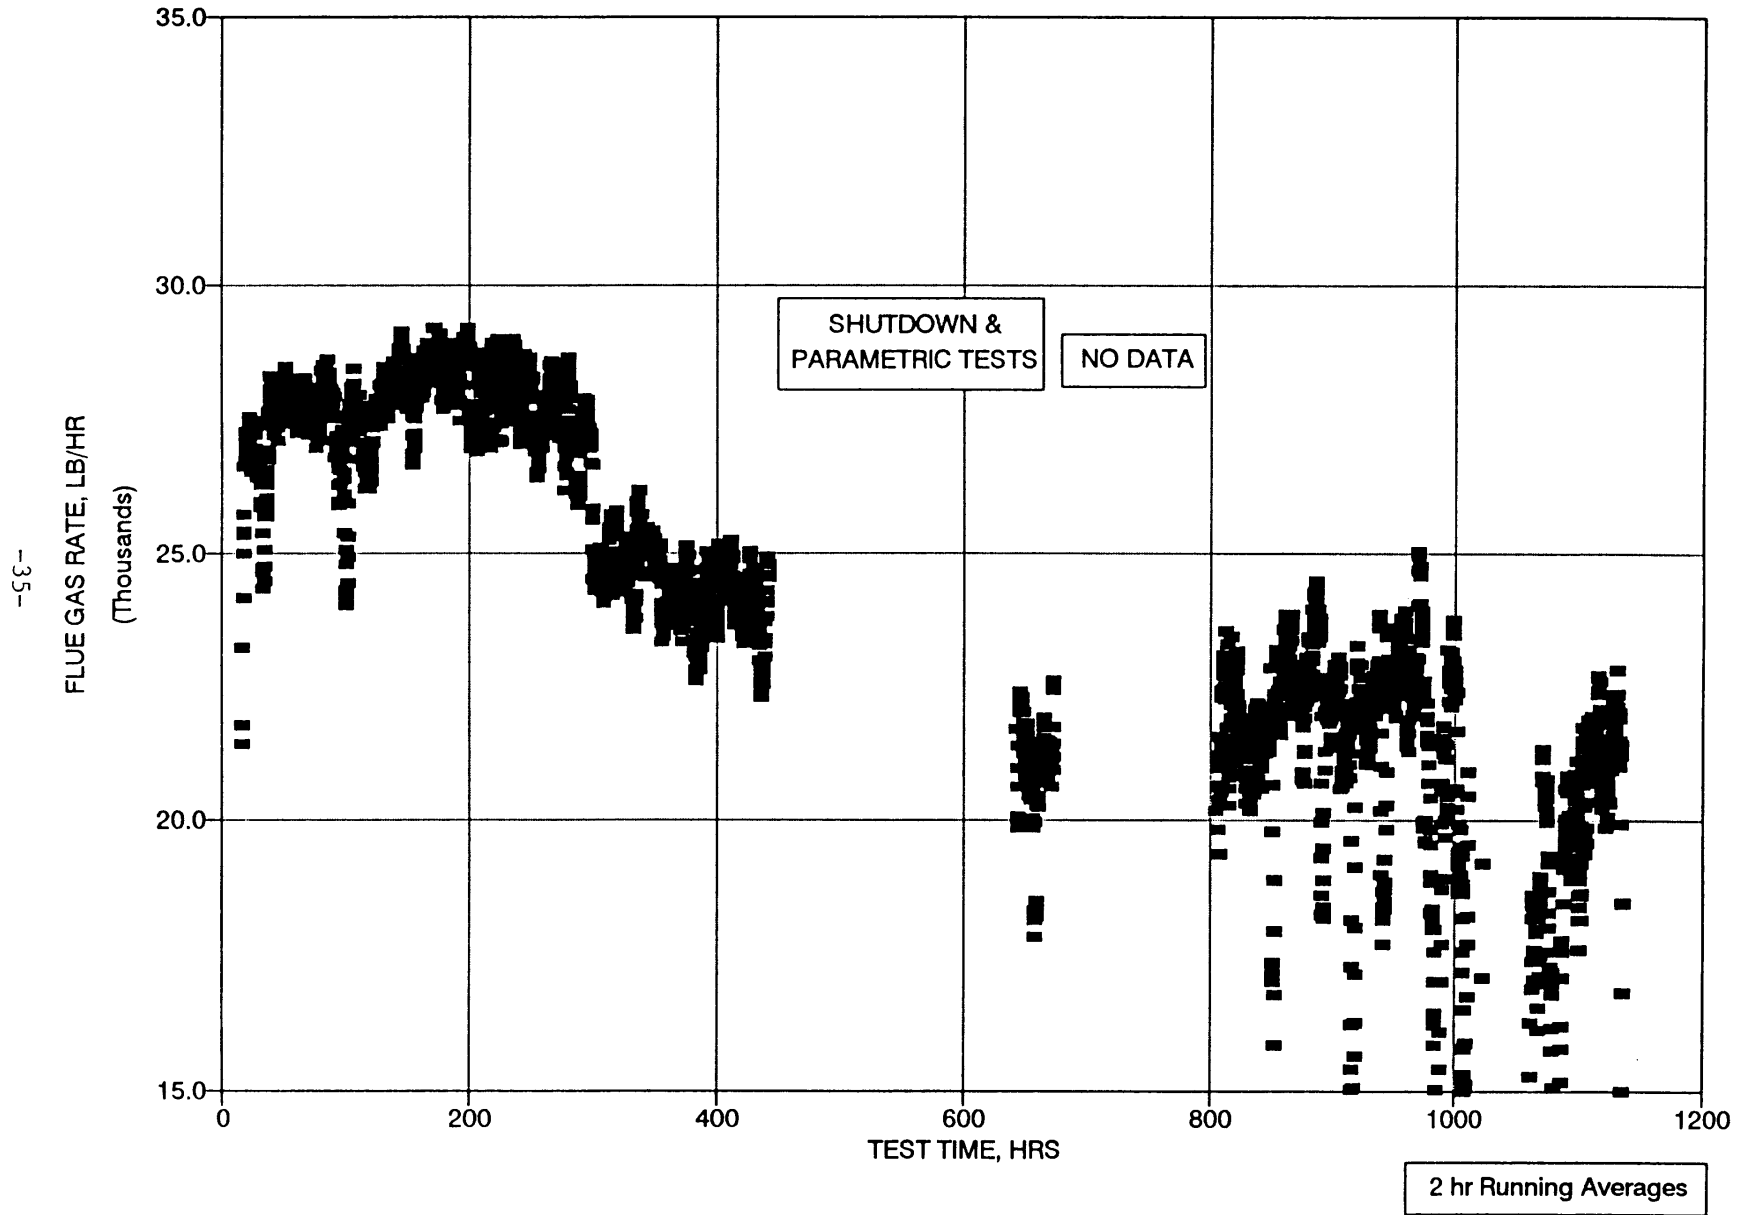
FIGURE 10 - PHASE I TEST
FLUE GAS MASS FLOW RATE

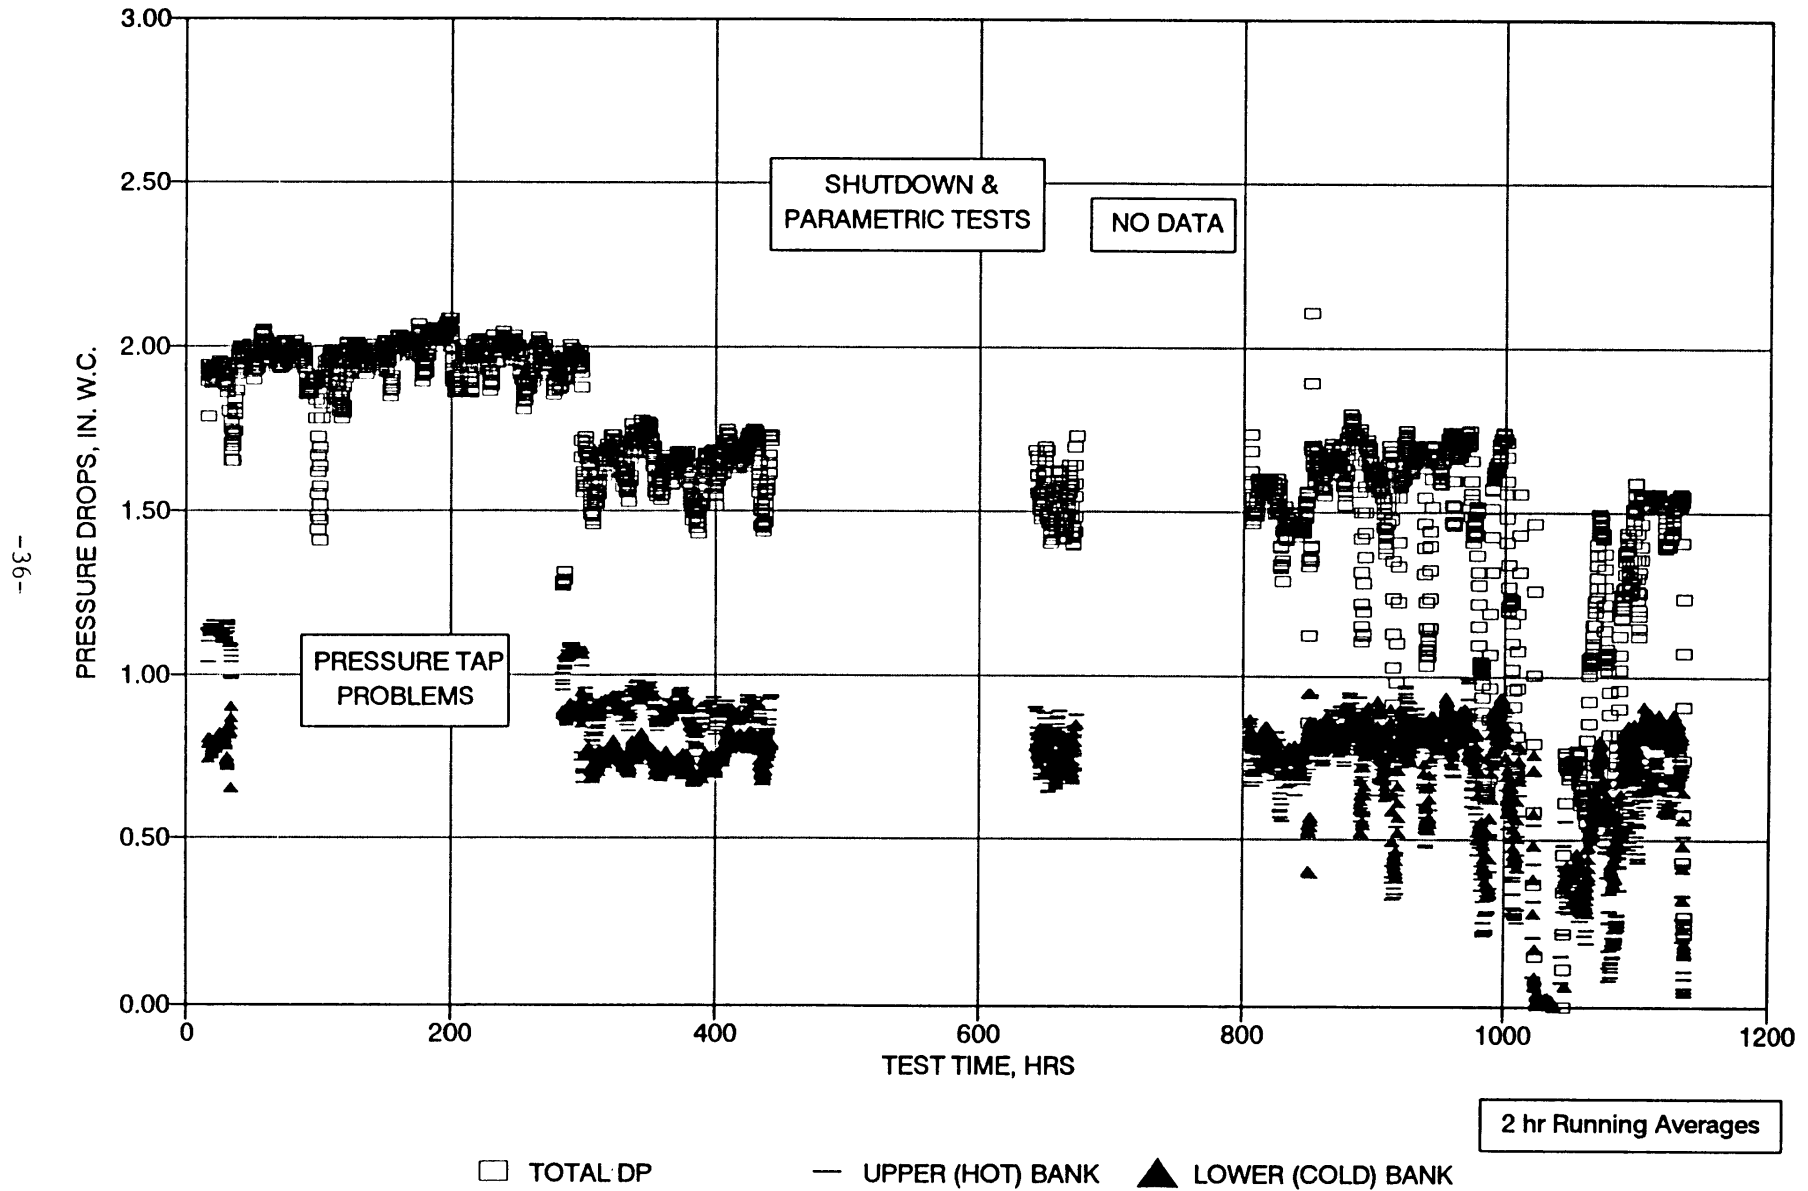
FIGURE 11 - PHASE I TEST
FLUE GAS SIDE PRESSURE DROP

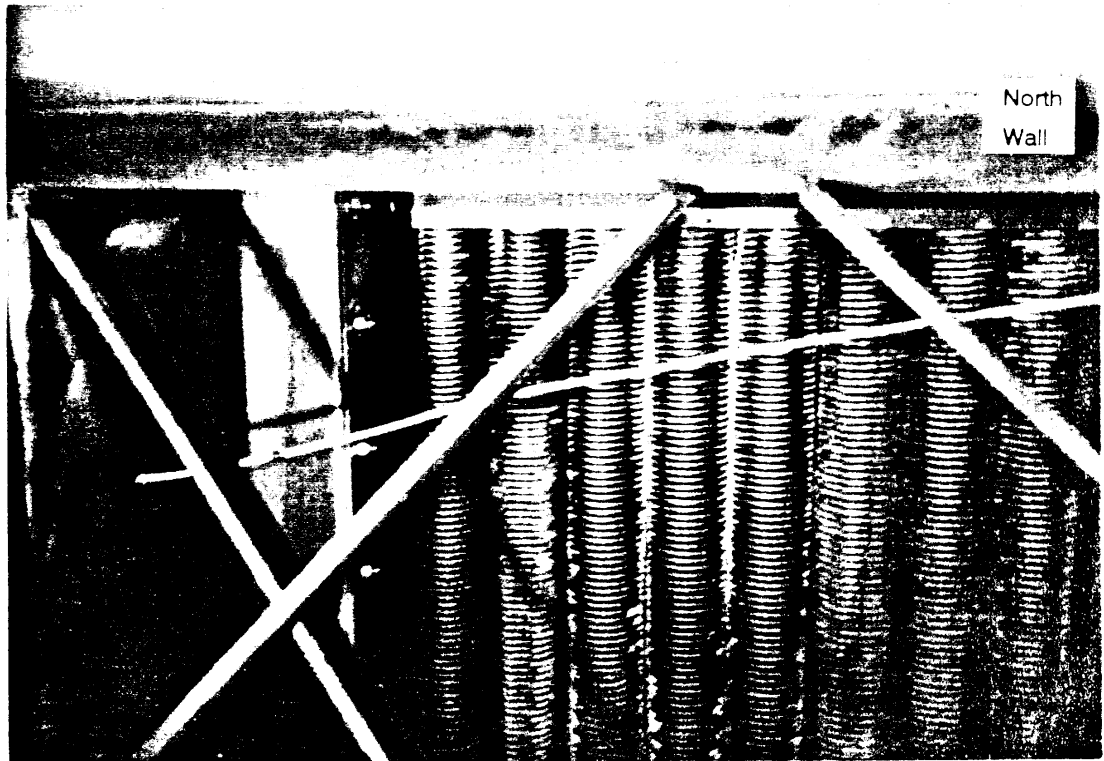
Figure 18b. End of Phase II testing -- Bottom side view of cold-end outlet heat pipes at outside (north) wall. Heat pipes show slightly more fouling than at the beginning or middle of the Phase I testing.

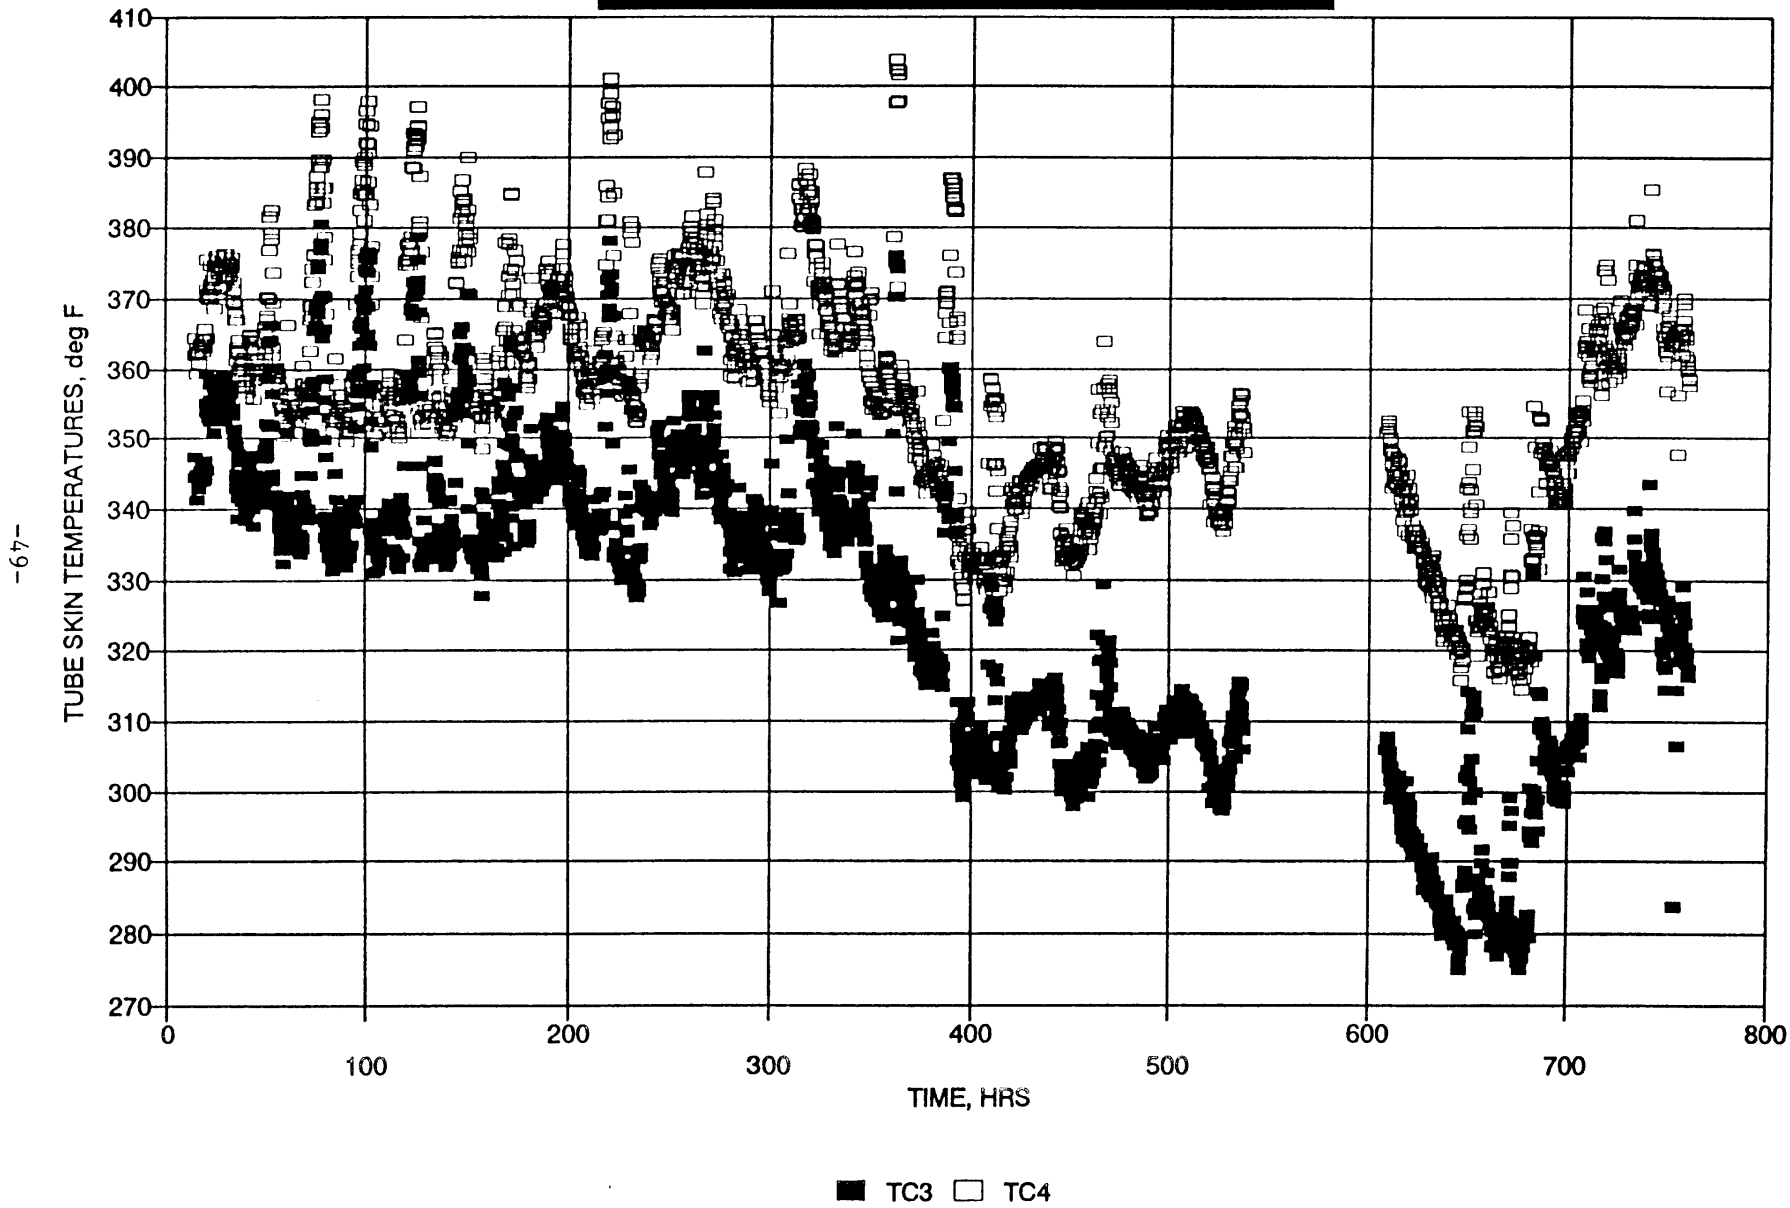
FIGURE 24 - PHASE II TESTS
HOT BANK OUTLET TUBE TEMPERATURES
