## Appendix G

### TEM Analyses of Pre-Test 1 Laboratory Solution

**Appendix H**  
**Sediment Analysis for Test #1**

# Appendix I

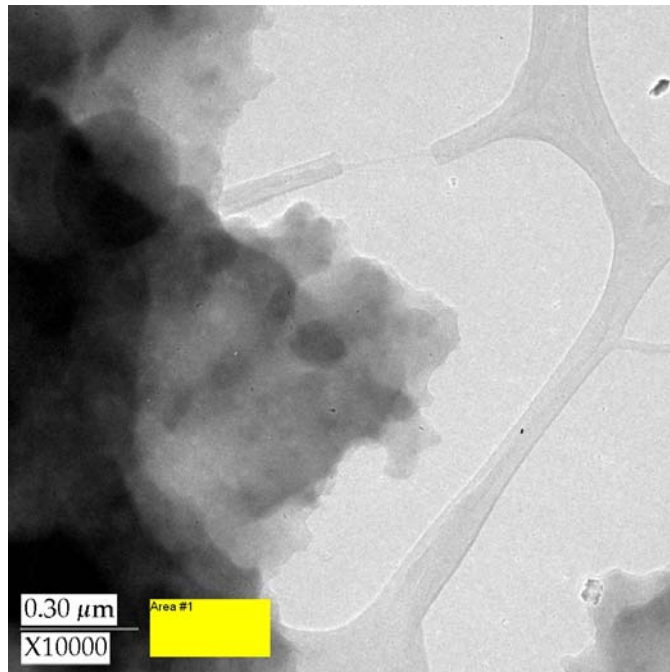
**Figure G-1.** Electron micrograph from the lab solution NUKON™ plus Al (Area #1), magnified 10,000 times.

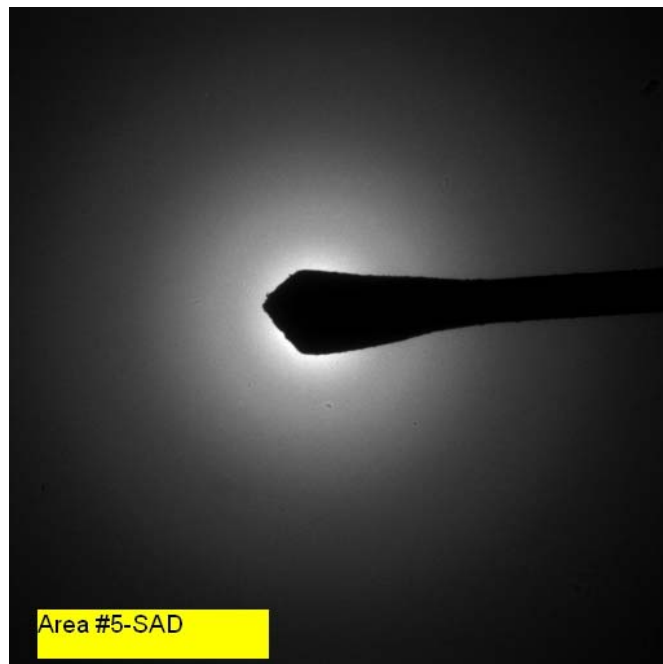
Figure G-7. Electron micrograph from the lab solution NUKON™ plus Al (Area #5), magnified 10,000 times.

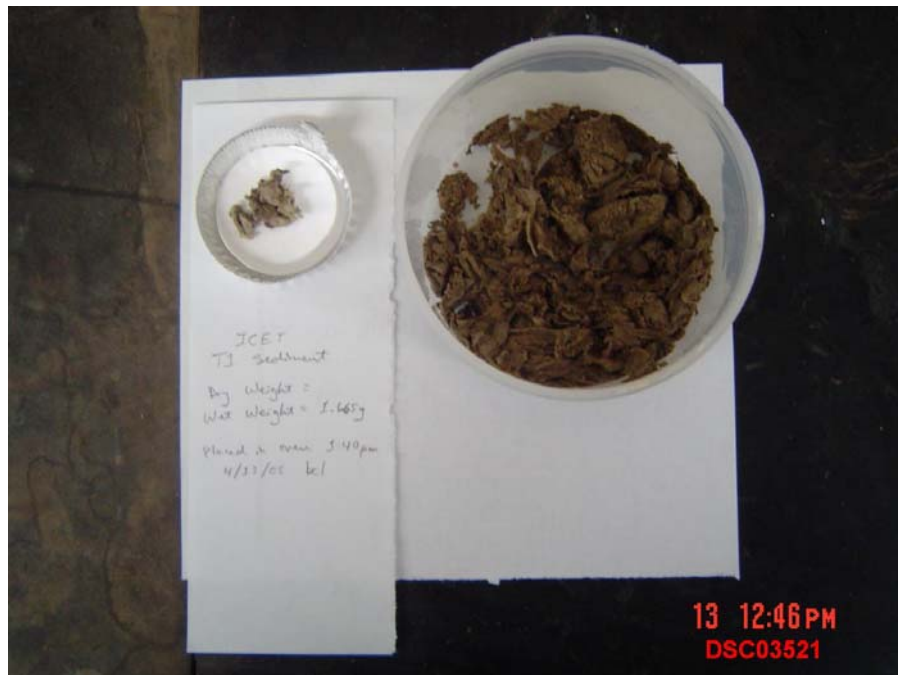
**Figure H-1.** T1 sediment container from south quadrant (right) and a 1.67-g sample for drying (left).

Using tweezers, a small, penny-sized sample of moist sediment was extracted from the interior of the debris and placed on a tared filter paper and metal sample cup. The sample was weighed on the Mettler AE 200 mass balance located in the Environmental Engineering Laboratory at UNM. The moist sample (measured to be 1.665 g) was placed in an air convection drying oven at 100°F. After 10 minutes in the oven, the surface color changed to ash gray, indicating rapid drying (see Figure H-1 and Figure H-2). After drying overnight for approximately 29 hours, the sample had a dry weight of 0.6395 g, indicating a loss of approximately 62% of the original moist mass. Earlier repetitions of this measurement using larger quantities of sediment indicated losses of 51%. Thus, the ratio between dry sediment mass and moist sediment mass ( $M_{dry}/M_{wet}$ ) is between 0.4 and 0.5. Similar measurements of T2 sediment exhibited a 48% mass reduction, which is again consistent with a dry-to-moist mass ratio of 0.5.

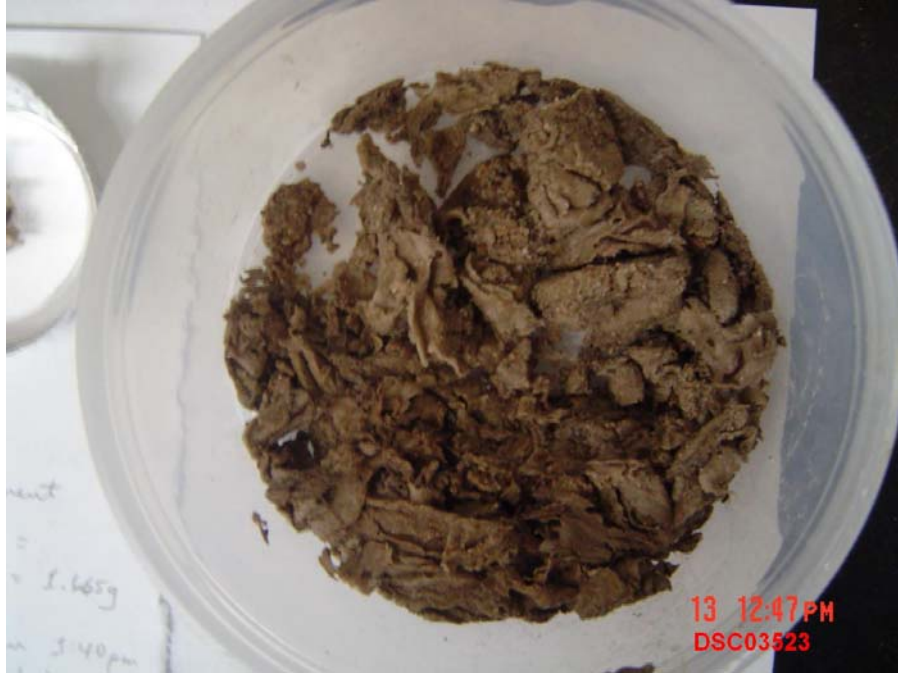
**Figure H-2.** T1 sediment container from south quadrant of tank (close-up).

All T1 sediment was characterized using material from the south quadrant of the ICET tank (87.4 g moist); however, the mass and visual appearance of sediment in each quadrant was consistent. The sample had been stored in a plastic container with a threaded lid. The sediment was still visibly moist, with uniform color and consistency. No free water was present, and no moisture condensation was present on the interior of the container. The aggregate sample of moist sediment appeared wrinkled (accordion folds) and grayish brown in color, much as wet cardboard that has been scraped from a surface. This appearance suggests that a relatively thin layer of material was removed from the bottom of the tank and that constituent fiber may have been present to help hold together the structural mat. Some patches of the debris clearly contained more sand-like

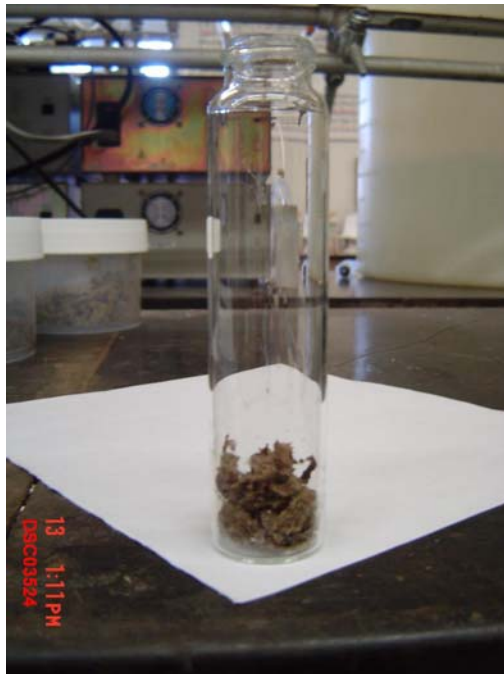
**Figure H-3.** Sediment sample (4.2 g) extracted for settling tests.

A larger sediment sample was similarly removed from the interior of the aggregate debris for use in the settling tests. Some effort was made to obtain a representative fraction of both the particulate “mud” and the wrinkled surface layer. The sample was placed directly into a pretared, clean glass vial for testing to avoid any sample losses that might occur during transfer between containers. The sediment material dropped cleanly to the bottom, with very little deposit on the side of the glass vial. The measured moist mass was 4.203 g (see Figure H-3).

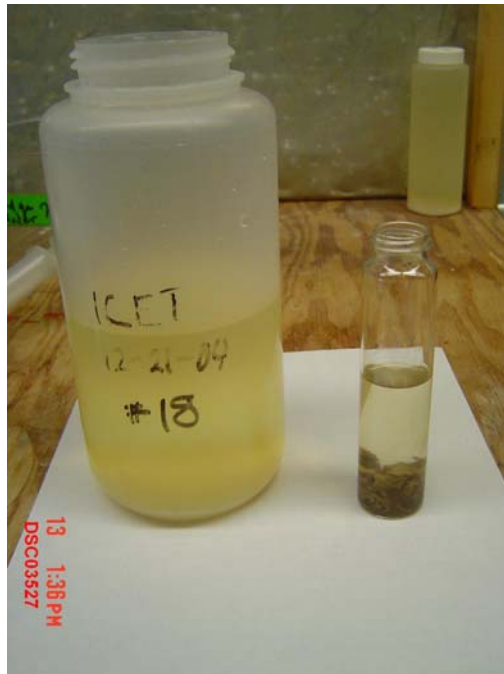
**Figure H-4. T1 archive solution and large vial used for resuspension/settling tests.**

Approximately 30 ml of supernate was removed from the top of bottle #18 using a syringe to avoid disturbing the precipitate at the bottom. This test solution was added to the sediment by tipping the large vial nearly horizontally and slowly injecting the liquid to avoid disturbing the sediment. Little to no evidence of disruption was observed in either the reservoir or the test sample, as indicated by the uniform color (pale yellow), and no visible suspended or swirling matter was observed. The large test vial was approximately half-full with T1 solution and immersed debris (see Figure H-4).

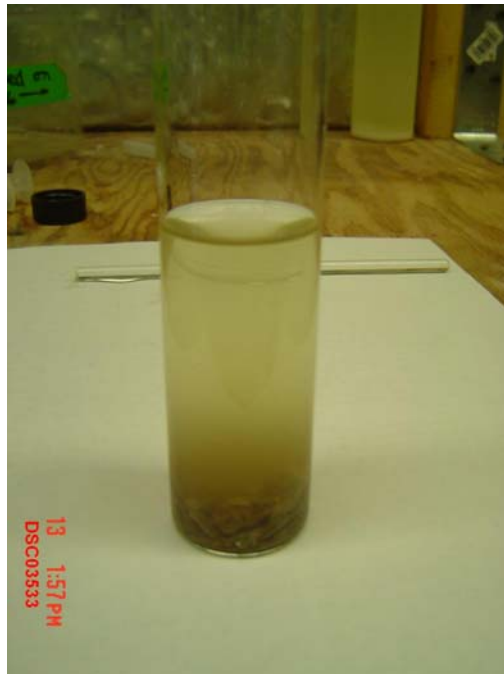
Figure H-5. T1 sediment in T1D30 T1 test solution after gently probing surface layers of debris. Note the brown haze of suspended particulate below the relatively clean solution.

After two or three stronger sweeps through the surface layers of the sediment, a uniform brown haze was visible in the top 2 cm of solution above the sediment. However, because the vial had not yet been uniformly mixed, the dirty layer sat beneath the “clean” solution with a well-defined interface at the mixing boundary. Gently rocking the vial side to side like a pendulum tended to settle the debris pile more uniformly and to separate some of the larger particles to the bottom. These exams left the impression that the sediment present in T1 was very loosely aggregated. It may be that the constituent soil and concrete dust added to the test as latent debris simulant would behave in much the same manner. Extremely fine particulates are easily released from the sediment sample with almost any degree of small agitation; thus, the fiber fraction, confirmed to be present by SEM examination, and any chemical constituents (if present) do not appear to enhance the cohesiveness of the sediment layer collected from T1 (see Figure H-5 and Figure H-6).

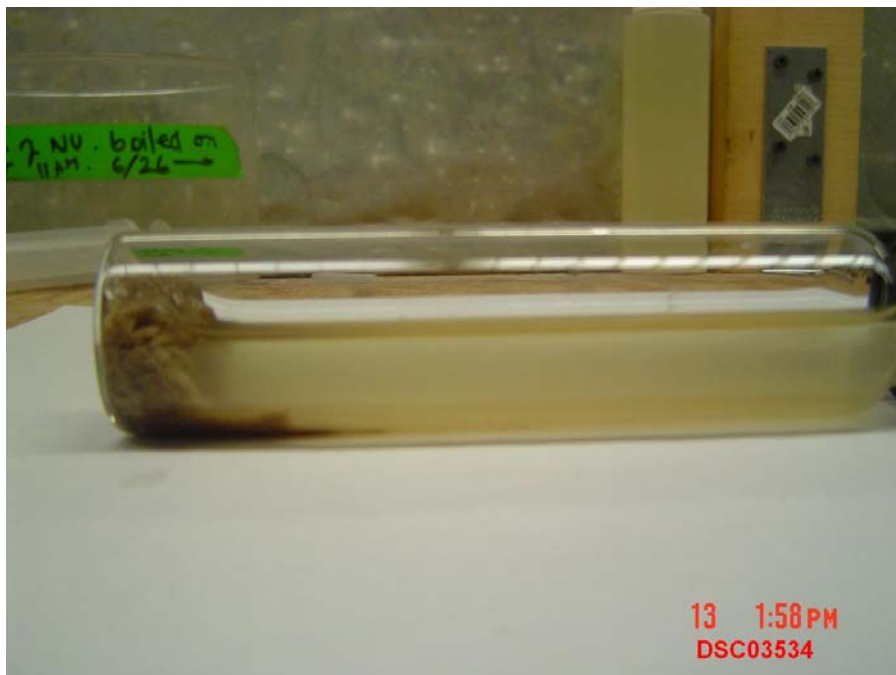
Figure H-6. Horizontal sediment vial showing mechanical behavior of a slumping bed before shaking.

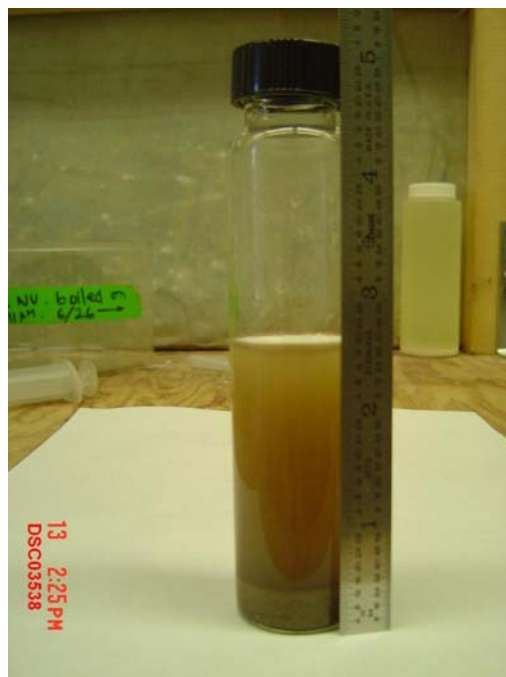
**Figure H-7. Large sediment vial after thorough mixing and 5 minutes of settling.**

When swirling the vial to the point of uniformly mixing the brown color, the solids behave like a suspension of river-bed silt. After significant agitation is stopped, the solids immediately stratify into well defined layers by size and color. At the bottom of the vial were found (a) the larger visible grains, followed by (b) a layer of dark brown “mud.” The largest portion of the vial in the middle, (c), was uniformly brown in color and appeared to be homogeneous in mixture. Near the top was (d), a layer of relatively clean semitransparent solution with a well-defined boundary separating it from the homogeneous mixture in the middle of the vial. The bottom sediment layer and the top clean layer grow with settling time as the middle layer shrinks through deposition and settling. Figure H-7 shows the vial after vigorous swirling and approximately 5 minutes of settling.

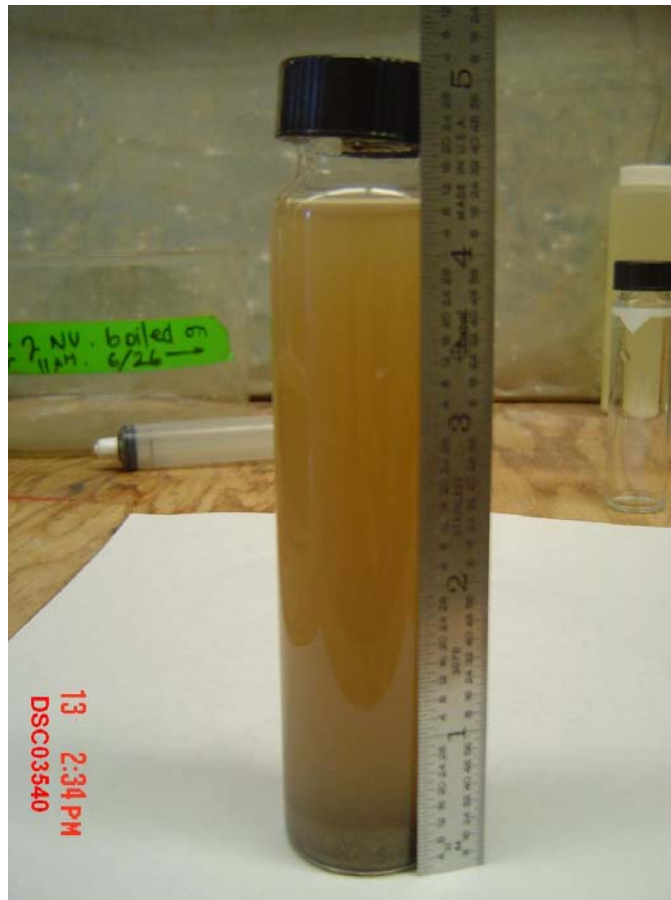
Figure H-8. Large sediment vial after filling, thorough mixing, and 5 minutes of settling.

the storage container as wet shredded fiber board. Figure H-8 shows the full vial after approximately 5 minutes of settling.

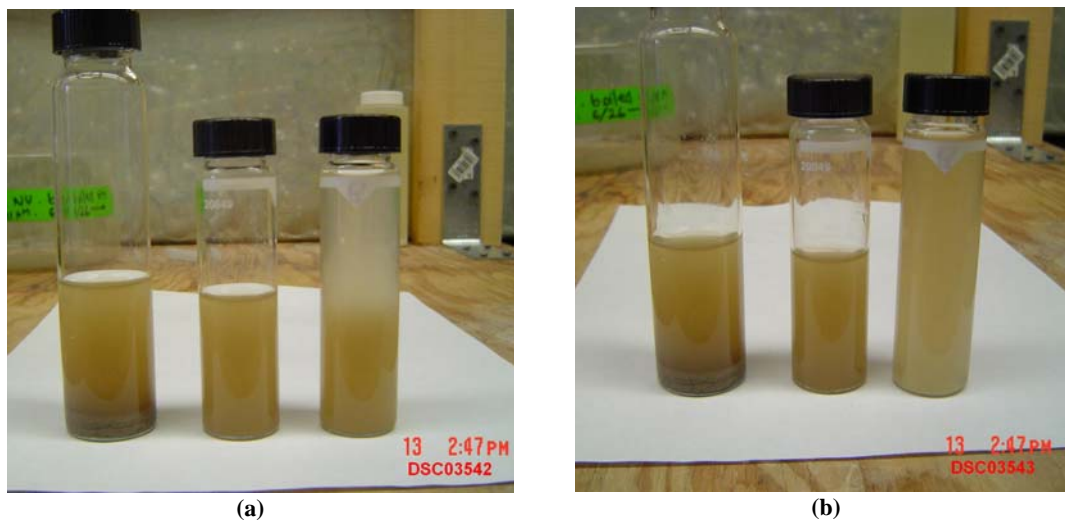
**Figure H-9. Dilution vial to the right before (a) and after (b) shaking.**

Approximately one half of the shaken contents of the small vial was poured into a second small vial and diluted with tap water. It was noted before shaking that the clean tap water remained stratified above the suspension of sediment. Figure H-9 shows the first dilution vial before and after shaking. The turbidity of clean tap water was measured to be 0.8 NTU. The turbidity of the diluted suspension still exceeded 200 NTU, so the dilution process was repeated a second time and a third time before the turbidity could be successfully measured. At this point, suspended solids were visible only as a slight discoloration, with an initial turbidity of 110 NTU, as shown in Figure H-10.

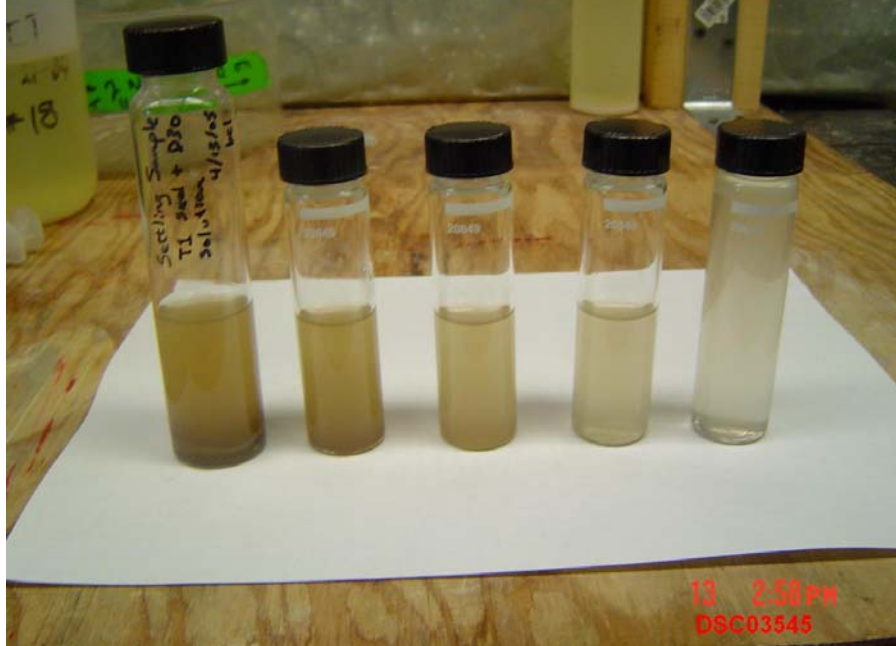
**Figure H-10.** Successive stages of dilution just before measuring turbidity. From left to right, the first two vials are original concentration followed by the first, second, and third dilution, respectively.

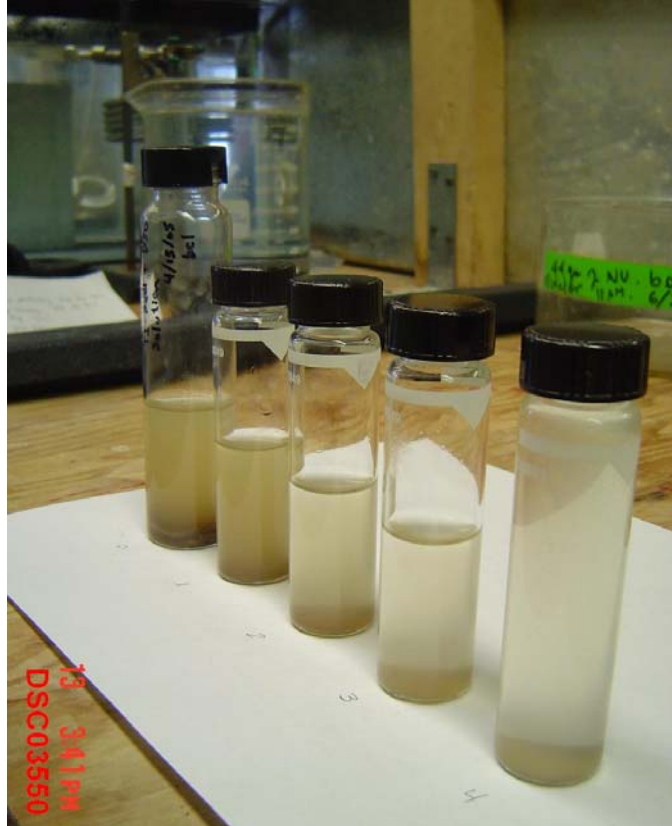
Figure H-11. Sediment vials after successive dilution and 40 minutes of settling.

The time-dependent turbidity of the successively diluted sample was monitored periodically for 60 minutes without removal from the turbidimeter, and again after 17 hours of settling. Figure H-11 shows the test vials after approximately 40 minutes of settling time, and Figure H-12 shows the test vials again after approximately 17 hours. Material sufficient to cover the bottom of each vial was noted in every sample. The depth of debris in the original large vial after settling overnight was measured to be 7.94 mm in a water column 8.10 cm in height. The turbidity of the last diluted sample had decreased to 17.6 NTU. Time-dependent turbidity data are tabulated in Table H-1 and are illustrated in Figure H-13.

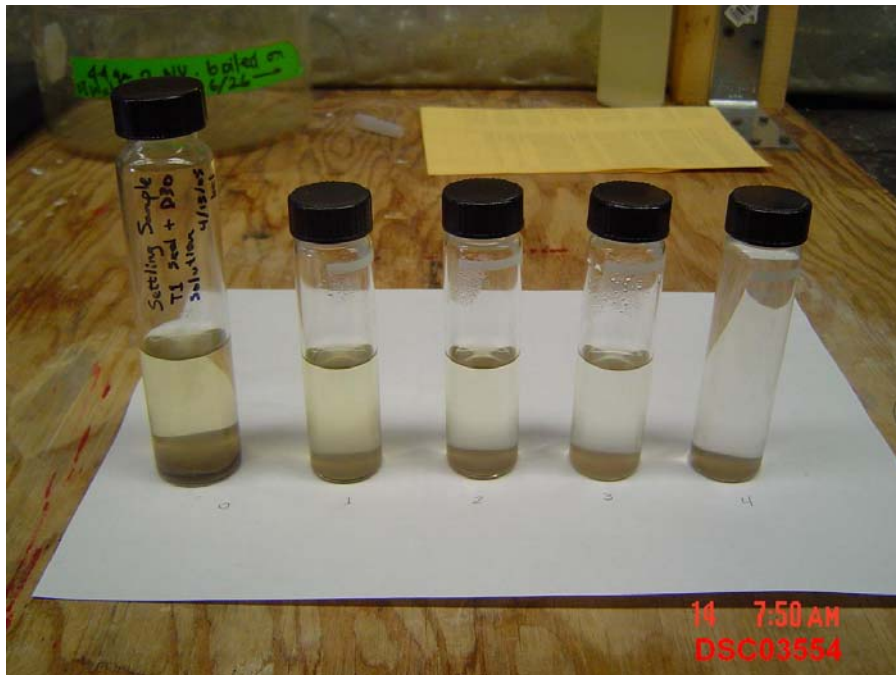
Figure H-12. Sediment vials after successive dilution and approximately 17 hours of settling.

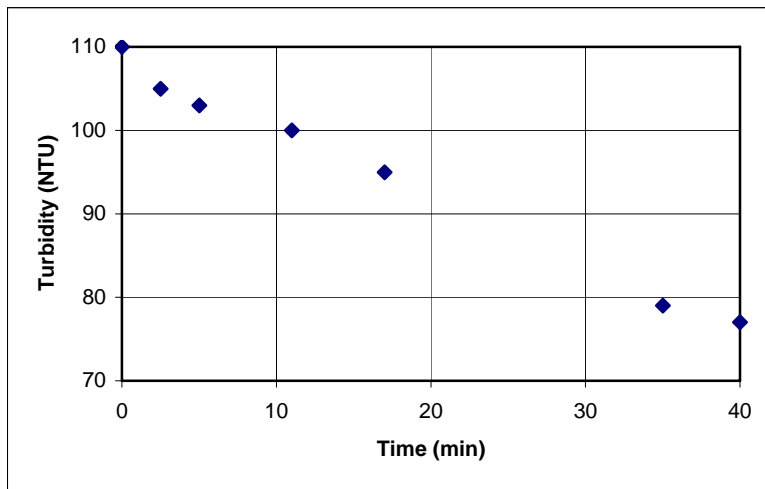
**Figure H-13. Time-dependent settling behavior of T1 sediment, as indicated by turbidity measurements.**

Time (minutes)	Turbidity (NTU)
0	110
2.5	105
5	103
11	100
17	95
35	79
40	77

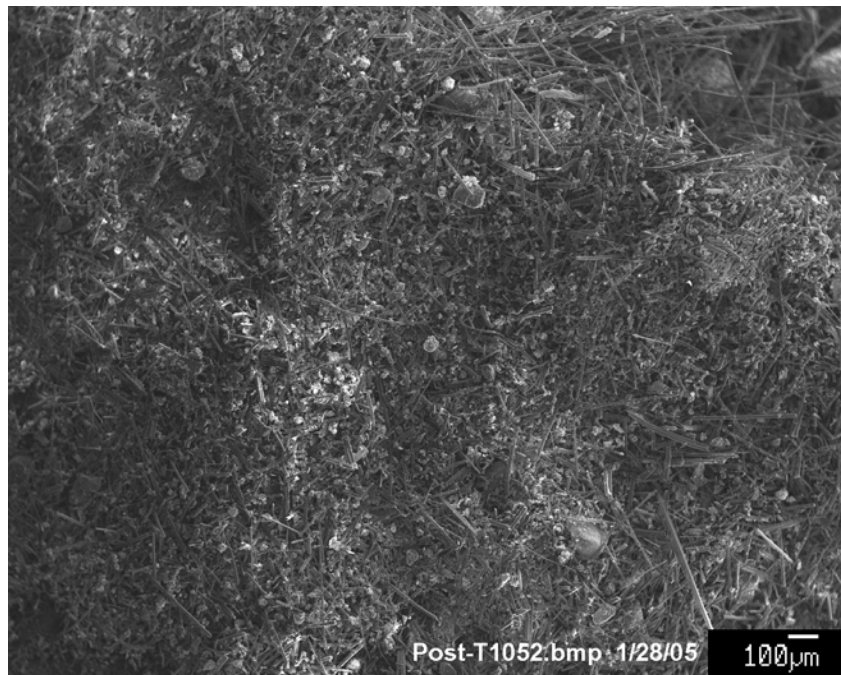
**Figure H-14. T1D30 tank sediment showing combination of fiber and particulate, magnified 43 times.**

Figure H-14 illustrates the complexity of sediment collected from T1. This view suggests that a significant amount of fiberglass is present in the debris. Qualitative visual estimates of the fiber fraction might range from 60% to 75% fiber by volume. Note that visual assessments can compare only the volume ratios and not the mass ratios. The fiber present at the bottom of the ICET tank represents fiberglass that has escaped the SS mesh bags that were constructed to hold the primary volume of this debris type. In the containment pool, the fiber-to-particulate ratios might vary greatly by location and may not resemble the ratios suggested by this image.

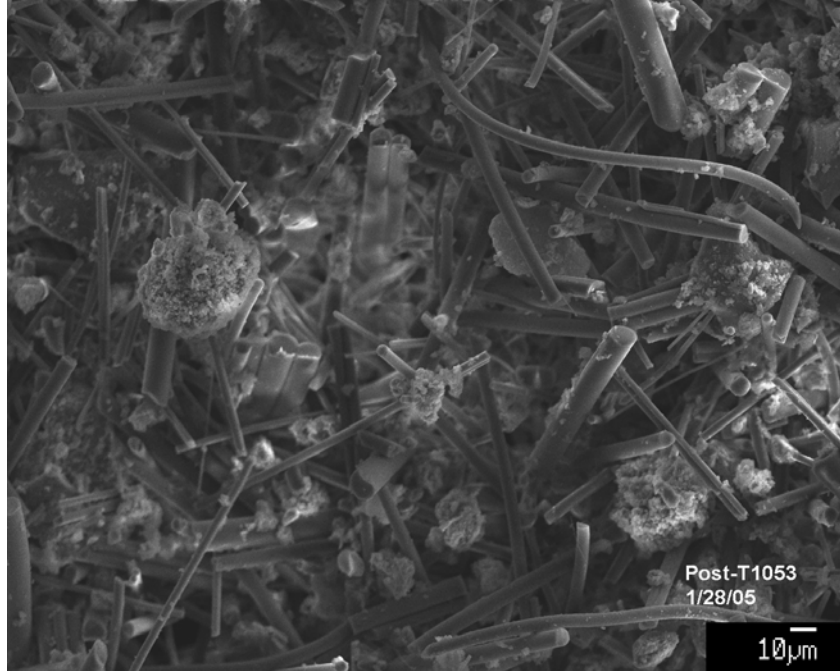
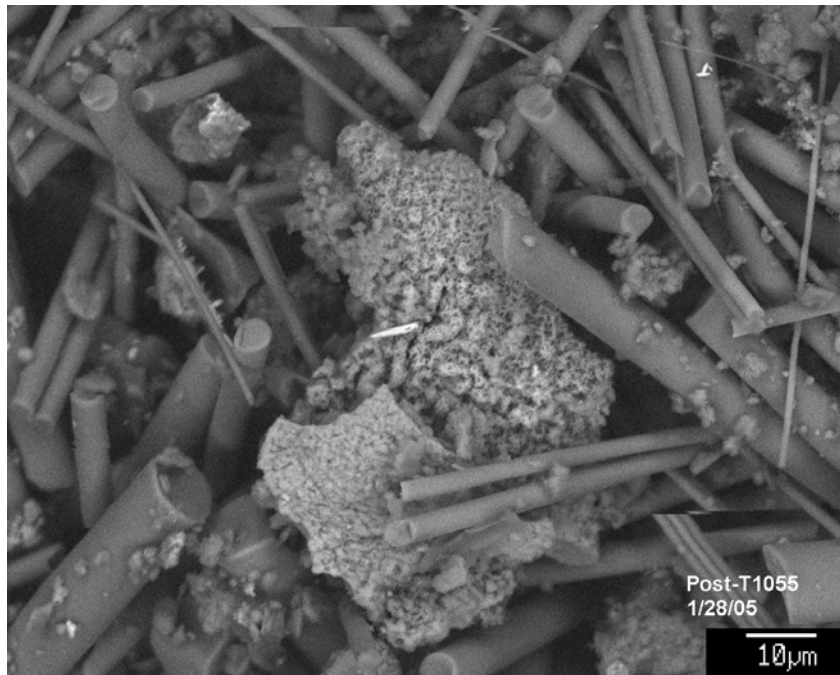
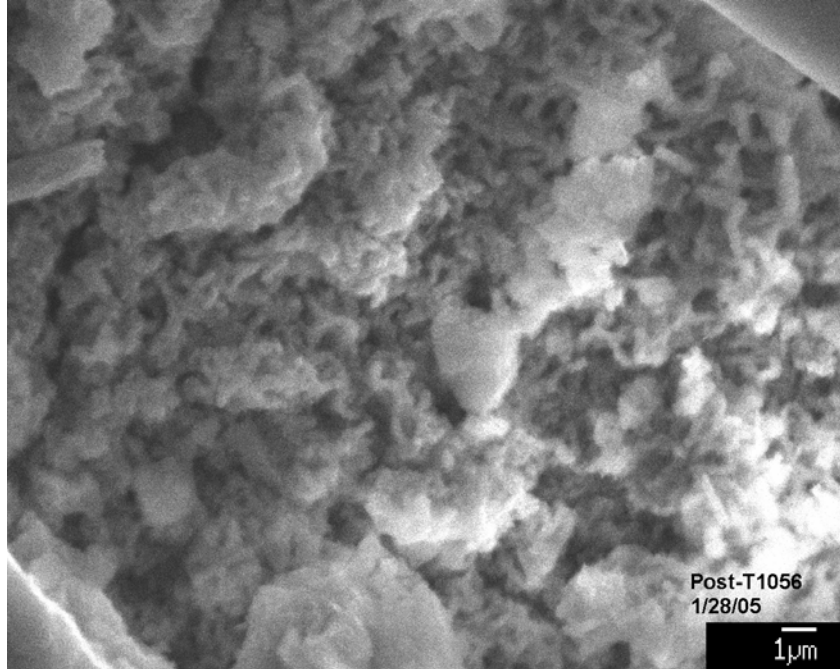
**Figure H-15.** T1D30 tank sediment focused on two large particles in Figure H-14, magnified 370 times.

**Figure H-16.** T1D30 sediment on a typical fuzzy particle, as shown in Figure H-15, magnified 1000 times.

**Figure H-17.** T1D30 sediment magnified 5000 times on the particle, as shown in Figure H-16.

Figure H-15 through Figure H-17 present a set of increasing magnification images that successively focus on a clump of particulate material. This set of images highlights the wide range of particle sizes present in the ICET sediment layer, ranging from 30  $\mu\text{m}$  down to submicron particles attached to individual fibers. The close-up provided in Figure H-17 suggests that some of the larger observed particles actually may be agglomerates of smaller constituents.

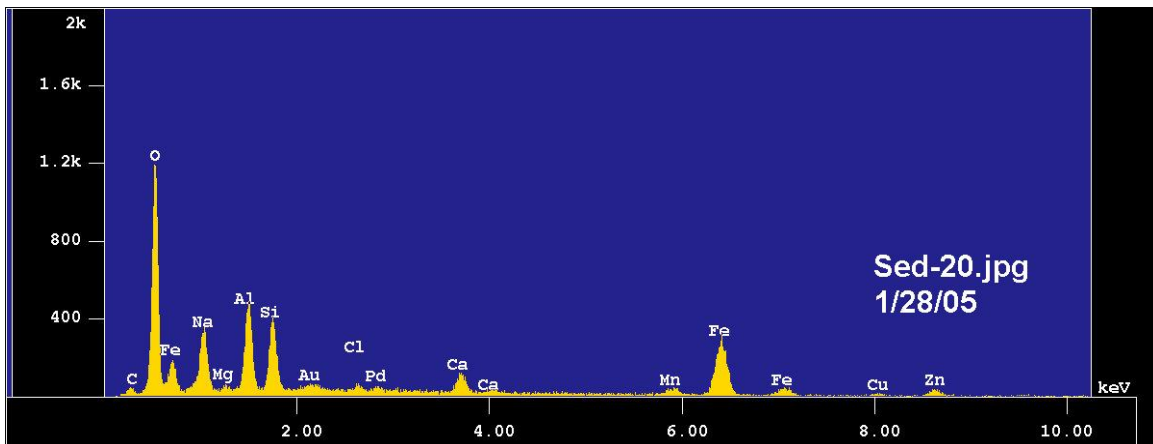
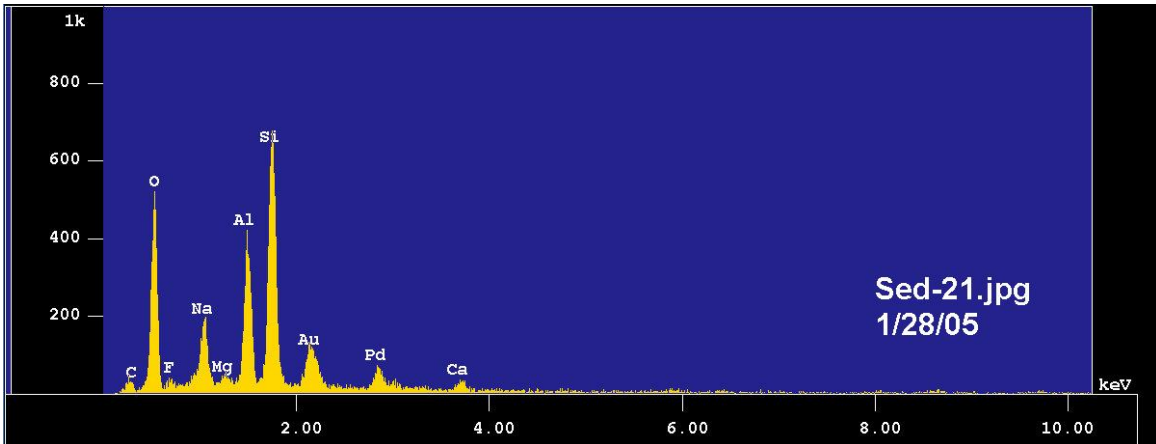
**Figure H-18.** EDS spectrum for the particle shown in Figure H-17.

**Figure H-19. EDS spectrum for another representative particle present in T1D30 tank sediment.**

Figure H-18 and Figure H-19 illustrate the variety of elemental compositions observed in the tank sediment. Note that a sputter coating of gold (Au) and palladium (Pd) is applied during SEM sample preparation; thus, these elements are always present in the spectrum. Given the presence of crushed concrete aggregate and common dirt present in the tank, it is not surprising to find a wide variety of mineral constituents.

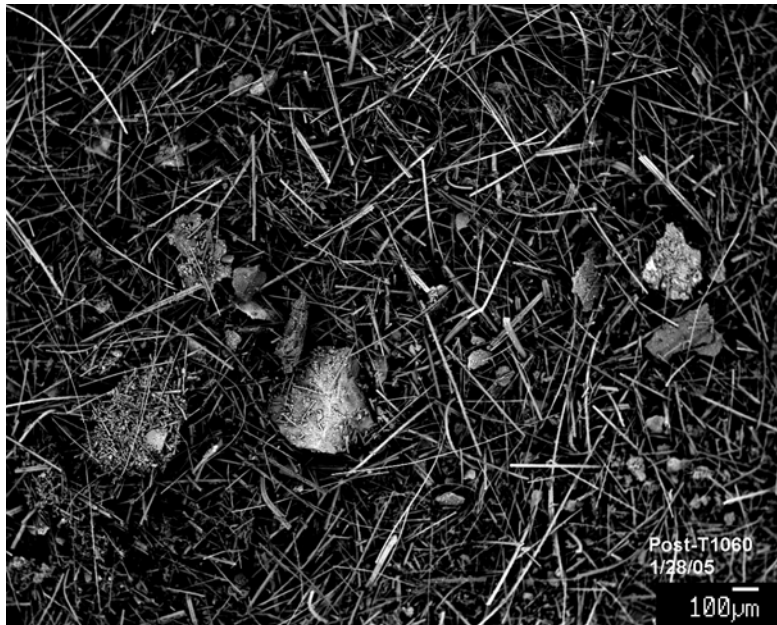
**Figure H-20. T1D30 tank sediment showing the presence of fiber, minerals (quartz) and possibly chemical products (EDS-23 and EDS-24), magnified 40 times.**

Figure H-20 illustrates another typical T1 sediment sample containing minerals such as quartz and possible chemical products. Points EDS-23 and EDS-24 marked in the figure exhibit dominant proportions of oxygen, sodium, silicon, and aluminum, consistent with the composition of white precipitate observed in T1 water samples when cooled (see Figure H-21). It is impossible to determine whether these flakes originated in the sediment bed or were dislodged from other surfaces while draining the tank.

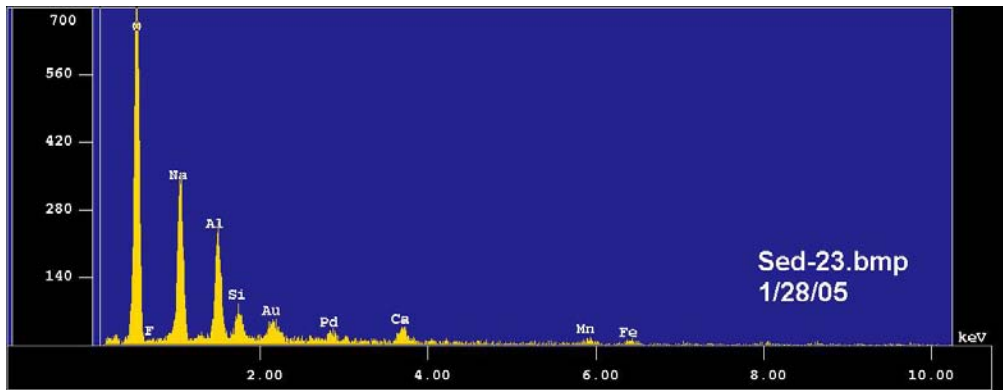
**Figure H-21.** EDS spectrum of point EDS-23 shown in Figure H-20 containing oxygen, sodium, aluminum, and silicon ratios similar to T1 precipitate.

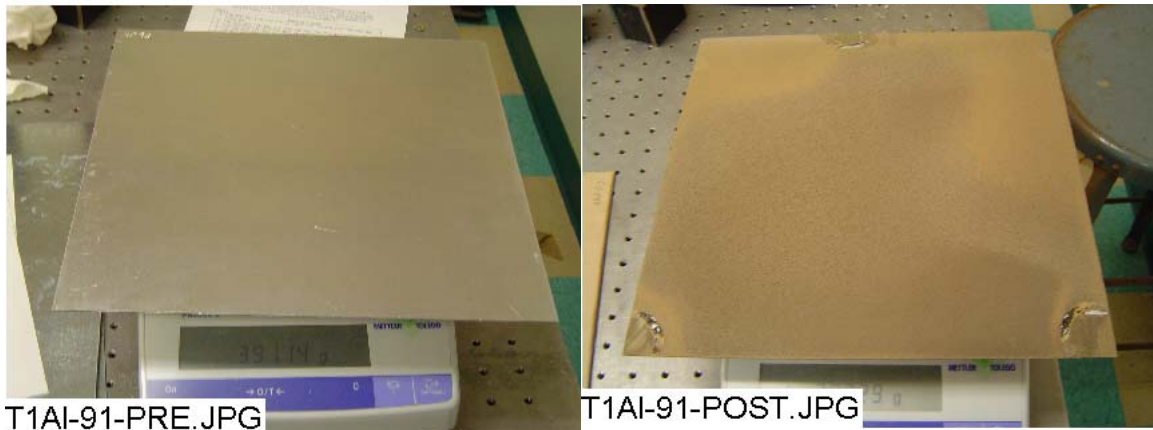
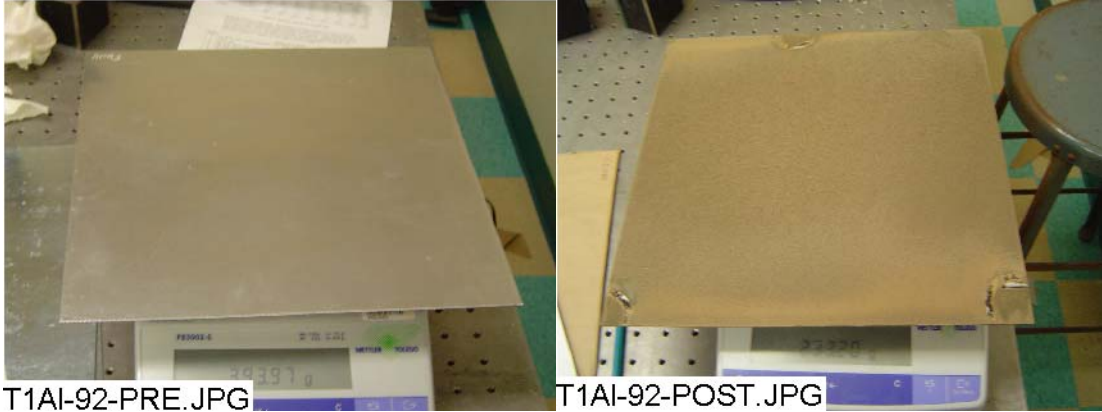
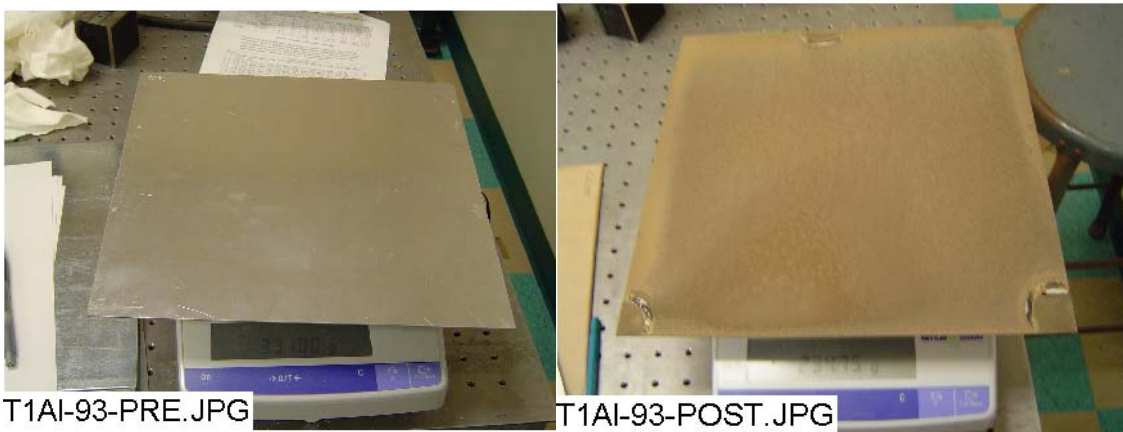
Figure I-1. Al-91 submerged—pre-test (left); Al-91 submerged—post-test (right).

**Figure I-2. Al-92 submerged—pre-test (left); Al-92 submerged—post-test (right).**

**Figure I-3. Al-93 submerged—pre-test (left); Al-93 submerged—post-test (right).**

There are three submerged aluminum coupons in each test. Figures I-1 through I-3 are the pre- and post-test pictures of the Test #1 coupons. The aluminum coupons Al-93, Al-92, and Al-91 (see Figures 3-71 through 3-73) were located from east to west, respectively, in the tank. The submerged aluminum coupons turned brown, and they developed a brown, powdery film on the surface. The film resulted in the surface of the coupon becoming rough to the touch, and it could be rubbed off easily. However, particles in direct contact with the coupon were more difficult to remove.

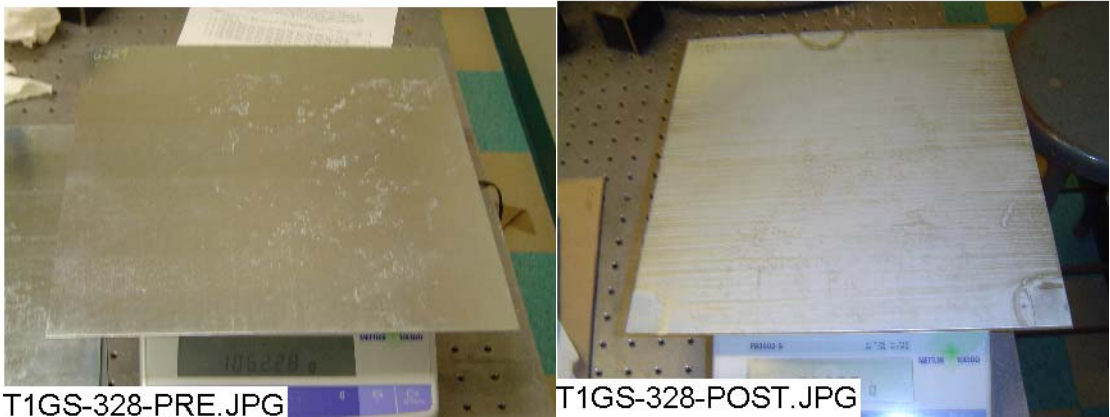
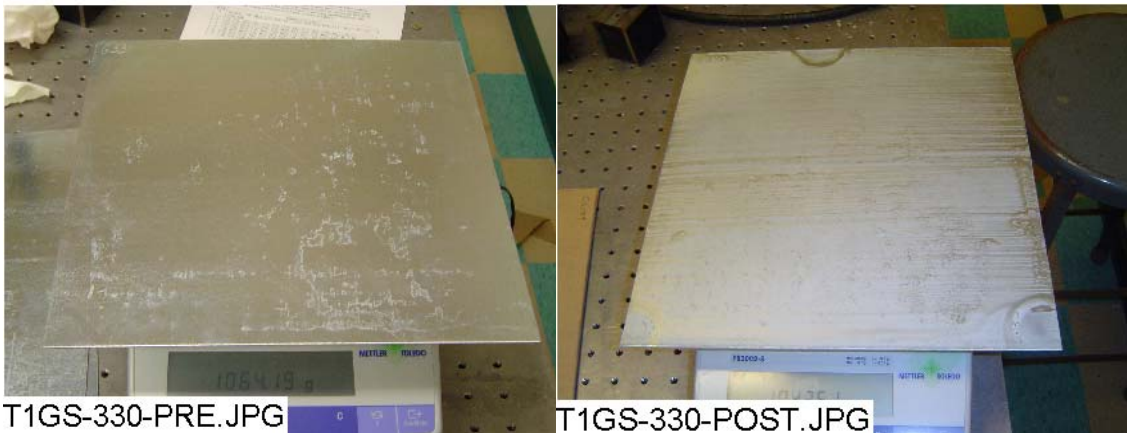
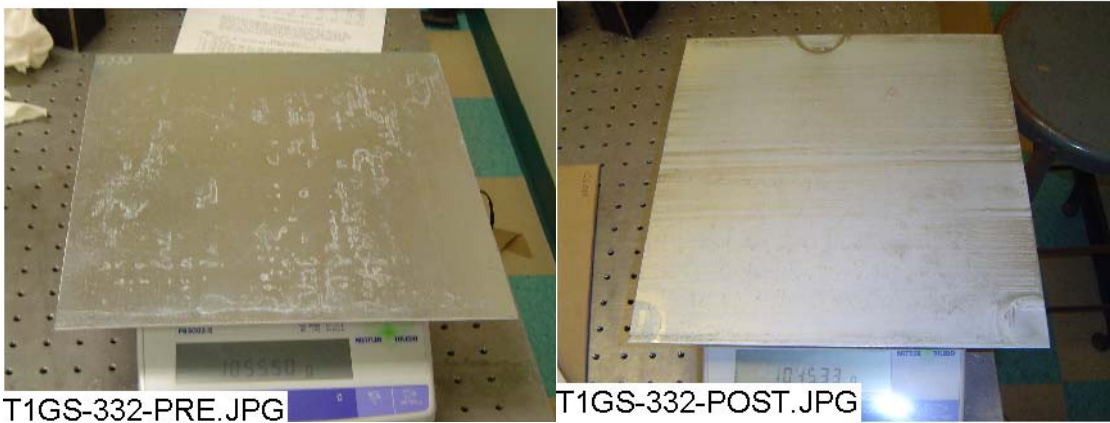
**Figure I-4.** GS-328 submerged—pre-test (left); GS-328 submerged—post-test (right).

**Figure I-5.** GS-330 submerged—pre-test (left); GS-330 submerged—post-test (right).

**Figure I-6.** GS-332 submerged—pre-test (left); GS-332 submerged—post-test (right).

Figures I-4 through I-6 present the pre- and post-test pictures of three submerged galvanized steel coupons. The galvanized steel coupons developed a white deposit on their surfaces, which caused the surfaces to have a coarse feel. The surfaces of the coupons had horizontal lines composed of this same white precipitate. The horizontal deposits may have been left during the slow draining of the tank solution.

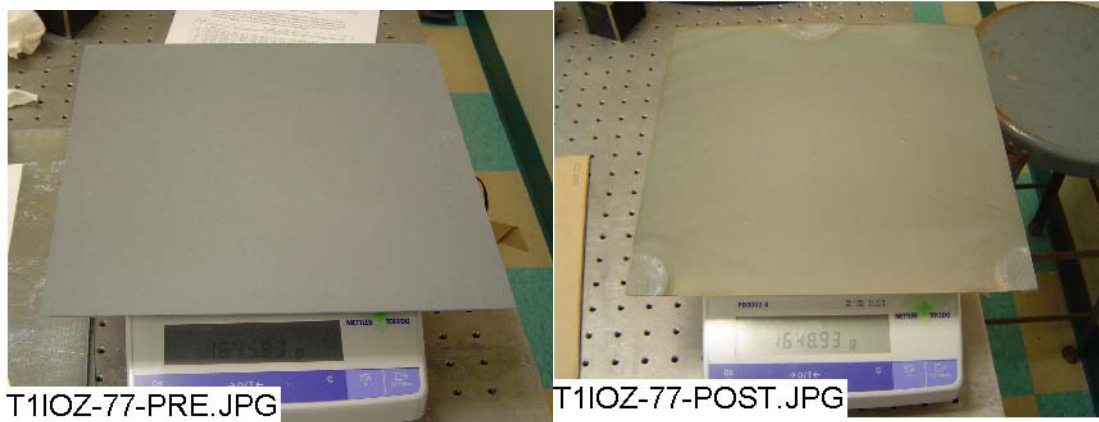
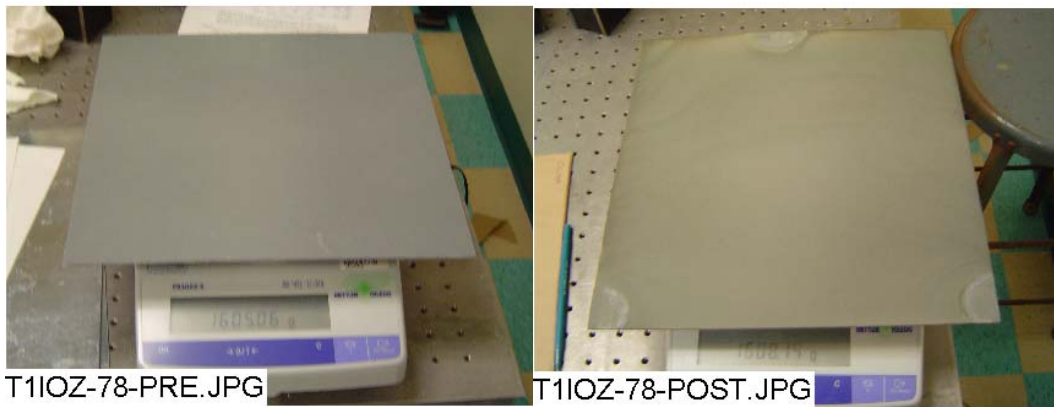
**Figure I-7. IOZ-77 Submerged—pre-test (left); IOZ-77 submerged—post-test (right).**

**Figure I-8. IOZ-78 submerged—pre-test (left); IOZ-78 submerged—post-test (right).**

Figures I-7 through I-8 present the pre- and post-test pictures of two submerged inorganic zinc coated steel coupons. Both submerged inorganic zinc coated steel coupons have

similar light particulate deposits, and they were covered with a light brown coating over their entire surfaces.

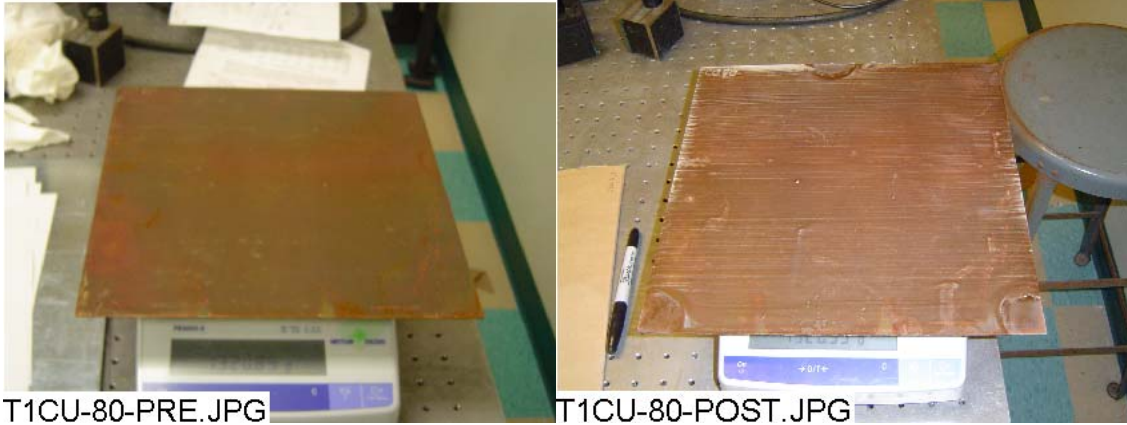
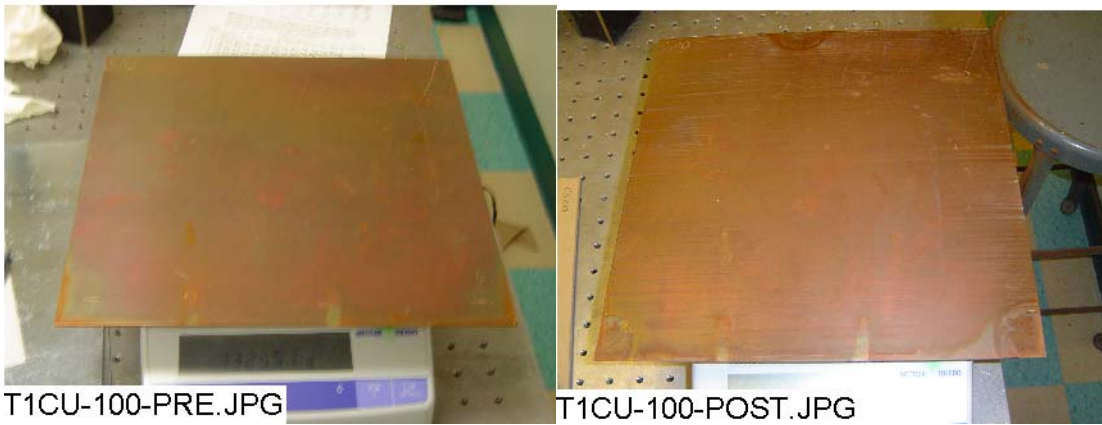
Figure I-9. CU-80 submerged—pre-test (left); CU-80 submerged—post-test (right).

Figure I-10. CU-100 submerged—pre-test (left); CU-100 submerged—post-test (right).

Figures I-9 through I-10 present the pre- and post-test pictures of two submerged copper coupons. The submerged copper coupons developed very light horizontal white deposits, which may be due to the slow tank draining process. The white horizontal lines could not be rubbed off, and the surface of the coupon remained relatively smooth.

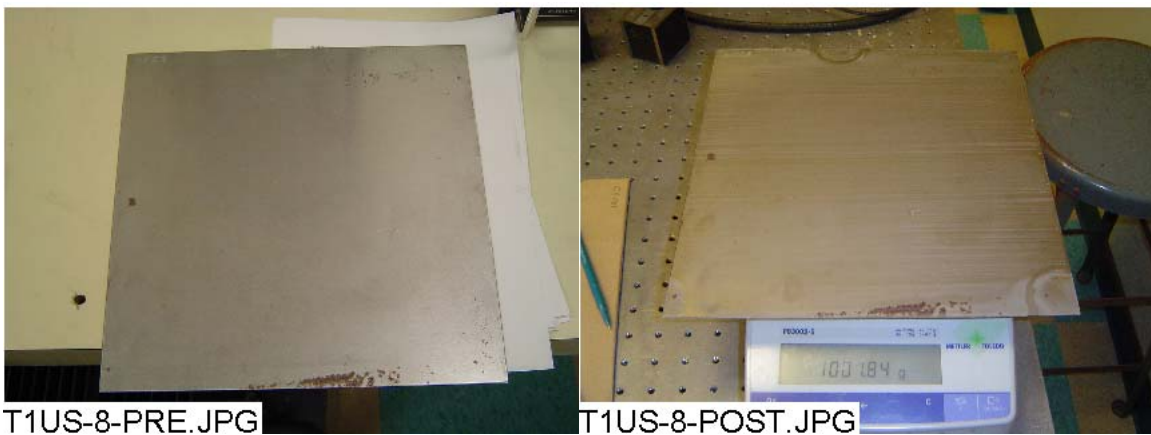
Figure I-11. US-8 submerged—pre-test (left); US-8 submerged—post-test (right).

Figure I-11 presents the pre- and post-test pictures of the submerged carbon steel coupon. The surface of the coupon was roughened by the deposition of white precipitate. There were also areas of rust on the coupon.

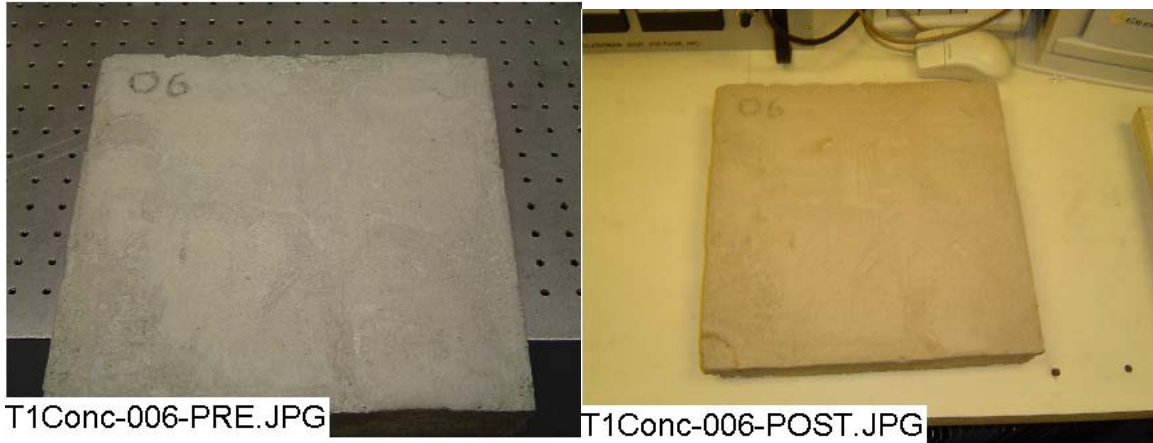
Figure I-12. Conc-006 submerged—pre-test (left); Conc-006 submerged—post-test (right).

Figure I-12 presents the pre- and post-test pictures of the submerged concrete coupon. The post-test concrete coupon developed a brownish color.

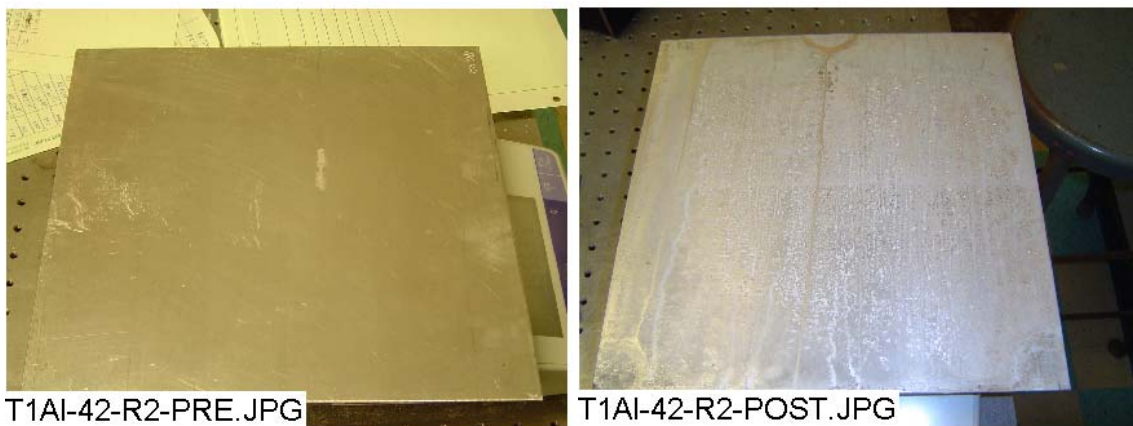
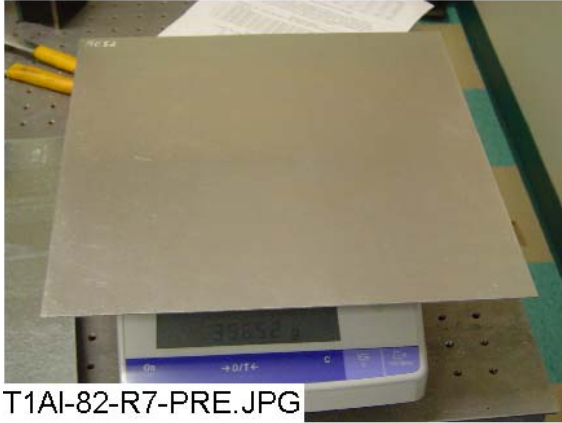
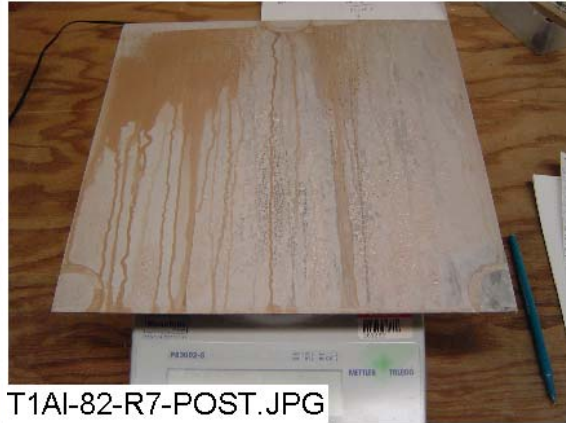
Figure I-13. Al-42 unsubmerged—pre-test (left); Al-42 unsubmerged—post-test (right).

**Figure I-14. Al-82 unsubmerged—pre-test (left); Al-82 unsubmerged—post-test (right).**

Figures I-13 and I-14 show the pre- and post-test pictures of two unsubmerged aluminum coupons. Each post-test aluminum coupon exhibits a similar pattern of vertical streaking deposition. Also, the texture of each post-test coupon is coarser and the surface quality of each coupon is less lustrous. The Al-82 post-test coupon exhibits an overall golden brown tint while the Al-42 coupon displays only faint streaks of golden brown. The Al-42 coupon was loaded in rack 2, which was located in the southern position of the middle tier of the tank. The Al-82 coupon was loaded in rack 7, which was located in the northern position of the top tier of the tank.
