## Appendix G

### TEM Analyses of Pre-Test 1 Laboratory Solution

**Appendix H**  
**Sediment Analysis for Test #1**

# Appendix I

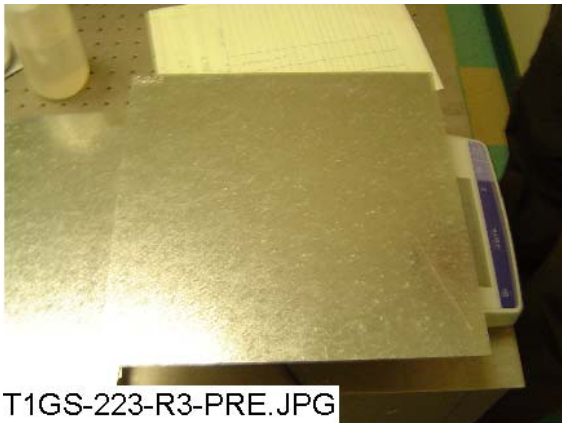
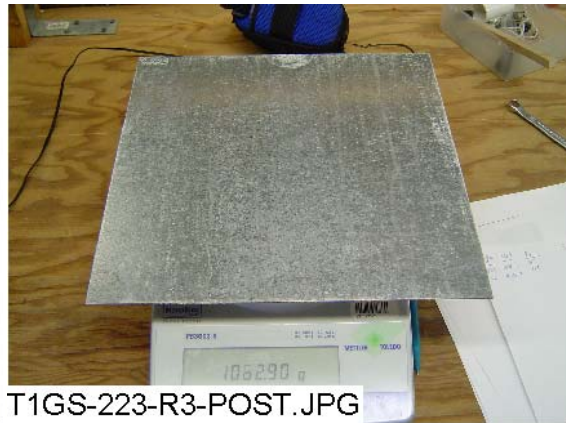
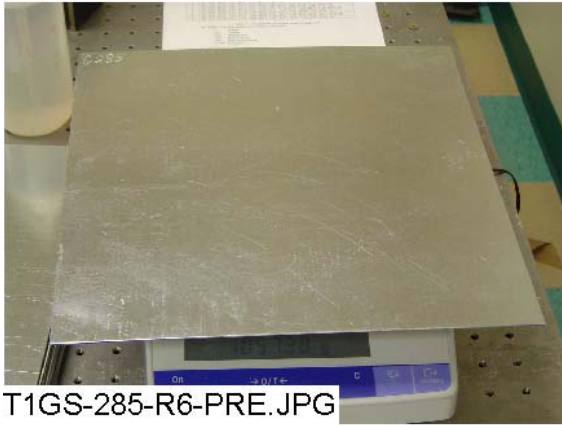
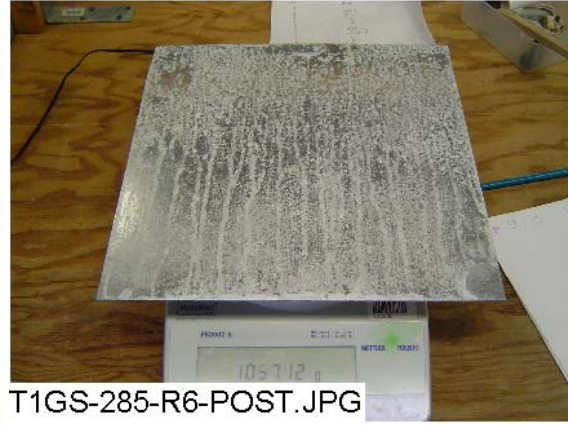
**Figure I-15. GS-223 unsubmerged—pre-test (left); GS-223 unsubmerged—post-test (right).**

**Figure I-16. GS-285 unsubmerged—pre-test (left); GS-285 unsubmerged—post-test (right).**

Figures I-15 and I-16 show the pre- and post-test pictures of two unsubmerged galvanized steel coupons. Each post-test galvanized steel coupon exhibits a similar deposition. The GS-223 coupon was loaded in rack 3, which was located in the center position of the middle tier of the tank. The GS-285 coupon was loaded in rack 6, which was located in the middle position of the top tier of the tank.

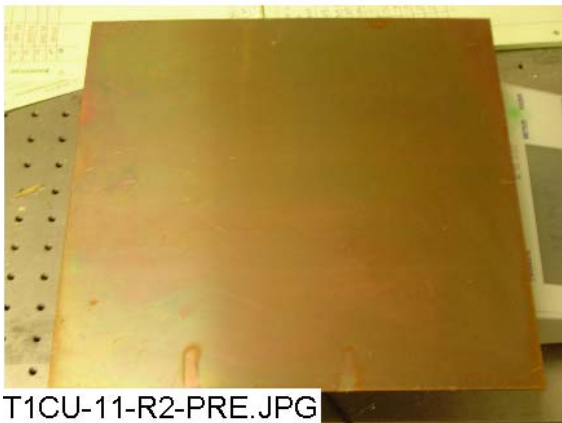
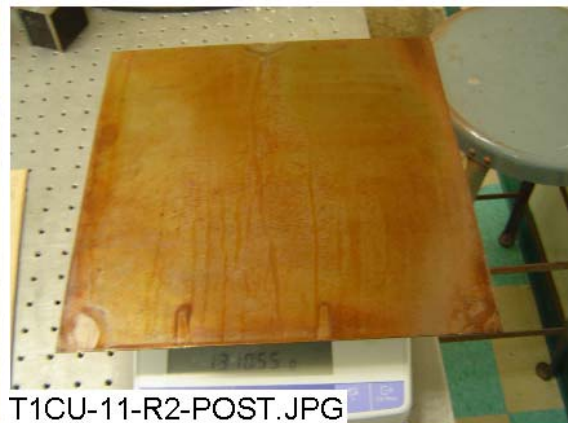
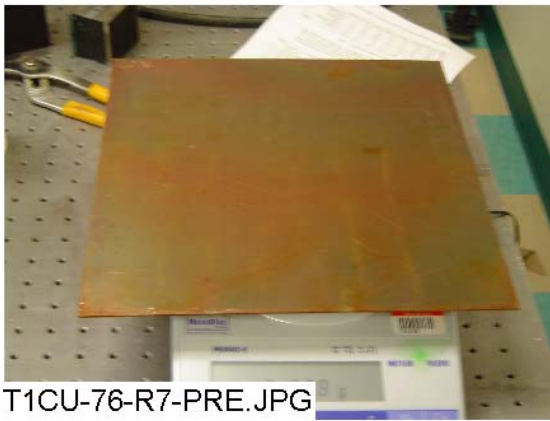
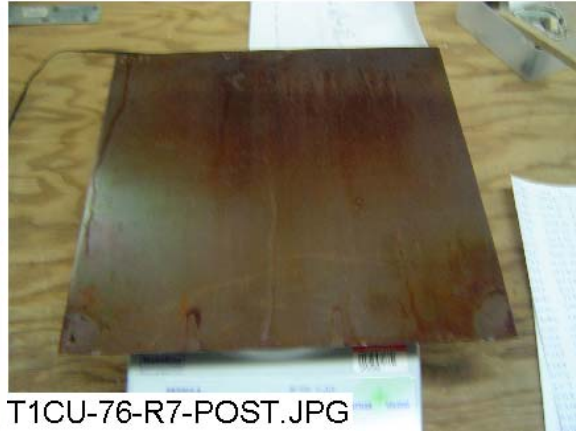
**Figure I-17. CU-11 unsubmerged—pre-test (left); CU-11 unsubmerged—post-test (right).**

**Figure I-18. CU-76 unsubmerged—pre-test (left); CU-76 unsubmerged—post-test (right).**

Figures I-17 and I-18 show the pre- and post-test pictures of two unsubmerged copper coupons. Each post-test copper coupon exhibits a similar pattern of very light deposition. The CU-11 coupon was loaded in rack 2, which was located in the southern position of the middle tier of the tank. The CU-76 coupon was loaded in rack 7, which was located in the northern position of the top tier of the tank.

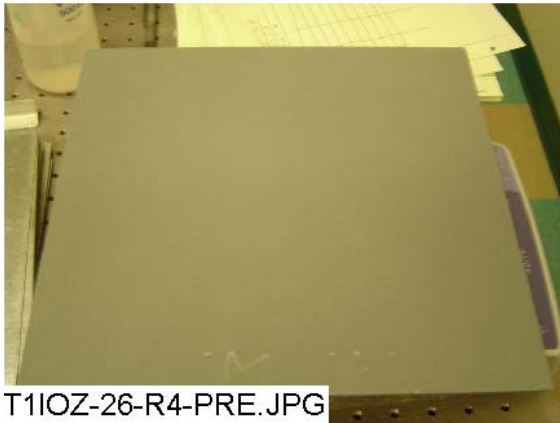
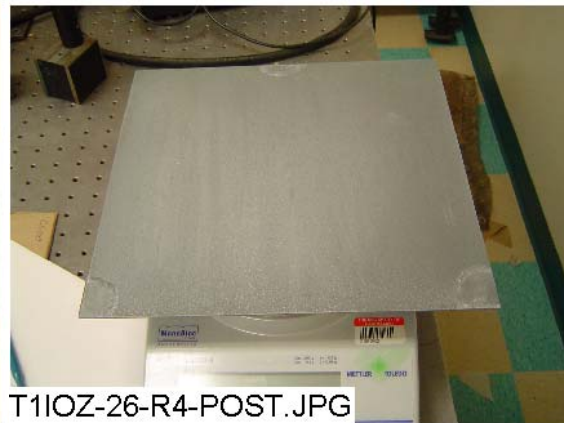
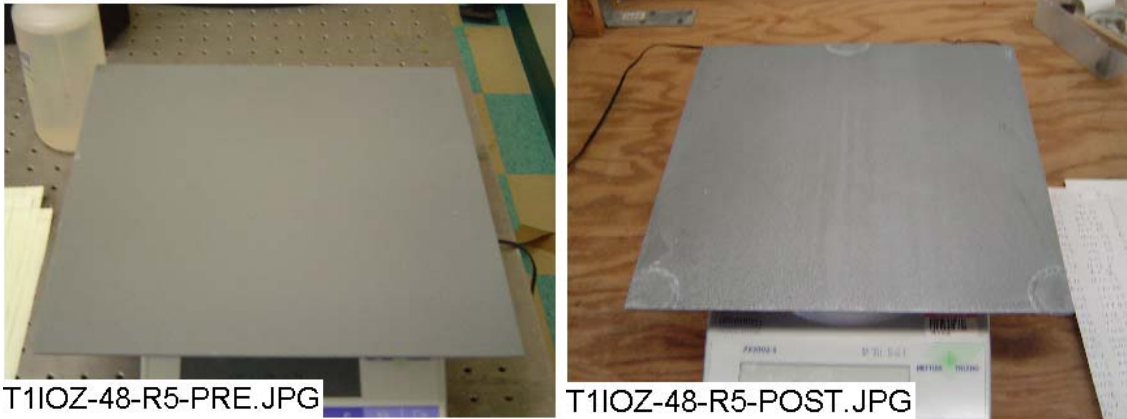
**Figure I-19. IOZ-26 unsubmerged—pre-test (left); IOZ-26 unsubmerged—post-test (right).**

**Figure I-20. IOZ-48 unsubmerged—pre-test (left); IOZ-48 unsubmerged—post-test (right).**

Figures I-19 and I-20 present the pre- and post-test pictures of two unsubmerged inorganic zinc coated steel coupons. Each post-test coated steel coupon exhibits a similar pattern of very light deposition. The IOZ-26 coupon was loaded in rack 4, which was located in the northern position of the middle tier of the tank. The IOZ-48 coupon was loaded in rack 5, which was located in the southern position of the top tier of the tank.

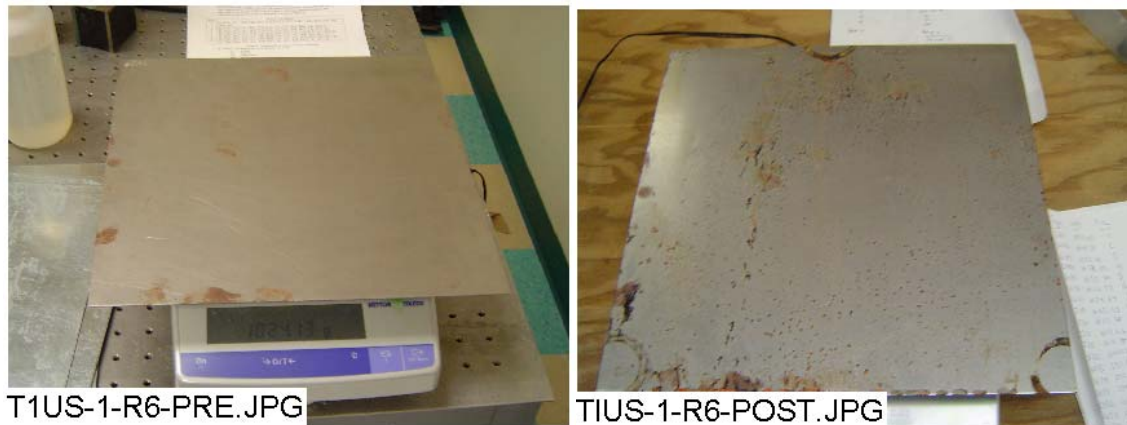
**Figure I-21. US-1 unsubmerged—pre-test (left); US-1 unsubmerged—post-test (right).**

Figure I-21 presents the pre- and post-test pictures of one unsubmerged carbon steel coupon. The post-test carbon steel coupon exhibits rust-like corrosion around the bottom edge and in small patches towards the coupon interior, much of which existed prior to the test. The US-1 coupon was loaded in rack 6, which was located in the center position of the top tier of the tank.
