# **Integrated Chemical Effects Test Project: Test #3 Data Report**

**Los Alamos National Laboratory**

# INTEGRATED CHEMICAL EFFECTS TEST PROJECT: TEST #3 DATA REPORT

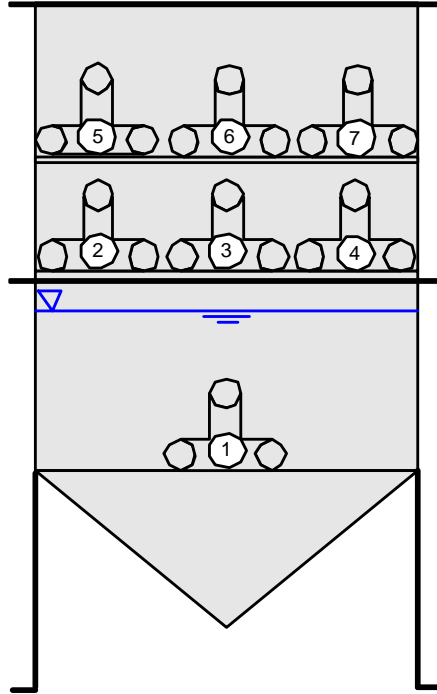
**Figure 2-2. Coupon rack configuration in the ICET tank. The blue line represents the surface of the test solution.**

The arrangement of the coupon racks in the test tank is schematically illustrated in Figure 2-2. The figure shows a side view of the ICET tank, with the ends of the seven CPVC racks illustrated. The normal water level is shown with the blue line in the figure. Rack #1 is the only submerged rack, and it sits on angle iron. It is centered in the tank, so that flow from the two headers reaches it equally. Racks #2–#4 are positioned above the water line, supported by angle iron in the tank. Racks #5–#7 are positioned at a higher level, also supported by angle iron. Racks #2–#7 are exposed to spray. In the figure, north is to the right and south is to the left. Directions are used only to identify such items as rack locations and sediment locations.

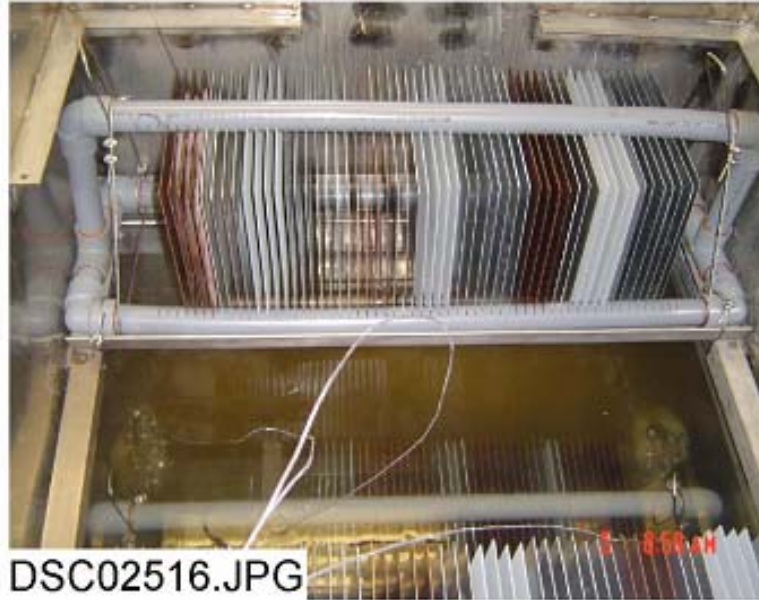
**Figure 2-3. A loaded coupon rack in the ICET tank.**

Figure 2-3 shows the configuration of an unsubmerged coupon rack loaded with metal coupons in the ICET tank. The loading pattern of the racks was nearly identical, varying by only one or two coupons. Shown in the figure from left to right, the coupons are arranged as follows: 4 Cu, 4 Al, 4 inorganic zinc (IOZ), 7 GS, 4 Cu, 3 Al, 4 IOZ, 7 GS, 4 Cu, 3 Al, 4 IOZ, and 7 GS.

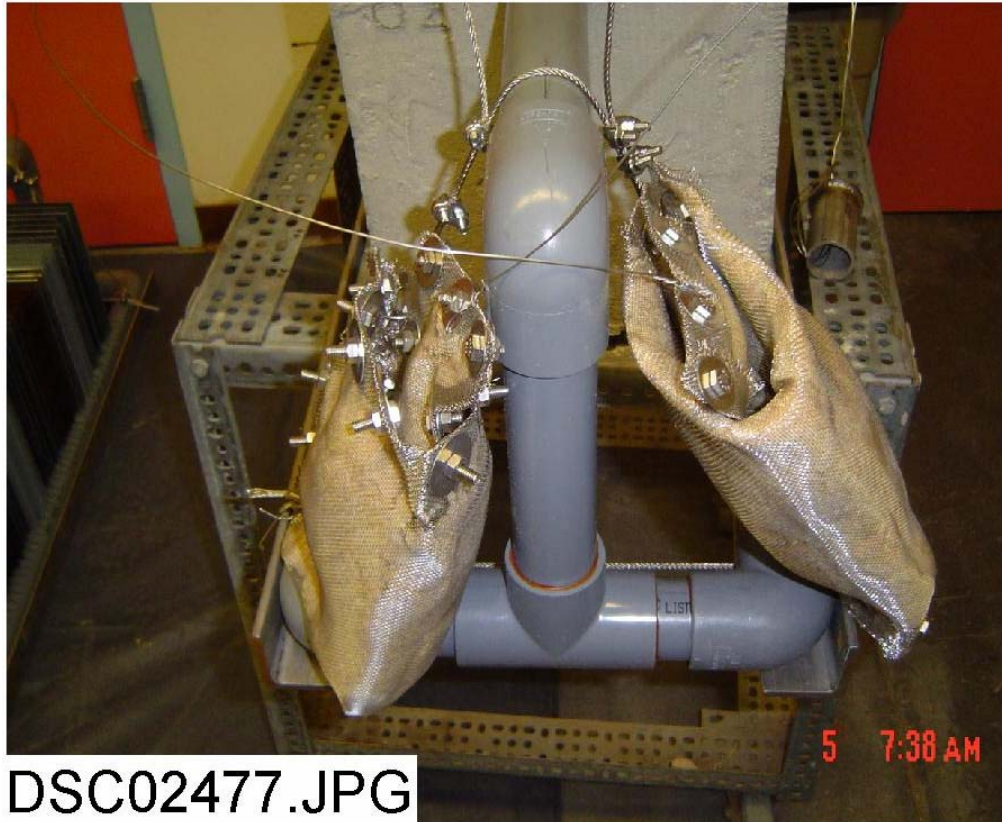
**Figure 2-4. Fiberglass samples attached to coupon rack.**

Several fiberglass samples were placed in the ICET tank. Samples were either submerged or held above the water level. The unsubmerged fiberglass samples were positioned so they would be exposed to sprays. The fiberglass samples were contained in SS wire mesh that allowed water flow while confining the fiberglass material. Both loosely-packed and more tightly-packed samples were used. In addition, some submerged fiberglass samples were located where they would be exposed to relatively high-flow conditions, and others were located in quiescent regions of the tank. Figure 2-4 shows the so-called “sacrificial” fiberglass samples in wire mesh pouches attached to the submerged coupon rack (rack 1 in Figure 2-2). Each pouch contains approximately 5 g of fiberglass. Those samples were attached with SS wire and removed from the tank on Days 4, 15, and 30, and examined. As shown in the figure, bigger insulation bags were wrapped around the sacrificial specimens during the test. See Subsection 2.4.1.1 for descriptions of other fiberglass samples.

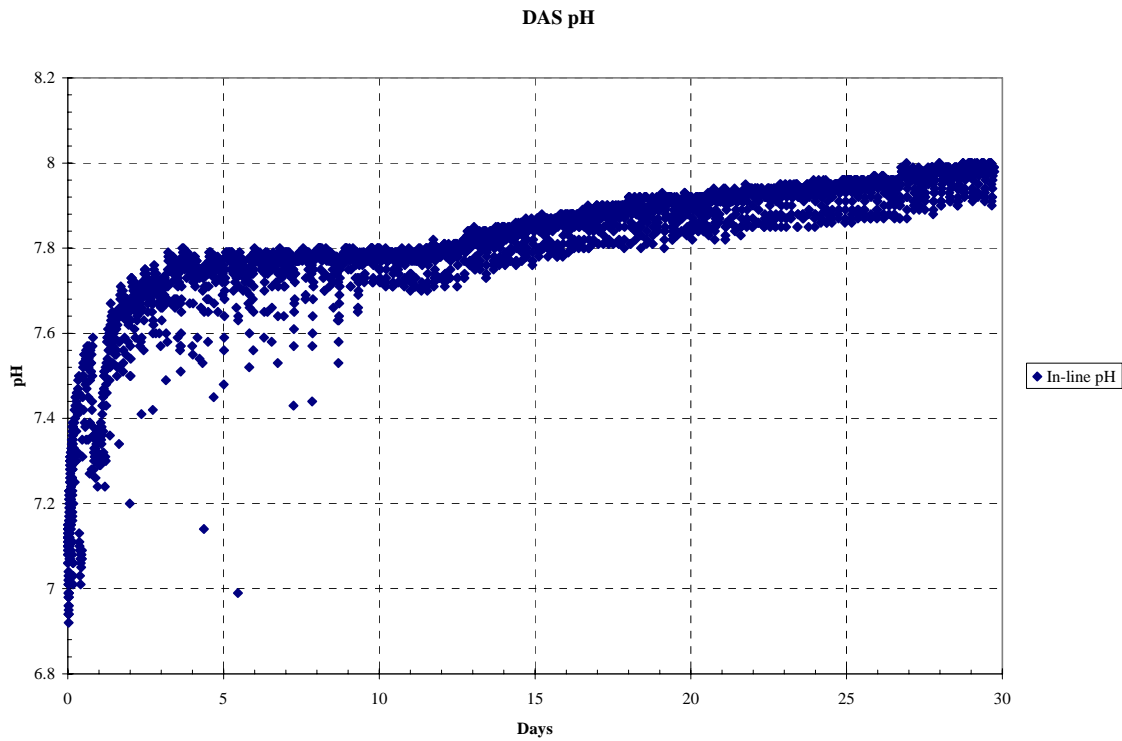
**Figure 3-1. In-line pH measurements.**

The in-line pH probe tracked the overall bench-top pH readings, but the results have noise and a slight offset. Due to the noise within the raw data, the bench-top pH readings are more reliable. Figure 3-1 shows results from the in-line pH probe.

Four hours into the test, the in-line pH measurement was 7.37, and at Day 30 the pH measurement was 7.92. Figure 3-2 presents the bench-top pH readings. Four hours into the test, the bench-top pH measurement was 7.32, and at Day 30 the pH measurement was 8.05.

**pH:** Before time zero, 15.45 kg of boric acid and 0.663 g of LiOH were dissolved in the ICET tank. The measured bench-top pH was 4.24, which was similar to the expected value obtained from analytical predictions. Following the addition of the premixed TSP batches, the pH was 7.32. The pH then continued to rise through Day 3 of testing to 7.9. After Day 3, the pH varied in the range of 7.8–8.0.

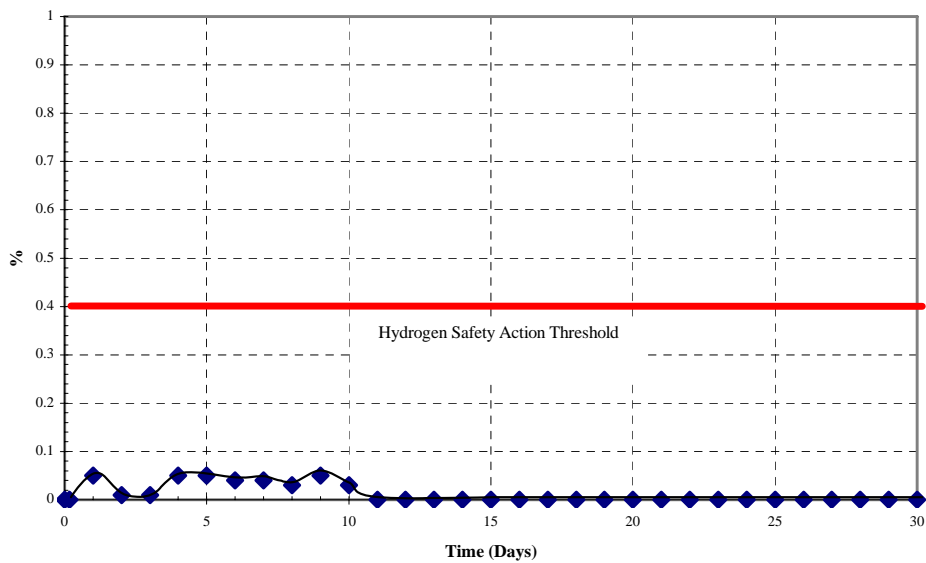
Figure 3-3. Hydrogen generation.

Hydrogen remained at or below 0.05% for Test #3. Figure 3-3 displays the evolution of hydrogen generation throughout the test. A general trend line has been superimposed upon the hydrogen generation data set. Each of the measured values is well below the hydrogen safety action threshold of 0.4%.

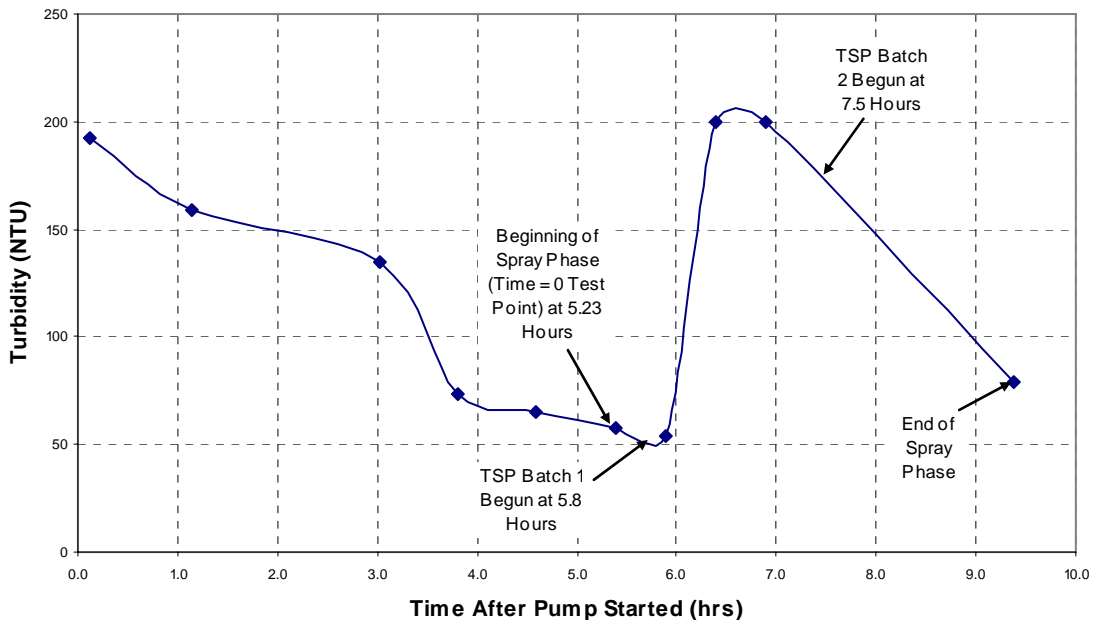
Figure 3-4. Day-1 turbidity results.

**Turbidity:** For the 23°C and 60°C water samples, the baseline turbidity values, which were taken after the latent debris and crushed concrete were added, were 7.3 NTU and 7.5 NTU, respectively. After the addition of cal-sil, the tank solution was observed to become much more turbid. Then with time, the turbidity decreased. Upon the addition of Batch 1 and Batch 2 chemicals, particulates were suspended in solution, and the solution was noticeably cloudier. Figure 3-4 presents the daily turbidity results.

Due to the cloudy nature of the water in the tank after the circulation pump was turned on, additional turbidity values were measured at 60°C over a 9-hour time period, in addition to the regular daily monitoring. Figure 3-4 depicts the evolution of turbidity during that time period. The x-axis on the graph represents the time in hours after the circulation pump was turned on, following cal-sil addition and while the system was heating up. As can be seen, the turbidity gradually decreased from 192 NTU at the 7-minute point to 54 NTU at the 5.9-hour point. Note that the 5.23-hour point on the graph corresponds to the time-zero test point. The spray nozzles were activated at that time. At the 6.4-hour point, the turbidity peaked above 200 NTU. The turbidity decreased to 79 NTU by the end of the spray phase. (Note that the Batch 1 addition began at approximately 5.8 hours on Figure 3-4, and Batch 2 addition began at 7.5 hours.)

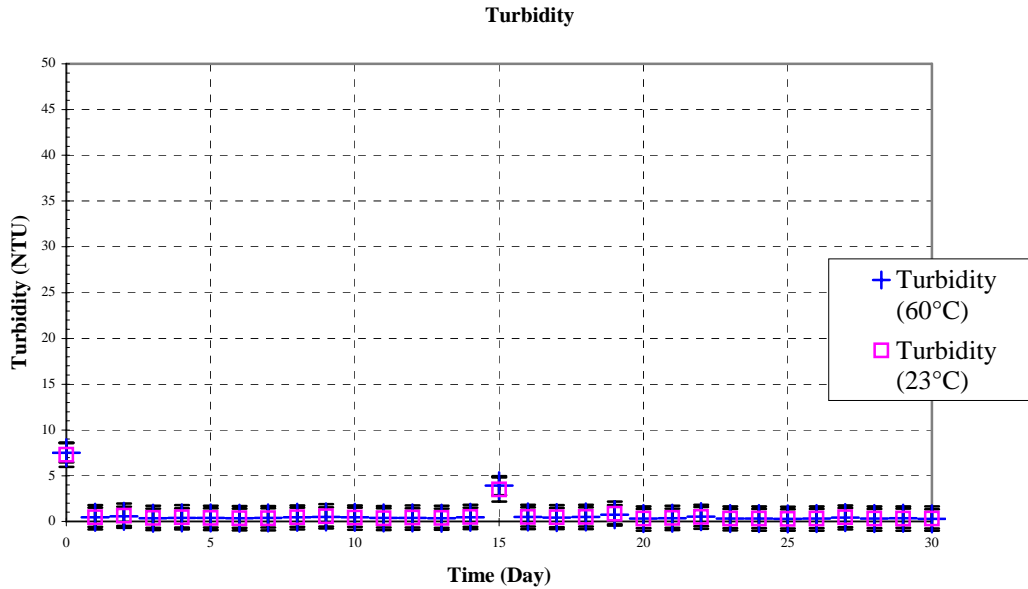
**Figure 3-5. Daily turbidity results.**

Figure 3-5 depicts the evolution of turbidity at 23°C and 60°C throughout Test #3. The trend of each curve exhibits an initial spike during the addition of Batch 1 chemicals, followed by a sharp decline to the Day-1 test point and steady behavior from then on. The turbidity values on Day 15 were slightly higher, but no direct cause has been identified. The Day-15 values were 3.9 NTU and 3.5 NTU for the 60°C and 23°C samples, respectively. Thereafter, the turbidity values decreased and remained steady.

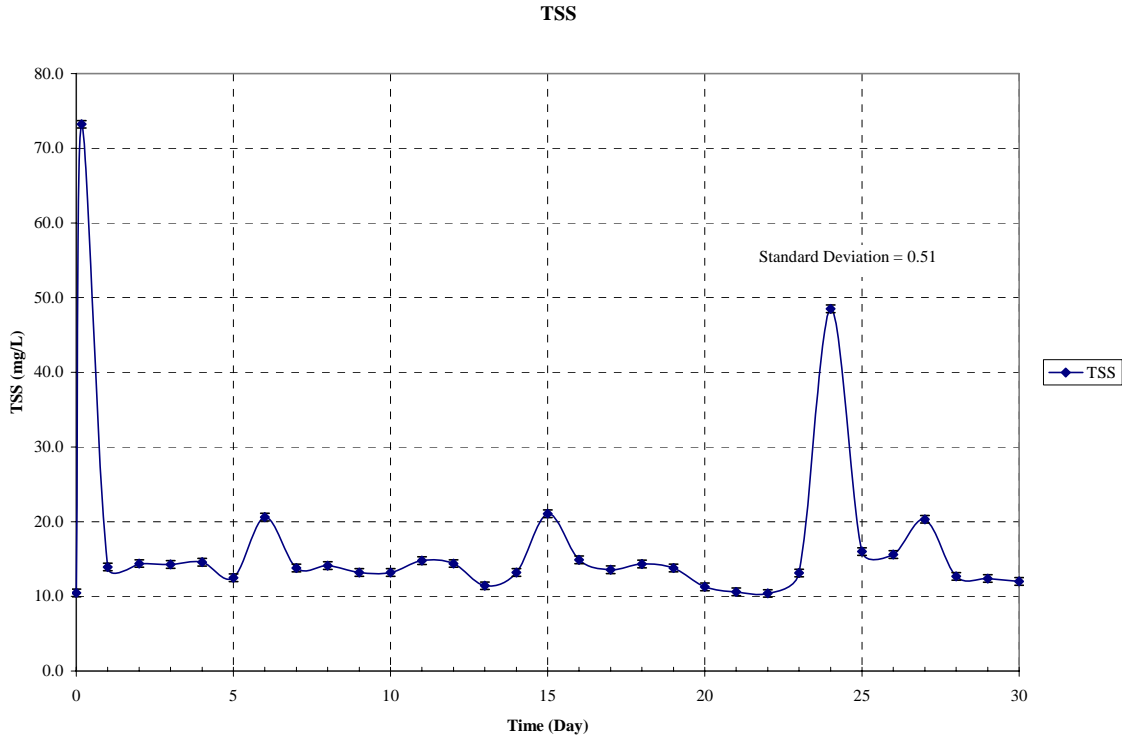
Figure 3-6. Test #3 TSS results.

**Total Suspended Solids:** TSS are measured by filtering a volume of approximately 500 mL through an in-line filter directly at the sample tap. The selected equipment ensures that TSS measurements are not affected by temperature-dependent or time-dependent precipitation reactions that may occur once the process solution is removed from the tank. Figure 3-6 presents Test #3 TSS data as the experiment progressed. The baseline TSS measurement was taken after the addition of latent debris but before the Batches 1 and 2 chemical additions. After the addition of the Batch 1 chemicals but before the addition of Batch 2 chemicals, a second TSS measurement (not shown on the graph) was taken, and the value was 268 mg/L. Although very high, it appeared to be a reasonable measurement because a large amount of particles was suspended in solution at that time. Four hours into the test, another TSS measurement was taken, and that value was 73.2 mg/L. At that time, fewer particles were seen suspended in solution. After 24 hours, the TSS measurement dropped to 13.9 mg/L, where it leveled out for the rest the test.

Although TSS remained fairly stable over the entirety of the test, TSS measurements from six different days deviated from the trend. The Day-6 TSS measurement was slightly higher at 20.6 mg/L, which was not unexpected because the sample was taken right after the return of excess test solution to the tank. The return of the excess test solution caused some of the particles that were sitting at the bottom of the tank to be

become resuspended in the solution, a situation that was reflected in the final measurement. The Day-15 and Days-24–27 measurements were higher than the test average of approximately 13.4 mg/L that was observed for the majority of the test. The TSS filter weights for these days were confirmed, and there is no direct explanation for these higher values.

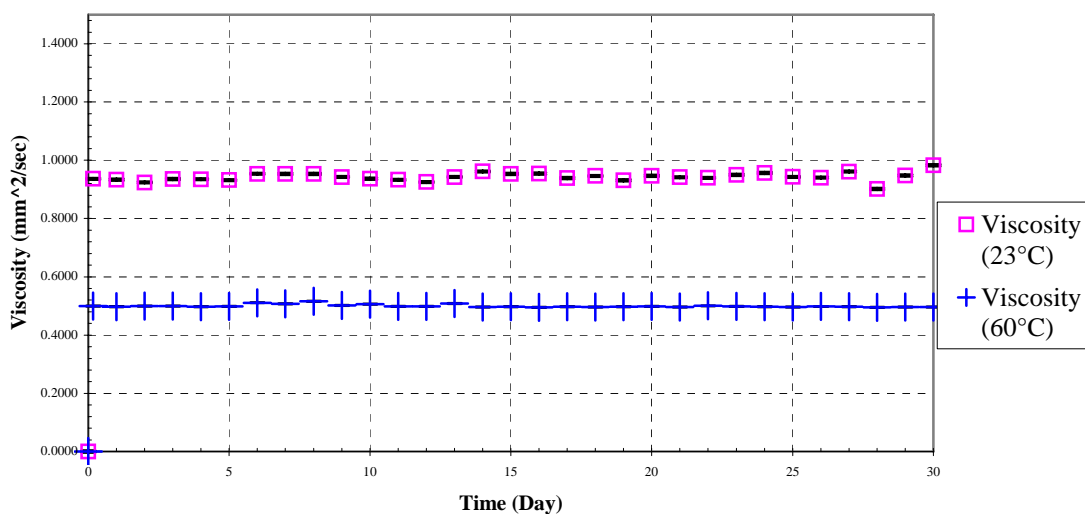
Figure 3-7. Viscosity at 60°C and 23°C.

**Kinematic Viscosity:** Kinematic viscosity was measured with a Cannon-Fenske capillary viscometer. Viscosity was measured on unfiltered samples, each at a temperature of 60°C ± 1.0°C (140°F ± 1.8°F) and 23°C ± 2.0°C (73.4°F ± 3.6°F). Figure 3-7 shows the viscosity results. Water’s viscosity is highly sensitive to temperature, and the allowed temperature range results in a variation of viscosity of 2.9% between 59°C (138.2°F) and 60°C (141.8°F) and 9.3% between 21°C (69.8°F) and 25°C (77.0°F). For this reason, temperature was measured to a 0.1°C accuracy with a National Institute of Standards and Technology (NIST)-traceable thermometer for all viscosity measurements. Also, the measured viscosity values were corrected to common temperatures to facilitate comparisons. The corrected temperatures were 60.0°C (140°F) and 23.0°C (73.4°F).

Viscosity remained relatively constant throughout Test #3. The viscosity at 60.0°C (140°F) remained at a value of approximately 0.49 mm<sup>2</sup>/s, and the 23.0°C (73.4°F) measurements remained around 0.95 mm<sup>2</sup>/s. These constant viscosity values are consistent with the steady water conditions in the test. Figure 3-7 shows the viscosity values through the course of the test.
