**VIRGINIA ELECTRIC AND POWER COMPANY**  
**NORTH ANNA POWER STATION UNITS 1 AND 2**  
**NRC BULLETIN 2002-02 – REACTOR PRESSURE VESSEL HEAD AND VESSEL**  
**HEAD PENETRATION NOZZLE INSPECTION PROGRAMS**  
**30-DAY RESPONSE FOR NORTH ANNA UNIT 2 INSPECTION RESULTS AND**  
**RESPONSE TO NRC REQUEST FOR ADDITIONAL INFORMATION**

**30 Day Response of Inspection Scope and Results  
NRC Bulletin 2002-02 - Item 2.A**

**North Anna Power Station Unit 2**

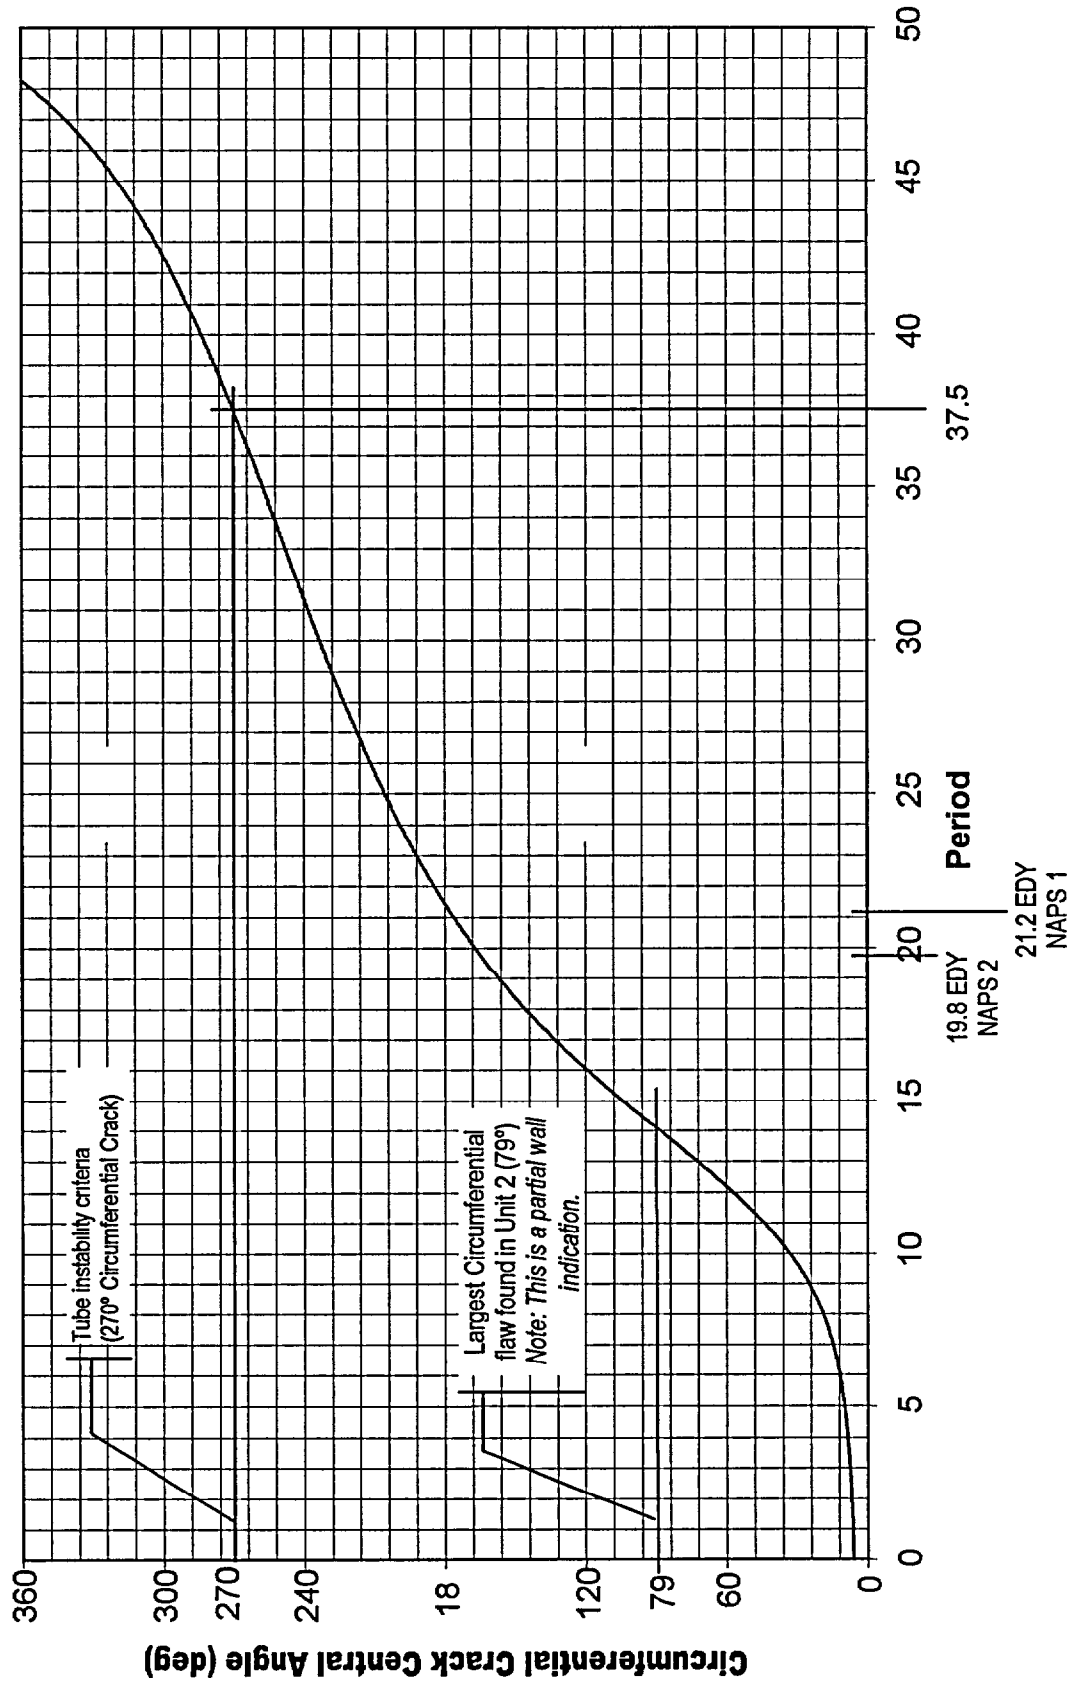
Attachment 1

**Stress Corrosion Crack Growth Prediction for Circumferential Through-wall Crack  
Near the Top of the Attachment Weld**

Also, a through-wall circumferential crack growth curve (Attachment 1) was developed using the same bases as those contained in Reference 1 except that the latest (i.e., more conservative) crack growth model recommended by the EPRI Material Reliability Program (Reference 4) and stress intensities as developed by the NRC (Reference 5) were used. The curve shows that a circumferential, through-wall crack, if initiated at the beginning life of the plant, would not grow to 270 degrees (3/4 of the circumference), the criteria for determining instability of the tube, until the unit has operated for 37.5 years. Since North Anna Unit 1 will only have 21.2 Effective Degradation Years usage by the 2003 refueling outage when the next inspection would be performed, no circumferential through-wall crack is expected that would approach this criterion. The maximum circumferential flaw size found in North Anna Unit 2 was contained within a central angle of 79 degrees and was part through-wall. However, it is estimated that this flaw would grow to through-wall in 1.8 years, and would require another 24.2 years to reach the 270 degree stability limit. Therefore, the tube would remain stable for approximately an additional 26 operating years.
