# **Cable Response to Live Fire (CAROLFIRE) Volume 2: Cable Fire Response Data for Fire Model Improvement**

NUREG/CR-6931, Vol. 2  
SAND2007-600/V2

Prepared by  
S.P. Nowlen, F.J. Wyant

Sandia National Laboratories  
Risk and Reliability Analysis Department 6761  
P.O. Box 5800  
Albuquerque, NM 87185

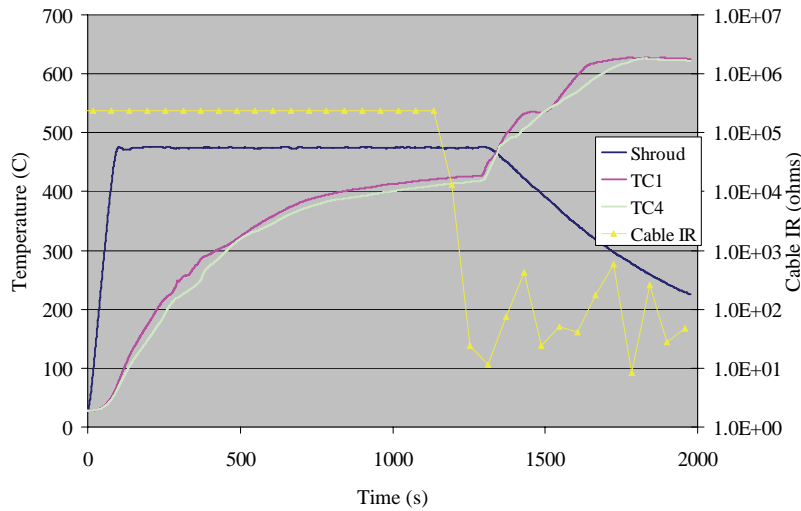
**Figure 5.4: Overlay of the electrical performance and thermal response for the cables in PT-11.**

Figure 5.4 illustrates the corresponding electrical failure data for the electrical performance cable. Shown in this plot are the shroud temperature, the two TCs just below the cable jacket, and a representative plot of cable IR for the electrical performance cable. In this particular test, the electrical fault detected was intra-cable shorting beginning at about 1225s (about 20 minutes). (The cable IR as shown was based on the behavior between conductor 6 and 7.)

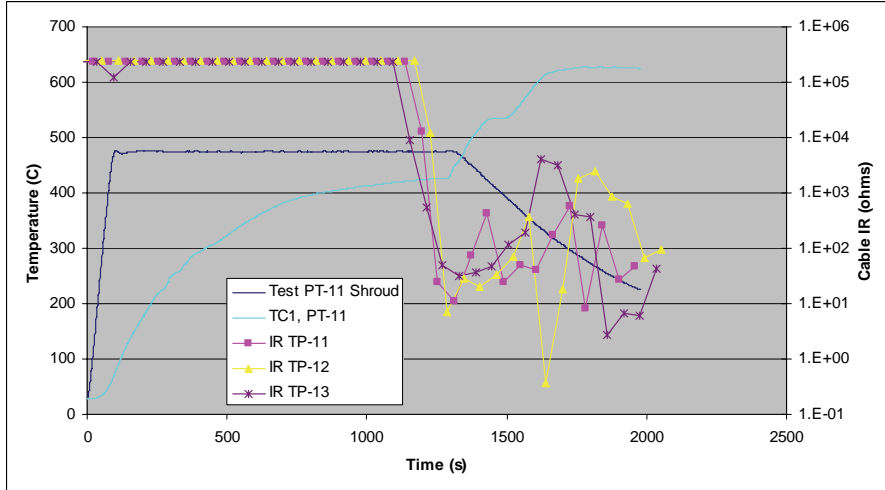
**Figure 5.7: Illustration in the repeatability of the cable’s electrical performance and the onset of electrical failure.**

The final aspect of repeatability considered was that associated with the cable’s electrical performance and the onset of electrical failure. This behavior is illustrated again for the same three tests in Figure 5.7. As in the earlier plots, the times have been offset, and the shroud temperature for PT-11 is shown for reference. Also shown is TC1 from PT-11 for general reference relative to the cable thermal response. Even here the degree of repeatability was quite strong. All three tests saw electrical failures at roughly the same time.

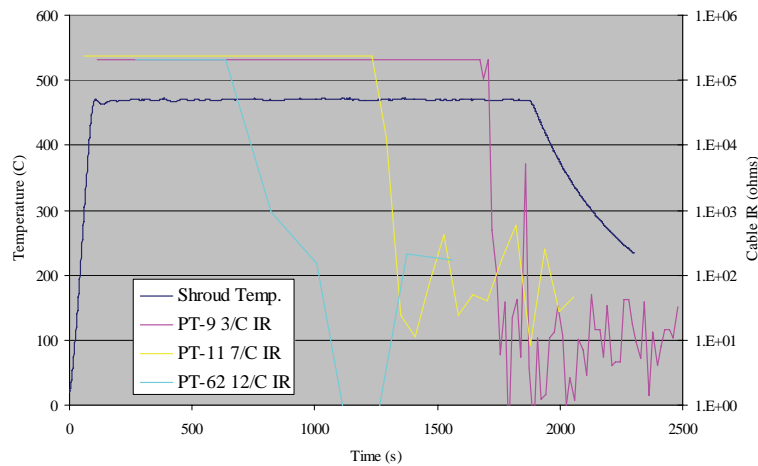
**Figure 5.10: Comparison of the electrical performance for cables with varying relative copper versus plastics content.**

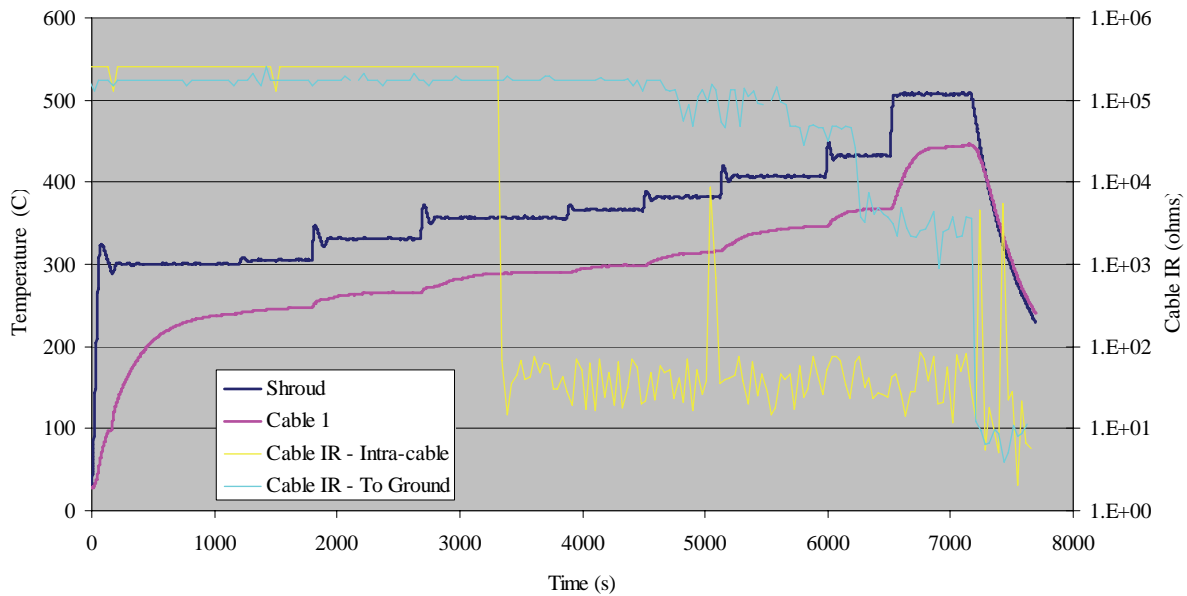
**Figure 5.21: Shroud temperature, cable temperature and electrical failures for test PP-18.**

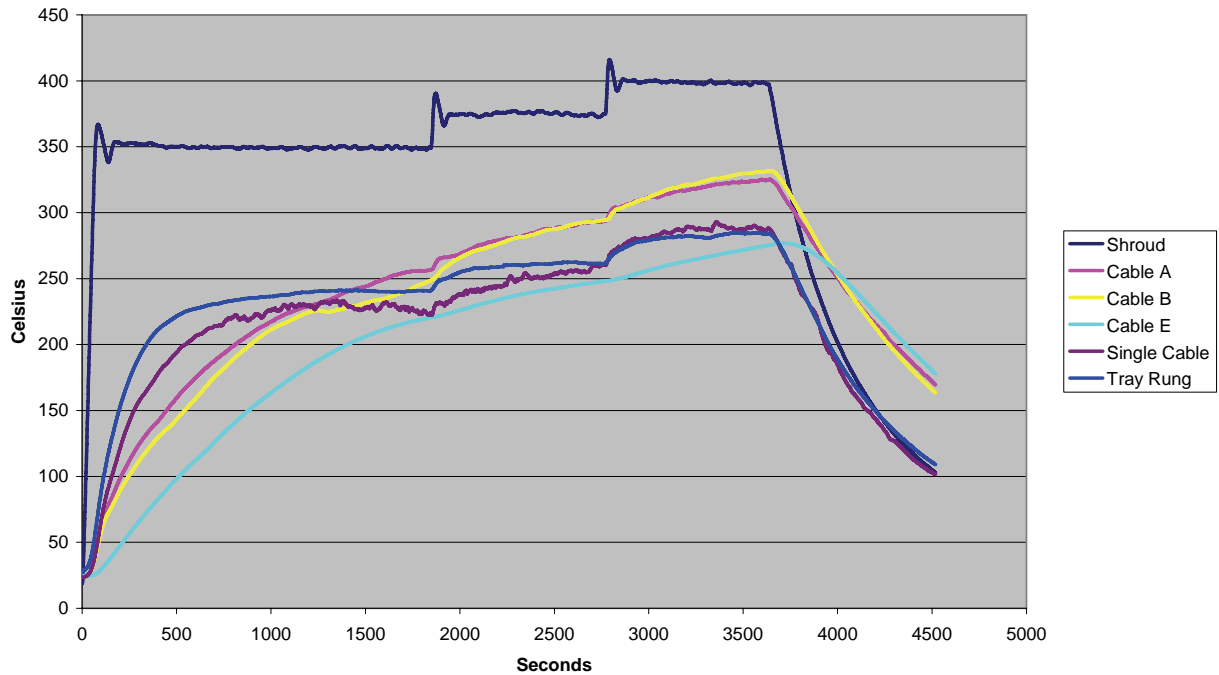
Figure 5.29: Temperature data from the ‘special thermal test’ Spec. 1.

The exposure conditions began with the shroud at 350°C (663°F). The shroud temperature was increased to 375° C at approximately 1950 s and was increased again to 400°C (752°F) at approximately 2875 s. The results for this test are illustrated in Figure 5.29. Note that the TC response for each cable is shown. The cable designators are as shown in the illustration immediately above. Also shown is the shroud temperature and the temperature measured on the cable tray rung at the center of the tray.

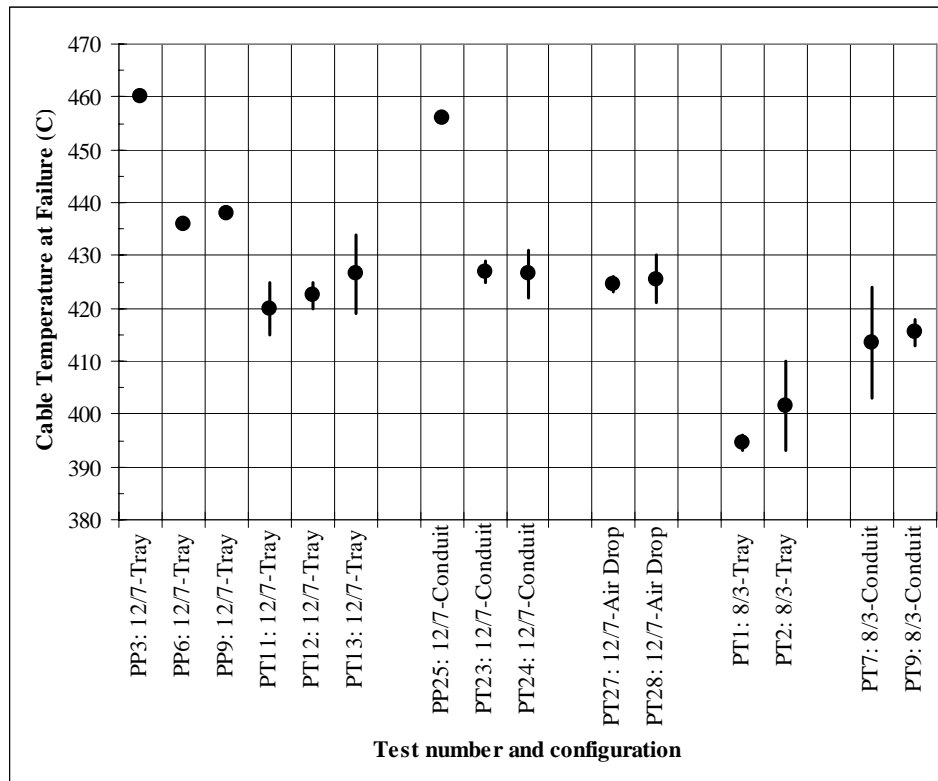
**Figure 5.31: Compilation of test results for the XLPE-insulated cables.**

cases, the central point represents the average of the two individual measurements, and the high/low bar indicates the range obtained for the two individual TCs.

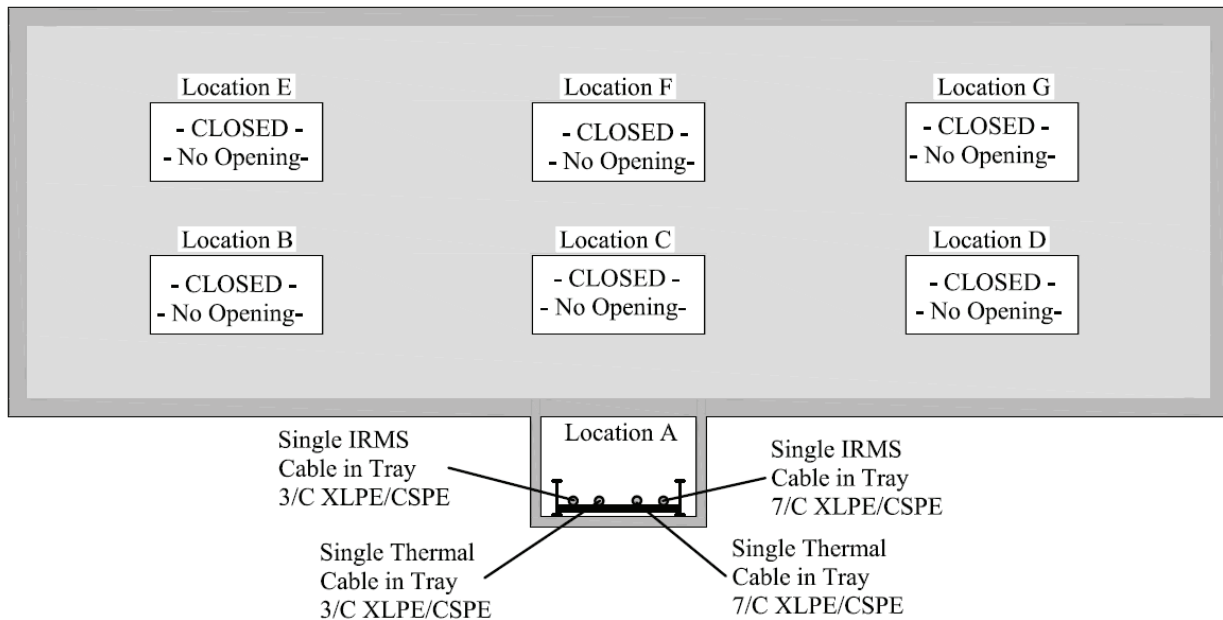
**Figure 6.1: Illustration of the test conditions for tests IP-1 and IP-2.**

Each test was run with four individual lengths of cable in a cable tray at Location A. There were two lengths of the XLPE/CSPE, 12 AWG, 7/C (Item #10) and two lengths of the XLPE/CSPE, 8 AWG, 3/C (Item #14). One of each cable type was monitored for thermal response, and the other was monitored for electrical performance using the IRMS. All of the other cable locations were closed (i.e., the holes to allow for installation of other raceways had not yet been cut) so the entire upper area of the test cell was intact with no openings. This arrangement is illustrated in Figure 6.1.

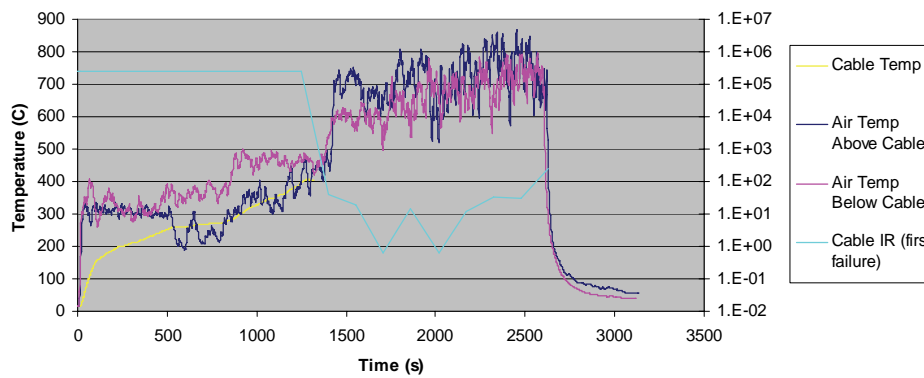
**Figure 6.4: Cable thermal response and first electrical failures for the 3/C cable in IP-1.**

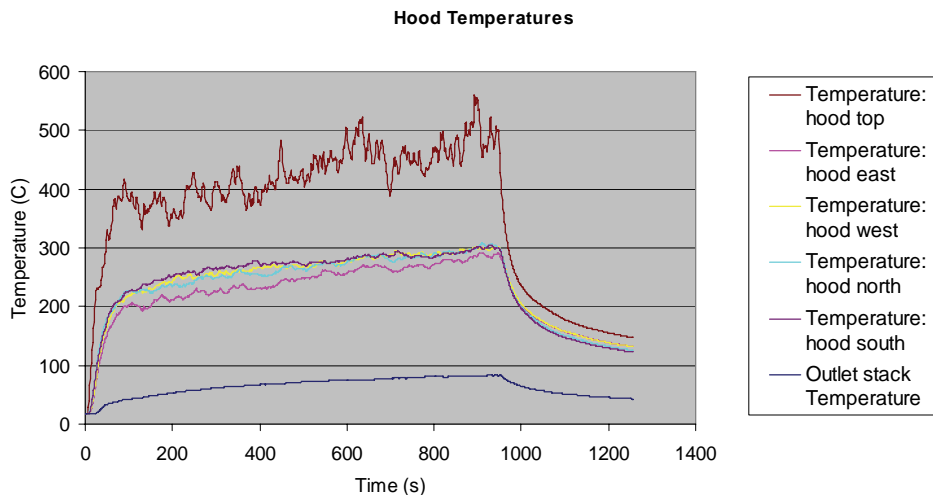
**Figure 6.7: Hood temperatures during IP-2.**

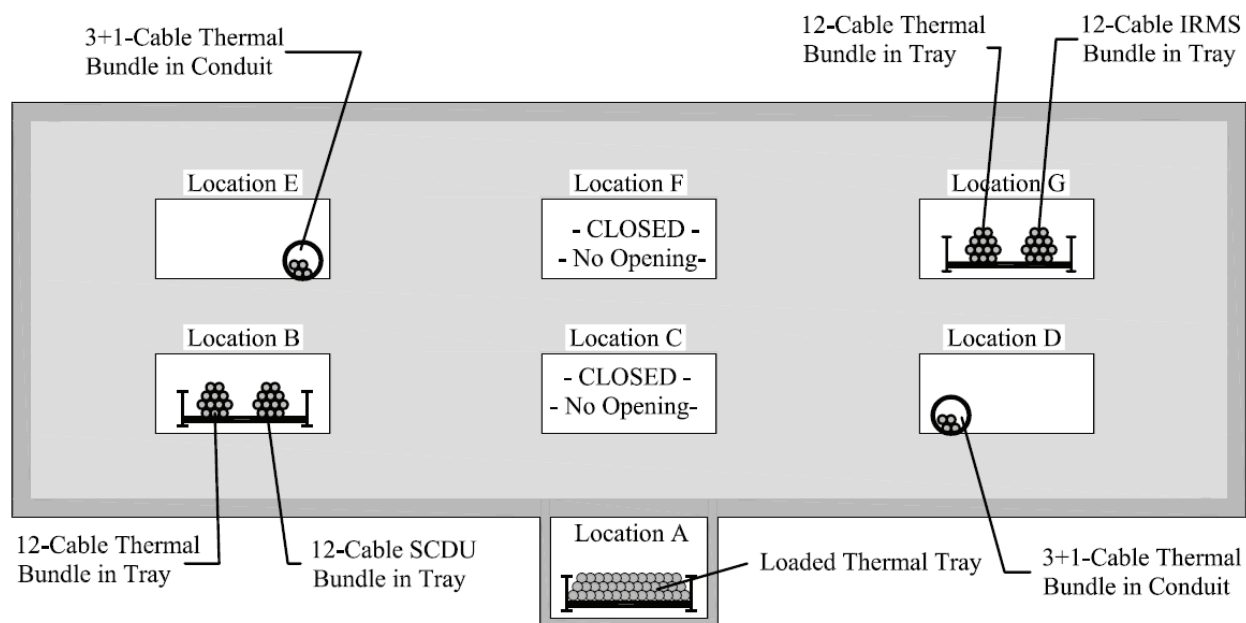
**Figure 6.19: Test setup for IT-1.**

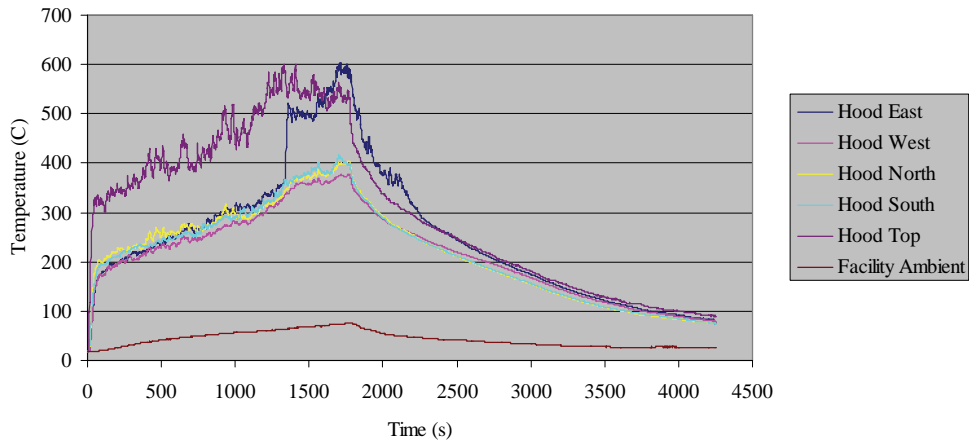
Figure 6.26: Hood temperatures measured during IT-2.

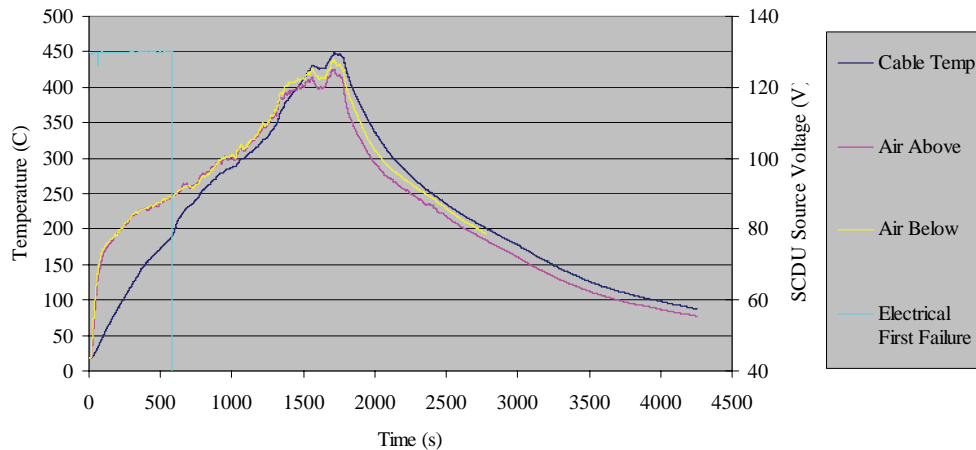
**Figure 6.27: Thermal response and electrical performance data for the paired single lengths of the PVC/PVC cable at Location G in IT-2.**

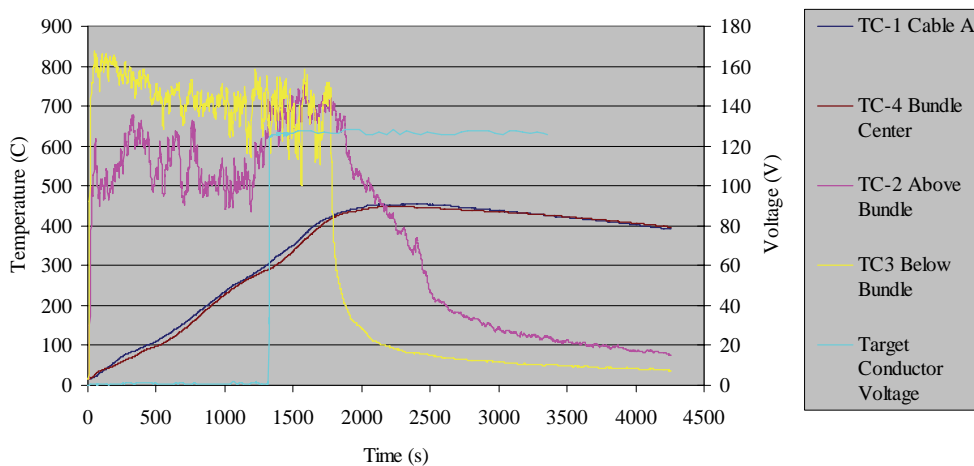
**Figure 6.28: Thermal response and electrical performance results for the paired 12-cable thermal response bundle and SCDU cable bundle at Location A during IT-2.**

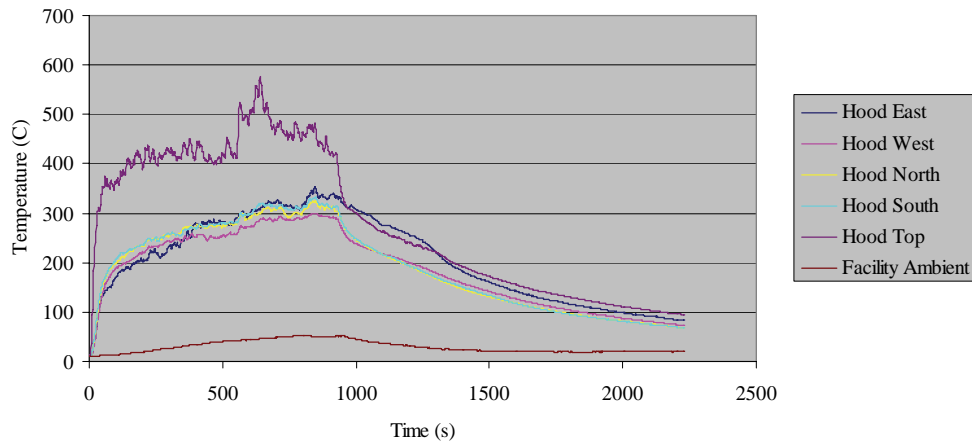
**Figure 6.31: Hood temperatures measured during IT-3.**

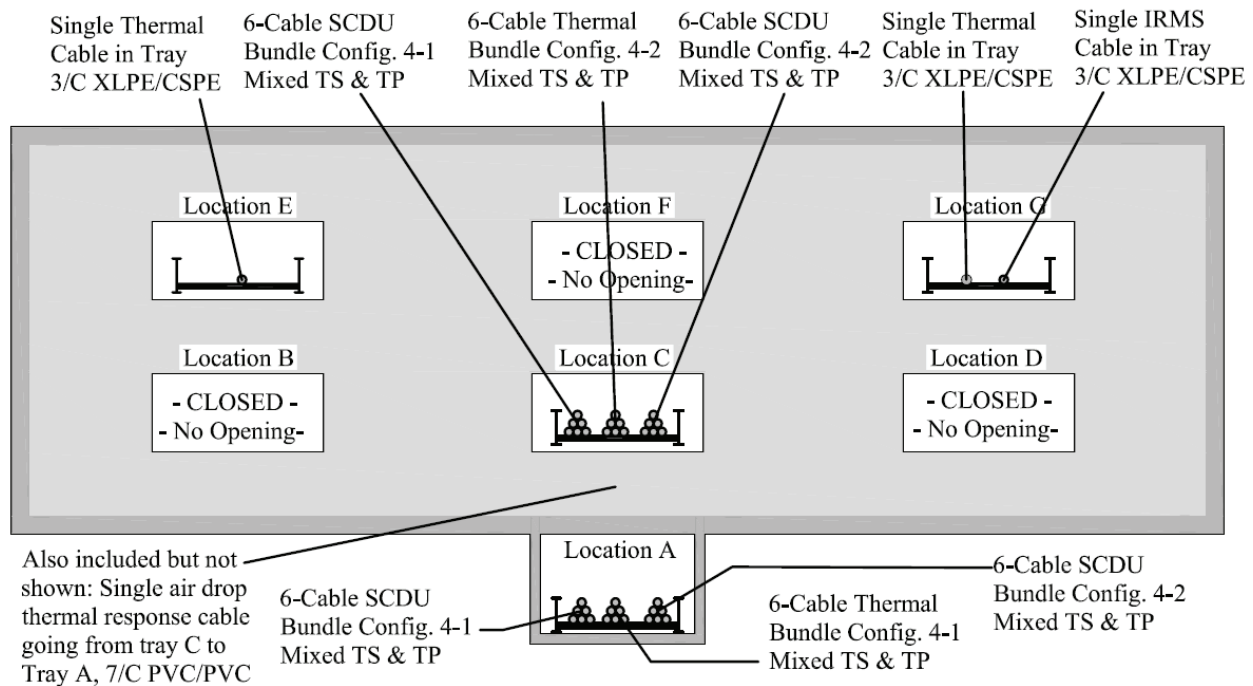
**Figure 6.34: Test setup for IT-4.**

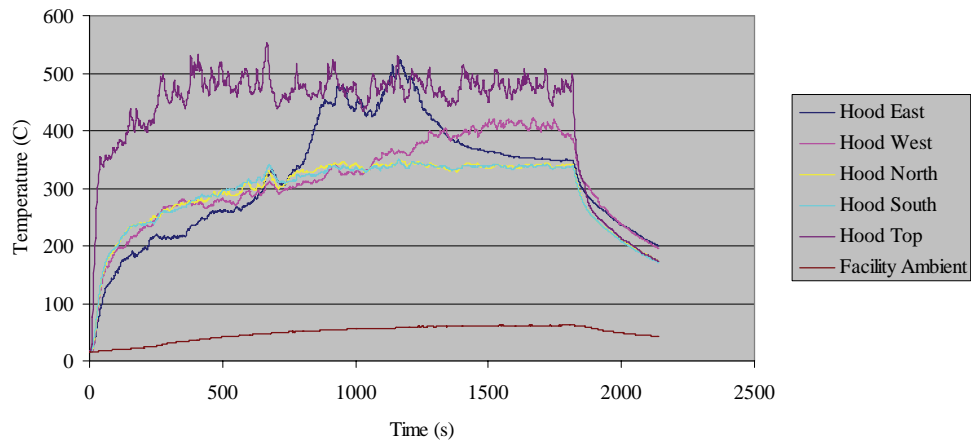
**Figure 6.36: Hood temperatures measured during IT-4.**

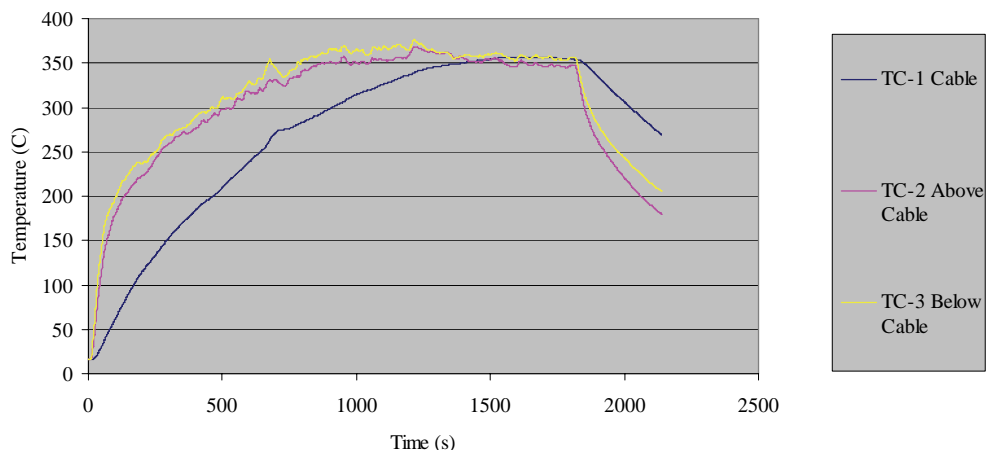
**Figure 6.37: Temperature data for the 3/C XLPE-insulated cable at Location G.**

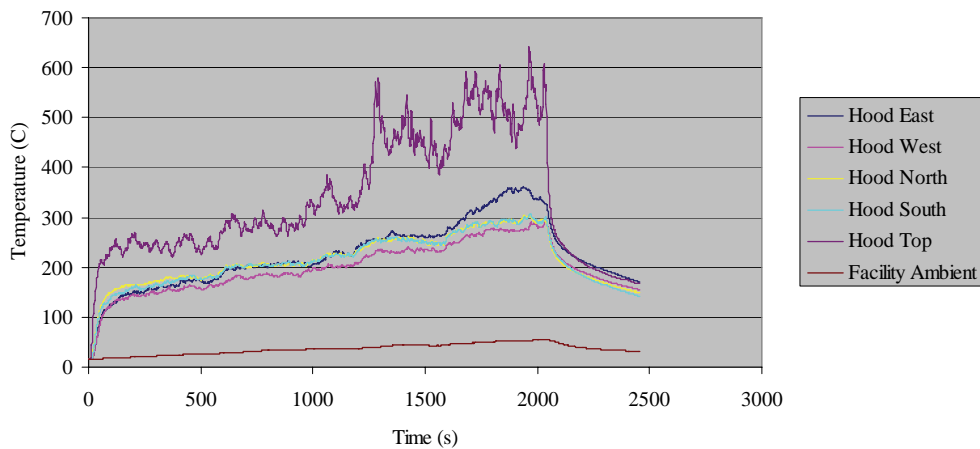
**Figure 6.52: Hood temperatures measured during IT-8.**

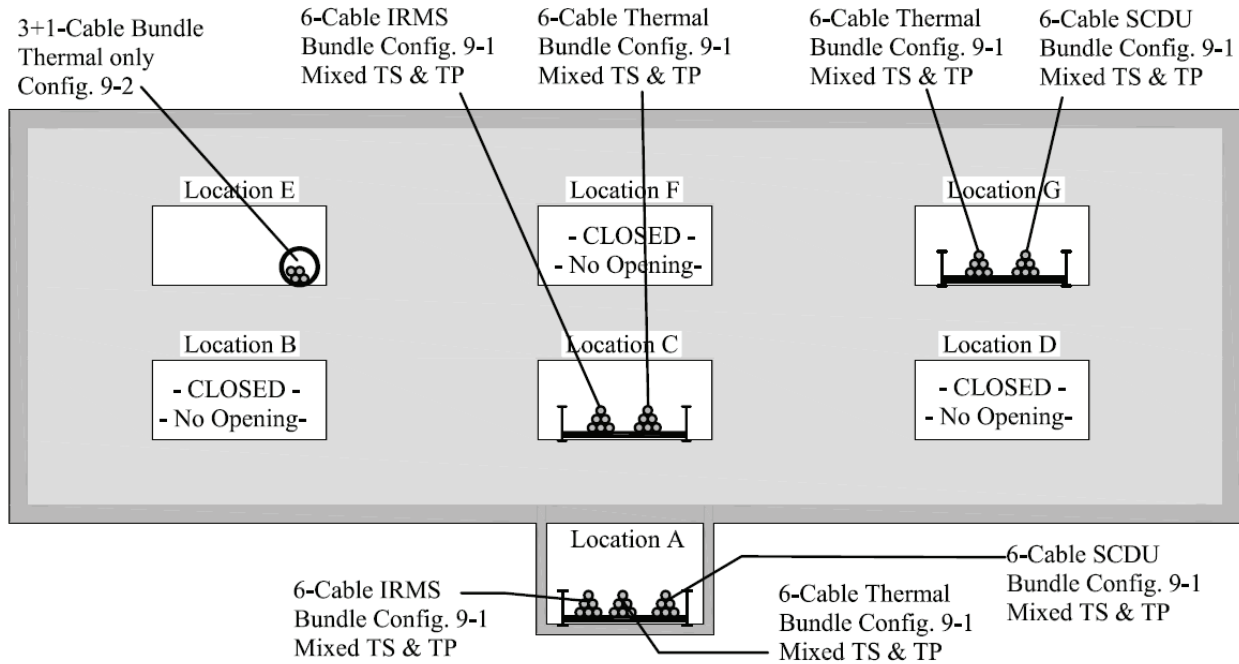
**Figure 6.55: Test setup for IT-9.**

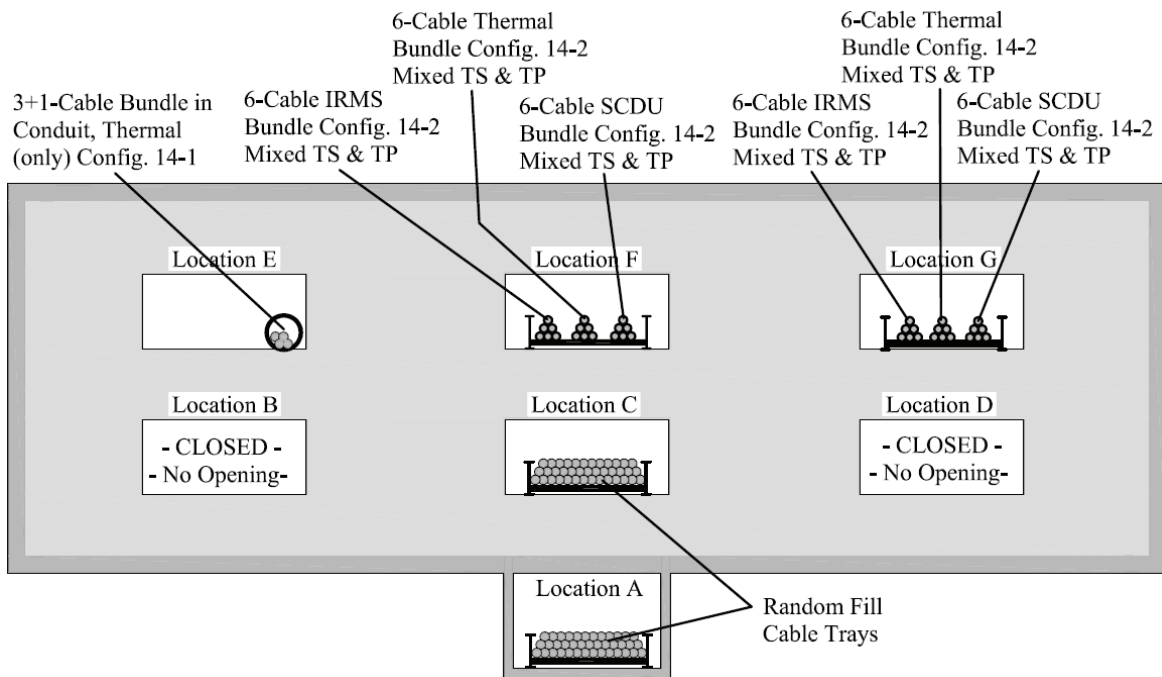
**Figure 6.73: Test setup for IT-14.**
