Emergency Watershed Protection Program:

Cave Gulch Erosion Mitigation Project

PHOTO STORY

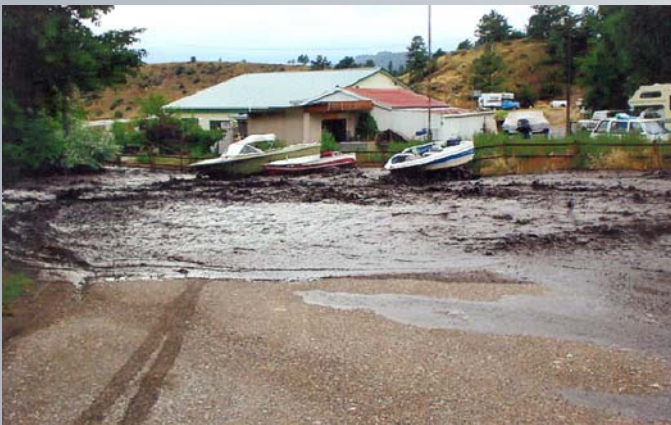
Typical flood damage to a home after the debris/flood flows.

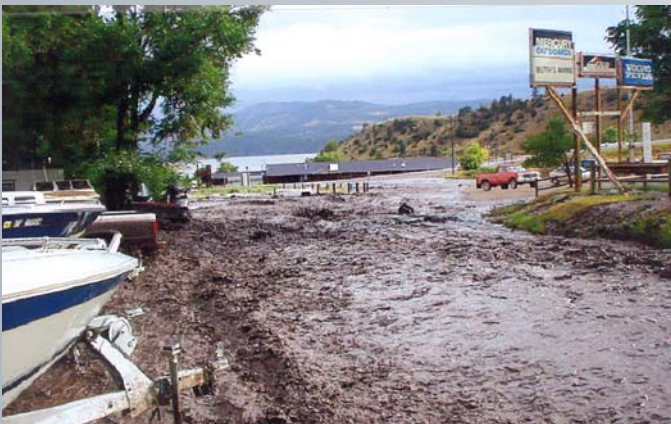
This flash flood affected businesses and homes in the Cave Gulch drainage with water and sediment washed down slopes left bare by the Cave Gulch fire.

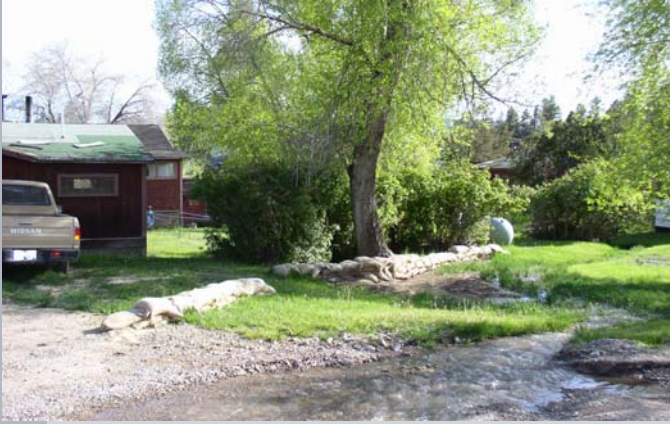
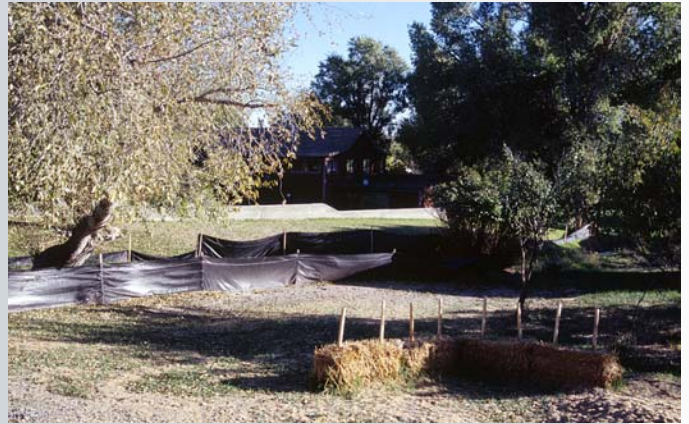
Above: Temporary barriers, like the sandbags, silt fence, and straw check dams above were used to protect homes from flooding prior to completion of the EWP project.

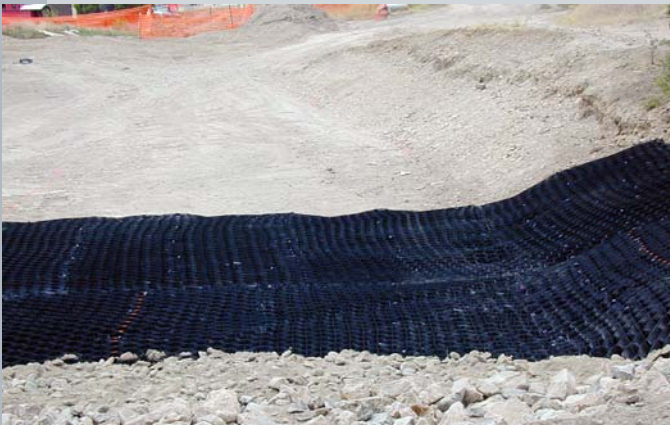
Left: Because of the steep grade of the channel, a lining of rock-filled geo-grid material was required to control erosion. After excavation was completed, the geo-grid material was laid down and filled with rocks, then covered with soil and seeded with grass..

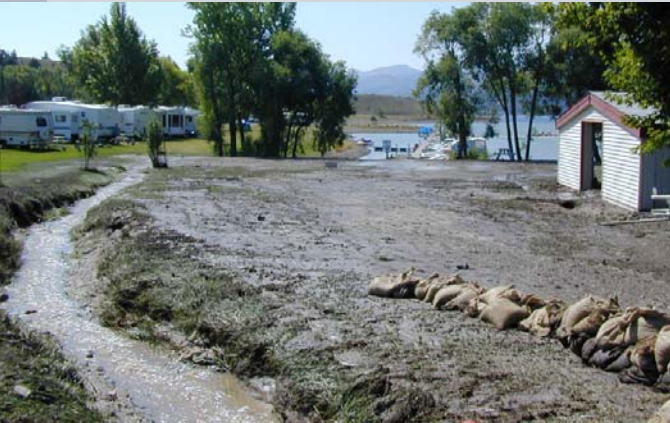
Before the dike and channel were constructed the flood waters ran into Kim's Marina.

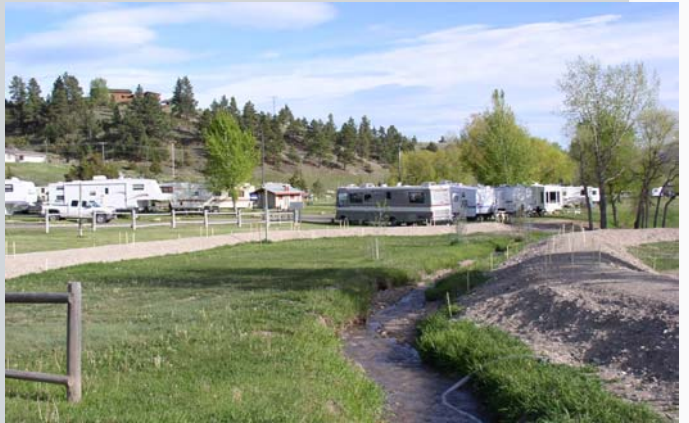
Now, the dikes on either side of the stream protect businesses and homes. The dikes have been lined with netting and seeded with grass to protect them from erosion.

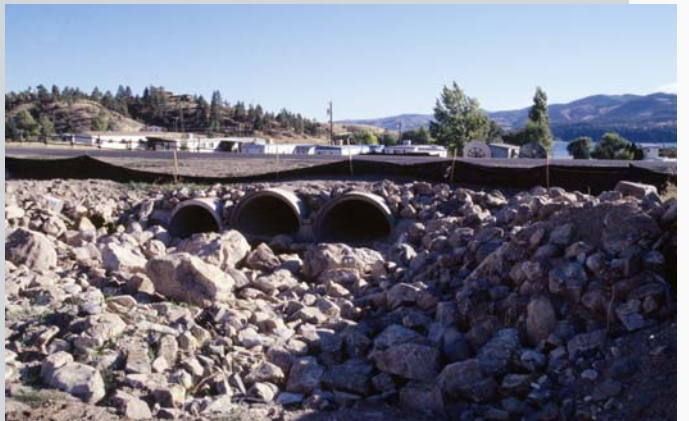
Right: Through the EWP project, three large culverts have replaced the one small culvert on the north side of Highway 284 and the area has been armored with rocks.

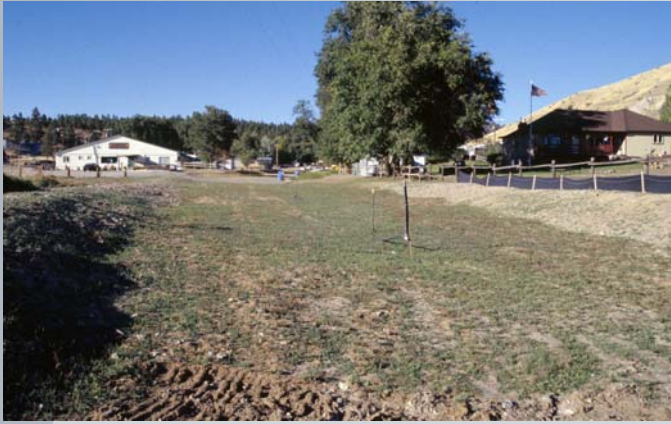
Above: The dikes, grass, and covered geo-grid material filled with rock armoring a little further upstream of Highway 284.

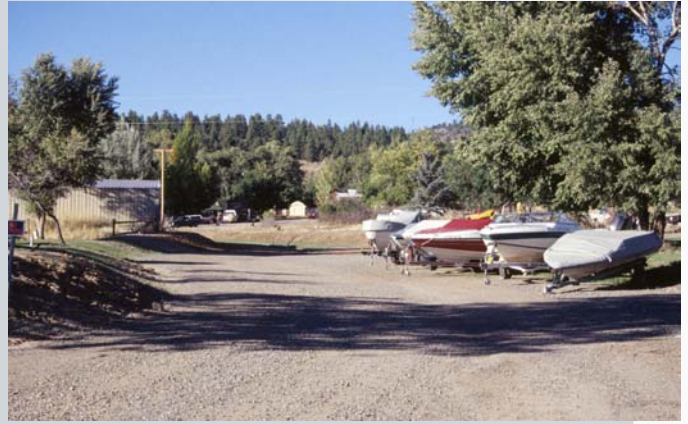
Some areas of rock armoring were needed in the channel to allow homeowners a safe, erosion resistant way to cross the stream channel to reach their homes. These boats are parked directly in the stream channel.

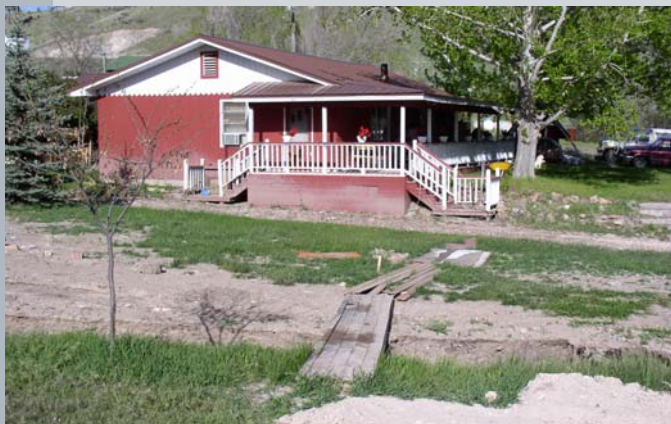
This home sustained damages from flood water. Water marks on this home (the gray area on the walls) show how high water rose during some of the flood events.

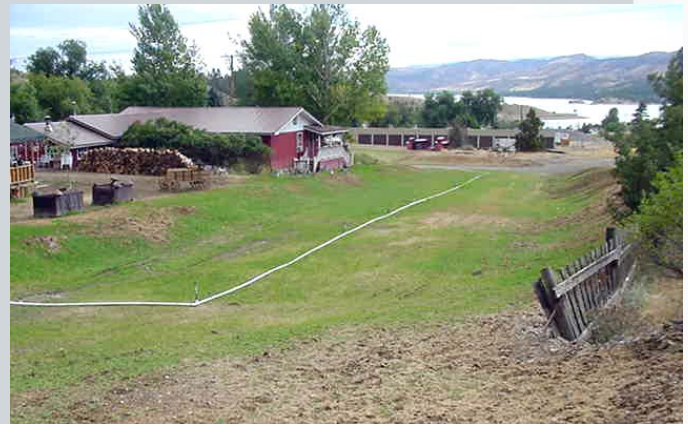
Now, a dike in front of the home helps keep flood waters and debris away from the home. Homeowners are using water from the stream, which has been redirected, to help grass establish in the channel.

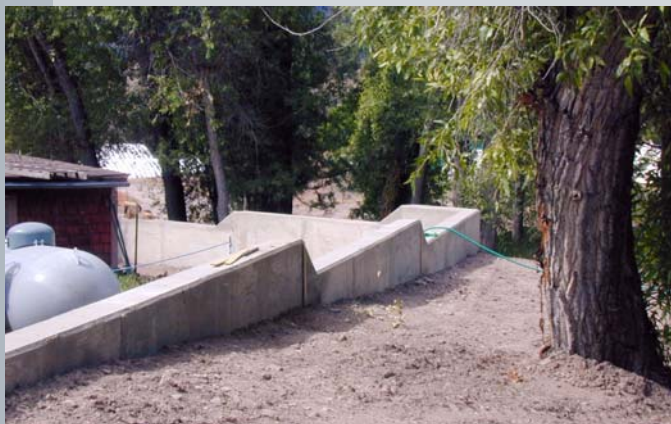
Concrete barriers were used to protect property where there was limited room to build a dike and/or channel.

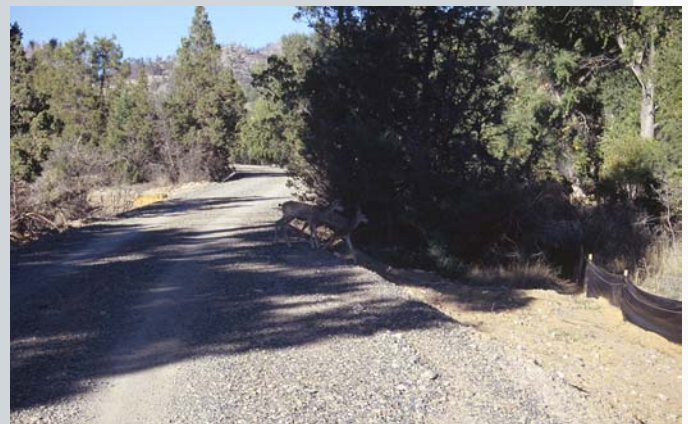
This access road to Forest Service, Bureau of Land Management, and private properties was built using the excess fill excavated from the channel. Construction was done and paid for by the Forest Service, BLM, and landowners.
