U.S. Department
Of Transportation

Federal Railroad
Administration

RR07-16
May 2007

Heavy Axle Load Revenue Service Rail Performance— Tehachapi, CA

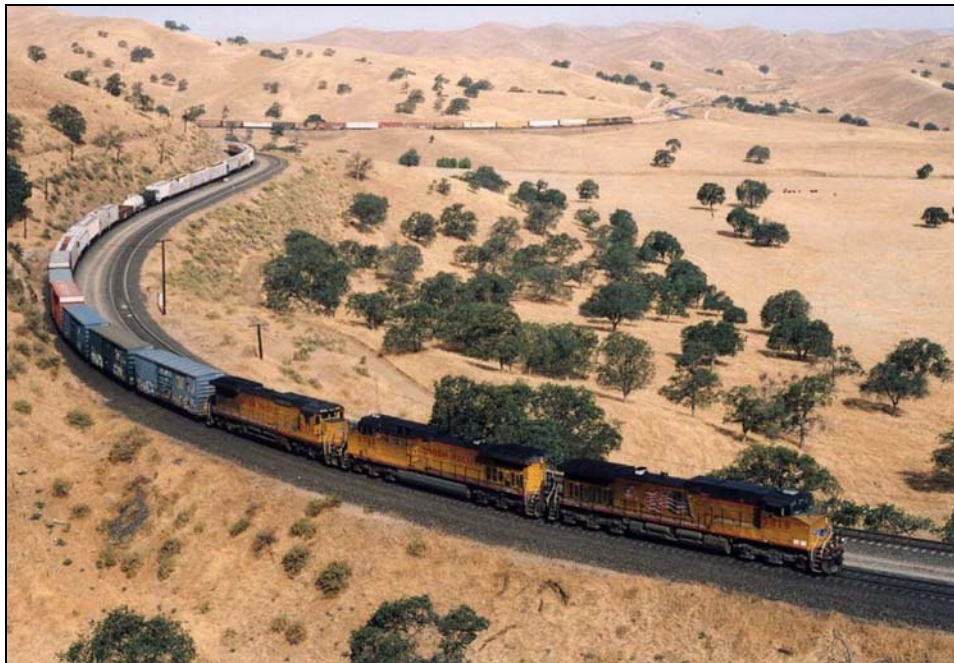
Figure 1. In-Revenue Rail Performance Test, Site 3, MP 340 at Tehachapi, CA

The Transportation Technology Center, Inc. (TTCI) in Pueblo, CO, performed rail performance tests in revenue track in cooperation with Union Pacific Railroad (UP). Figure 1 shows an in-revenue rail performance test at Site 3, Milepost (MP) 340 at Tehachapi, CA. These tests suggest that new versions of premium rails have an average expected life of 200 million gross tons (MGT), based on a 0.75-inch gage face wear limit, or approximately 900 MGT life using a 30 percent head area loss criteria.

In cooperation with UP, a rail test site was made available in the Tehachapi Pass area of California. Figure 2 shows the general site, which is located in a severe mountain territory with 2 percent grades and curves of 5 to 10 degrees. As referenced earlier, Figure 1 shows Site 3, MP 340. Traffic is mixed freight with a high percentage of intermodal equipment. Within the test zone, five test curves were selected for installation of premium test rails, as shown in Table 1. The last column shows average predicted life for all rails based on a 0.75-inch gage face wear limit.

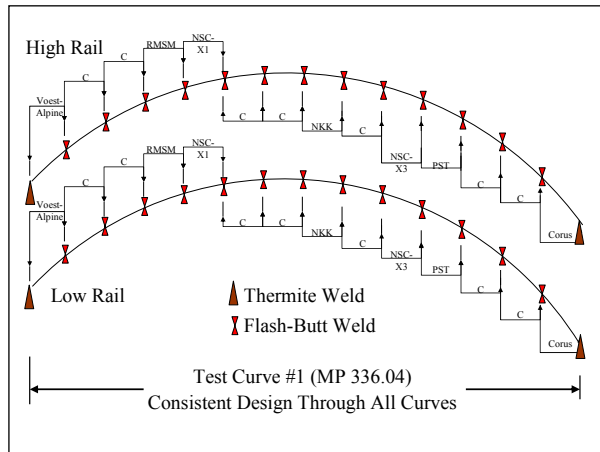
While the FAST loop generally provides steady state test conditions, in the field, items such as lubrication and train speeds can vary from curve to curve, as well as within a curve. UP selected the NSC HE 400 rail type as a control rail to be installed at various locations through each test curve. This allows wear rates to be determined on the same rail at all locations within a curve, thus capturing variables that might influence wear or fatigue at one end or the other of a particular curve. Figure 3 shows the layout of rails in Test Curve 1, which is typical of all test curves.

Figure 3. Rail Evaluation Test Layout Shown for Curve 1

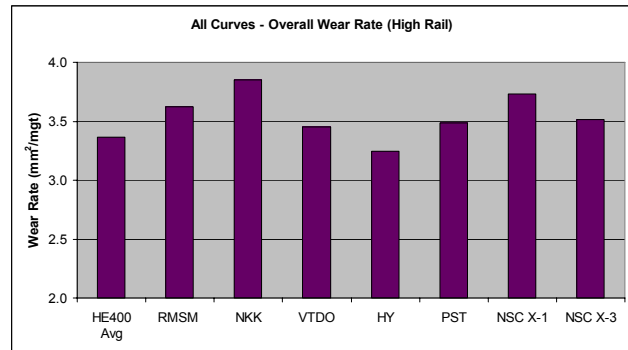
Figures 4 and 5 summarize area loss wear rates for each rail type, averaged for all test curves, for the initial 169 MGT. Longer term tests conducted at FAST show a gradual decrease in wear rate (for all test rails) after about 150 MGT of traffic. Predicted rail life may be longer than that shown in this report, based on the first 169 MGT.

Figure 4. Total High Rail Wear Rate (area loss in mm²/MGT) for Complete Test Period

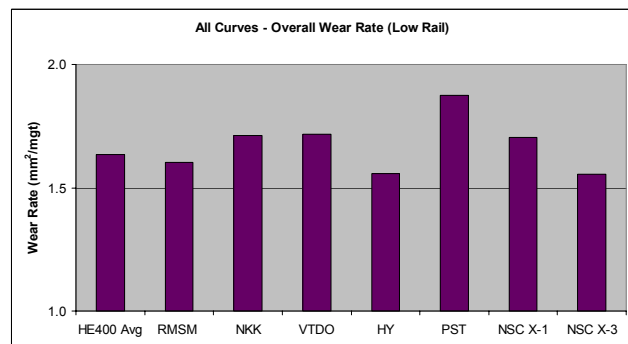
Figure 5. Total Low Rail Wear Rate (area loss in mm²/MGT) for Complete Test Period

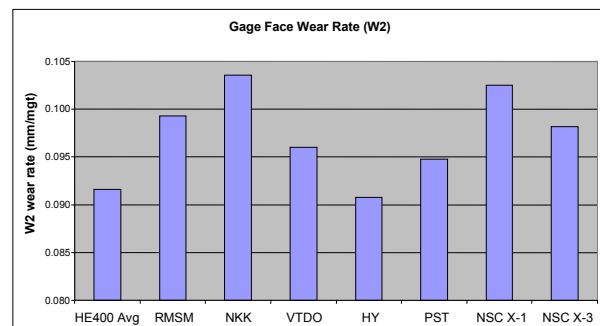
A common measurement to determine rail replacement in high curvature territories is gage face wear. In the Tehachapi Pass area, which is equipped with concrete ties, re-gaging is not an option. The end of rail life is often reached when side wear reaches 0.75 inch. This allows for some additional gage widening due to fastener deflection, rail seat abrasion, and pad deterioration. Figure 6 shows gage face wear rates for test rails. The relative ranking between rails is similar to that shown from high rail area loss (Figure 4). The average projected 0.75-inch gage wear life of all curves of the highest to lowest wearing rail is between 185 to 210 MGT. For the existing operations and lubrication conditions at this site, projected rail life (80 MGT/year) would range from 2.3 to 2.6 years.

Figure 6. Gage Face Wear Rate (MiniProf W2) in mm/MGT, for the Complete Test Period

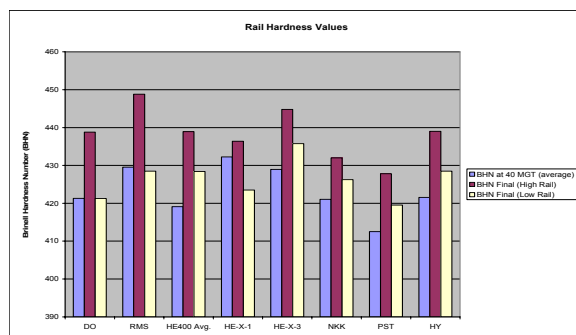
Hardness data obtained near the beginning and end of testing is averaged for all curves and shown in Figure 7. Data suggests that the high rail hardness increased for most rails with applied tonnage, while the low rail exhibited less change or a slight increase over the same period. No direct correlation with hardness and observed wear rate exists.

Figure 7. Hardness for All Test Rails as Installed for All Rails and High and Low Rails at End of Test

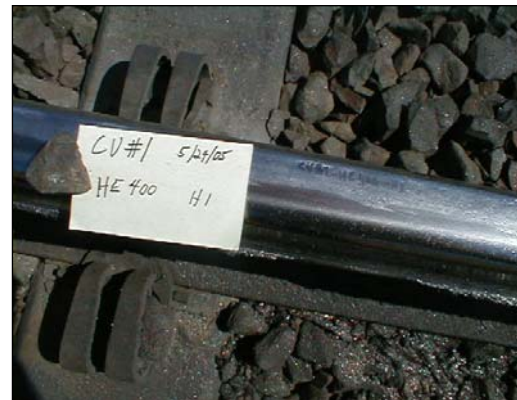
One item that could reduce projected rail life would be deterioration of the running surface, leading to spalling or chipping. In many cases, this requires the use of grinding to eliminate these defects. In the 169 MGT of this test, no significant rail surface deterioration was noted. Figure 8 is an example of typical rail surface conditions observed after 160 MGT of traffic. If grinding were limited to the top rail areas, then gage face life, which is the limiting factor at the test site, would not be significantly reduced.

Figure 8. Photo of Rail Surface Condition After 169 MGT
