Research
Paper
FPL-RP-572

Field Performance of Timber Bridges

17. Ciphers Stress-Laminated Deck Bridge

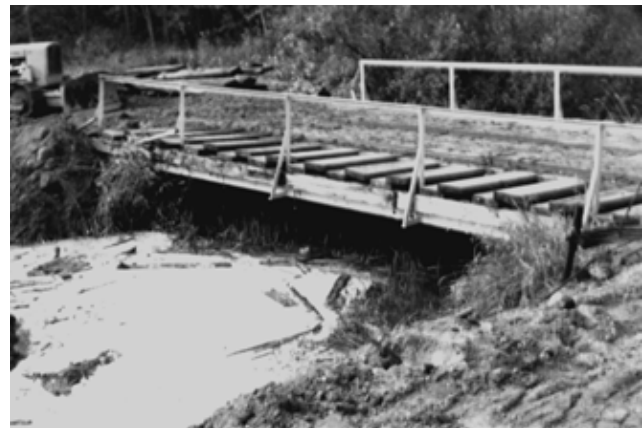
Before replacement in 1989, the Ciphers bridge was a flatbed railcar with a wooden deck (Fig. 2). Originally constructed in the 1950s, the bridge was vandalized with fire in 1988. The damage caused by the fire was severe and necessitated replacement of the bridge.

Figure 2—Ciphers bridge before replacement in 1989.

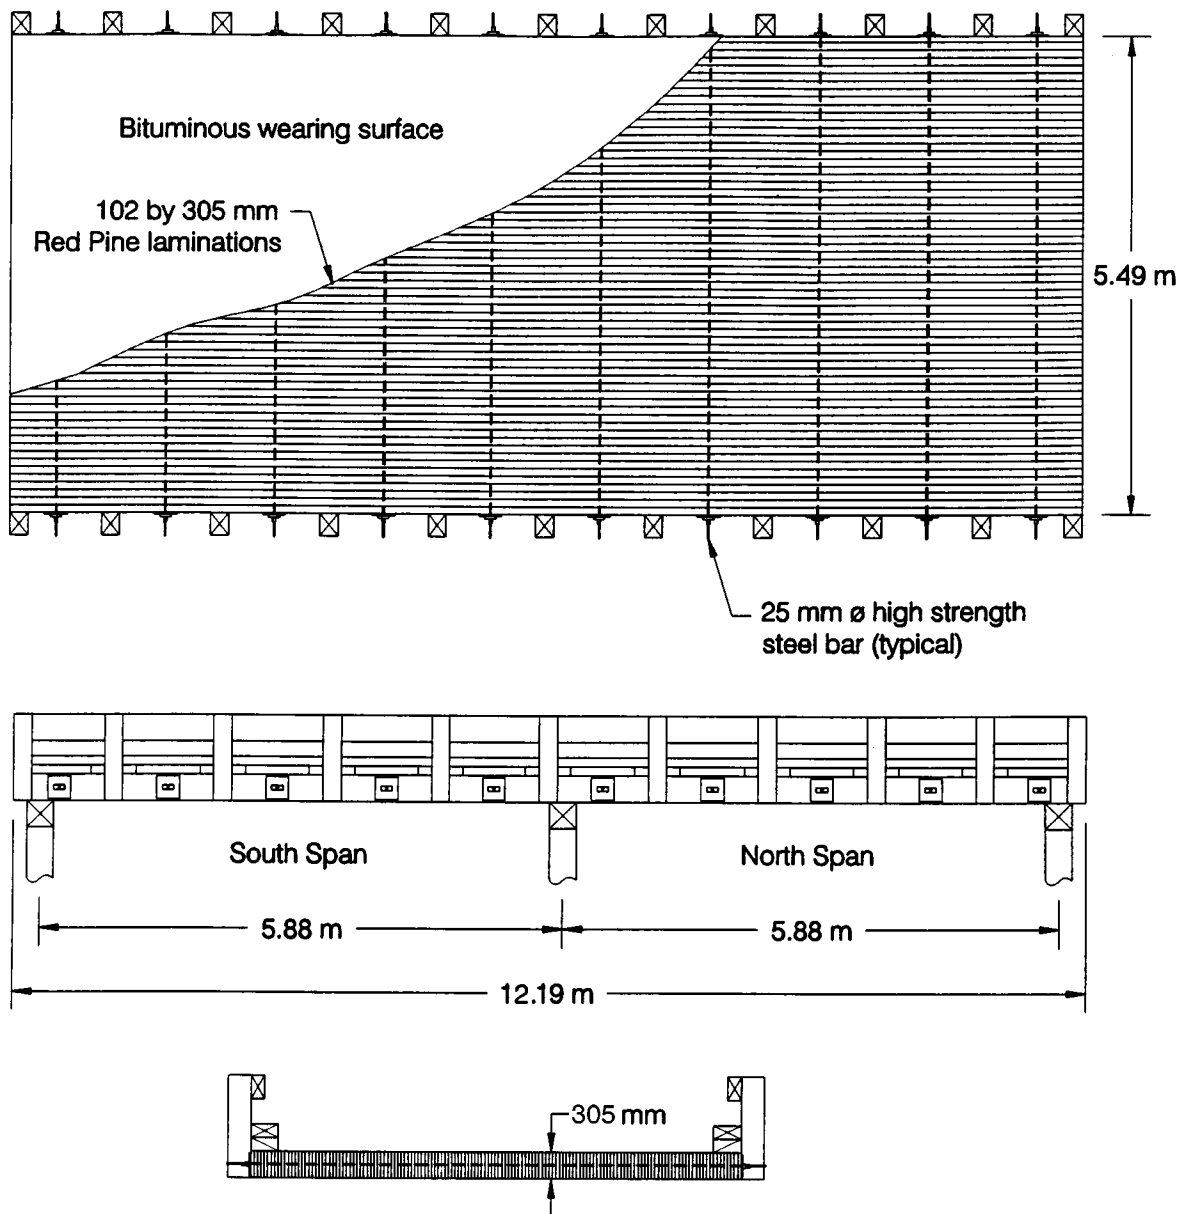
Figure 3—Design configuration of the Ciphers bridge.

Design of the Ciphers bridge was completed during 1989 by the MN-DNR in cooperation with the University of Minnesota-Department of Forest Products. The stress-laminated deck superstructure was designed according to USDA Forest Service standards (Ritter 1990) under development at the time and met American Association of State Highway and Transportation Officials (AASHTO) load requirements (AASHTO 1989). The design included procedures for prefabricating into two half-width panels that were interconnected during construction.

The design geometry provided for a stress-laminated deck superstructure 12.19 m long, 5.49 m wide, and 305 mm deep (40 ft long, 18 ft wide, and 12 in. deep) with a single support at mid-length (Fig. 3). Design calculations were based on a 11.76-m (38.6-ft) bridge length (center-center of end bearing) in a two-span continuous orientation. Each span was designed for 5.88 m (19.3 ft) (center-center of bearing) between supports. Deck laminations were specified as 102 by 305 mm, S1S to 98 mm (nominal 4 by 12 in., S1S to 3-7/8 in.), red pine, grade No. 2 and better, pressure treated with creosote. The deck lamination moisture content

was specified to be 19% maximum. Because the deck laminations were not available in lengths required to span the entire bridge, the deck design included lamination butt joints in a repetitive pattern. Transversely, butt joints were limited to no more than one in every fourth adjacent lamination. Longitudinally, rows of butt joints were spaced at 1.22-m (4-ft) intervals.

For stress laminating, the design specified the use of 25-mm- (nominal 1-in.-) diameter ASTM A722 high strength, threaded steel bars with an ultimate strength of 1.034 GPa (150×10^3 lb/in²) (ASTM 1988). The bars were spaced at 1.22-m (4-ft) intervals, beginning 610 mm (2 ft) from the ends of the bridge. The design tension bar force of 300 kN (67,500 lb) provided an interlaminar compressive stress of 807 kPa (117 lb/in²). Bars were anchored with a discrete-plate system consisting of 279- by 533- by 25-mm (11- by 21- by 1-in.) steel bearing plates, 152- by 305- by 38-mm (6- by 12- by 1-1/2-in.) steel anchor plates, and hexagonal nuts. All components of the stressing system and other steel hardware were galvanized for corrosion protection.

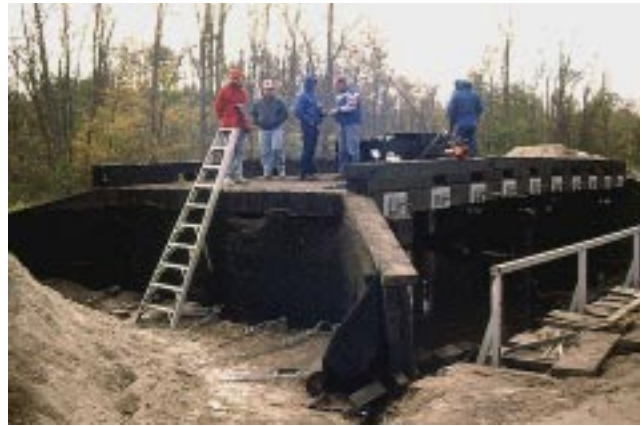
Figure 4—Ciphers bridge was prefabricated in two half-width panels that formed the deck after the initial bridge stressing.

The deck was preassembled into two half-width panels at the fabrication facility to simplify transportation to the site. At the bridge site, an overhead crane lifted and placed the preassembled deck panels next to each other on the abutments. The stressing bars extended only through the half-width panels and were interconnected with couplers along the deck interface. After removal of anchorage plates from every other bar on each panel at the interface, the coupled bars were tensioned to the required design force level to achieve a single deck unit from the two half-width panels (Fig. 4).

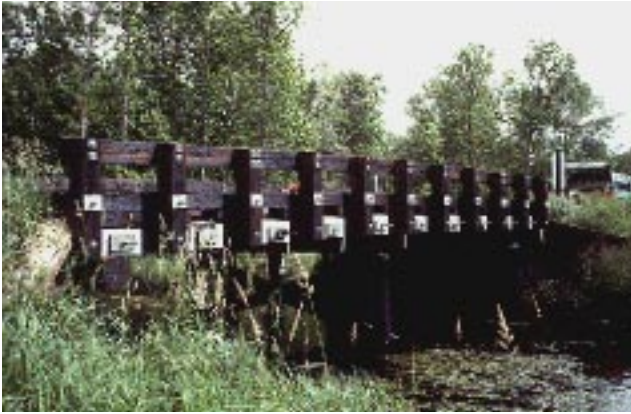
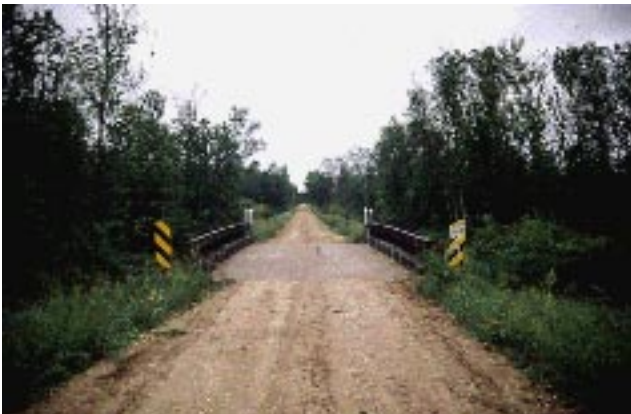
A view of the completed bridge, at the initiation of FPL monitoring, after approximately 46 months in service, is shown in Figure 5.

Figure 5—Ciphers bridge after 46 months in service: side view (top); end view (bottom).

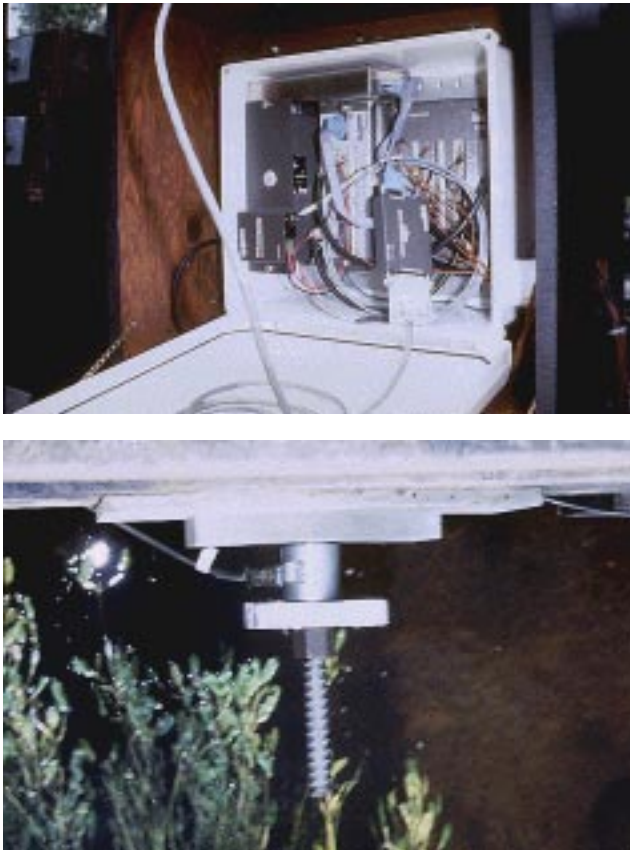
Figure 6—Remote data acquisition system used at the Ciphers bridge: datalogger attached to the bridge rail (top); load cell installed over stressing bar (bottom).

A remote data acquisition system was used to collect bar force and deck temperature data (Fig. 6). A battery-powered datalogger was preset to collect bar force and temperature readings each hour. Data were stored in solid-state memory modules that were interchanged by local MN–DNR personnel and sent to FPL on approximately a monthly basis throughout the monitoring period.

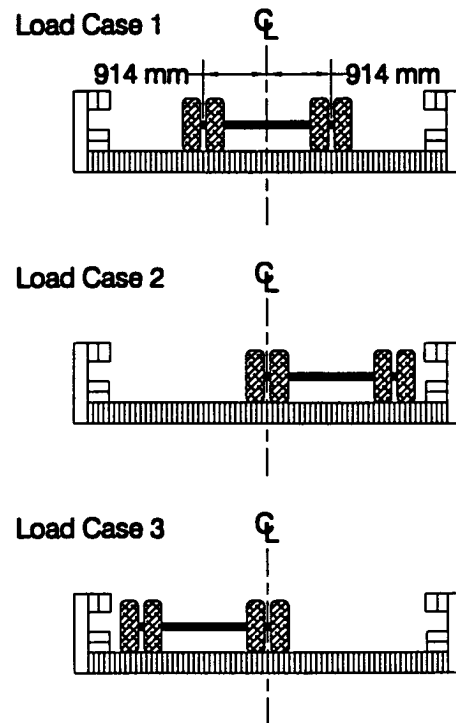
Figure 7—Transverse test truck positions used for both load tests, as viewed from the south end of the bridge (looking north). For all load cases, the test truck was placed longitudinally with the rear axles at the centerline and the front axle off the end of the bridge.

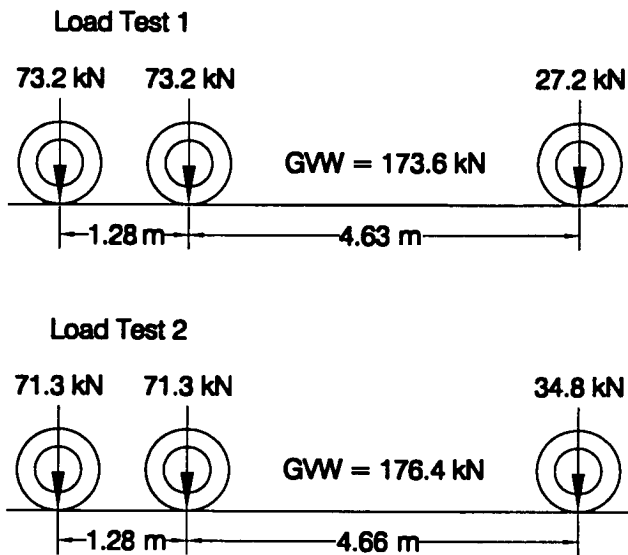
Figure 8—Test truck axle weights and spacings used for load testing.

Load test 1 was conducted July 12, 1993, with a gross vehicle weight of 174 kN (39,020 lb) for the test truck. Load test 2 was completed June 29, 1995 with a gross vehicle weight of 176 kN (39,660 lb) for the test truck (Fig. 8).

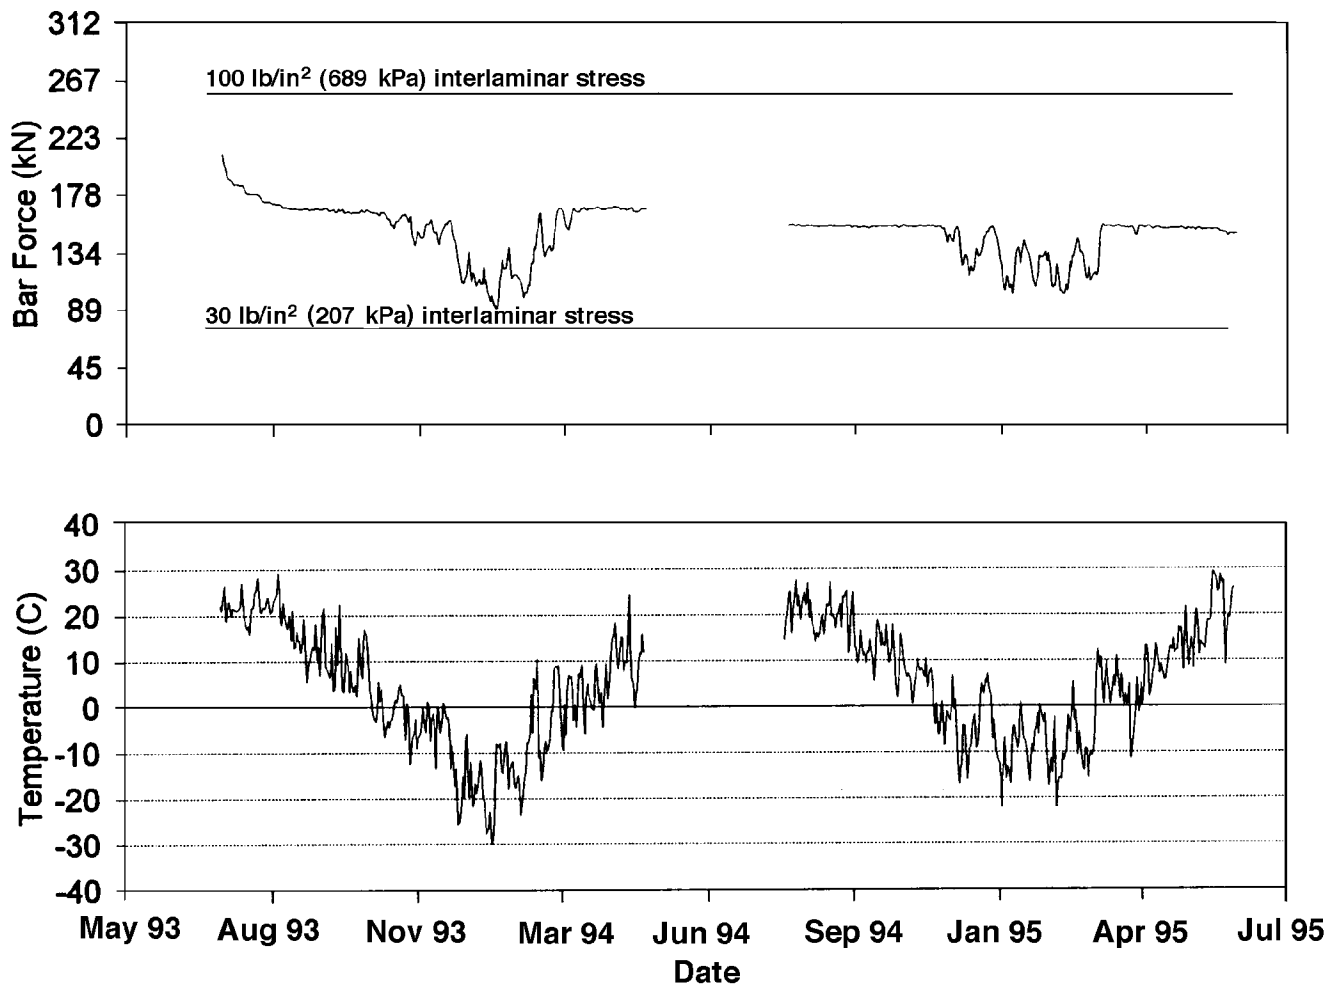
Figure 9—Bar force and deck temperature summary: Average daily load cell readings (top); interior deck temperatures (bottom). Note that the gap in the data was due to a computer hardware failure that occurred during summer when bar forces are not significantly affected by temperature.

Although the Ciphers bridge had been in service for nearly 4 years and the bars were re-tensioned to 258 kN (58×10^3 lb), or 690 kPa (100 lb/in^2) interlaminar deck compression, at the initiation of monitoring, substantial bar force loss was observed during the monitoring period and was attributed to stress relaxation in the deck laminations caused by high moisture content. Daily bar force and deck temperature data are presented in Figure 9. The bar forces decreased rapidly during the first few weeks but leveled off at approximately 156 kN (35×10^3 lb), or 414 kPa (60 lb/in^2)

interlaminar deck compression, for the remainder of the monitoring period. However, during both winter seasons, bar force temporarily decreased an additional 67 kN (15×10^3 lb). The bar force remained greater than 80 kN (18×10^3 lb), or 207 kPa (30 lb/in^2) interlaminar deck compression, for the duration of the monitoring period.

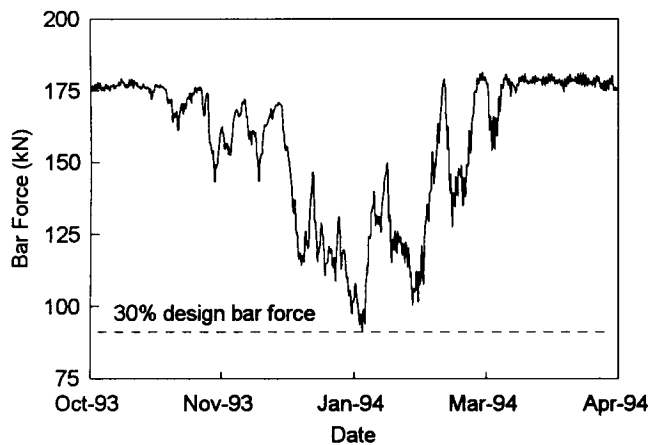
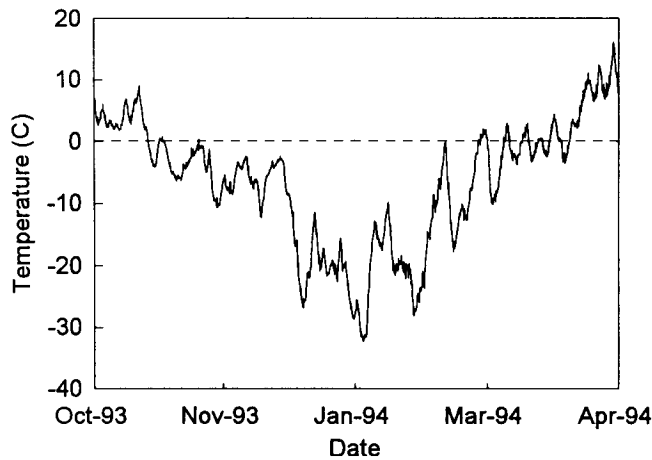
Figure 10—Bar force and deck temperature summary, Winter 1994.

Temporary bar force losses were observed during both winter seasons because the rate of thermal contraction for the deck laminations exceeded that of the steel stressing bars. In both winters, the correlation between the interior deck temperature and the bar force loss was most pronounced when the interior deck temperature remained less than 0°C (32°F) (freezing point of water). The bar force loss observed during the winter of 1994 is presented in Figure 10. During the first winter, temperatures at the deck interior remained below -18°C (0°F) for several weeks and reached as low as -32°C (-25°F) during January. The bar force loss observed during the winter of 1995 is presented in Figure 11. During the second winter, temperatures at the interior of the deck remained at approximately -18°C (0°F) for several weeks and reached as low as -22°C (-8°F) during February. As temperatures began to increase during the spring, bar forces recovered to levels observed the previous fall.

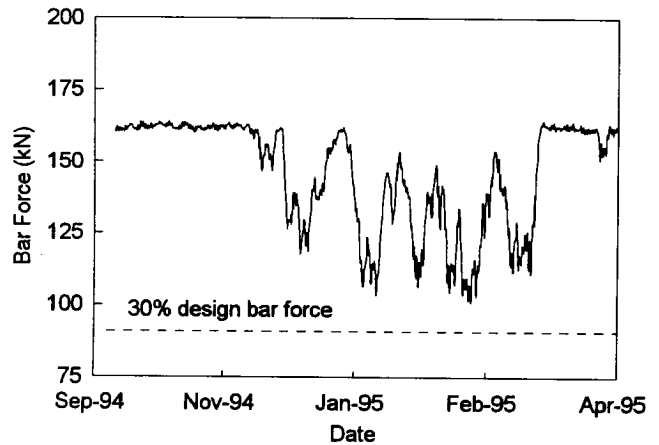
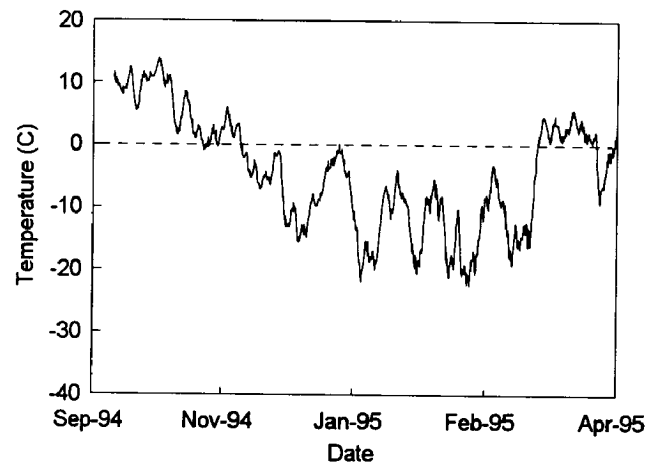
Figure 11—Bar force and deck temperature summary, Winter 1995.

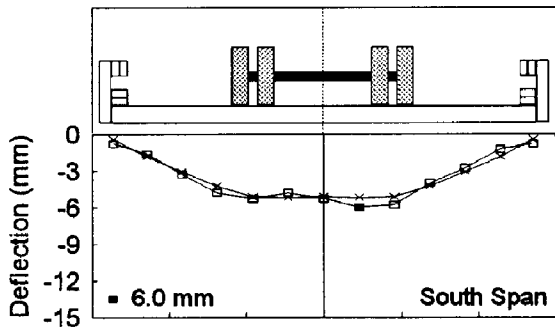
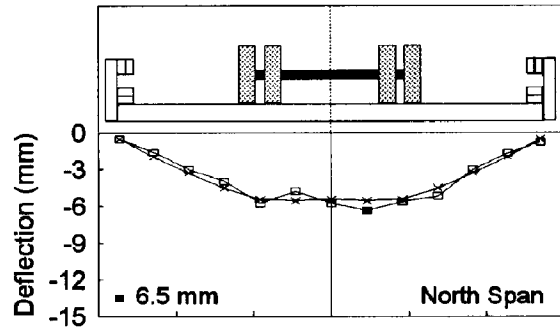
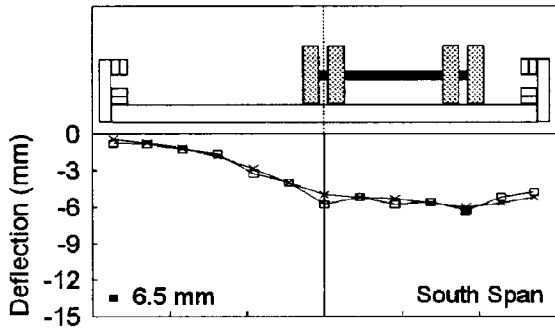
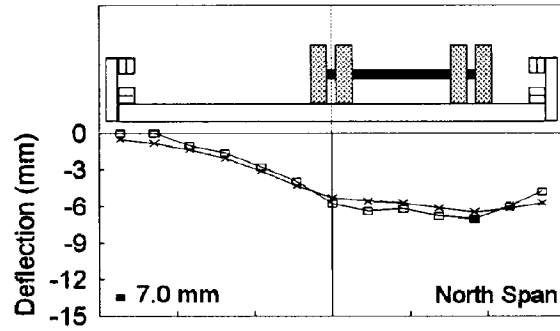
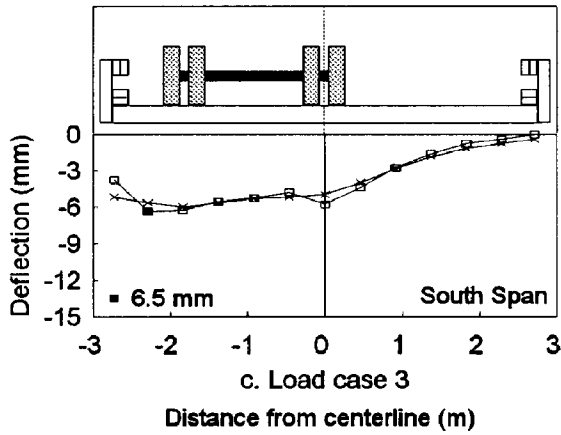
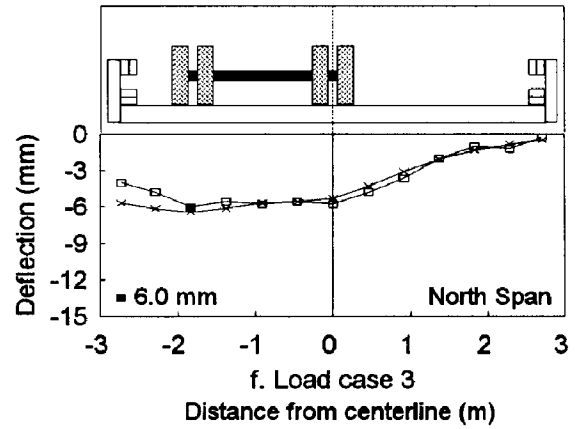
Figure 12—Load test 1 comparing measured and predicted centerspan deflection (looking north). Bridge cross-sections and vehicle positions are presented to aid interpretation only and are not to scale.

Measured and predicted transverse deflections for load test 1 are shown in Figure 12. For load case 1 on the south span, the maximum measured deflection near the centerline of the bridge was 6 mm (0.23 in.) (Fig. 12a). For load cases 2 and 3 on the south span, the maximum measured deflections occurred near the outside truck wheel line and were both 6 mm (0.25 in.) (Fig. 12b,c). For load case 1 on the north span, the maximum measured deflection near the centerline of the bridge was 6 mm (0.25 in.) (Fig. 12d). For load cases 2 and 3 on the north span, the maximum measured deflections occurred near the outside truck wheel line and were 7 and 6 mm (0.28 and 0.24 in.), respectively (Fig 12e,f).

Predicted deflections given in Figures 12 and 13 provide a good approximation of the measured deflection for each load case. Minor differences between measured and predicted deflection are noticeable at the edges of the bridge and are caused, in part, by the edge-stiffening effect of the sawn lumber curb assemblies.

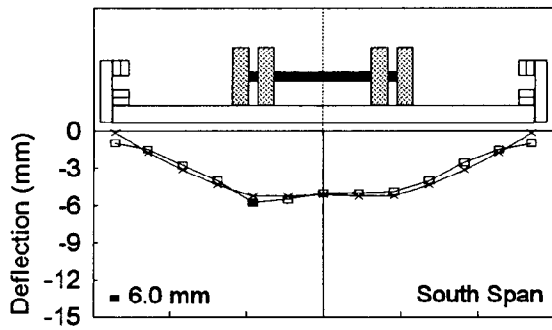
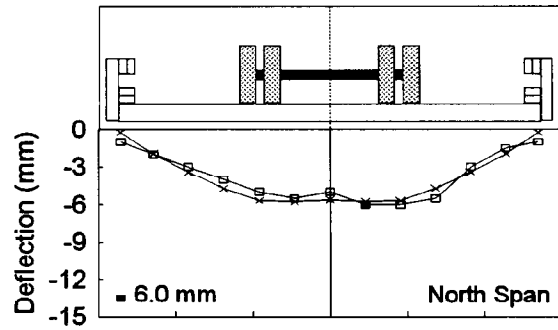
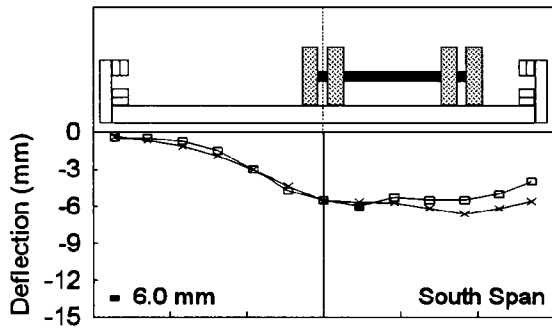
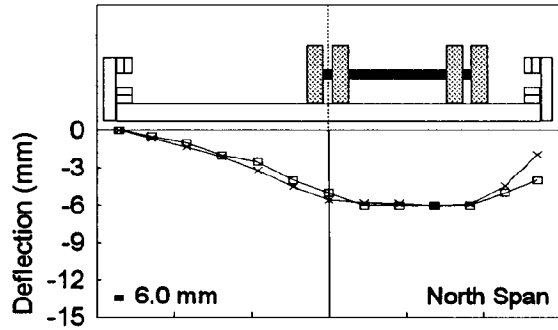
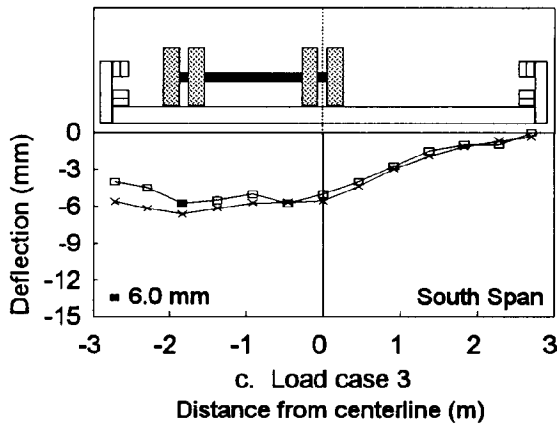
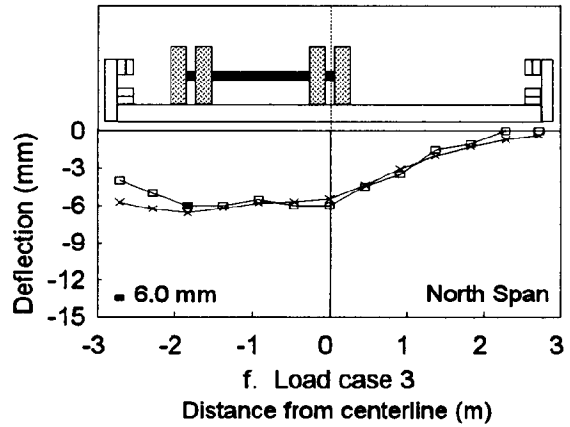
Figure 13—Load test 2 comparing measured and predicted centerspan deflection (looking north). Bridge cross-sections and vehicle positions are presented to aid interpretation only and are not to scale.

Measured and predicted transverse deflections for load test 2 are shown in Figure 13. For load case 1 on the south span, the maximum measured deflection near the bridge centerline was 6 mm (0.23 in.) (Fig. 13a). For load cases 2 and 3 on the south span, the maximum measured deflections occurred near the outside truck wheel line and were 6 mm (0.24 and 0.23 in., respectively) (Fig. 13b,c). For load case 1 on the North span, the maximum measured deflection near the centerline of the bridge was 6 mm (0.24 in.) (Fig. 13d). For load cases 2 and 3 on the north span, the maximum measured deflections occurred near the outside truck wheel line and both were 6 mm (0.24 in.) (Fig 13e,f). Additional load test figures that further present load test data are given in Appendix B.

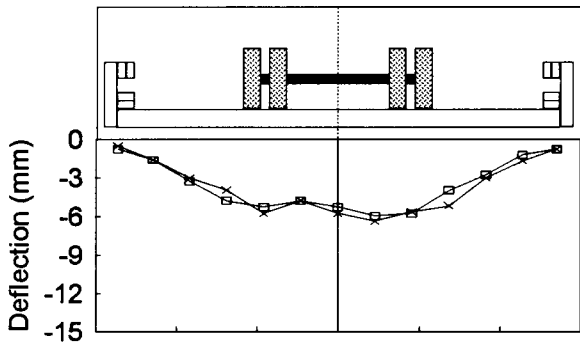
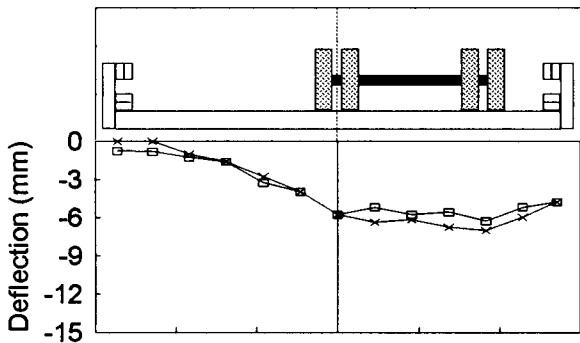
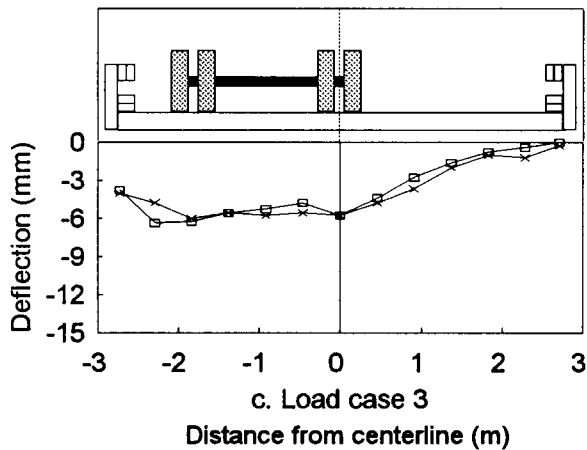
Figure B1—Load test 1 comparing measured center-span deflection of the north and south span from load cases 1, 2, and 3 (looking north). Bridge cross-sections and vehicle positions are presented to aid interpretation only and are not to scale.

The following transverse deflection figures present additional data comparisons from both load tests. Figures B1 and B2 compare the deflection measured at each span for Load Test 1. Figures B3 and B4 compare the deflection measured at each span for Load Test 2. Both sets of figures serve to validate the deflection data collected during load tests.

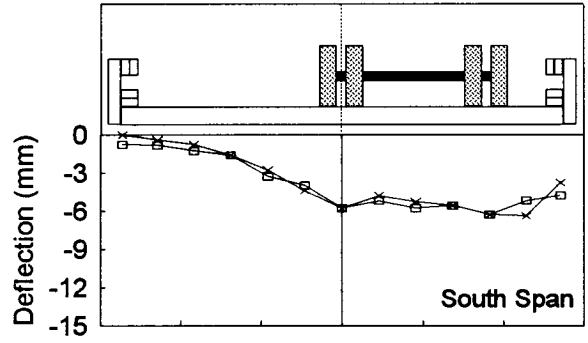
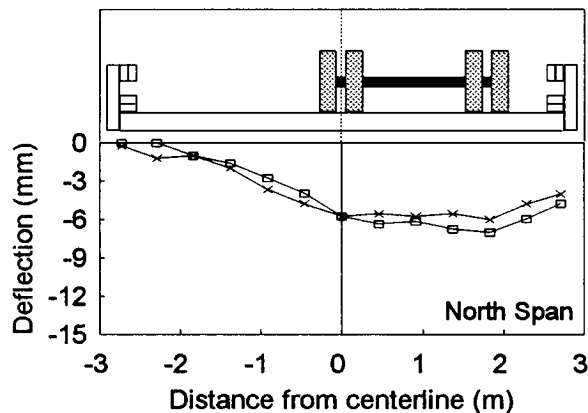
Figure B2—Load test 1 comparing measured center-span deflection from load cases 2 and 3 (looking north). Bridge cross-sections and vehicle positions are presented to aid interpretation only and are not to scale.

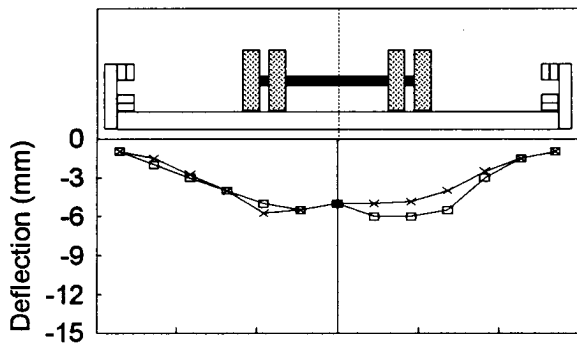
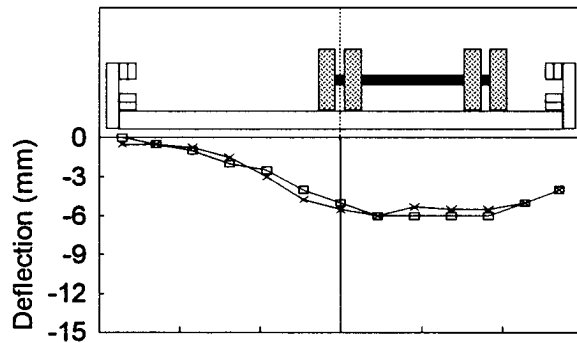
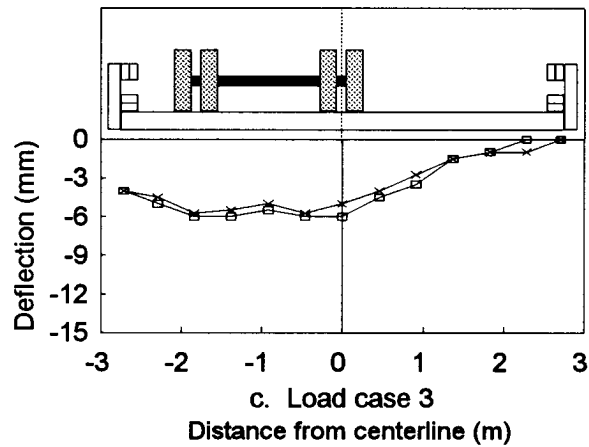
Figure B3—Load test 2 comparing measured center-span deflection of the north and south span from load cases 1, 2, and 3 (looking north). Bridge cross-sections and vehicle positions are presented to aid interpretation only and are not to scale.
