**Shawnee National Forest  
Hidden Springs Ranger District  
Trails Designation Project Accomplishments  
September 2008**

The following are highlights of trail work in September 2008:

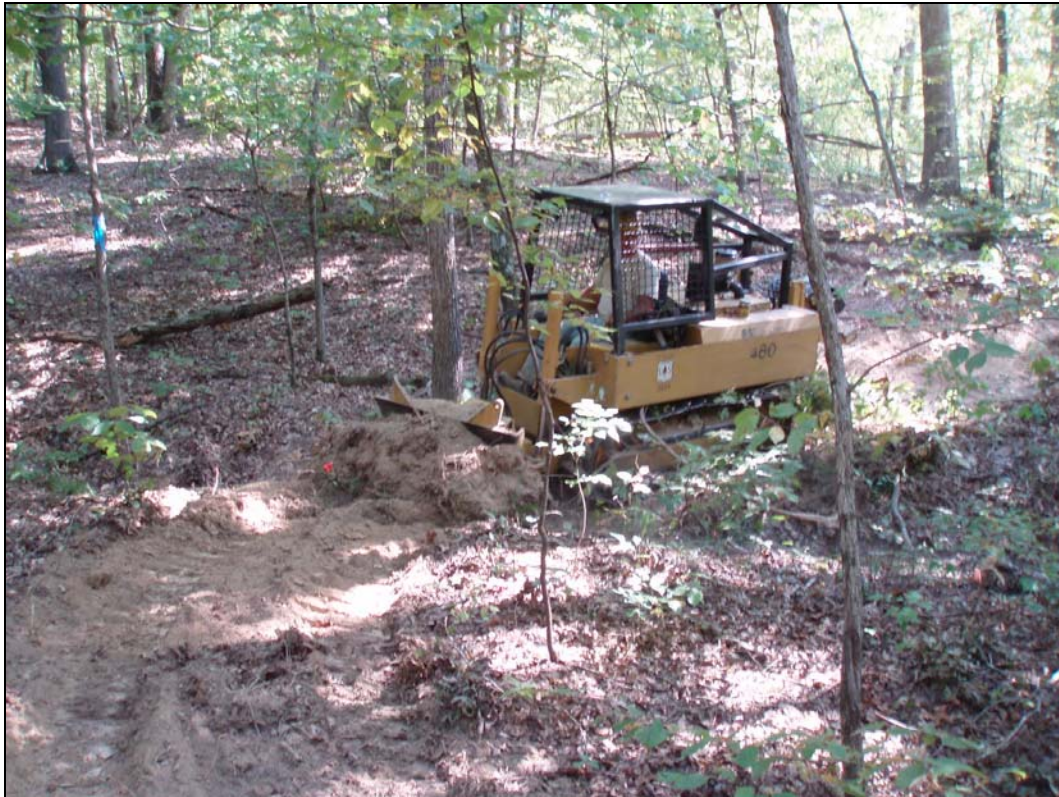
**Figure 1. Sweco trail dozer being used to cut new trail tread on FS Trail 487**

*Non-designated Wilderness* - Mechanized work was conducted outside of non-designated wilderness areas. Sections of Forest Service (FS) Trail 487, 487H, and 487K, located north of Frank's Track continue to be re-routed along the natural contour of the terrain. The Sweco trail dozer and mini-excavator were used to create the new trail tread, back slope, and drainage drips of the re-routes (Figures 1 - 3).

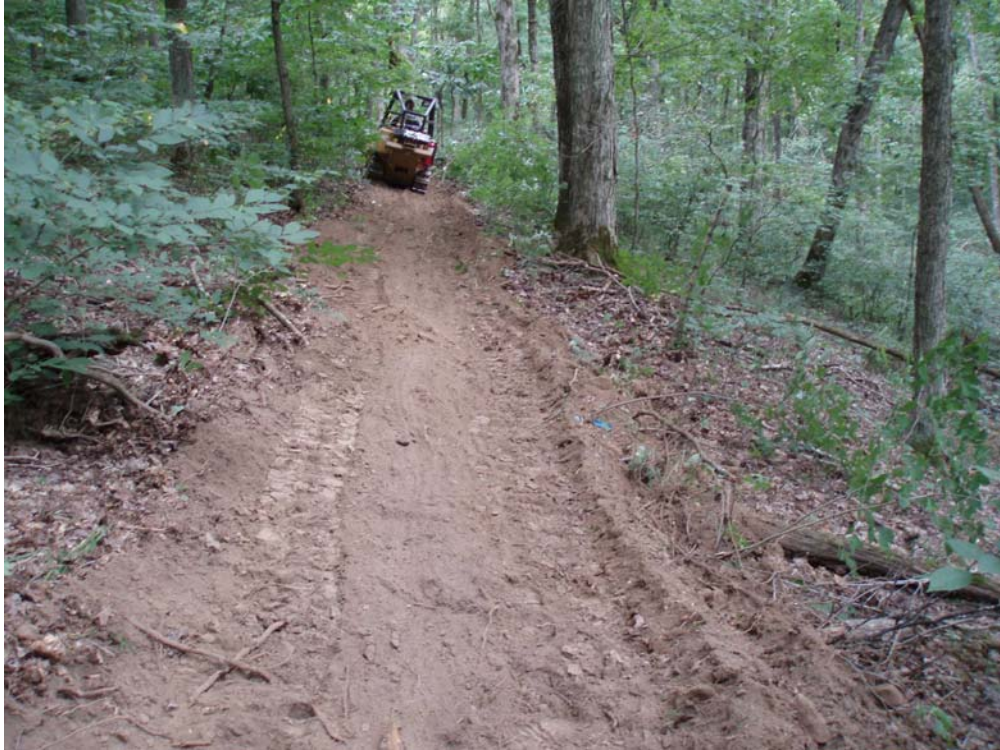
**Figure 2. New trail tread on re-routed trail.**

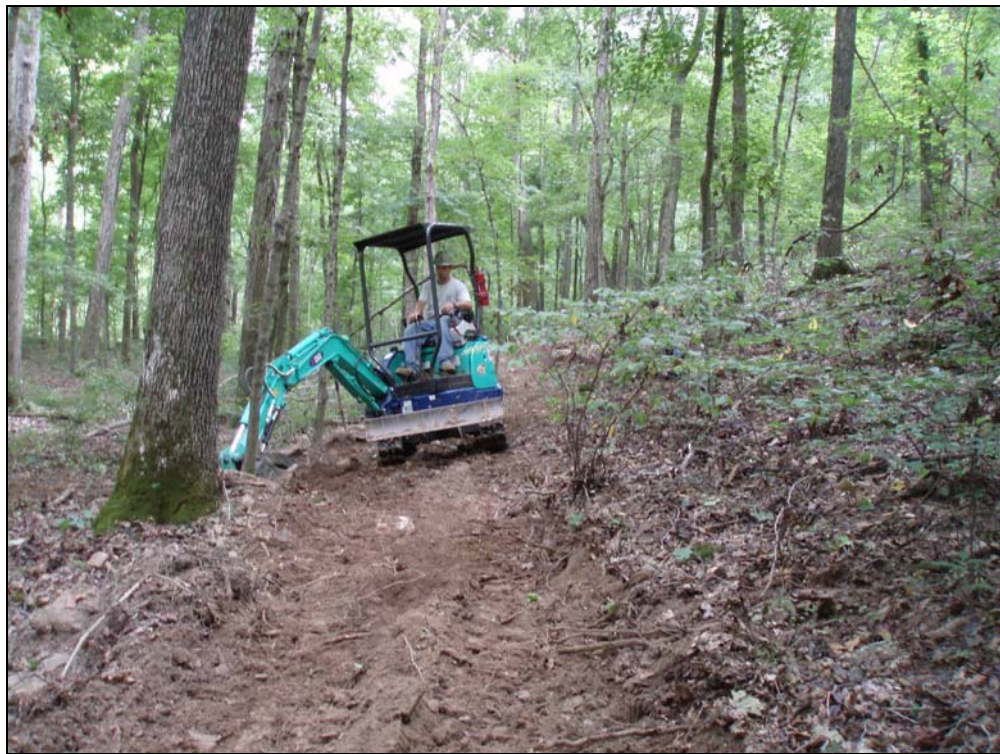
**Figure 3. Mini-excavator being used to install drainage dips on re-route.**

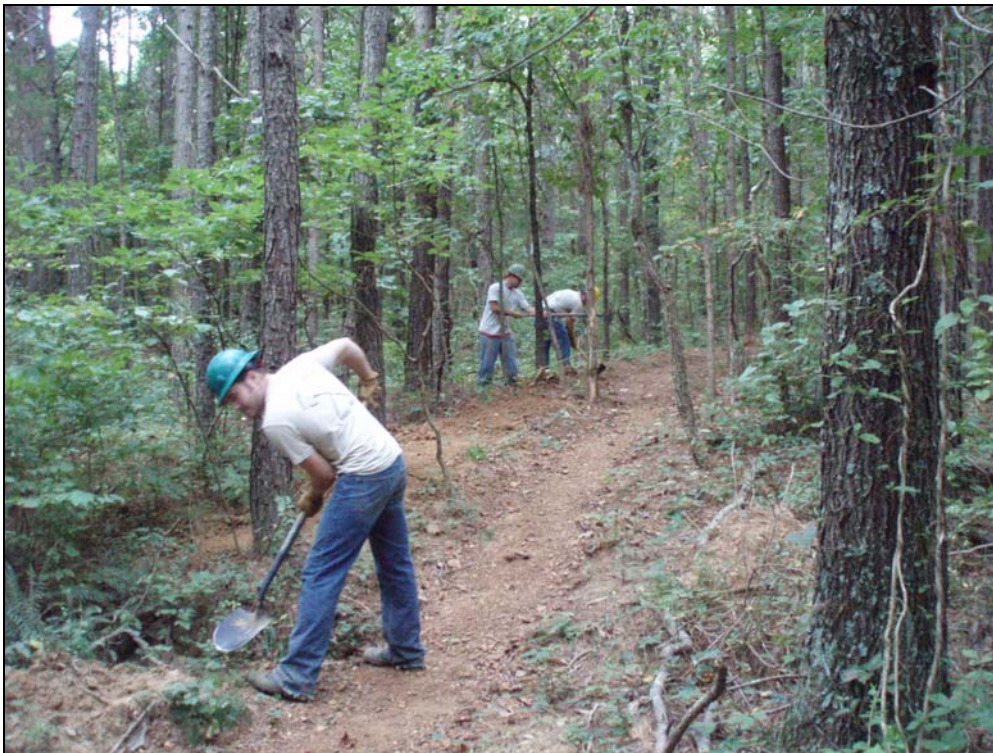
**Figure 4. Trail crew member clearing an outflow ditch along the trail.**

Light maintenance was also performed on FS Trail 481B. Drainages along the trail were cleared of leaf litter that had the potential to plug the outflow ditches (Figure 4).

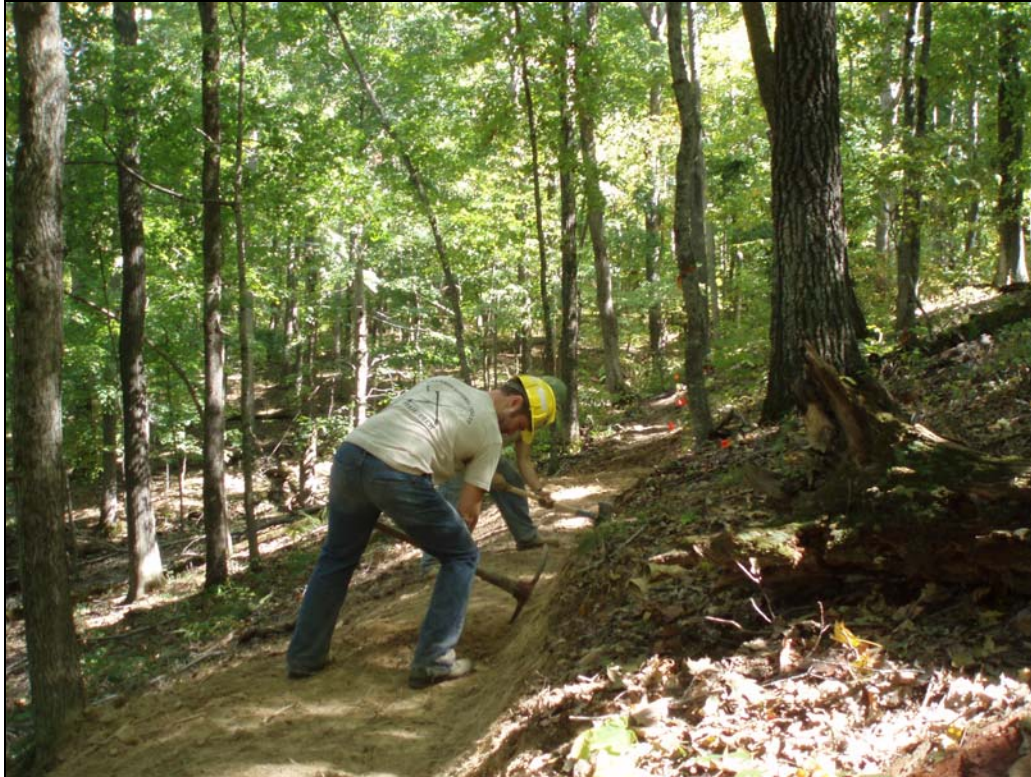
**Figure 5. Trail crew digging the new trail tread for the Owl Bluff re-route.**

In addition, the trail crew began construction of the new re-route for the River-To-River (R-T-R) Trail section between the Bowed Tree Creek Crossing and Owl Bluff (Figures 5 and 6). The re-route will begin at the creek crossing along the east bank of Lusk Creek and continue upslope towards the existing R-T-R Trail section that leads to Owl Bluff. The existing user-created trail upslope is eroded down to the sandstone, difficult to ascend to the bluff, and has the potential to add sedimentation to the creek. Once the new re-route is complete, the old, user-created trail segment will have gully plugs installed and brushed in with natural material (fallen tree branches and sandstone rock).

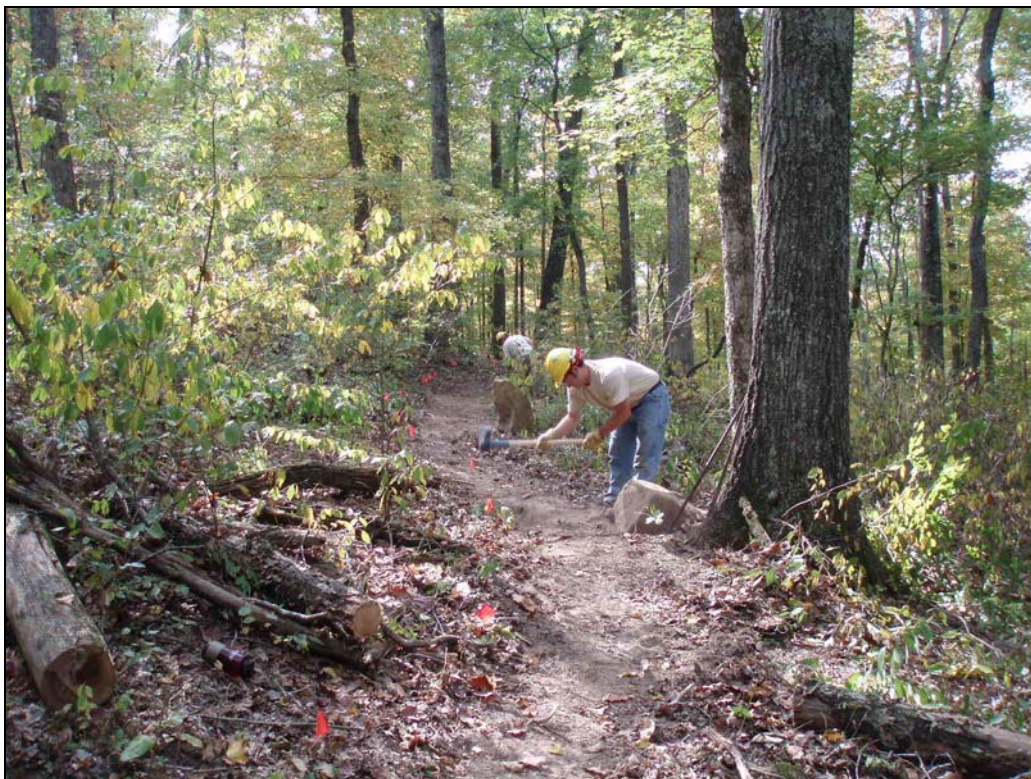
**Figure 6. Owl Bluff re-route located above the Bowed Tree Creek Crossing.**

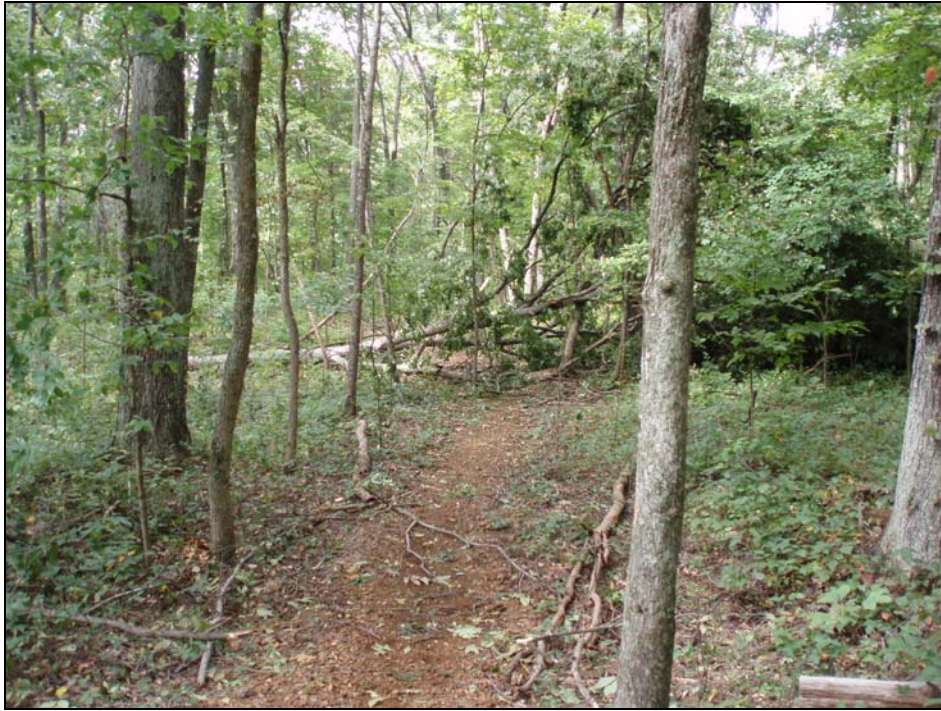
**Figure 7. Before. Tree blown down across the Barger Branch Trail.**

In addition, heavy maintenance was conducted on the Barger Branch, River-To-River, Coyote Club, and Wishing Well Trails. Approximately 20 mature trees fell across these trail sections as a result of the strong winds from the remnants of Hurricane Ike. The trail crew used crosscut saws and hand axes to clear away the obstacles (Figures 7 – 10).

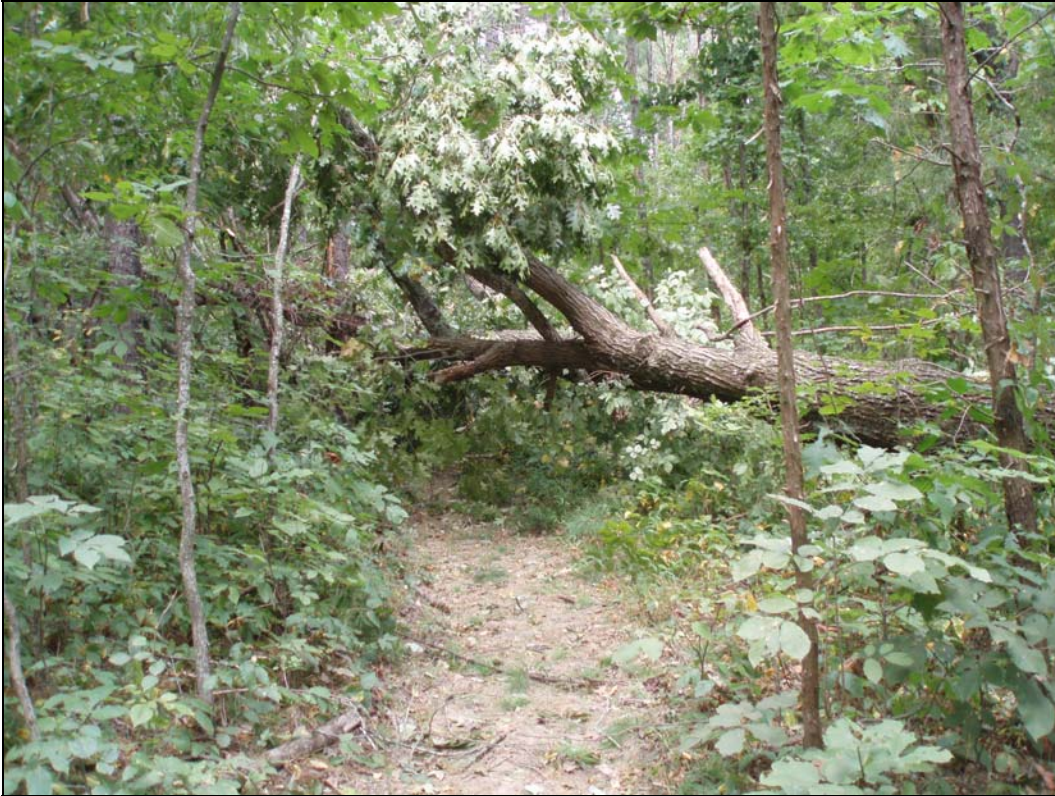
**Figure 9. Before. Tree blown down across the Cactus Trail.**
