# Post Storm Data Acquisition Aerial Wind Mapping Mission Hurricane Ivan - 2004

#### Overview

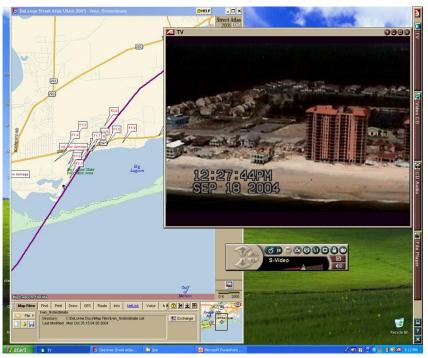
Figure 1: Display showing example analysis procedure of using time-stamped digital imagery to map F-scale damage.

Digital imagery recorded during the PSDA missions was combined with the recorded GPS position and time data to perform a more detailed estimate of the winds associated with Ivan's landfall. Wind estimates were assigned using subjective estimation techniques associated with determining Fujita Scale damage ratings. Such techniques can be used to estimate peak wind values that are considered to be 3 to 5 second gusts. Wind estimates were calibrated from available surface observations where possible. However, observation density and instrument failure limited the degree of calibration within the region of strongest estimated winds.

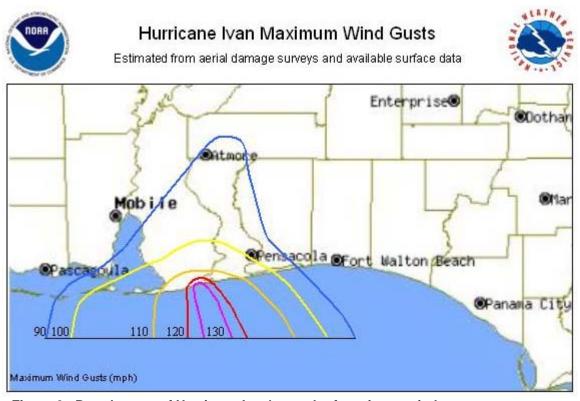
The wind analysis from the two Hurricane Ivan PSDA aerial wind mapping missions suggests maximum wind gusts of 130 mph were present during Ivan's landfall (see Fig. 2). These winds were estimated to be located near the Big Lagoon State Recreation Area located in the extreme western Florida peninsula. Wind speeds in excess of 110 mph were estimated to extend from near Gulf Shores, Alabama to near Gulf Breeze, Florida. Appendix A provides a detailed mapped peak wind wind analysis. Noteworthy are the inherent uncertainties mentioned earlier which could yield wind estimates +/- 20 mph within each contoured value.

Figure 2: Broad scope of Hurricane Ivan's swath of maximum winds.

The location of strongest estimated winds was characterized by damage clearly related to winds, with portions of roofs well removed from the parent structure. The damage pattern as it related to the parent structure was used as the primary mode for determining between storm surge and wind related damage. The majority of damage noted along the immediate coastline outside the axis of strongest winds was deemed to be predominately surge related with imbedded wind damage signals.
