3 General Assessment/Characterization of Damages

3.1 Flood Damage Observations

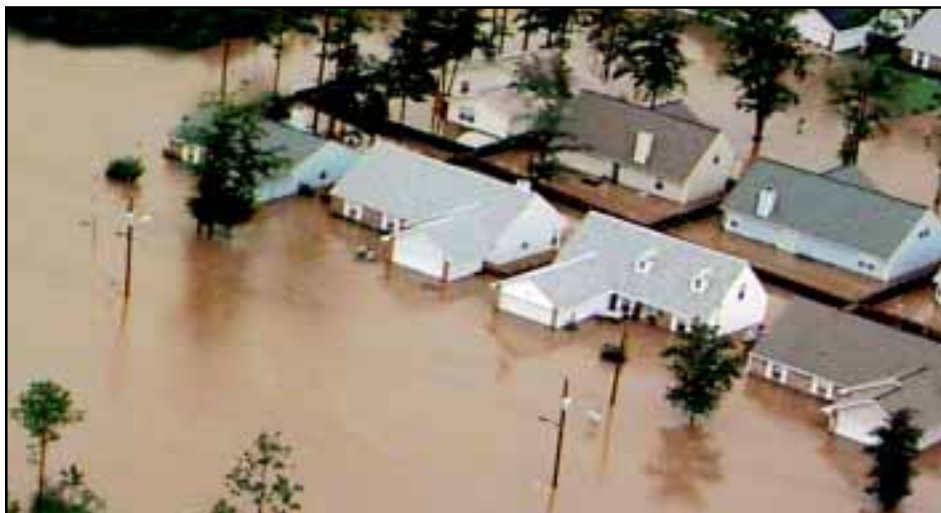
FIGURE 3-1 Houses inundated by 2 to 3 feet of floodwaters in the Florida Panhandle.

Hundreds of inland residential structures in Alabama, Florida, and Mississippi were inundated with water by riverine flooding. Structural damage, however, was limited; most damages were caused by water inundation (Figures 3-1 and 3-2). Damages observed included loss of contents, flooring, interior finishes, and portions of wallboard and insulation. Elevated homes generally performed well and required only minor cleanup (Figure 3-3).

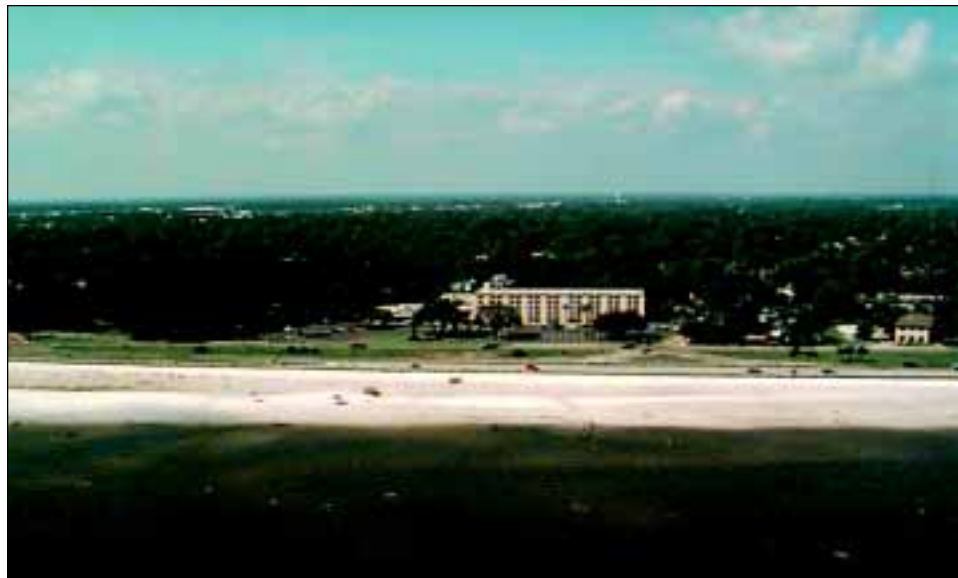
FIGURE 3-5 Mississippi Gulf Coast near Biloxi. Minimal coastal surge damage or overwash was observed.
