Reshaping the Course of a River's History

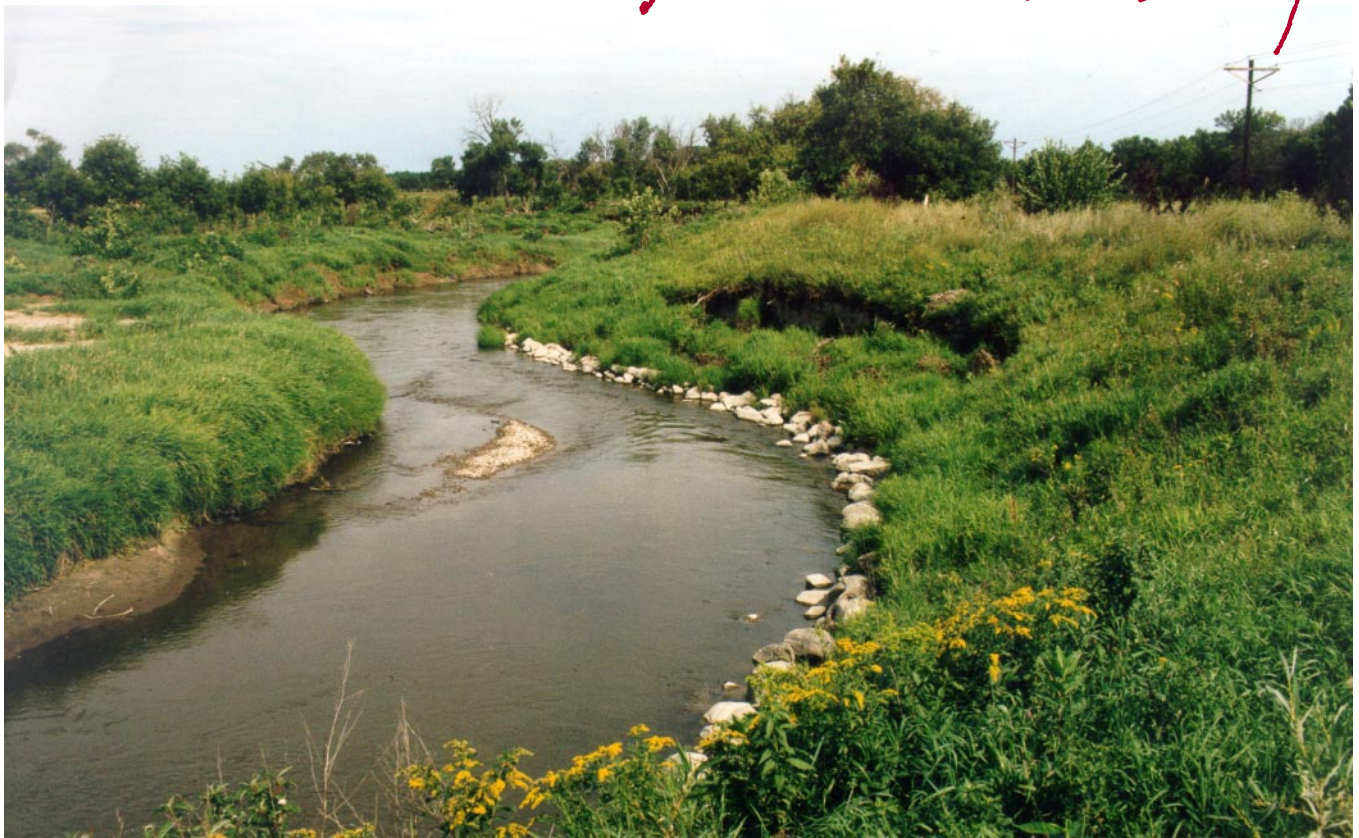
August 2000: After five years and countless floods, this riverbank (right side of photo) still holds the line against major erosion that was threatening a nearby county road. Photo courtesy of Rich Axvig, NRCS.

Kingery said she, too, is pleased with how well the riverbank fared in the June flood which she termed as “way off the charts” in magnitude.

“When we addressed that site, what we really wanted to do was stop the erosion,” Kingery said. “This performed marvelously under a big test. We didn’t see any new erosion. There were quite a few people who were involved in building that thing who were really amazed that it didn’t really show any negative effects.”

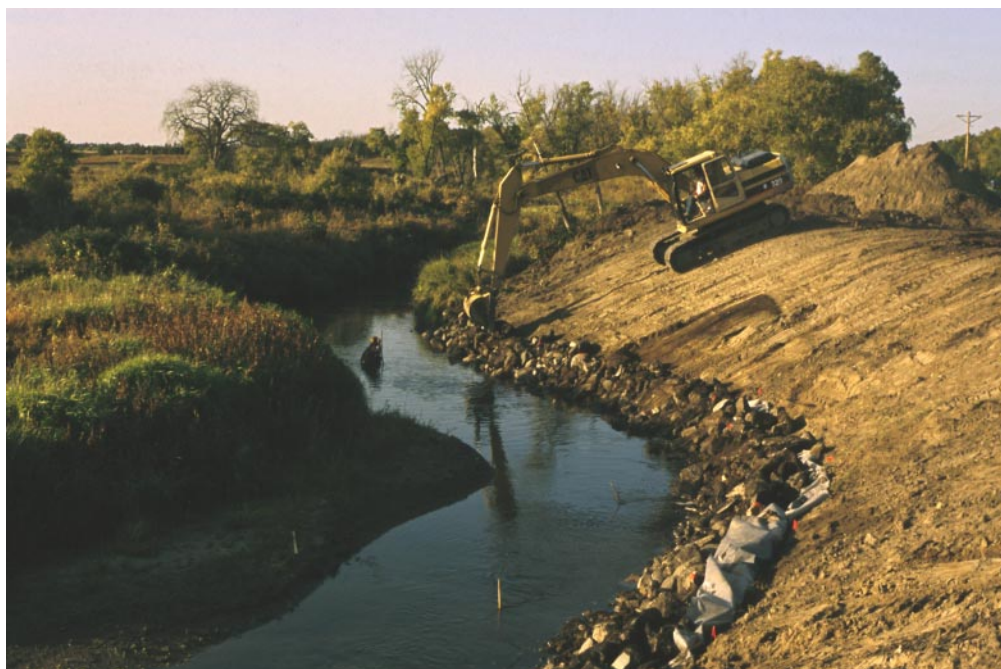
September 1995: A backhoe, sitting on the newly reshaped riverbank, places large rock along the toe of the Turtle River to provide some protection from the river's ebb and flow. Afterwards, the bank was planted with willows and straw grass to begin restoring natural vegetation. Photo courtesy of Rich Axvig, NRCS.

Next, rock was laid along the bank both 2 feet above and below the water level to protect the soil from the river's constant wave action.

Workshop participants dug a trench behind the rock above the water level. They made bundles of willows and laid them into the trench to begin rooting. A second trench was dug farther up the bank where additional bundles were placed.

Brush mattresses, fashioned from more willows, were laid on the riverbank and switch grass was planted—both to help form a natural cover that would protect the soil. Willows and switch grass, indigenous to the area, were used because they are hardy, especially around water, and have good, fast-growing root systems.

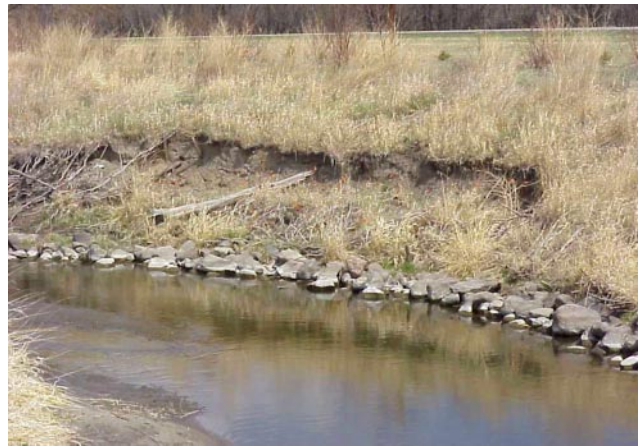
“One of the lessons we learned there was that we had squeezed the radius too tight for that river,” Kingery said, when the riverbank was brought back away from the road. When high-flow events occur, the river cuts into the bank because it can’t navigate the shortened bend.

May 2000: High-water events beginning in 1996 scoured out a curve on the riverbank because the radius curvature was too tight for the river to easily navigate.

About 100 willows tied to small wooden stakes were planted within the erosion area to spur new growth, Kingery said. Wire cages were placed over stakes in six sections of the area to protect the young plants from resident beavers—long suspected of stunting the growth of the willows closest to the water.

When floodwaters hit the riverbank, the cages were crushed. The willows, on the other hand, survived.

“By August of 2000, there were only three stakes that hadn’t grown,” Kingery said. “Virtually all of them had new growth. They’ll continue to branch out and probably hide that erosion in a year or so. In time, it will fill in by itself.”

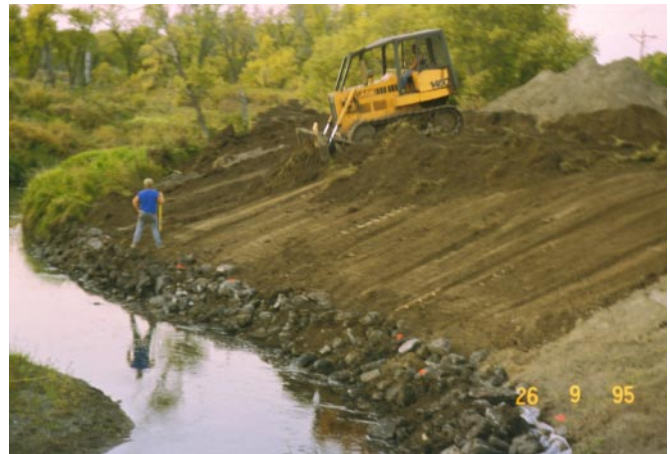
September 1995: A dozer moves dirt to begin reshaping the riverbank that had been eroded into a sheer cliff about 12 feet high. In 10 years, the riverbank had eroded 40 feet. Photo courtesy of Rich Axvig, NRCS.

Prior to the hands-on phase, the riverbank first had to be moved back from the road and reshaped because erosion had carved out a sheer, 12-foot-high cliff. So heavy machinery was brought in to cut down the cliff and re-create a sloping bank that would increase the distance between the river and the road.
