FINAL REPORT

**DISPERSANT EFFECTIVENESS TESTING
IN COLD WATER**

**U.S. Department of the Interior
Minerals Management Service
Herndon, VA**

**SL Ross Environmental Research
Ottawa, ON**

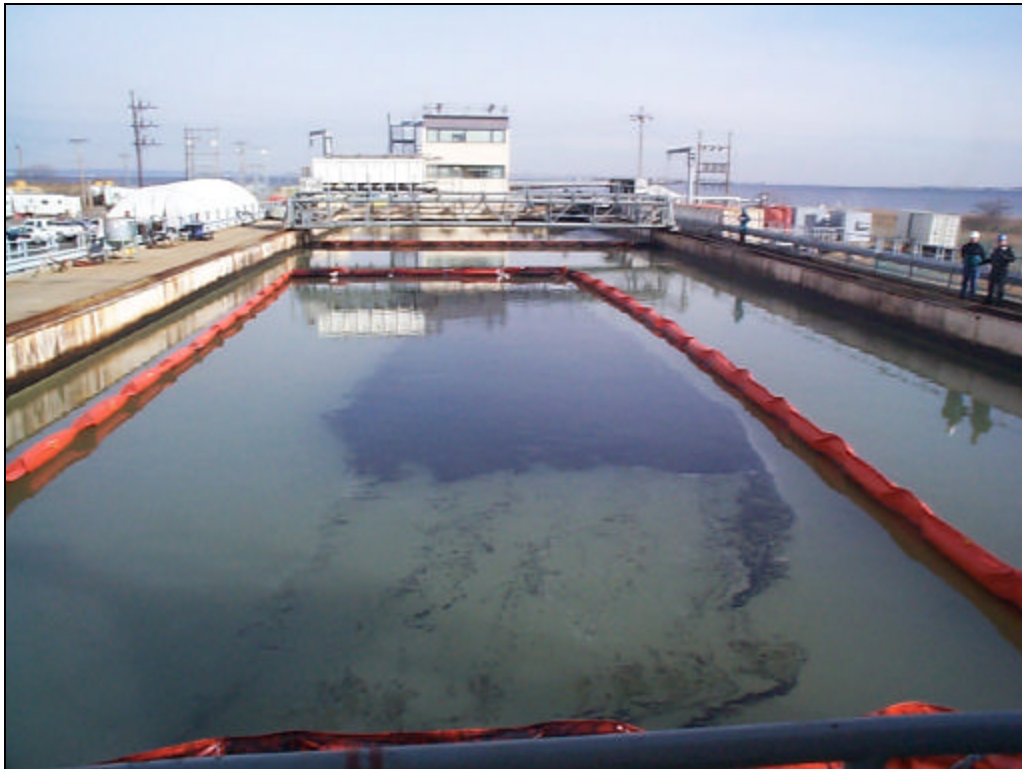
Figure 1. Ohmsett Test Tank with Oil Containment Boom

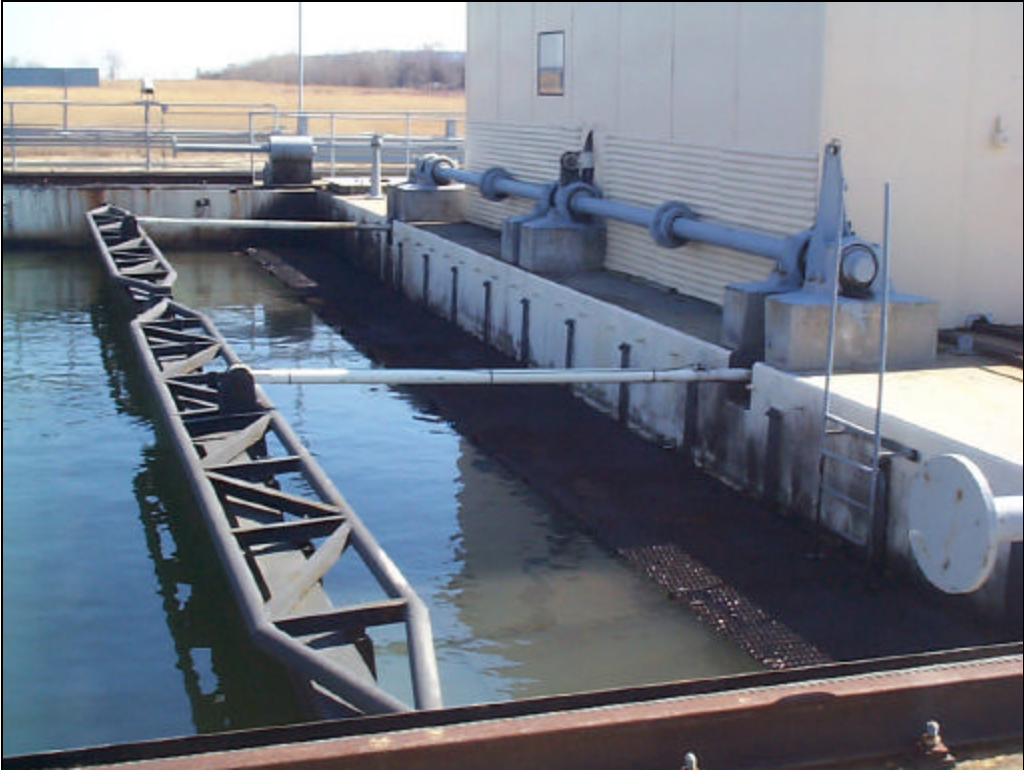
Figure 2. Ohmsett Tank Wave Paddle System

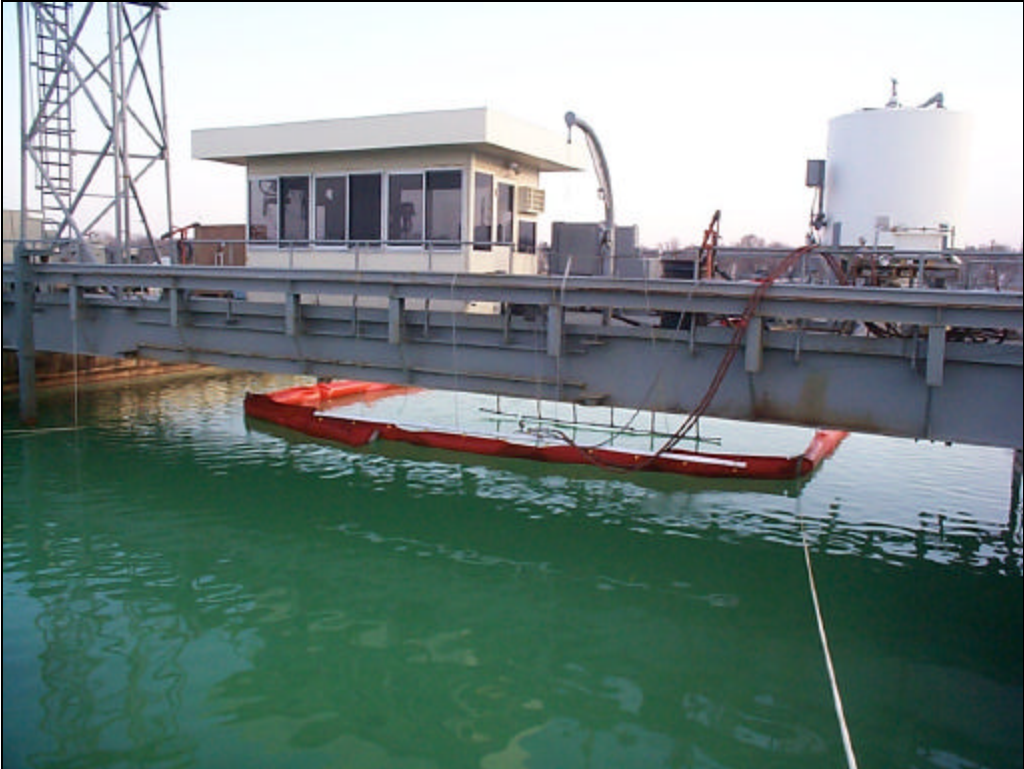
Figure 3. Main Bridge with Dispersant Spray Bar in Foreground, Oil Distribution Behind

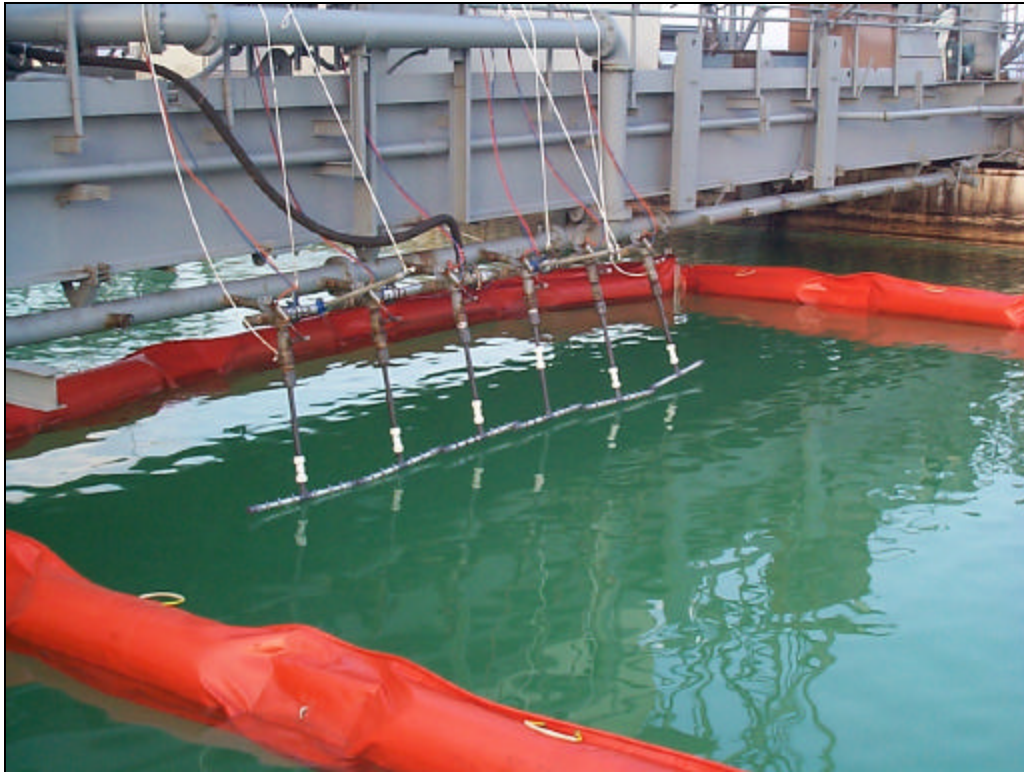
Figure 4. Oil Distribution System

- The oil distribution manifold was modified so it could be pulled up out of the way after the test slick is laid down.

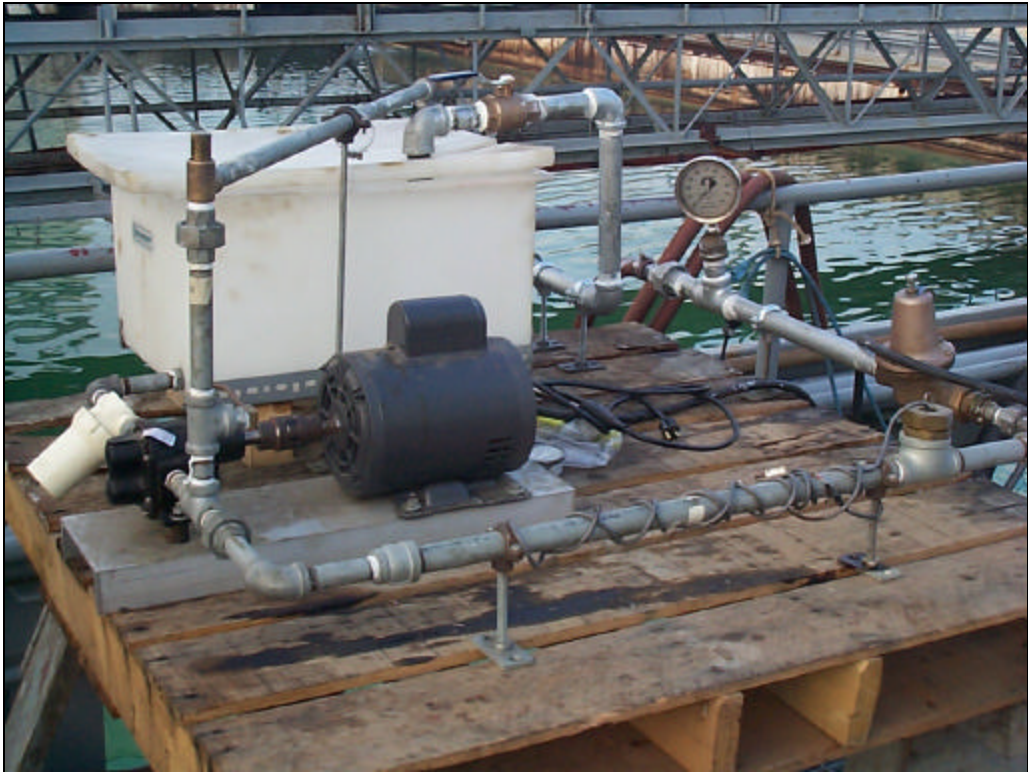
Figure 6. Dispersant Supply Tank and Pump

- The dispersant spray system was plumbed to allow re-circulation of the dispersant from the spray bar back to the pump module. This eliminates poor spraying due to viscous dispersant in the supply lines.
- A larger, 24 inch, protected-water boom was used to form the containment rectangle in hopes of reducing oil loss.
- The wave generator was turned on at the start of the oil distribution so the first wave reached the slick shortly after the end of the dispersant spraying. This was implemented only in some of the later cold-water tests.

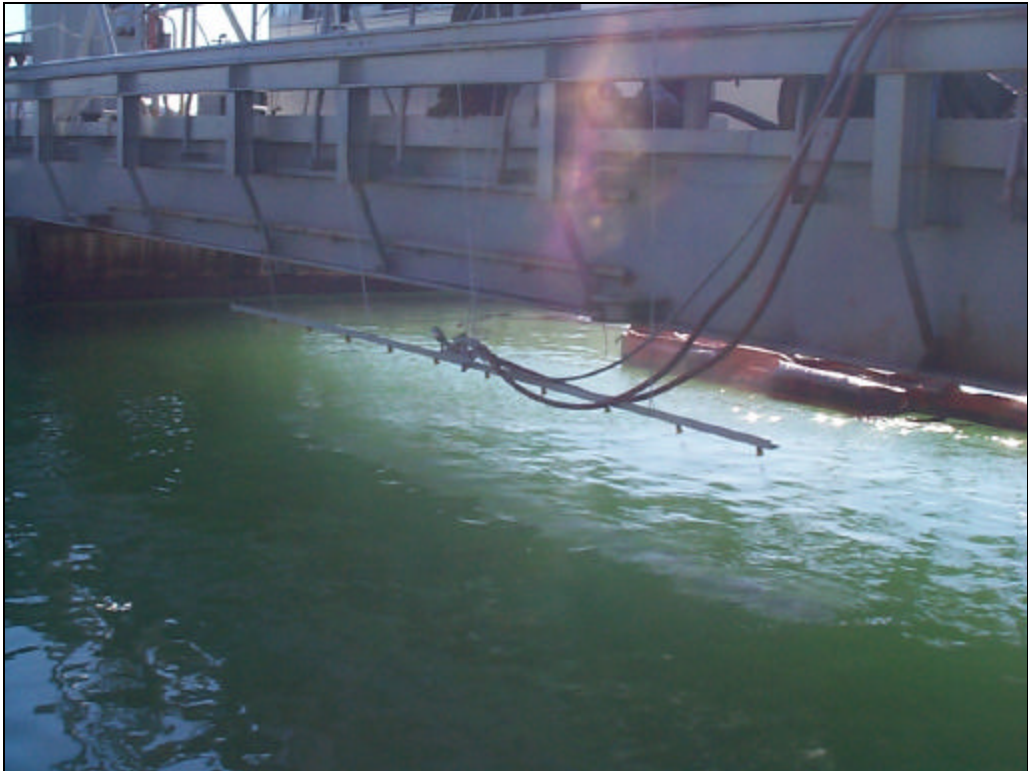
Figure 7. Dispersant Spray Bar in Operation

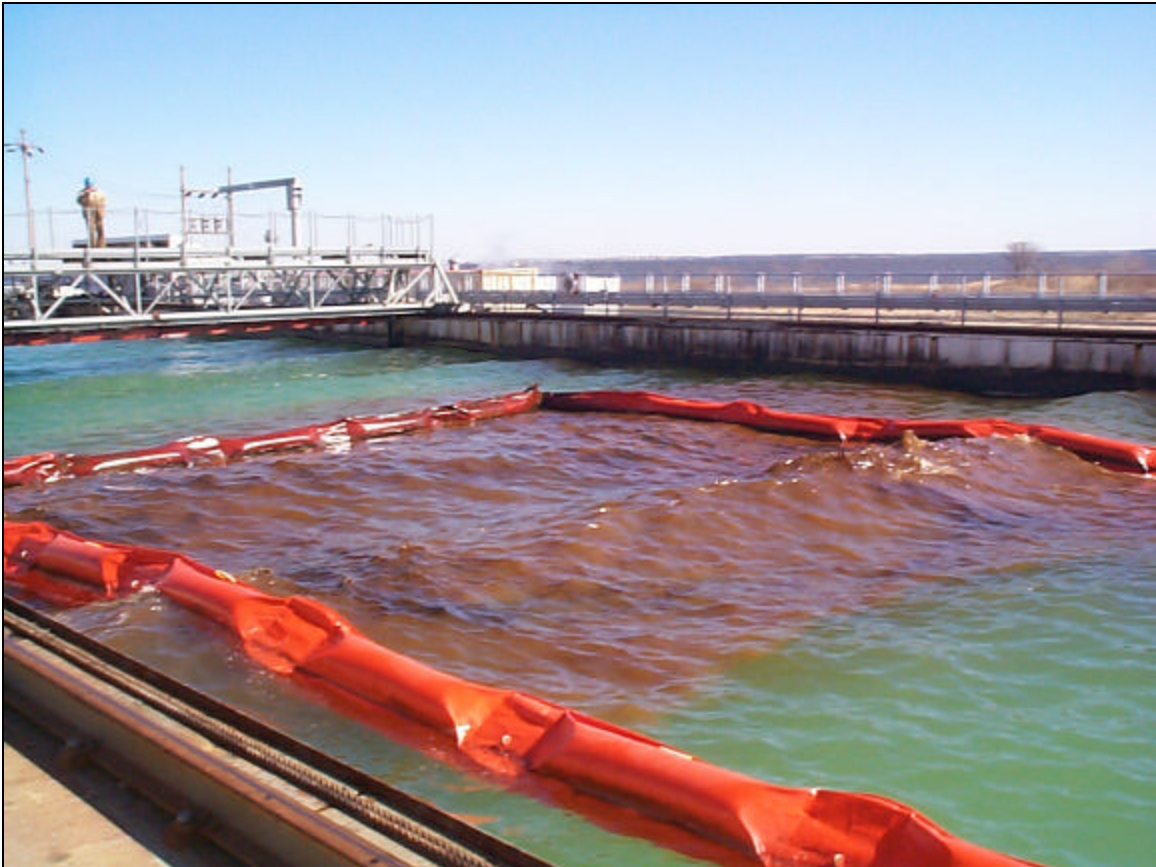
Figure 8 shows a typical test in cold water shortly after the onset of wave cresting. The photo provides a good indication of the wave energies used in the tests and illustrates what a successful dispersion of a slick looks like.

Figure 8. Successful Dispersion, Start of Cresting Wave at Right of Photo

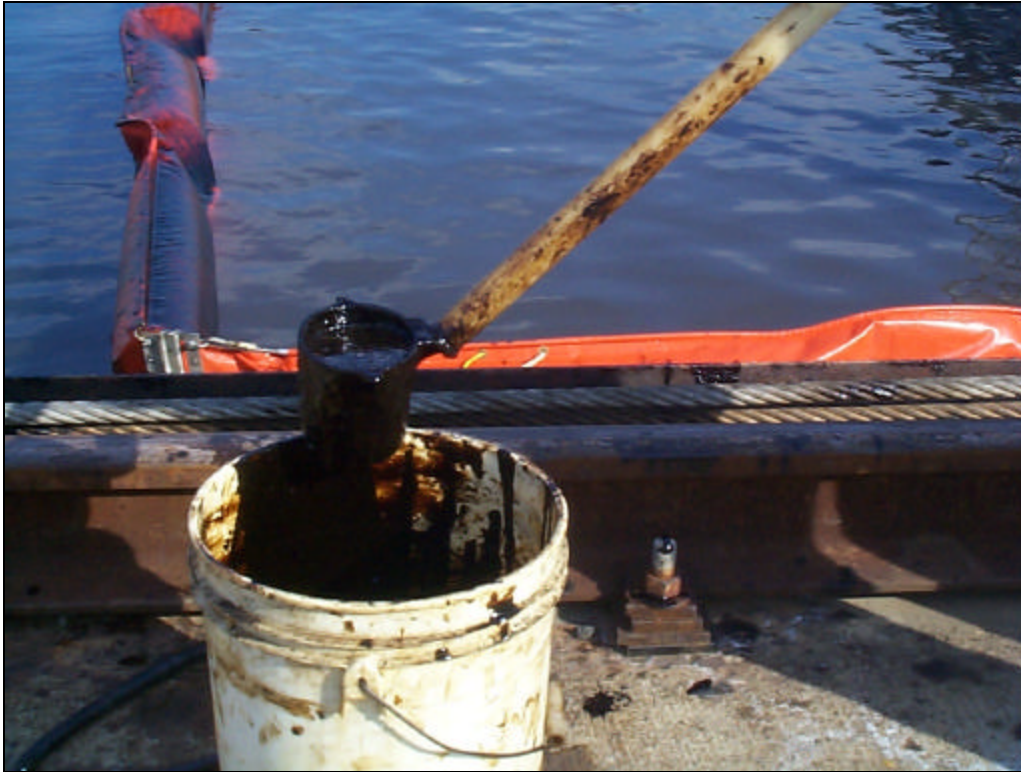
Figure 10 shows the ladle that was used to collect the oil from inside the boom after most of the tests. A larger amount of oil was left after a few of the tests; in those cases the oil was pumped from the surface, using a P-trap skimmer, into a decant drum.

Figure 10. Ladle Used to Remove Oil Herded to Corner of Containment Boom

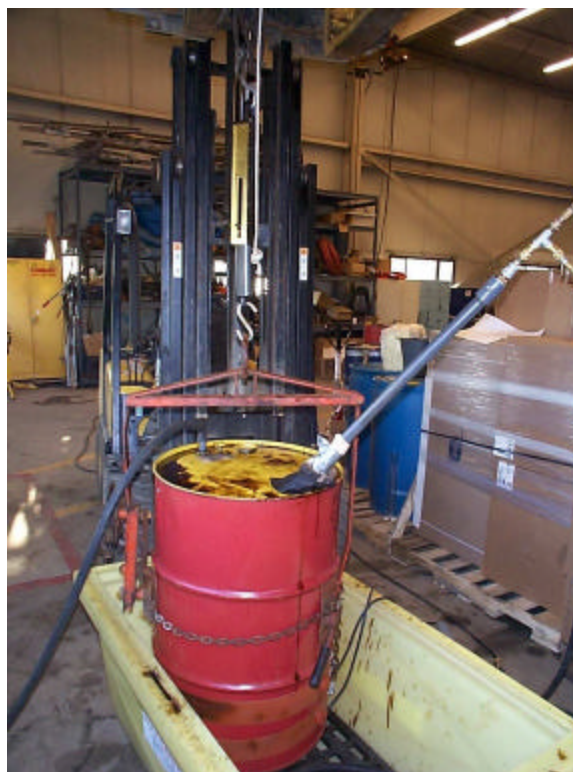
Figure 11. Oil Evaporation Setup

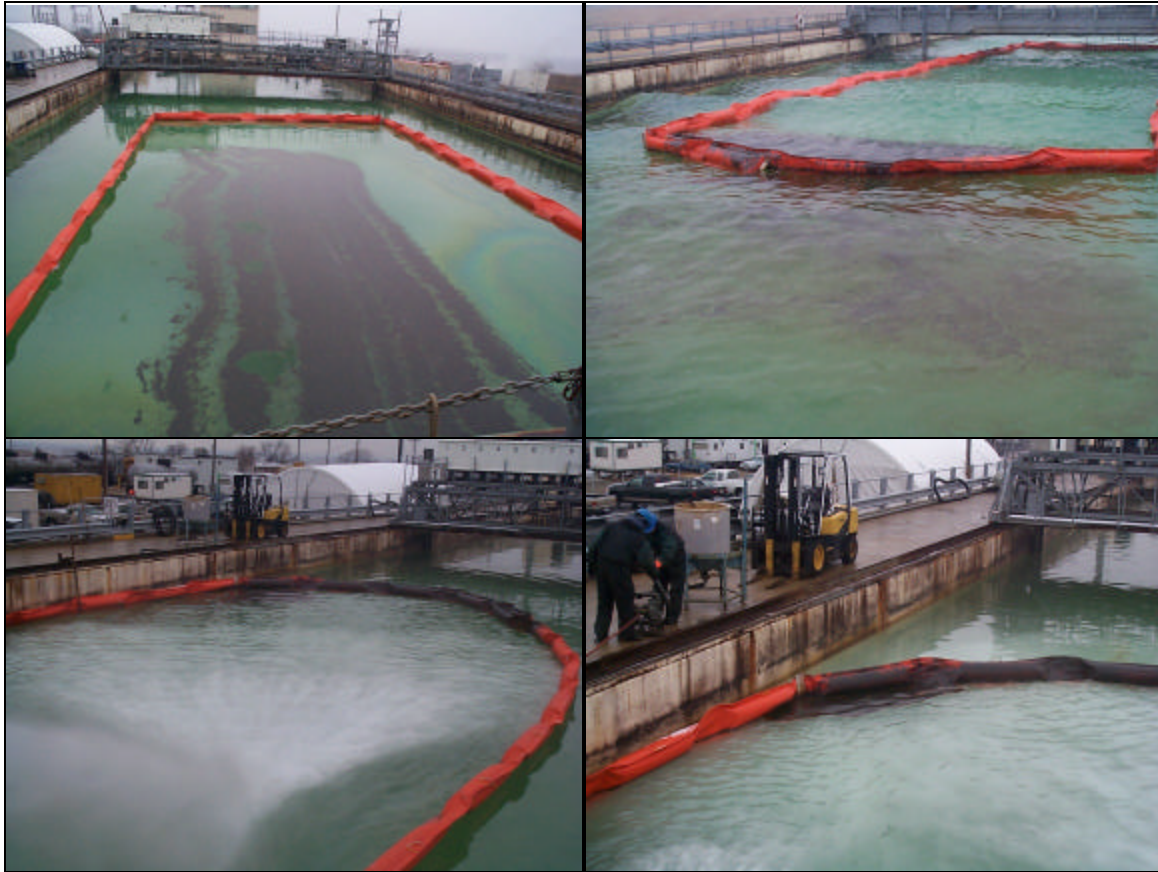
The first test completed using the Hibernia crude oil was a control test with no application of dispersants. The purpose of the test was to evaluate the ability of the containment boom to hold oil in the test area and to establish how much of the oil would evaporate and naturally disperse over the test period. Approximately 86 liters of oil were applied the water surface using the oil distribution system. The waves were started with a 7.6 cm (3.0 inch) wave paddle stroke and 35 cycles per minute (cpm) frequency. It was obvious, due to the absence of a cloud of visible oil in the water column, that no significant natural dispersion of the oil occurred at this wave energy over the duration of the test. Unfortunately, the oil was herded by wind and wave action to the north end of the boomed area and a considerable amount of oil splashed over the boom when waves crested at the boom. This behavior is clear in the video record that can be accessed via the following hyperlink ([control slick behavior](#)). The oil that escaped the boom remained visible on the surface outside of the boomed area, moved downwind and collected along the tank walls. At the end of the one hour test period about 20 liters of emulsion with a 30% water content was collected from within the boomed area. A total of 14 liters of oil was recovered. To prevent this oil loss in future tests, larger boom should be installed at the ends of the containment area. Figure 12 provides a sequence of photos that show the initial oil slick, oil on the surface outside of the containment zone (that splashed over the north boom segment), the use of fire monitors to herd oil to a collection zone at the end of the test and the oil remaining at the end of the one hour test.

Figure 12. Photo Sequence for Hibernia Crude Oil Control Test

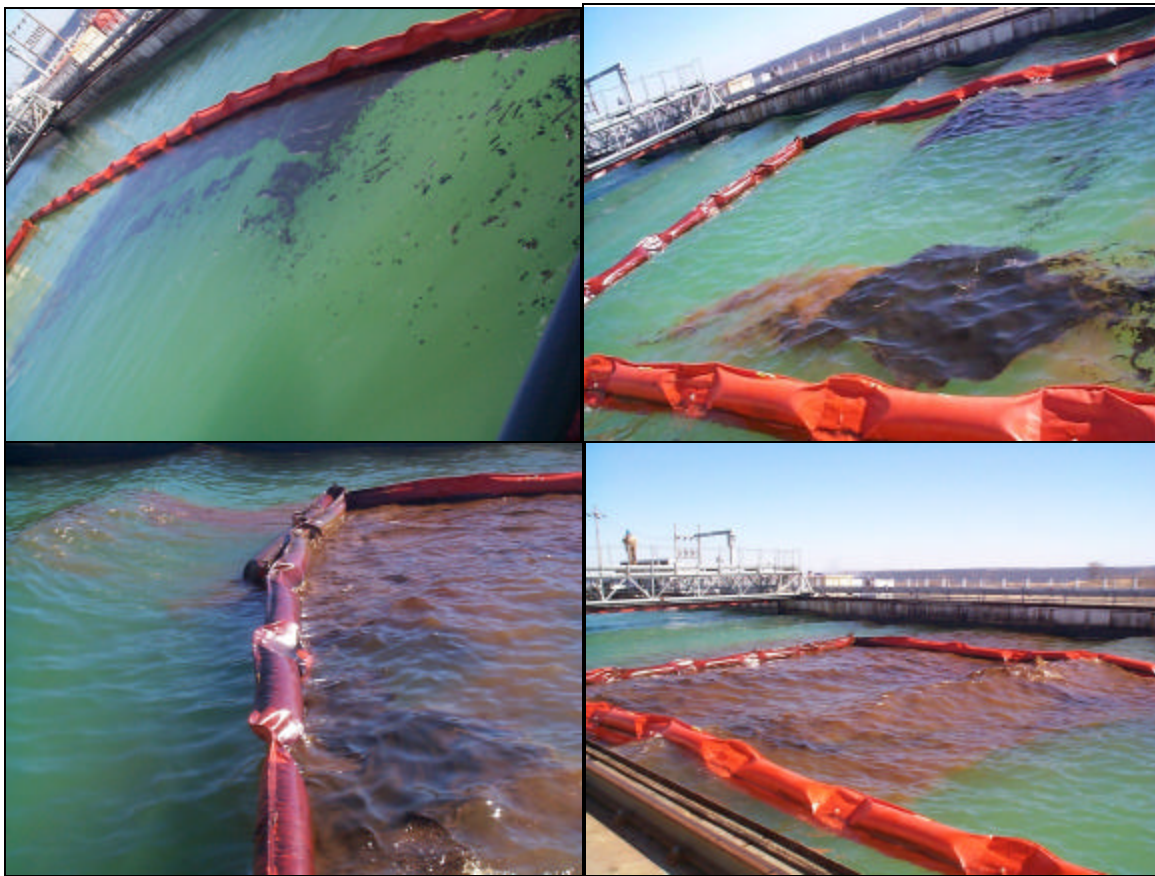
content of 17 % (16 liters of oil), was collected after the 1 hour test period. Since a total of 88 liters of oil was used in the test, a maximum of 82% of the oil may have dispersed.

The sequence of photos in Figure 14 shows the behavior of the slick after dispersant application and over the one-hour test period. The first photo shows the oil herded to the east side of the containment area prior to any significant wave action. In the second photo, taken about 3 minutes later after the start of waves, the oil appears to have become more fluid and dispersion of the oil has started. In the third photo, most of the surface oil has dispersed to form a highly concentrated oil-in-water dispersion. Some of this oil and water splashed over the end of the north boom, but this oil dispersed into the water column and did not form a surface slick. This is evident in the third photo in Figure 14. In the fourth photo most of the surface oil has dispersed and the dispersed oil cloud has mixed across the end of the containment zone and beyond.

Figure 14. Photo Sequence for 7.5% Evaporated Hibernia Crude & Corexit 9500 at 1:38 DOR

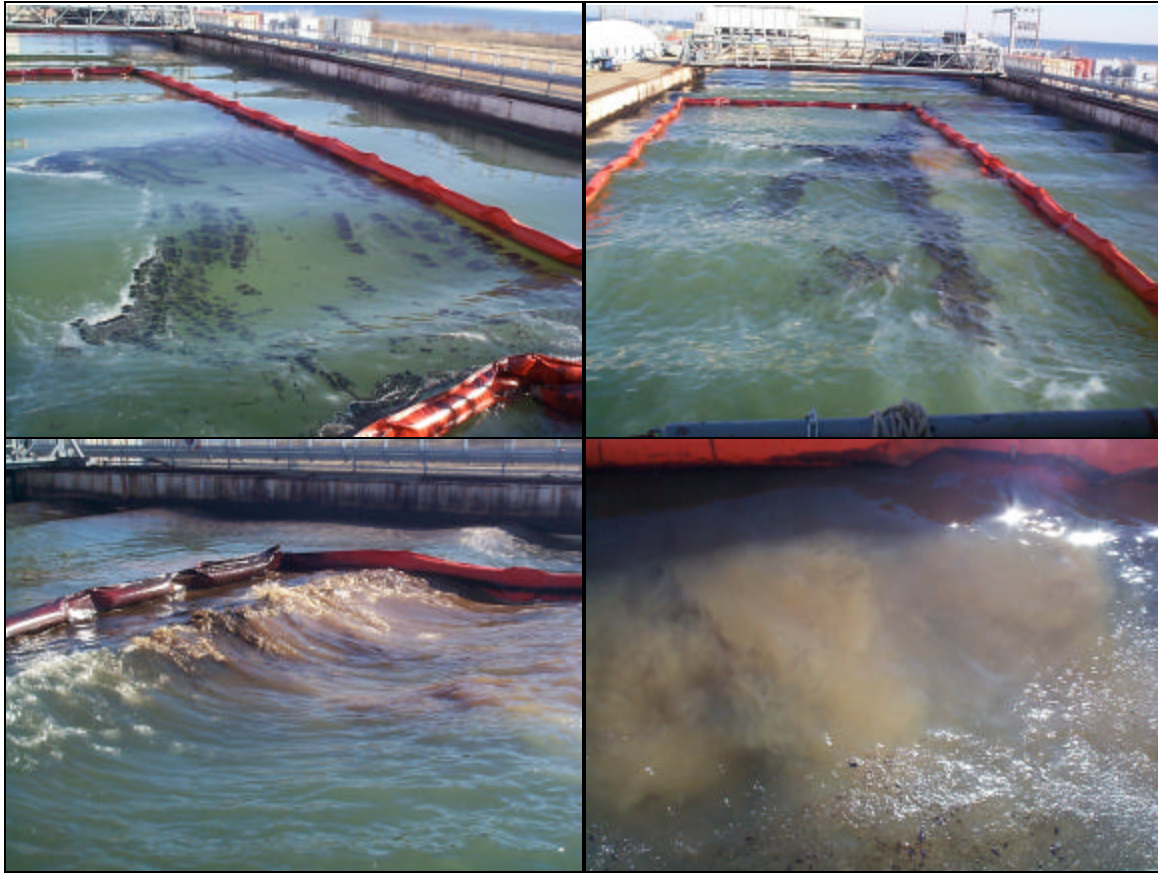
Hibernia oil, evaporated 10.3% by volume, was treated with Corexit 9500 in this test. The oil appeared to quickly gel once it hit the cold water and only spread to cover about 50% of the swath area by the time the dispersant was applied. Distinct patches of oil were evident even after the initial application of dispersant, as shown in the first photo in Figure 15. A relatively high DOR of about 1:14 was applied because previous testing (SL Ross 2001) indicated that this oil would be more difficult to disperse than fresh Hibernia oil. Within 2 to 3 minutes after the start of visible wave action the oil appeared to form a more fluid slick and began to disperse. This can be seen in the second photo of Figure 15. The third photo of Figure 15 shows the slick during the heaviest stages of dispersion, about 5 minutes after the start of waves. The last photo in Figure 15 is a close-up of the fine oil droplets in the dispersed oil cloud that diffused under the containment boom. Click on the following link for a short video clip of this test ([test #5 video clip](#)).

A total of 4.6 liters of emulsion, with a water content of 27% (3.4 liters of oil), was collected after the one-hour test period. A total of 68 liters of oil was used in the test. If all of the oil lost from the containment area is assumed to have dispersed, the dispersant effectiveness in this test would be about 95%. No black surface oil was observed exiting the boomed area during the test. Some dispersed oil and water splashed over the north boom segment but this oil quickly dispersed into the water column and did not re-surface during the test. This can be seen in the left of the scene in the above video clip at about 35 seconds into the playback.

Figure 15. Photo Sequence for 10.3 % Evaporated Hibernia Crude & Corexit 9500 at 1:14 DOR

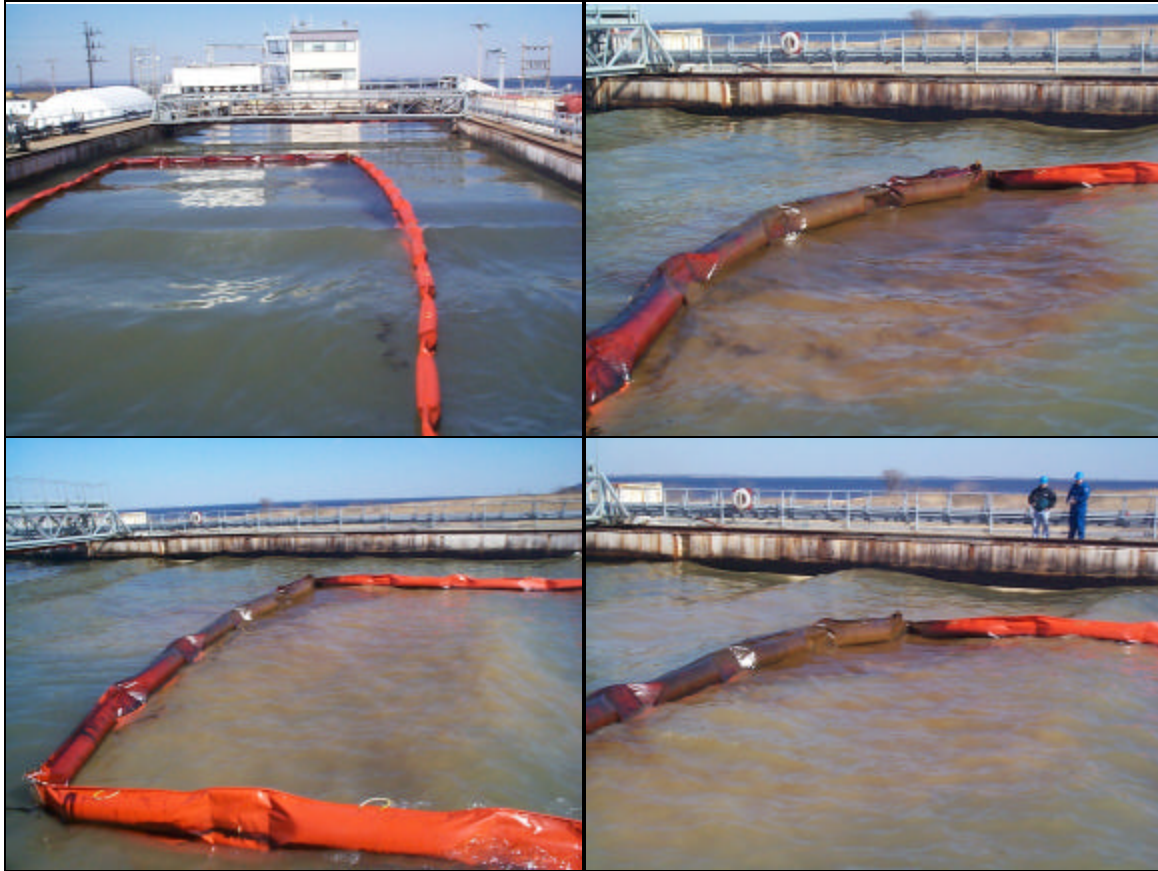
In this test, fresh Hibernia crude was heated to 45°C and discharged onto the cold water. Previous tests (SL Ross 2001) have shown that hot, fresh Hibernia crude will gel when quickly cooled to 1°C. Hibernia crude is stored offshore and shipped at temperatures in the 35 to 45 °C range, so the behavior and dispersibility of this oil spilled under these conditions is of interest. The spilled oil formed patches of non-fluid oil similar to the 10.3 % evaporated oil shown in the first photo of Figure 15. As with the evaporated oil, the slick became more fluid after the onset of waves. The first photo in Figure 16 shows the slick herded to the north east corner of the containment area shortly after being laid down and sprayed. The other three photos show the slick 5, 10 and 20 minutes after the onset of cresting waves. Click on the following link for a short video clip of this test ([main dispersion](#)). A total of 1.4 liters of emulsion with a water content of 27% (1.0 liter of oil) was collected after the one-hour test period. A total of 70 liters of

oil was used in the test. If all of the oil lost from the containment area is assumed to have dispersed, the dispersant effectiveness in this test would be about 98%. Some dispersed oil and water splashed over the north boom segment but this oil quickly dispersed into the water column and did not re-surface.

Figure 16. Photo Sequence for Hot, Fresh Hibernia Crude & Corexit 9500 at 1:14 DOR

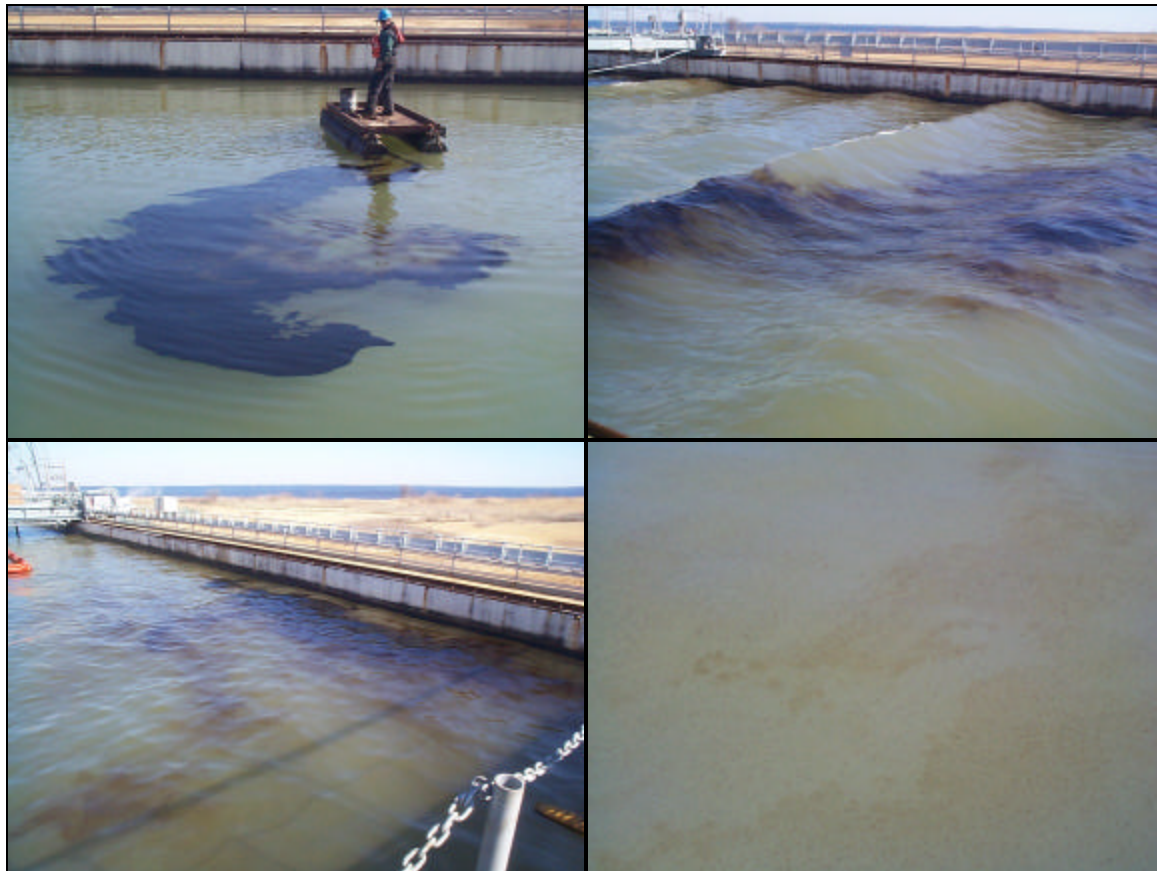
Twenty liters of fresh ANS crude oil were applied in the middle of the wave tank far enough south of the containment boom to allow the free oil to experience cresting waves before drifting to the containment area. This control test was completed to determine if the fresh oil would disperse in the water column without the application of dispersant. The previous “control” test (Test #1, Hibernia crude, no dispersant) was unsuccessful because considerable oil escaped over the north containment boom; this prevented an accurate measure of oil left on the surface. Rather than use a large quantity of oil to complete the control test with the ANS crude, a small (5 gallon) release was made. The waves were started after the oil was spilled and the behavior of the oil was observed. The photos in Figure 17, and a short video clip ([breaking wave](#)), show the behavior of the oil. The first picture in Figure 17 shows the oil spread to a relatively thin slick shortly after being spilled. The second photo shows a breaking wave moving through the slick. The third photo shows the surface oil after about 10 minutes of wave action. The final photo shows a close-up of a surface film of oil forming from the rapid re-surfacing of large oil drops

generated by a passing wave. No suspended cloud of fine droplets was noticed after the wave passed. A cloud of very distinct, black oil drops formed when a breaking wave passed through the slick but these drops quickly re-surfaced and formed a new slick. The test showed that the fresh oil did not disperse appreciably under the wave energies used in the tests when dispersant is not applied.

Figure 17. Photos from Test #6: Fresh ANS, no Dispersant

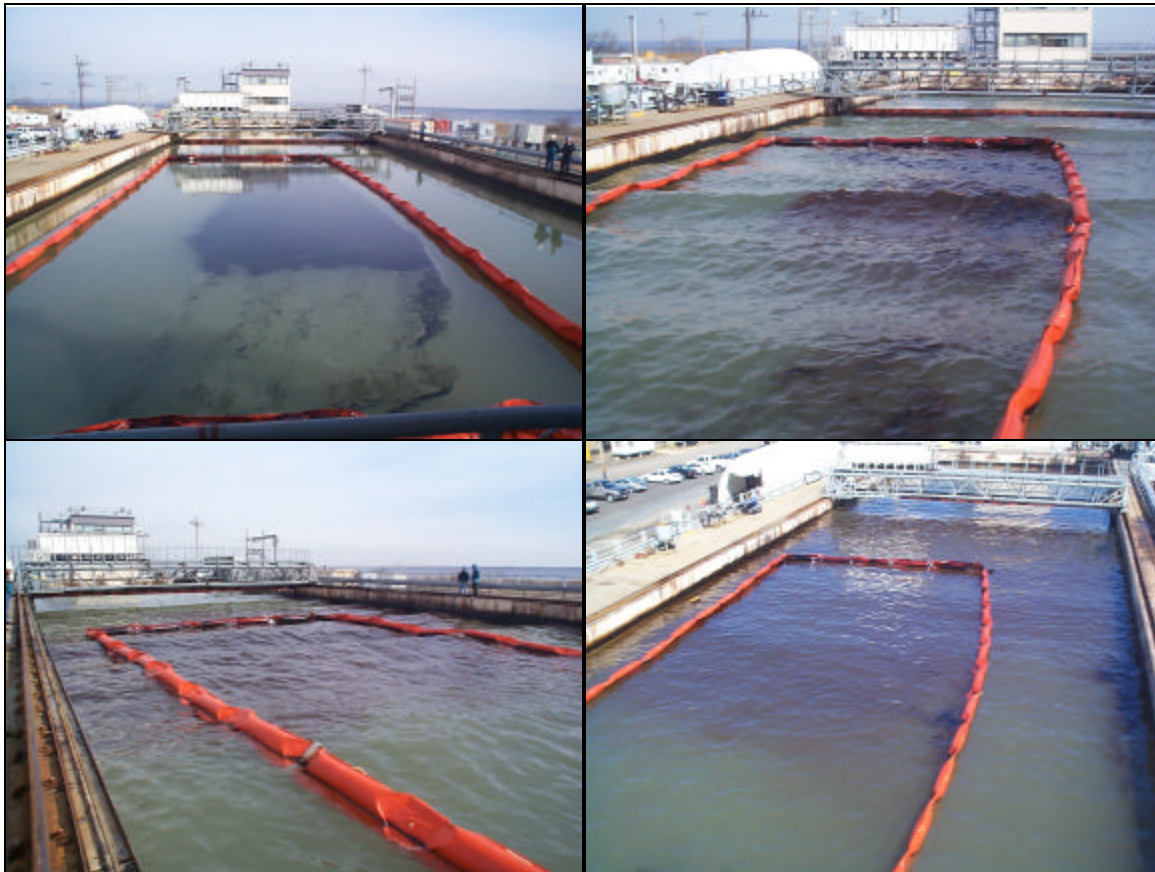
Corexit 9527 was applied to fresh ANS crude at a dose rate of 1:31 in this test. Winds were light and the slick did not herd to the side of the containment area as happened in some of the other tests. The sequence of photos in Figure 18 shows the slick shortly after dispersant application, after a few minutes of dispersion and after most of the surface oil has dispersed into the water and formed a fine oil cloud (about 10 minutes after the start of waves). Click on the following link for a short video clip of this test ([test #9 video clip](#)). A total of 1.4 liters of emulsion, with a

water content of 27% (1 liter of oil), was collected after the 1 hour test period. A total of 71 liters of oil was used in the test. If all of the oil lost from the containment area is assumed to have dispersed, the dispersant effectiveness in this test would be about 98%. No surface oil was observed splashing over the end containment boom during this test.

Figure 18. Photos from Test #9: Fresh ANS Treated with Corexit 9527 at 1:32 DOR

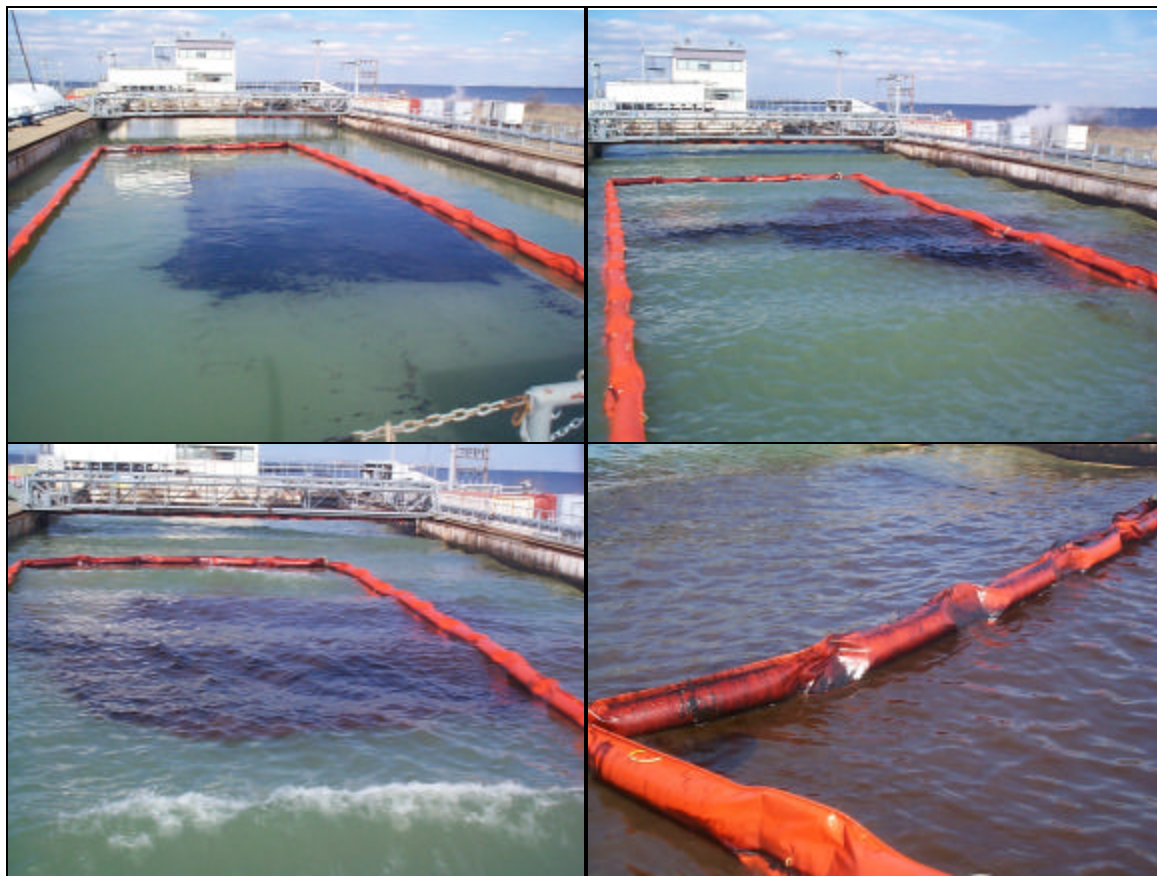
Corexit 9527 was applied to the 10% evaporated ANS crude oil at a dose rate of about 1:48 in this test. Wind herded the oil to the east side of the containment boom shortly after the application of dispersant. The oil quickly dispersed once waves started to build and a dispersed oil cloud grew to fill the full north portion of the boomed area and beyond. Figure 19 provides a sequence of photos that depicts the behavior of the oil over the one-hour test. No surface oil reached the north end of the boom in the test; it all dispersed before it had a chance to be herded to the end of the containment area. This is evident from the second and third photos in the

sequence where “clean” water is seen beyond the north edge of the dispersed oil cloud. The third photo also shows a typical cresting wave moving through the test area. Click on the following link for a short video clip of this test ([test#8 video clip](#)). A total of 1.4 liters of emulsion, with a water content of 32% (0.95 liters of oil), was collected after the 1 hour test period. A total of 79 liters of oil was used in the test. If all of the oil lost from the containment area is assumed to have dispersed, the dispersant effectiveness in this test would be about 99%. The surface oil slick dispersed prior to any oil reaching the end containment barrier and no surface oil was observed exiting the containment boom during this test. Some rogue oil can be seen along the tank wall in the video for this test but this oil was present prior to the discharge of the oil for test #8.

Figure 19. Photos from Test #8:10% Evaporated ANS with Corexit 9527 at 1:48 DOR

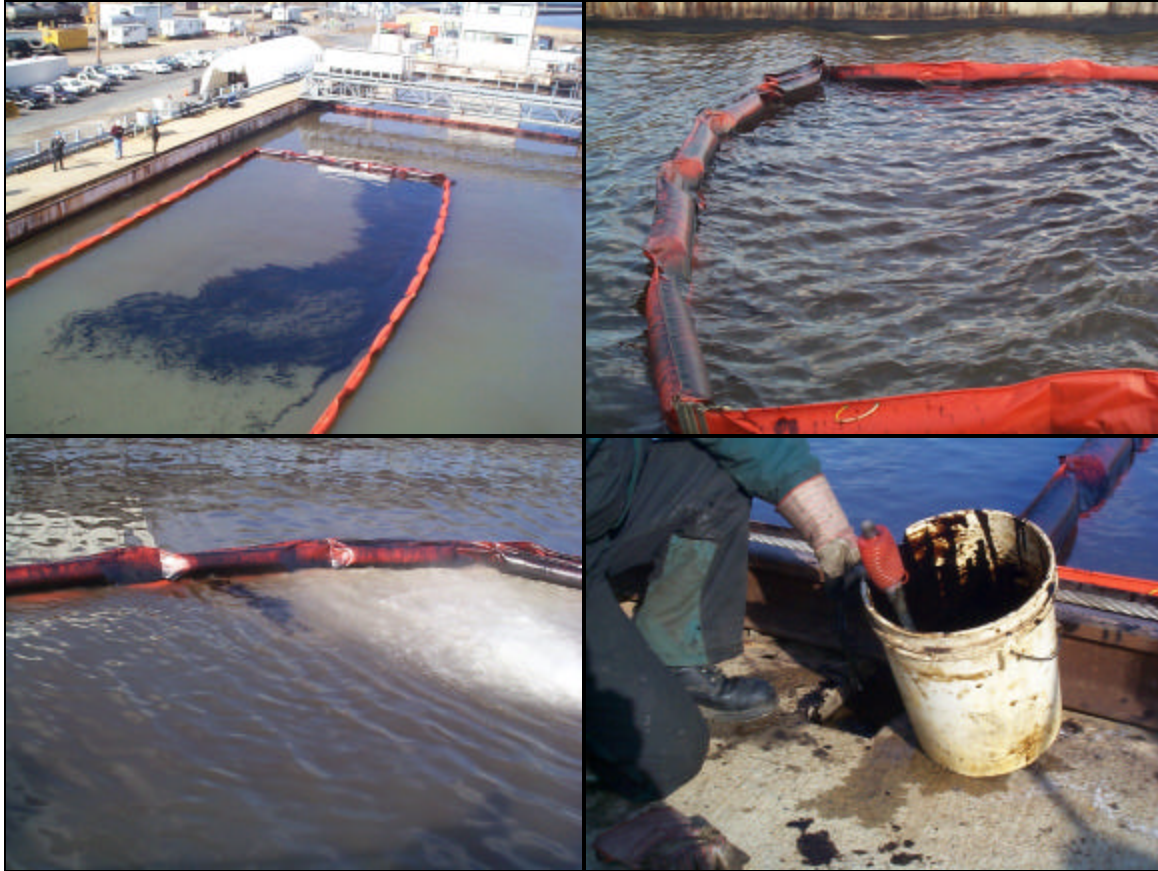
Corexit 9527 was applied to the 20% evaporated ANS crude oil at a dose rate of about 1:44 in this test. Wind herded the oil to the east side of the containment boom shortly after the application of dispersant, as seen in the first photo of Figure 20. At the time of the test, the clarity of the tank was poor from earlier tests, the weather was overcast, and it was difficult to see the dispersed oil cloud that formed. This is evident from the second photo in Figure 20. A small amount of oil, seen in the third photo of Figure 20 was collected at the end of the test. The fourth photo shows a siphon being used to remove the free water from the collection bucket. Click on the following link for a short video clip of this test ([test #10 Video Clip](#)). A total of 0.5 liters of emulsion, with a water content of 27% (0.36 liters of oil), was collected after the one-hour test period. A total of 79 liters of oil was used in the test. If all of the oil lost from the containment area is assumed to have dispersed, the dispersant effectiveness in this test would be about 99%. Some dispersed oil and water splashed over the north boom segment but this oil was observed to quickly dispersed into the water column and did not re-surface.

Figure 20. Photos from Test #10: 20% Evaporated ANS with Corexit 9527 at 1:44 DOR

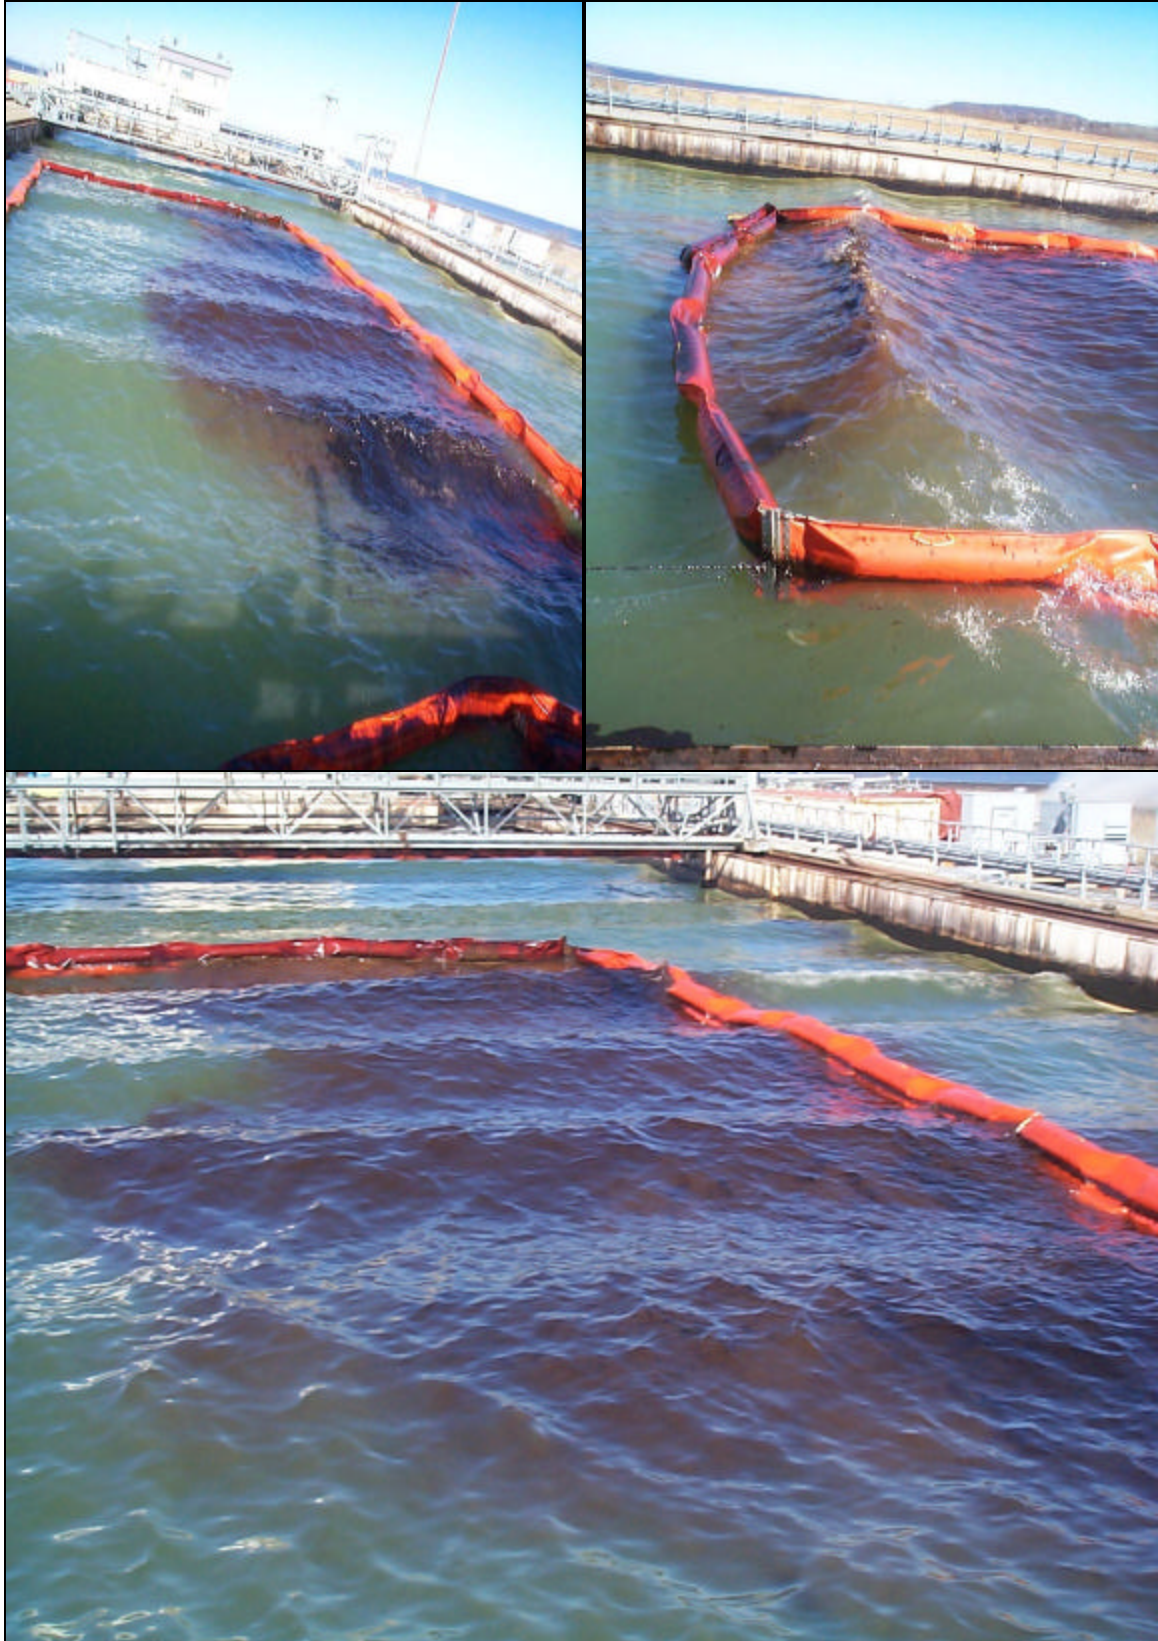
Corexit 9500 was applied to fresh ANS crude at a dose rate of 1:34 in test #4. The first photo in Figure 21 shows the slick shortly after dispersant application. The bottom photo shows the slick and dispersed oil about one minute later. The photo on the top right shows the high concentration of dispersed oil in the water and minimal surface oil after about 5 minutes of cresting waves. Click on the following link for a short video clip of this test ([test #4 Video Clip](#)). A total of 3.6 liters of emulsion, with a water content of 40% (2.1 liters of oil), was collected after the test. A total of 71 liters of oil was used in the test. If all of the oil lost from the containment area is assumed to have dispersed, the dispersant effectiveness in this test would be about 97%. A small quantity of highly concentrated “oil-in-water” cloud splashed over the north boom (see 2nd photo in Figure 21) but this oil diffused into the water column and did not form a surface slick.

Figure 21. Photos from Test #4: Fresh ANS with Corexit 9500 at 1:34 DOR

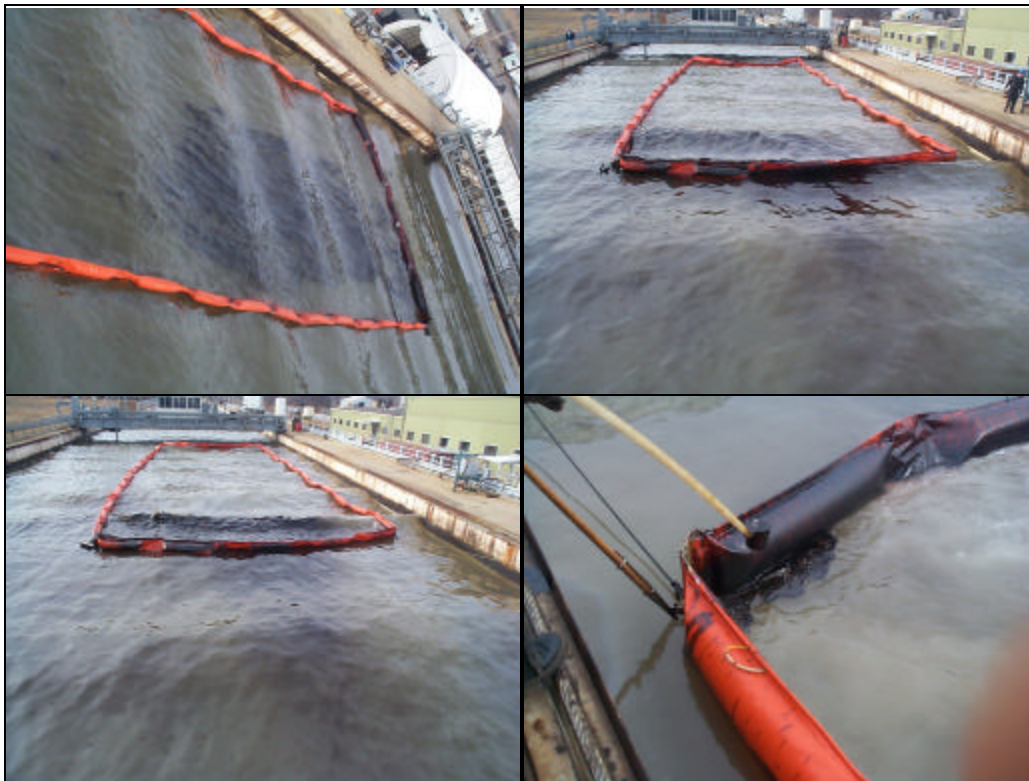
In this test a light dosage of Corexit 9500 (1:81 DOR) was applied to fresh ANS crude oil. The tank was heavily contaminated with oil from previous tests and the weather was overcast during this test. As a result, the dispersed oil cloud from the dispersion was not as clearly visible as in many of the other tests. Of all of the tests where dispersant was applied, this was the only one where oil could be seen on the surface north of the containment boom. The first photo in Figure 22 shows the initial slick shortly after dispersant application. The second and third photos show surface oil outside of the containment boom that escaped and did not disperse into the water column. It is clear from observations that the 1:81 dose of dispersant did not fully disperse the oil as it had in other tests involving higher doses. The final photo in Figure 22 shows the collection of the oil remaining at the end of the test. Only 3.2 liters of the initial 74 liters of oil (5.7 liters of emulsion with 42% water content) spilled were collected, but the amount that escaped the boom as surface oil is not known. If the loss of surface oil out the north end of this boom is ignored, the estimate of dispersant effectiveness in this test is about 93%.

Figure 22. Photos from Test #11: Fresh ANS with Corexit 9500 at 1:81 DOR
