FINAL REPORT

**DISPERSANT EFFECTIVENESS TESTING
IN COLD WATER**

**U.S. Department of the Interior
Minerals Management Service
Herndon, VA**

**SL Ross Environmental Research
Ottawa, ON**

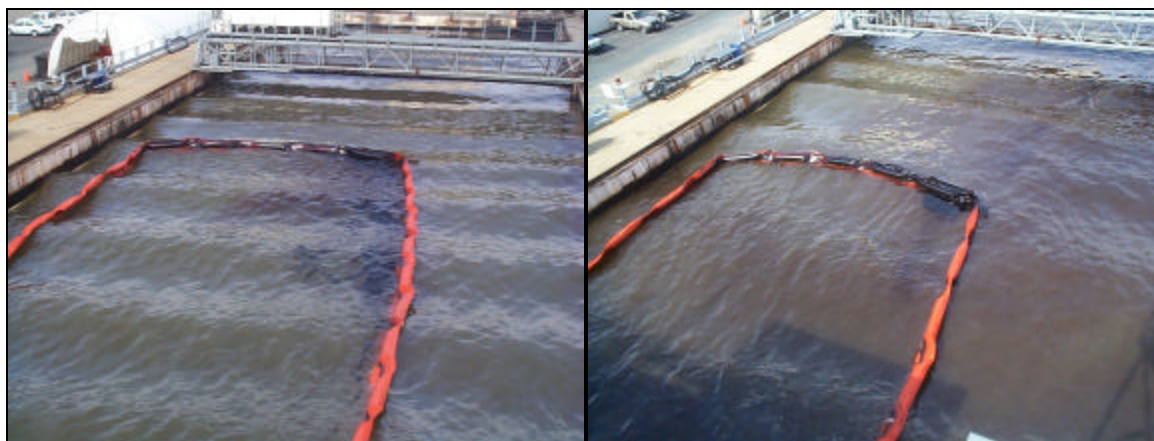
Twenty percent evaporated ANS crude oil was treated with Corexit 9500 with a DOR of 1:38. The tank water was not clear in this test and the development of the dispersed oil cloud was not as visible as in earlier tests. Click on the following link for a short video clip of this test ([mid test behavior](#)). The first photo in Figure 23 shows the slick shortly after the application of dispersants. The second photo shows the containment zone about 10 minutes later. A small amount of surface oil remains in the north-east corner of the boom at this time and the water has a darker hue due to additional dispersed oil. A total of 5 liters of emulsion, with a water content of 43% (2.9 liters of oil), was collected after the one-hour test period. A total of 76 liters of oil was used in the test. If the loss of surface oil out the north end of this boom is ignored, the estimate of dispersant effectiveness in this test is about 96%. It was difficult to visually confirm the formation of a dispersed oil cloud in this test due to the poor water clarity at the start of the test. There was no visual evidence of oil escaping the boomed area that remained as a surface slick.

Figure 23. Photos from Test #12: 20% Evaporated ANS with Corexit 9500 at 1:38 DOR
