Upgrades to TA-33-87, -88, and -89

Historic Building Survey Report No. 230

Los Alamos National Laboratory

August 27, 2004 Survey No. 944

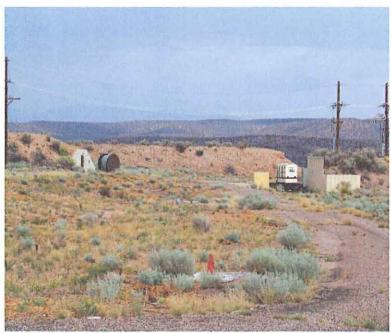
Fig. 6. East Site (looking east toward TA-33-88)

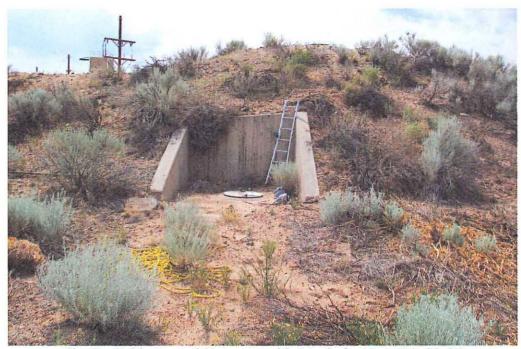
A cable tunnel connected the control room (TA-33-87) to an instrumentation building located further to the east (TA-33-88). Cabling also extended to the X-unit vault (TA-33-89) and to the X-ray shack discussed above. The cables were housed in a 36-inch diameter corrugated metal pipe running along the length of the 6 ft 10 in high tunnel. The cable tunnel was designed to be accessed through a series of manholes (Fig. 7). According to a former site worker, the tunnel is big enough to walk through (Hoard 1991).

Fig. 7. Cable Tunnel Entrance with Manhole, Near TA-33-87

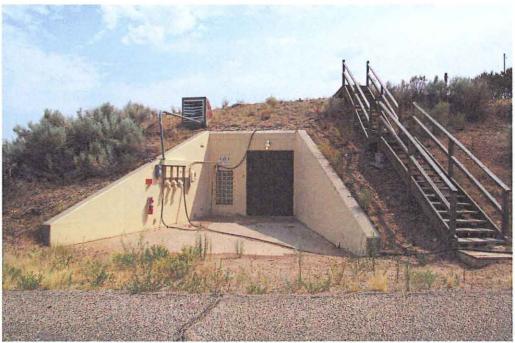
A berm-covered transformer vault, TA-33-95, is also located at East Site. The vault was constructed to withstand explosive blast effects in order to protect the power transformer (LANL 1992).

Fig. 8. Transformer Vault, TA-33-95

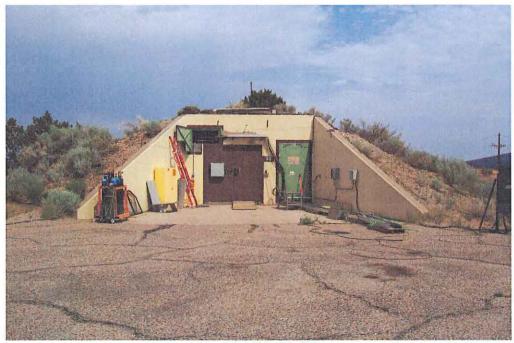
Fig. 9. TA-33-87

TA-33-87 is a one-story rectangular building measuring 92 ft 5 in by 21 ft. The building contains 1584 ft² of useable floor space and is approximately 15 ft in height. The interior of the building is divided into five rooms: one large main "control" room, and four small rooms including a bathroom, darkroom, and two utility rooms. The floors in the main room have built-in trenches for running electrical cables.

Building 87 is constructed with a reinforced concrete foundation and floor slab and has reinforced concrete walls and a flat roof. The west concrete headwall is constructed with angled wing walls that serve as a retaining system for the compacted earthen berm covering the remaining three sides and roof. This western elevation, the only exposed exterior wall, has a painted concrete finish. A pair of heavy-duty metal doors, a single heavy-duty metal door, and a grated ventilation duct are set within the headwall on this elevation, and provide the only access

into the building. The pair of doors seen today replaced a single reinforced metal strap hinged door sometime after 1984. A building identification sign and electrical conduit and control boxes are located on the exterior surface of the wing walls.

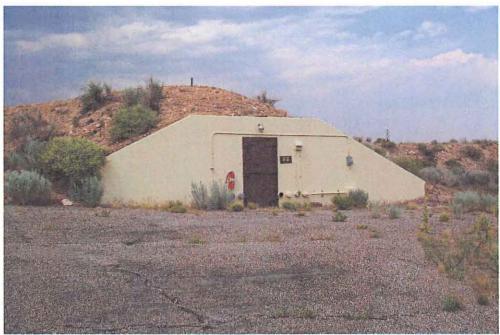
Fig. 10. TA-33-88

TA-33-88 is a one-story single room building measuring 17 ft 8 in by 14 ft with 192 ft² of useable floor space and an 8 ft interior ceiling height. The building is constructed with a reinforced concrete foundation and floor slab. It has reinforced concrete walls and a flat roof. The south exposed concrete headwall is constructed with wing walls that serve as a retaining system for the compacted earthen berm covering the remaining three sides and roof. This exposed wall has a painted concrete finish. A single reinforced metal door is set within the headwall, providing the only access into the building.

A fire extinguisher, security light, electrical conduit and control box, capped pipe sleeve openings, and building identification sign are located on the exterior face of the building.

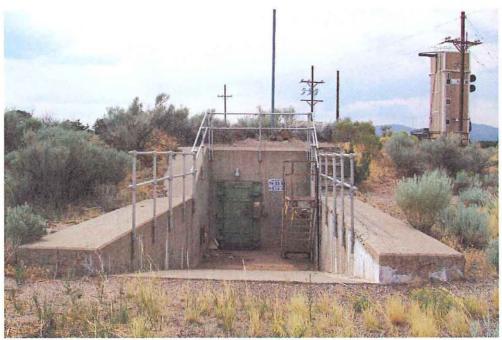
Fig. 11. TA-33-89

TA-33-89 is a one-story single room building measuring 13 ft by 16 ft (excluding the protruding wing walls). The interior measures 70 ft² with an approximate 7 ft interior ceiling height. The structure is constructed with a reinforced concrete foundation and floor slab and has reinforced concrete walls and a flat roof. The east exposed concrete headwall is constructed with wing walls that are continuations of the sidewalls of the structure. These wing walls serve as a retaining system for the compacted earthen berm covering the remaining three sides and roof. This exposed portion of the building is unpainted concrete.

A single reinforced metal door with heavy-duty strap hinges and a steel lever door handle is set within the headwall and provides the only access into the building. There is a concrete ramp leading down from the surrounding ground surface to the building entry level. Additionally, there is a set of metal stairs and landing leading down from the surrounding ground surface to the building entry level along the north sidewall.

A fire extinguisher, security light, building identification sign, and metal safety-railing are located on the exterior face of the building and wing walls. A metal pipe sleeve with elbow and cap is also extruding from the roof of the building.

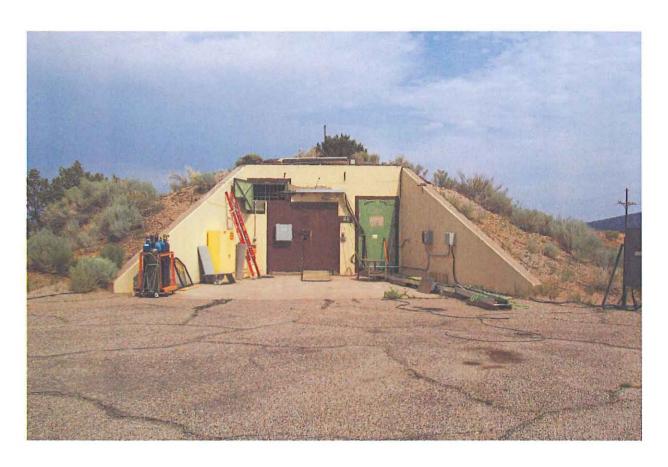
West Elevation: Entrance into Control Building. Sometime after 1984 the front entrance was modified. The original single personnel door (a reinforced metal door with heavy duty strap hinges) located in the center of the west elevation, was replaced with a pair of heavy-duty metal doors. When these doors were installed the ventilation duct opening and covering were also modified. North, east, and south elevations are covered by a surrounding earthen berm as is the roof of the building.

TA-33-87, West side, facing east

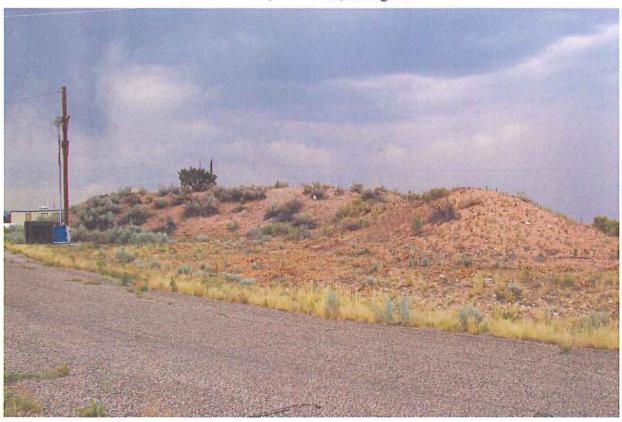
TA-33-87, South side, facing northwest

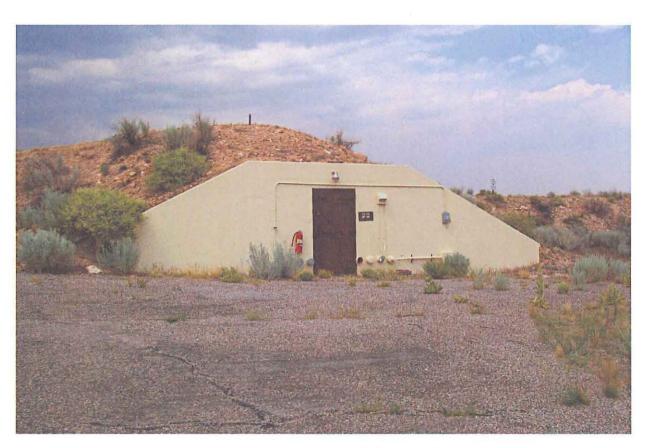
South Elevation: Entrance into Cable Building. North, east, and west elevations are covered by a surrounding earthen berm as is the roof of the building.

TA-33-88, South side, facing north

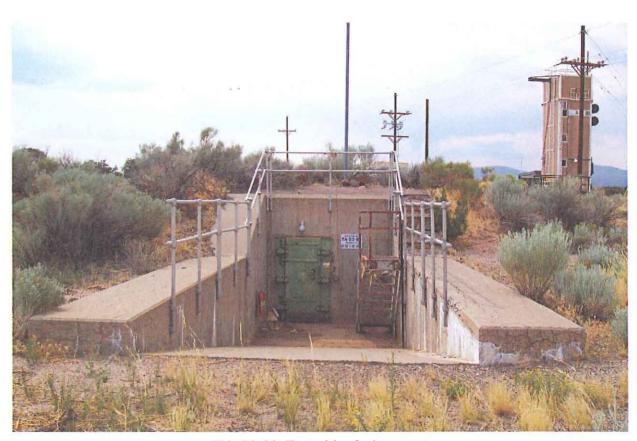
Recommendations/ Additional Commen	nts
Architectural Features (elevations)	East Elevation: Entrance into X-unit Vault. North, west, and south elevations are covered by a surrounding earthen berm as is the roof of the building. A utility tunnel connects buildings TA-33-87, -88, & -89. This 5' X 6'10" tunnel holds a 36" conduit that carries the cables connecting electronic experimental equipment in each of the buildings.
Total sq ft 70 Arch	itect/ Builder A/E is Max Flatow - Jason Moore, Builder R. E. McKee
Alterations	
List of Drawings (Cntrl + Enter for para	break)
ENG-C 10509 TA-33 Recovery Box Installation Civil - Plot Plan November 9, 1956 Revised to as built status June 25, 1957	
ENG-SK 2306 Sheet 9 of 18 TA-33 Extension of TA-33 Facilities Plot Plan - Area B March 4, 1953	
ENG-C 3305 Sheet 4 of 66 TA-33 Additional Facilities, TA-33 Profile & Details 36" Conduit April 19, 1954	
ENG-SK 2308 Sheet 11 of 18 TA-33, Buildings 88 & 89 (Buildings HP-88 & Extension of TA-33 Facilities Plan, Elevation, & Section March 4, 1953	HP-89)

TA-33-89, East side, facing west
