Hurricane Rita Rapid Response Wind Water Line Report – Texas

Task Order 446

February 28, 2006 (Final)

Hazard Mitigation Technical Assistance Program
Contract No. EMW-2000-CO-0247
Task Order 446
Hurricane Rita Rapid Response
Wind Water Line (WWL) Data Collection – Texas
FEMA-1606-DR-TX

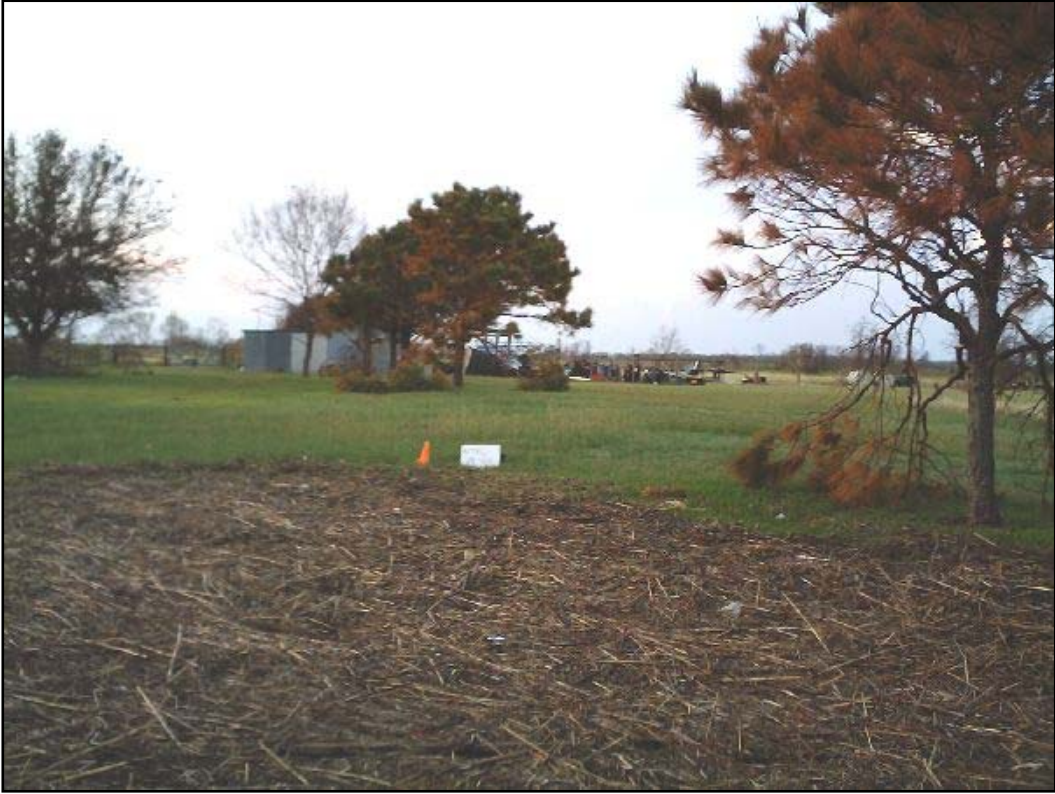
Figure 5: Example Debris Field

Each field crew was tasked with identifying and documenting the WWL and collecting data points along the coastlines. The WWL data points were documented using a standardized flagger form to collect detailed information about the point. To define points along the WWL, field crews visited areas of known flood damage. Traveling away from the coast to the edge of damage, they attempted to locate debris fields (see Figure 5) or water marks close to the ground, and to trace them along topographic features to determine the extent of flooding (see Figure 6) and flood damages.

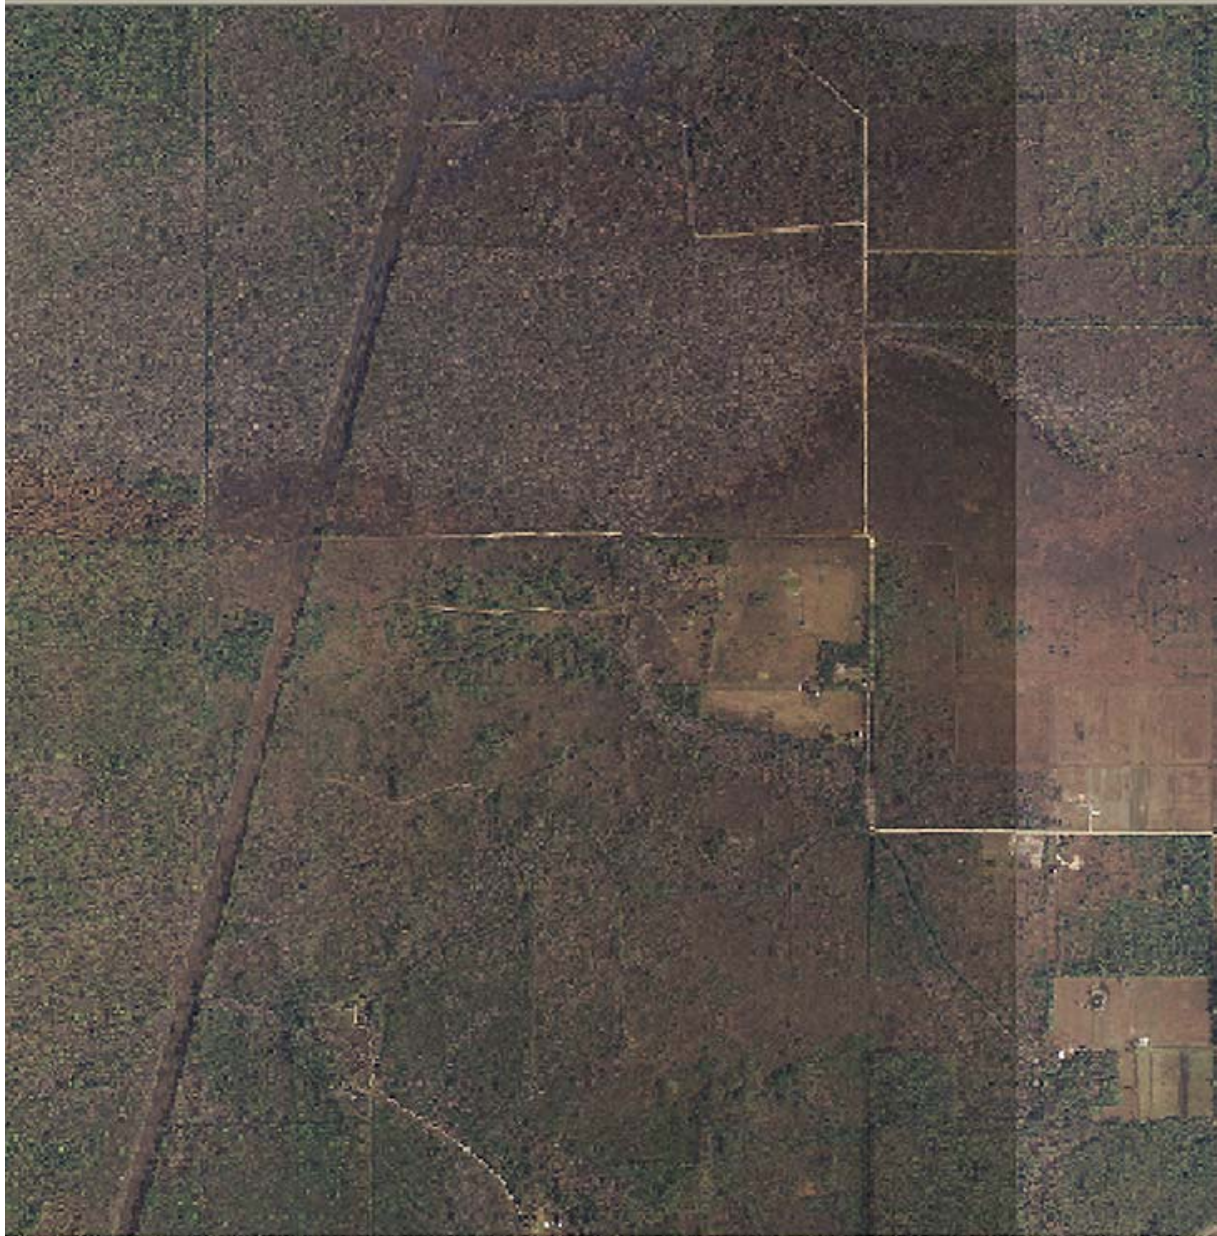
When flood waters recede quickly before the photographs are taken, analysts are confronted with a more complex interpretation assessment. In these cases, analysts look for signatures in the photographs, such as leaning trees, standing water, deposited debris (mud, silt, vegetation, etc.) and other features, that indicate the presence of inland flood waters. Figure 2 depicts an area which was interpreted to have been entirely inundated with water that receded before the photo was taken. This was determined by the presence of mud, fallen trees and saturated ground indicated by brown coloration throughout the image.

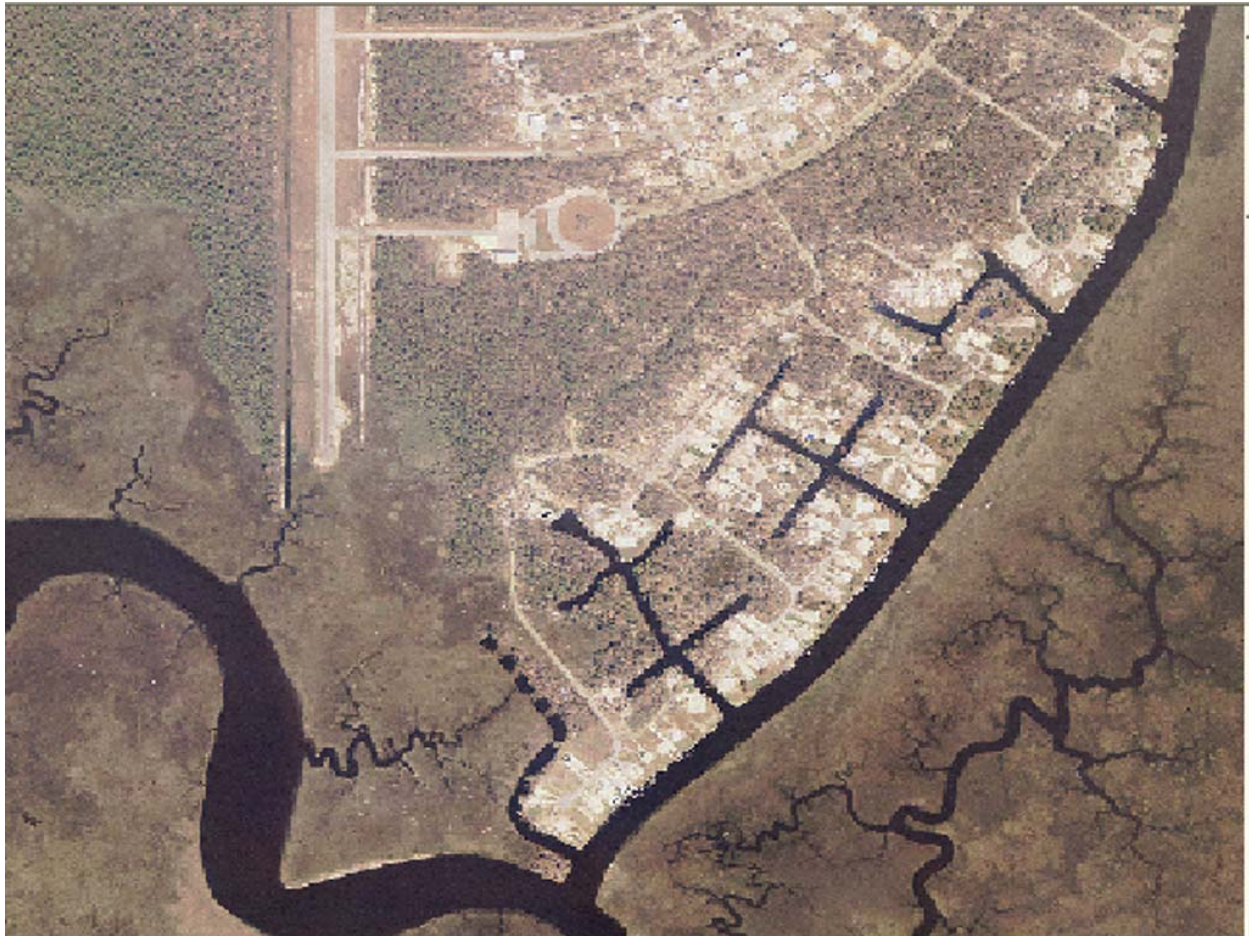
Figure 3 represents an area where the presence of marsh results in a unique situation whereby debris no longer collects as it would typically do on dry land. What is normally a visible debris line on dry land becomes less obvious for photo-interpretation when over marsh and other standing water bodies. In such cases, analysts may use contour lines, the presence of high water marks, deposited mud and silt, and/or any damage to vegetation that has been submerged by flood waters. The marsh in Figure 3 is evident in the lower left and lower right sectors of the image. URS engineers judged final placement of the wind/water line in such areas where photo interpretation alone was not conclusive.

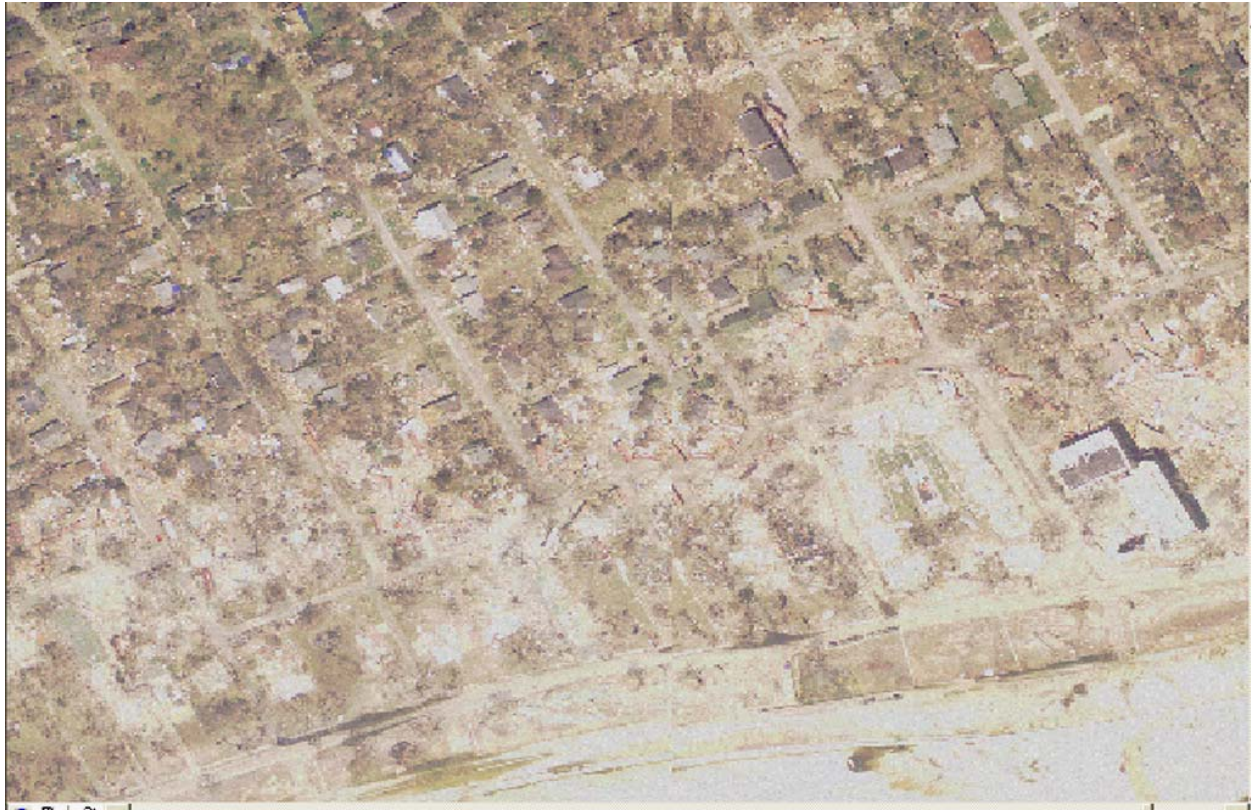
Figure 4 depicts the presence of multiple debris lines. In such cases, the analyst must decide whether all debris was deposited by the ocean surge or some debris was later swept up by inland flooding caused by heavy rain. If tide waters are present along the coast, it can result in multiple debris lines being left behind. Typically, the analyst will place the debris line at the most evident and consistent debris line or along the furthest inland point (high water mark).

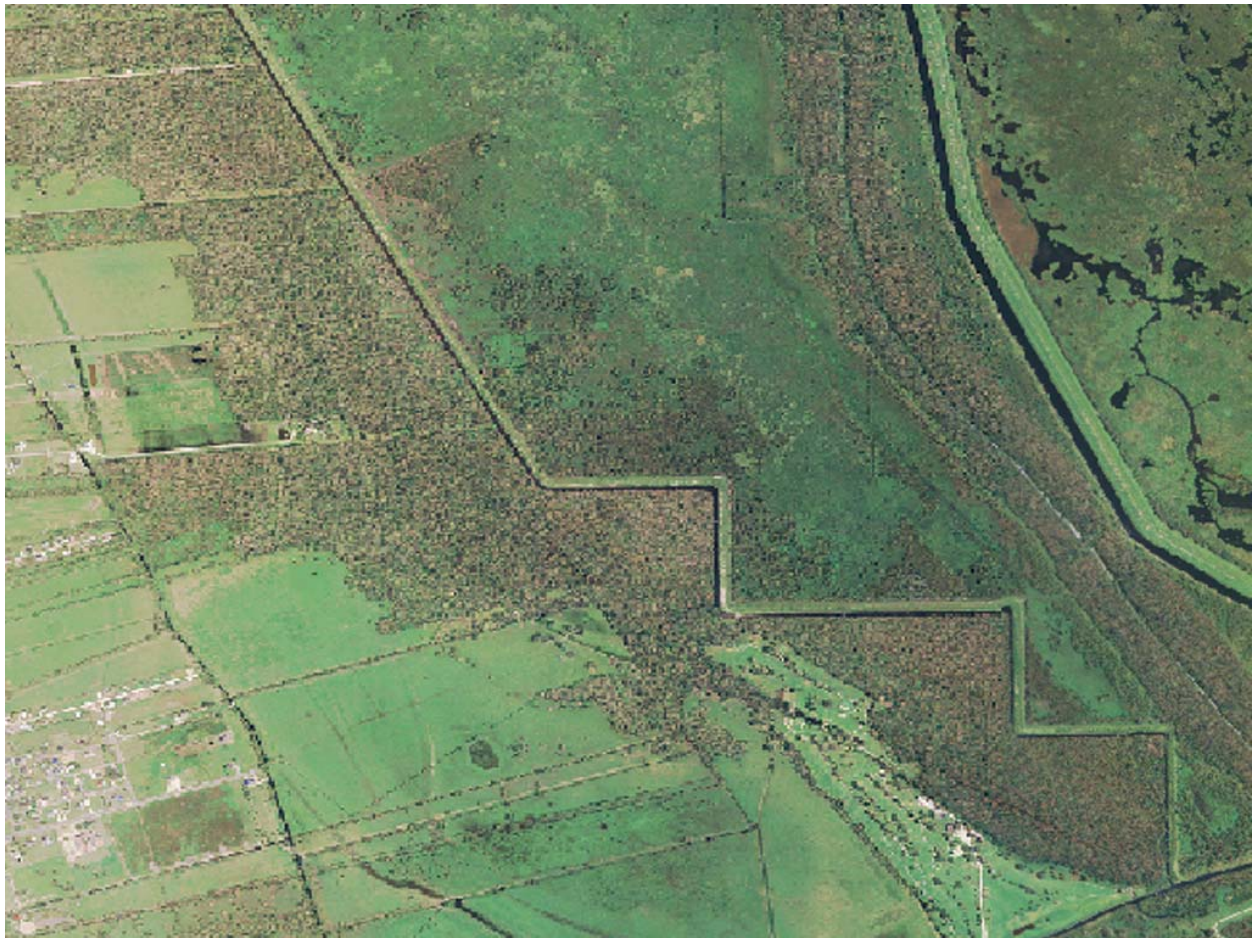
Coastal areas containing salt marshes and other low-lying areas such as that represented in Figure 5 can pose a challenge to photo-interpreters delineating flood waters. An analyst must determine whether or not to represent an area as flooded. There are many cases in which land appears to be flooded, but the area is really a marsh and always has saturated characteristics. In these cases analysts often review other sources such as secondary maps, historical data, and field surveyed conditions. Analysts also look for deposited mud and the condition of nearby vegetation to determine whether an area has been flooded or whether it is simply a marsh.
