**Subject: Submittal of the Work Plan for Installation of Stormwater Controls at Area of Concern 00-030(f)**

LA-UR-09-0794  
February 2009  
EP2009-0043

# **Work Plan for Installation of Stormwater Controls at Area of Concern 00-030(f)**

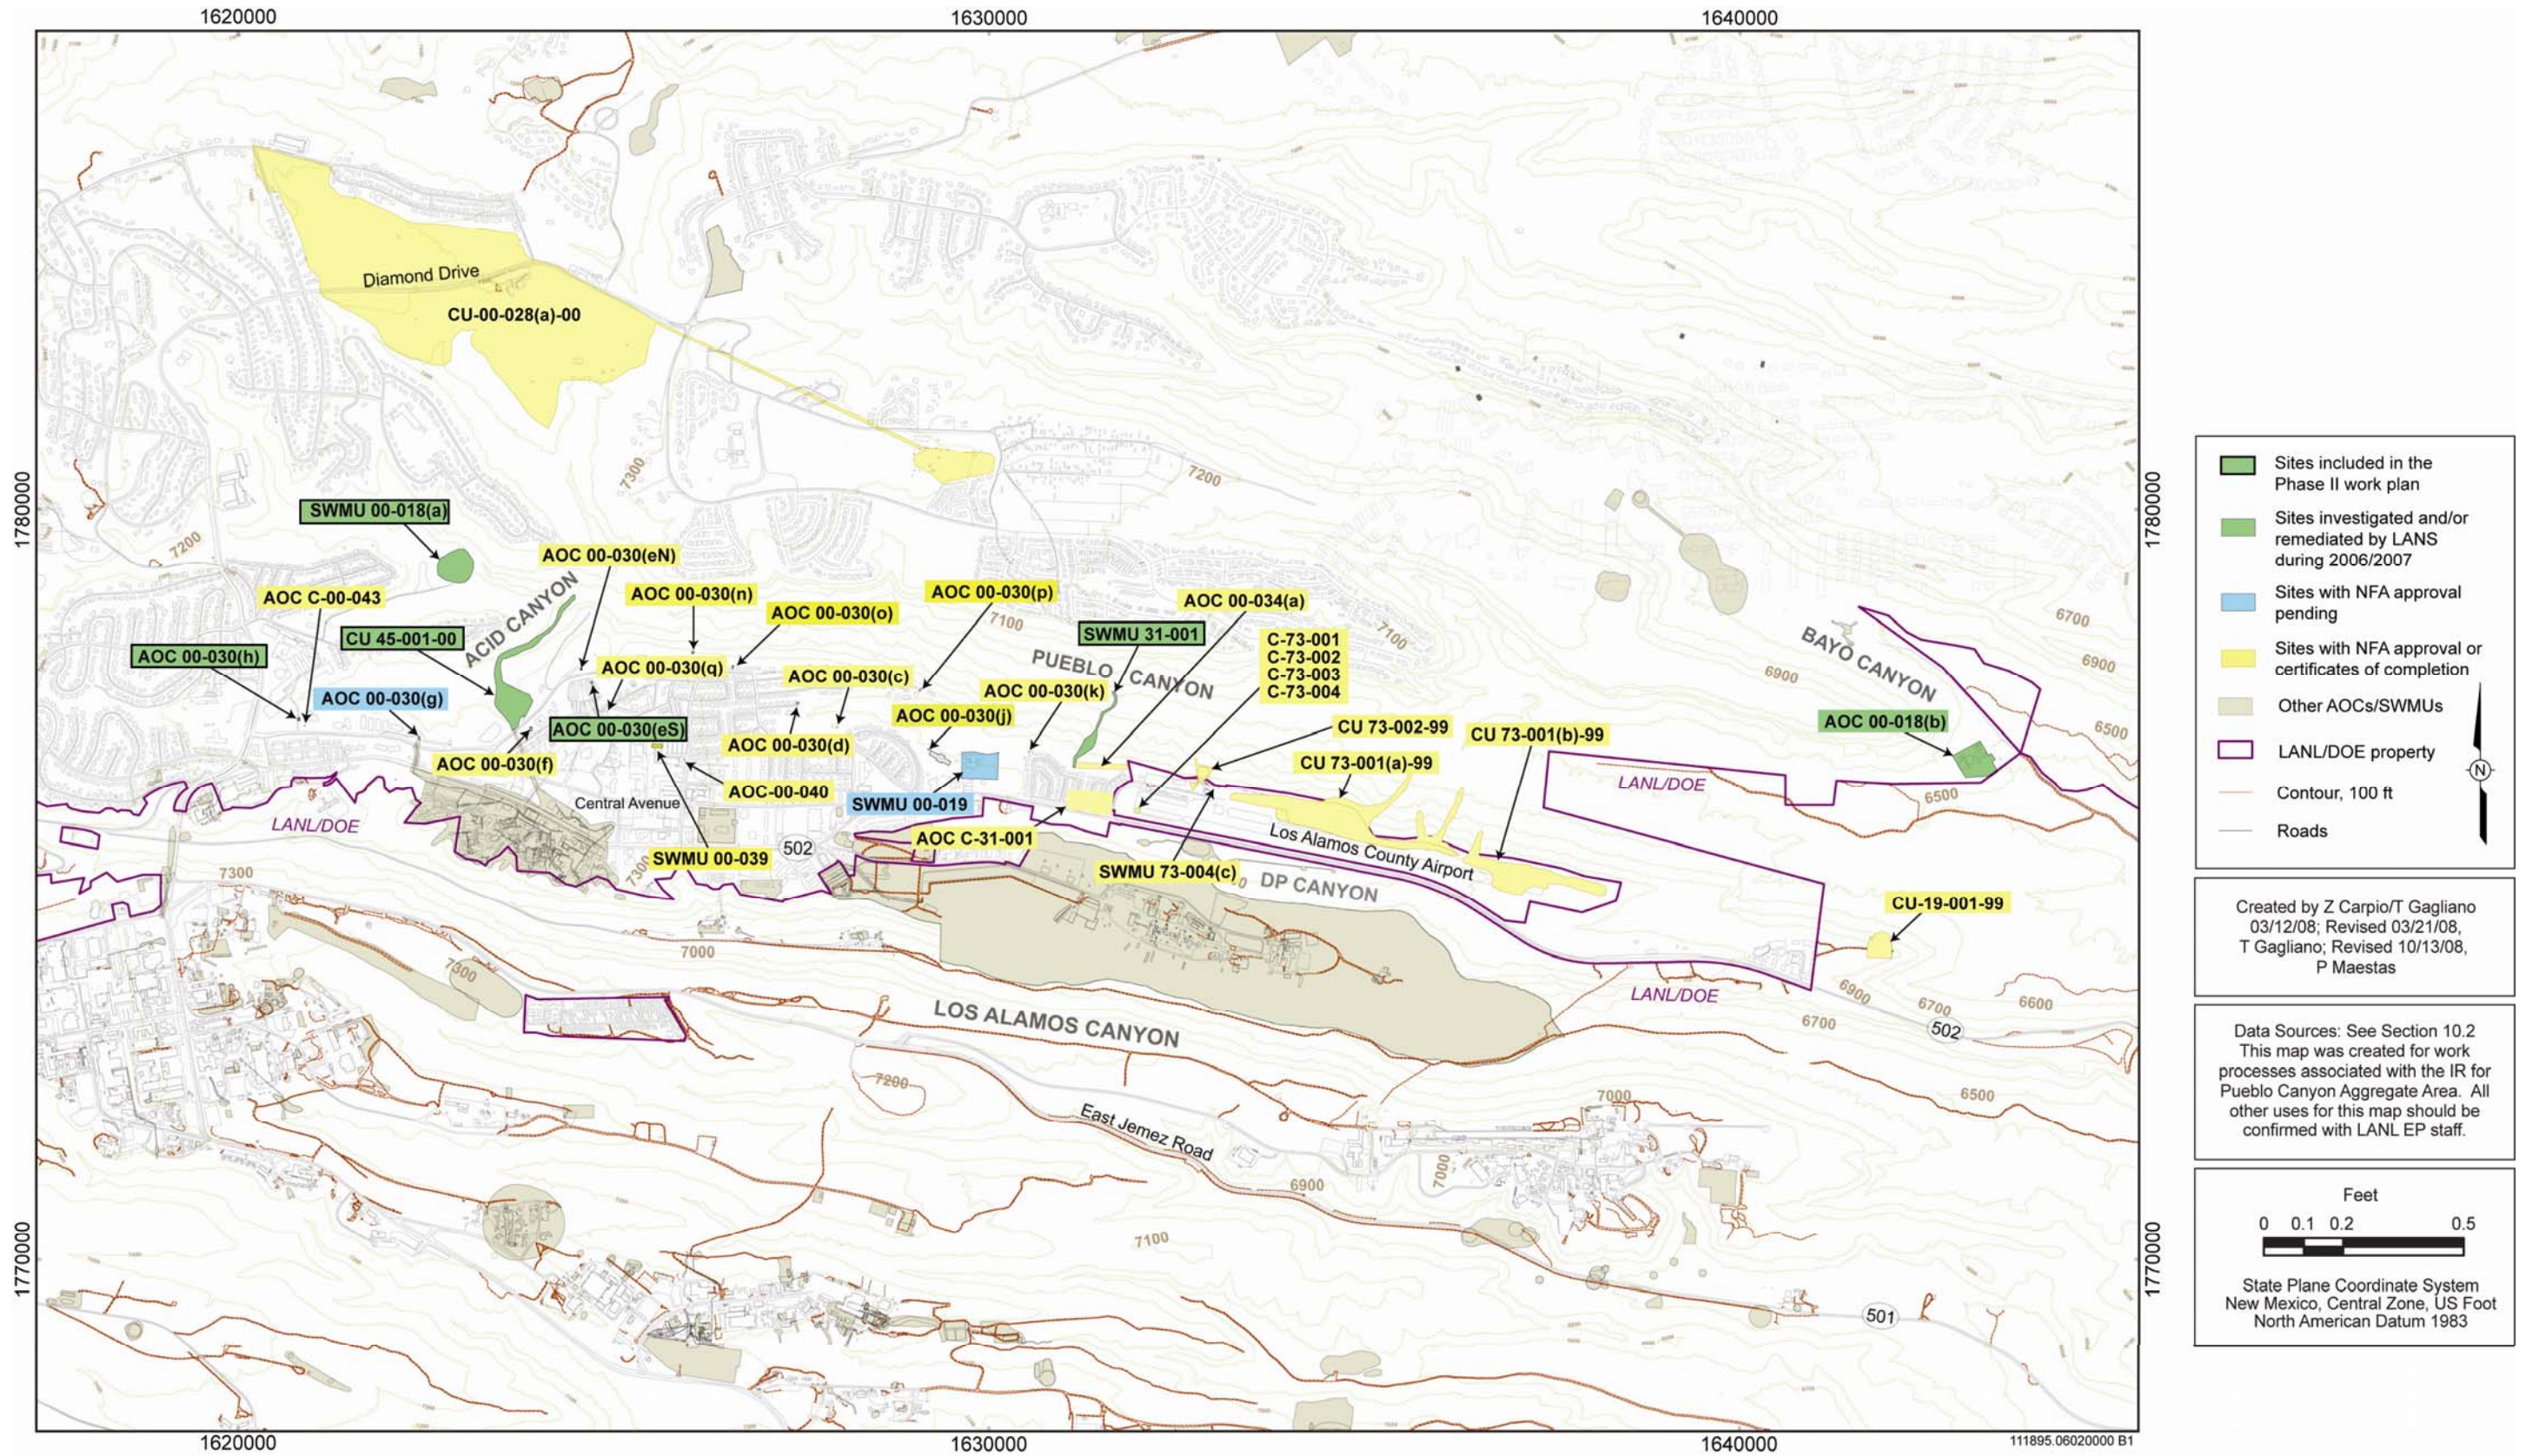
Figure 1.1-1 Locations of Pueblo Canyon Aggregate Area SWMUs, AOCs, and consolidated units

The Pueblo Canyon Aggregate Area consists of solid waste management units (SWMUs) and AOCs that were formerly on Laboratory property within Technical Area 00 (TA-00). The Laboratory began operations at TA-00 in 1943 and had largely ceased using this area by 1986. Figure 1.1-1 shows the Pueblo Canyon Aggregate Area SWMUs and AOCs with respect to the Laboratory boundary and surrounding land holdings.

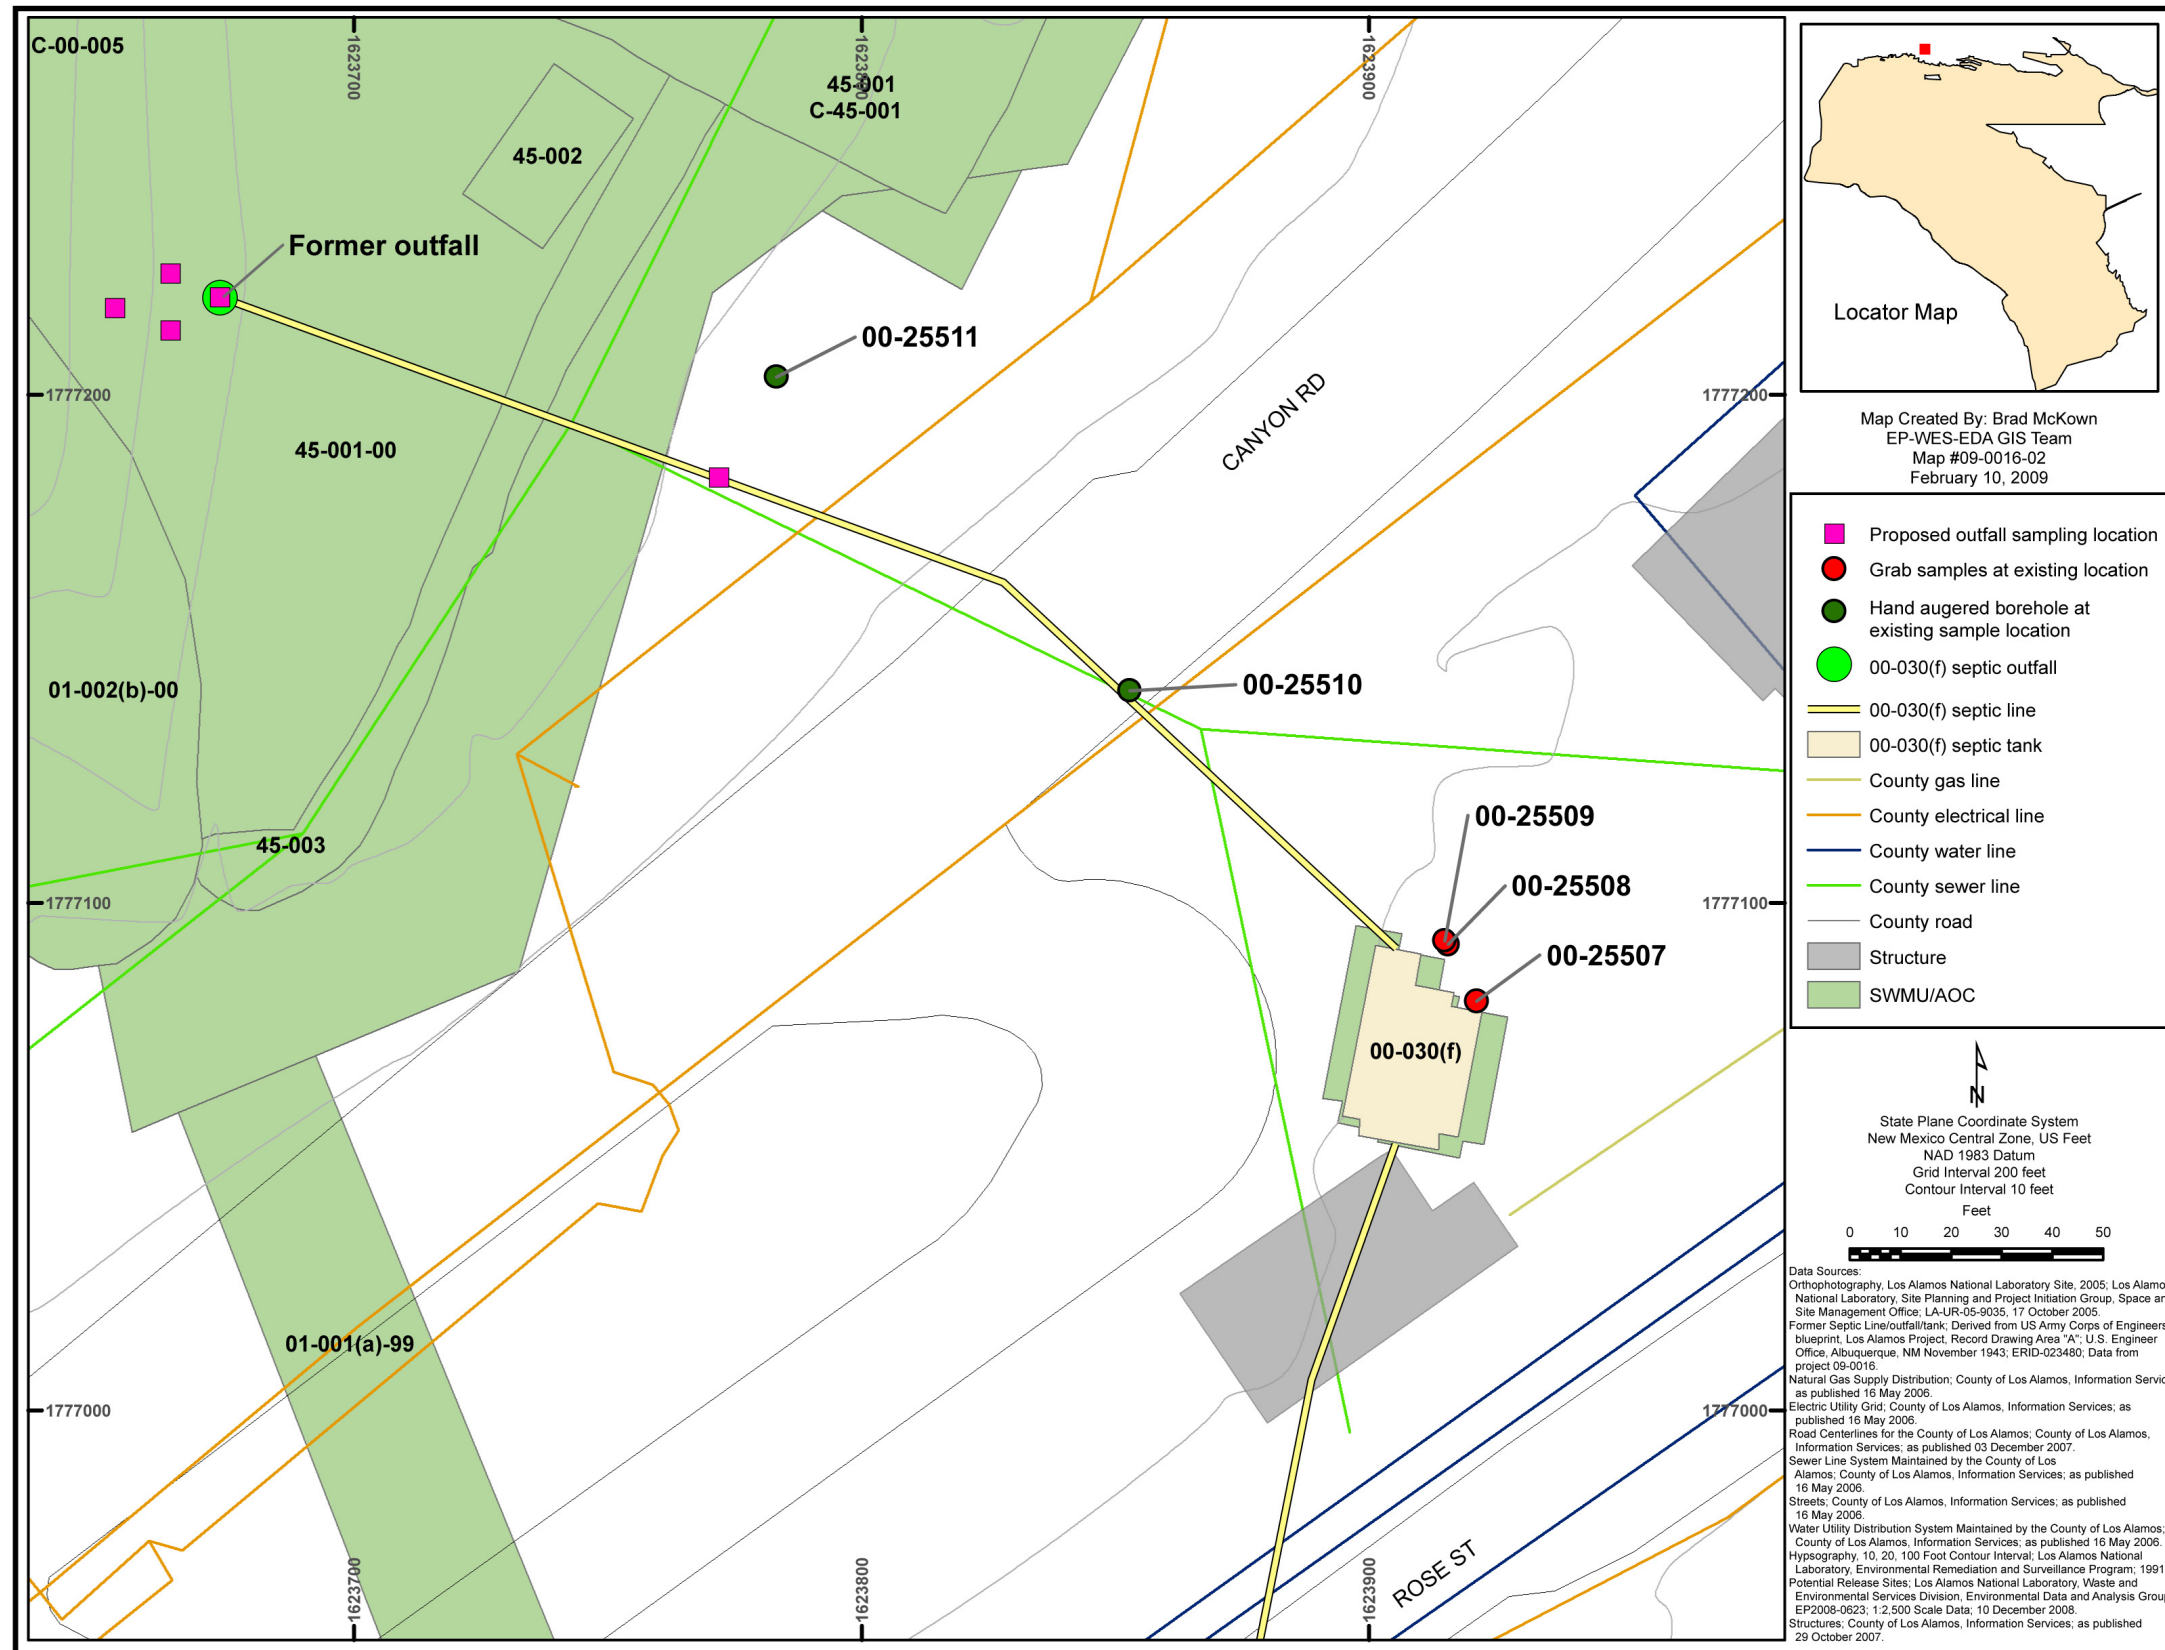
Figure 2.4-1 Existing and proposed sampling locations at AOC 00-030(f)

Based on the newly identified outlet line information, soil/sediment samples will be collected at the approximate locations shown in Figure 2.4-1 and analyzed to better define the nature and extent of contamination, if any, at the site. Four outfall locations will be sampled at two depths each (the surface of the undisturbed soil/sediment and at the tuff interface) for a total of eight samples. One location along the outlet line will be sampled at two depths (directly beneath the former line and 2 ft deeper). These samples will be submitted for analysis of target analyte list metals, cyanide, nitrate, perchlorate, polychlorinated biphenyls, pesticides, volatile organic compounds, semivolatile organic compounds, americium-241, and radionuclides by gamma spectroscopy. These are the same analyses conducted on all other samples collected at AOC 00-030(f) during the 2006 Pueblo Canyon Aggregate Area investigation.

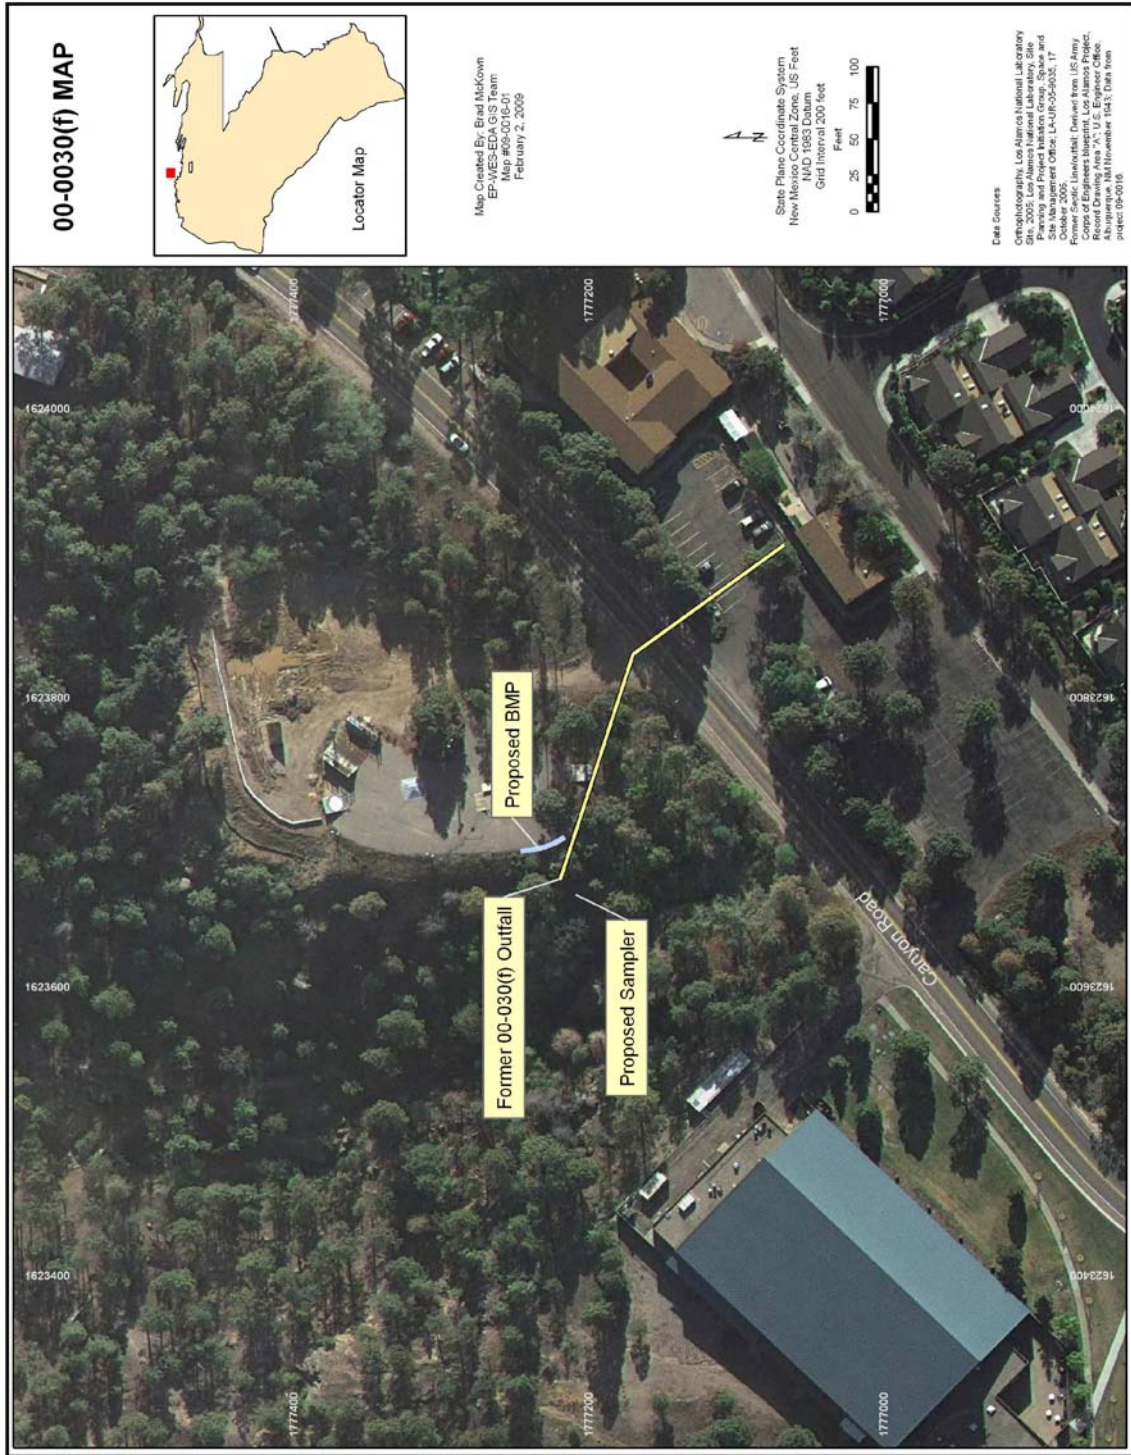
**Figure 3.0-1 Former outfall for 00-030(f)**

The exact location of the former AOC 00-030(f) outfall was unknown until January 2009 when a historical drawing was discovered that showed the tanks and the entire outlet line and provided coordinates for the former outfall location. The correct outfall location for AOC 00-030(f) was north of Canyon Road and southwest of the access road to the Los Alamos County yard (Figure 3.0-1). The former outfall discharged near the rim of the south fork of Acid Canyon, where other significant discharges occurred during the operation of the former TA-45 WWTP.

Notes: The proposed berm will be placed along the outside of the County yard fence. The sampler/sensor will be placed approximately 10 ft downslope from the former outfall location.

In compliance with the certificate of completion for corrective actions complete with controls, the Laboratory will install stormwater controls in accordance with best management practices (BMPs). A small berm is proposed for installation along the perimeter of the Los Alamos County storage area to eliminate the potential for stormwater run-on from this asphalt-covered area. The proposed berm would be approximately 1 ft high by 10 ft long and constructed of base-coarse material. The berm, as well as the drainage channel that routes stormwater from the storage area to Acid Canyon, will be inspected in accordance with the schedule and requirements set forth in the Laboratory's National Pollution Discharge Elimination System permit (the Individual NPDES Permit). In addition, a stormwater sampler/sensor will be installed below the former outfall location to verify that there is no discharge from the AOC 00-030(f) outfall, as required by the Laboratory's Individual NPDES Permit. Inspections and sampling will occur as defined in the Individual NPDES Permit.

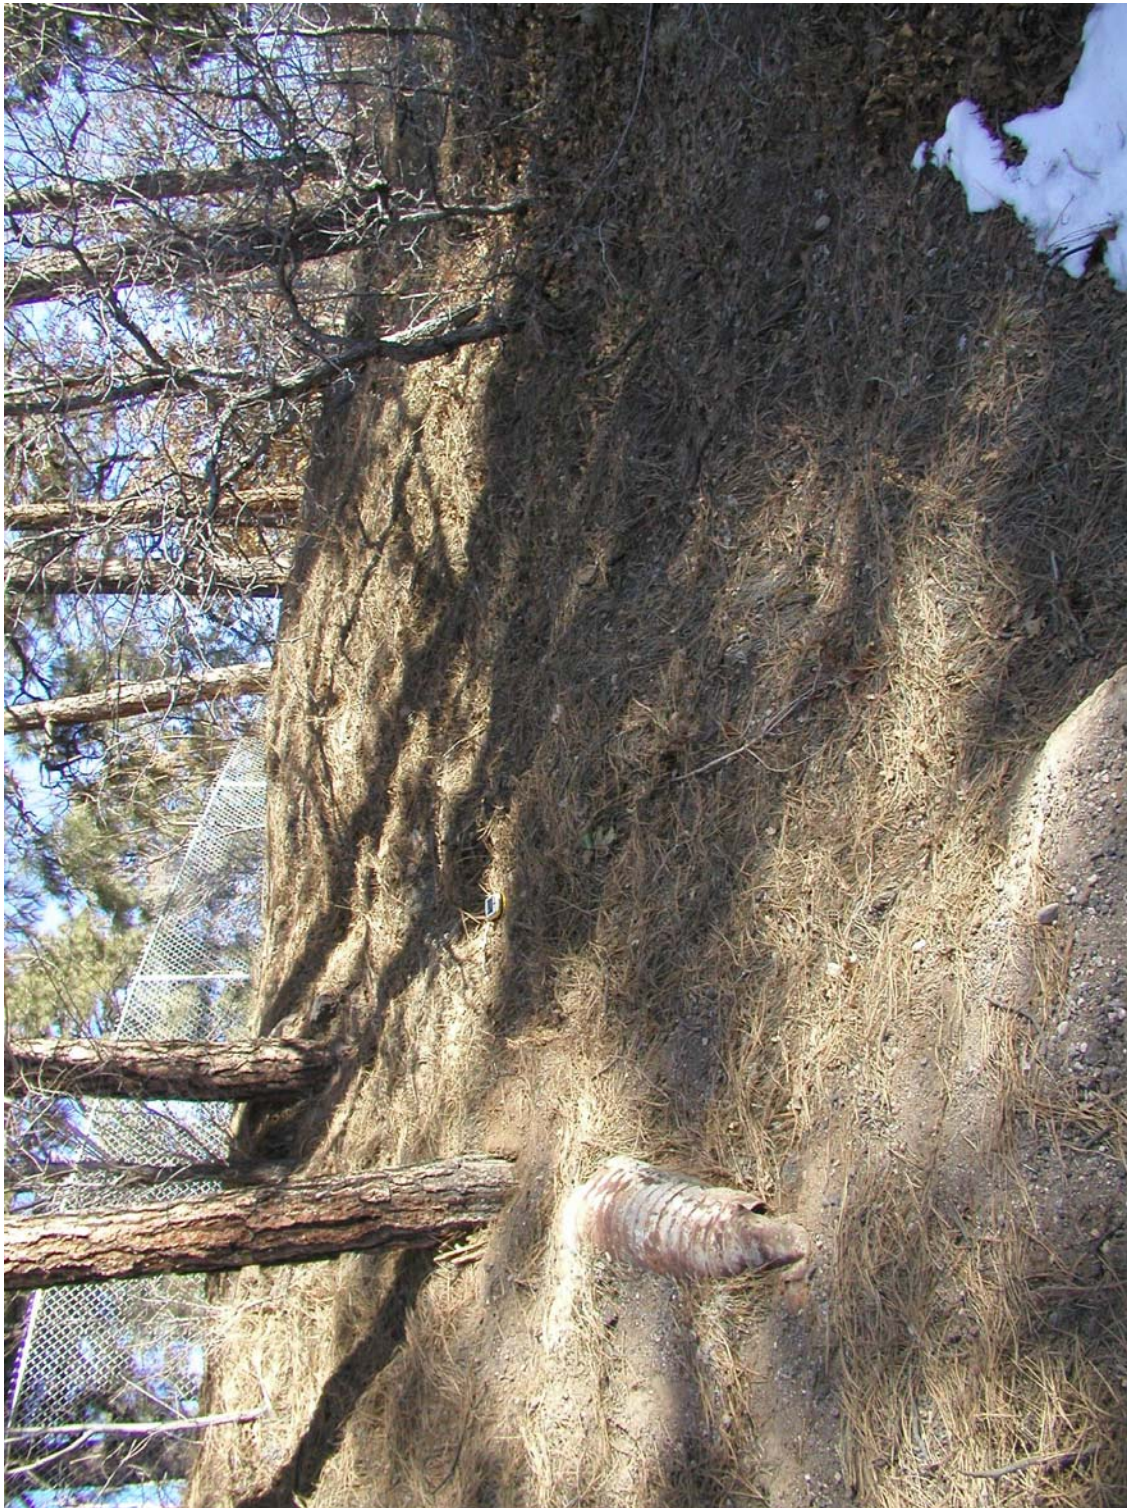
**Figure 3.0-2 Upslope at the location of former outfall for 00-030(f)**

The location of the former outfall is now covered with a thick layer of leaf litter (Figures 3.0-2 and 3.0-3) that serves as a very effective control of stormwater runoff. There is no evidence of any run-on to the former outfall area. The only potential source of run-on to this area is from the county storage yard, located at the site of former TA-45, which currently drains to the south fork of Acid Canyon through a well-defined drainage channel.

Notes: Global positioning system (GPS) unit is in approximate location of former outfall. Note the extensive groundcover and lack of visual evidence of erosion or stormwater runoff. Also note that the piece of corrugated metal culvert is not an outfall.

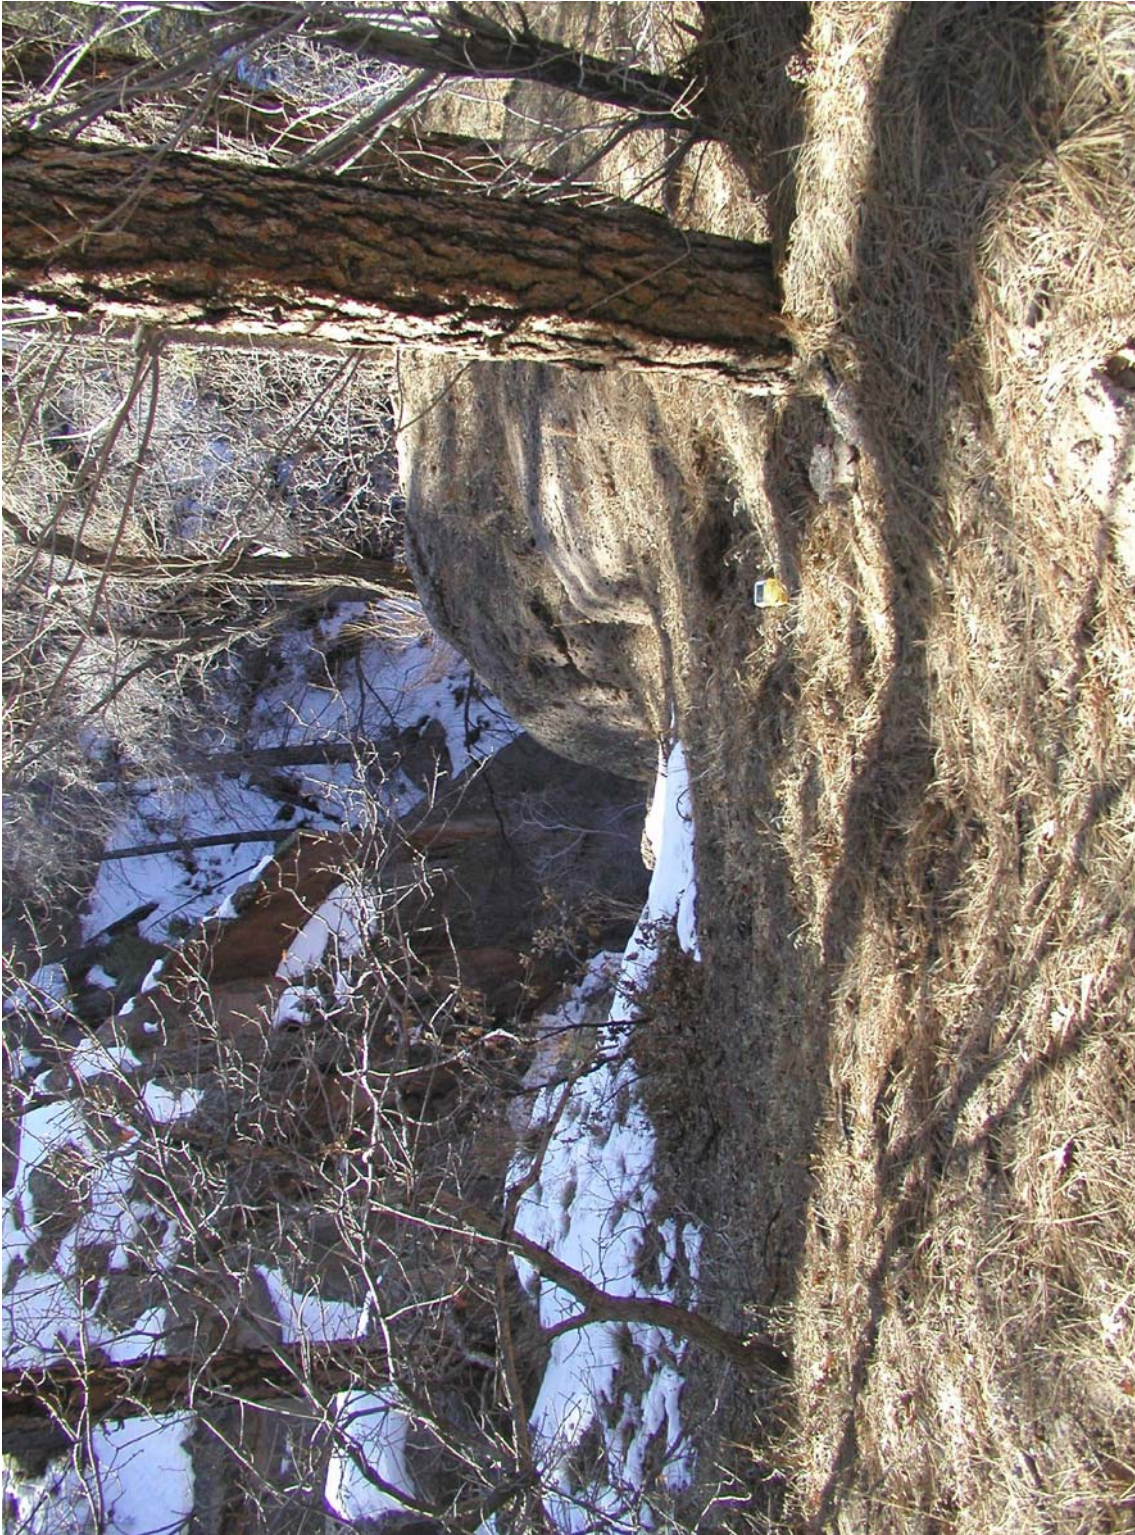
**Figure 3.0-3 Downslope at the location of former outfall for 00-030(f)**

Notes: Global positioning system (GPS) unit is in approximate location of former outfall. Note the extensive groundcover and lack of visual evidence of erosion or stormwater runoff.
