Prepared in cooperation with the

U.S. AGENCY FOR INTERNATIONAL DEVELOPMENT

DEBRIS-FLOW AND FLOODING DEPOSITS IN COASTAL VENEZUELA ASSOCIATED WITH THE STORM OF DECEMBER 14–16, 1999

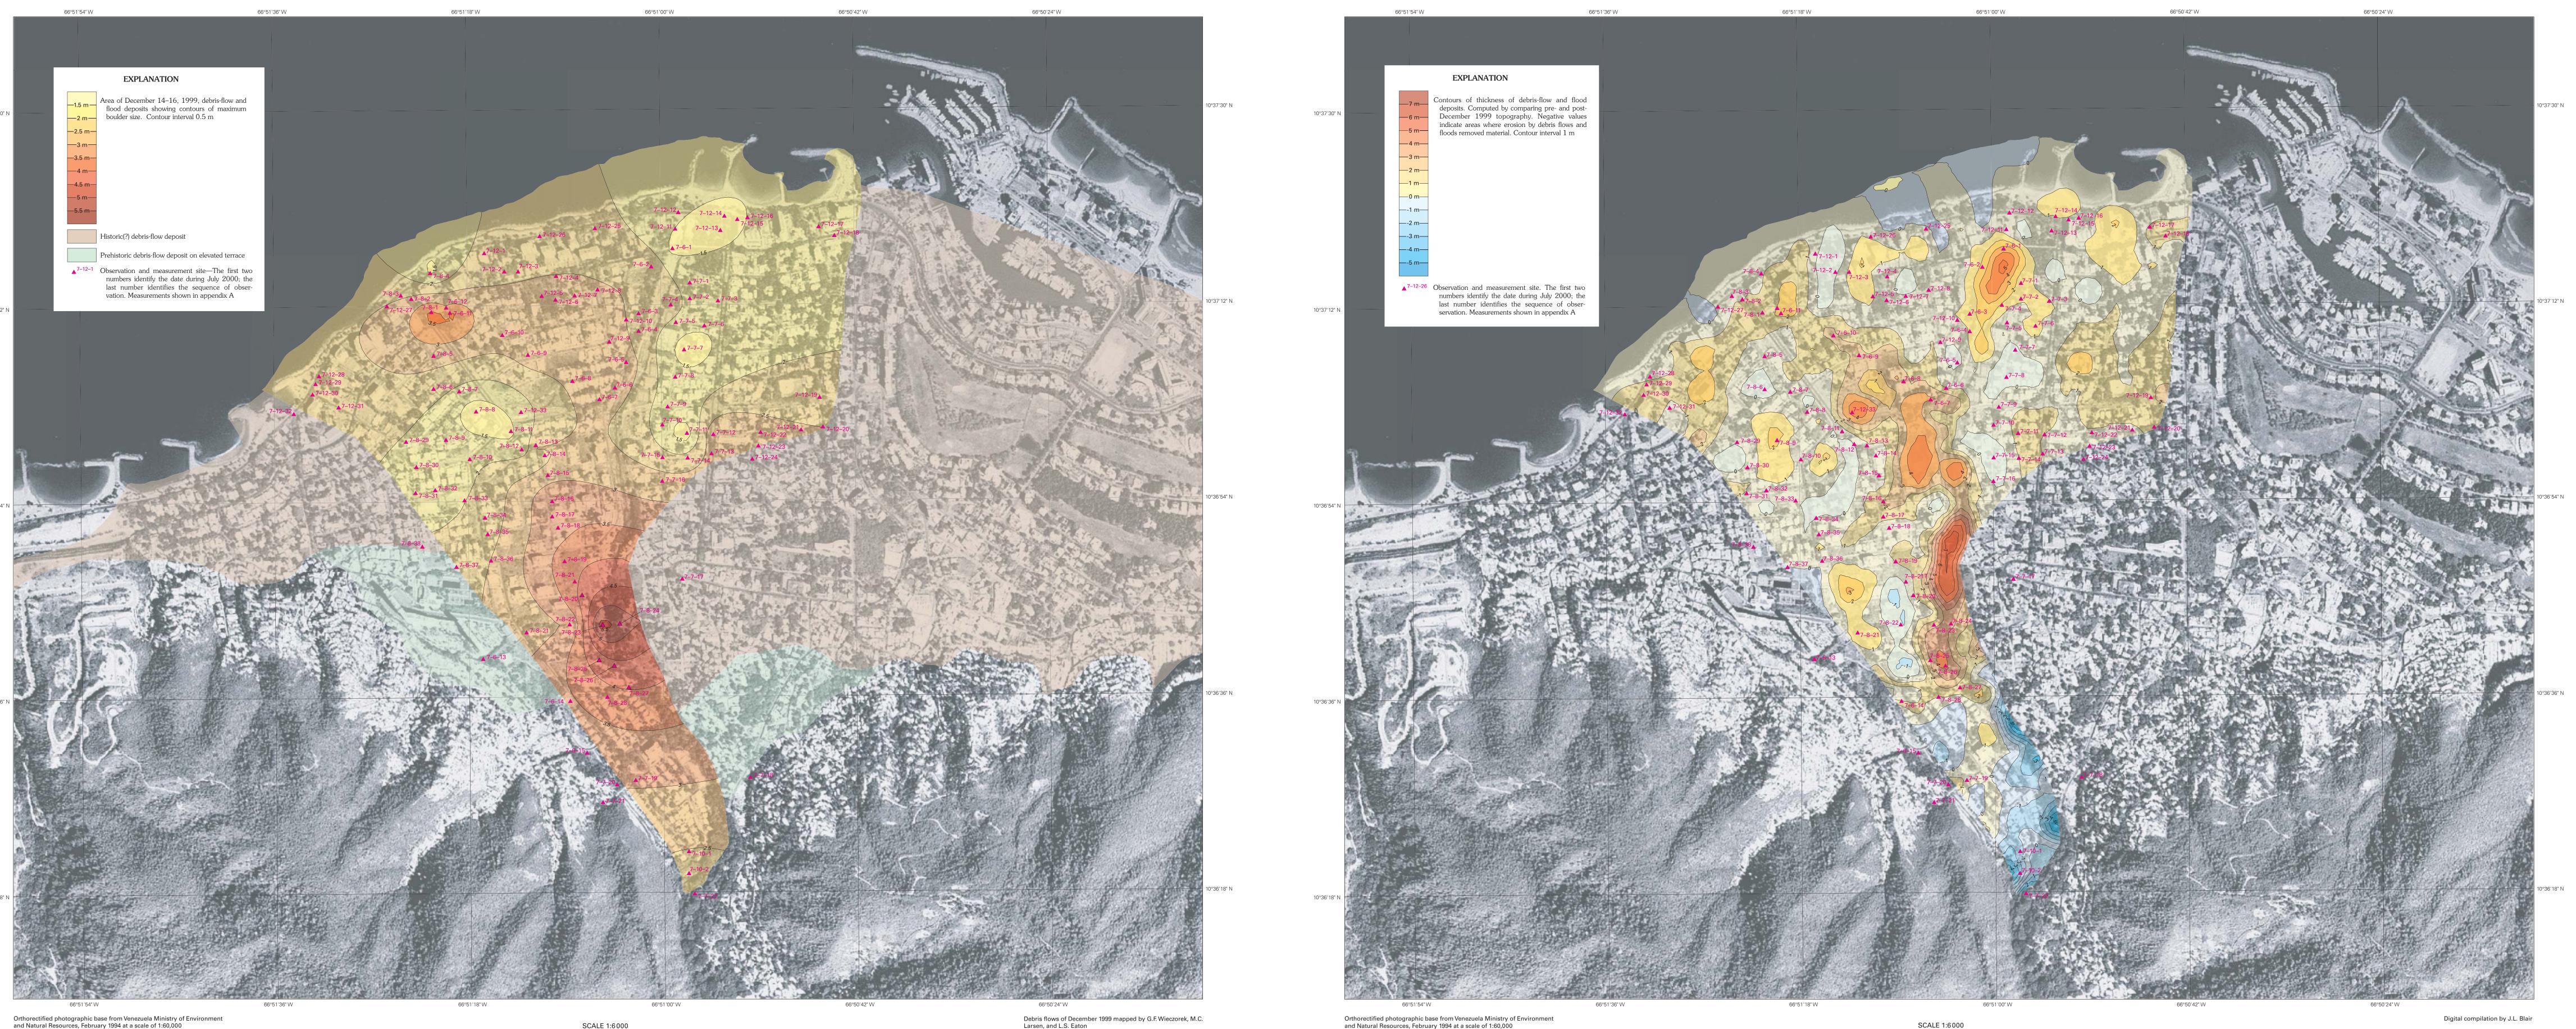
Figure 3.—Debris-flow and flooding deposits with contours of maximum transported boulder size on the Caraballeda fan.

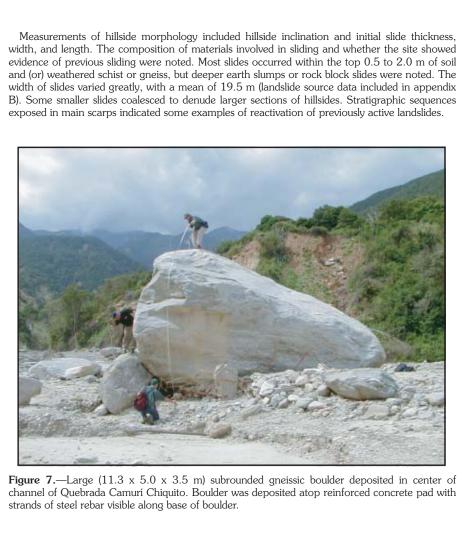
bedrock of Tacagua Formation. Shallow slides that initiated on concave or planar slopes coalesced with other slides as they traveled into main channels. Transmission tower, 30 m high (upper right), for scale. The undermining and collapse of prehistoric debris-flow deposits along the banks of channels was one mechanism by which large boulders became incorporated into the 1999 flows (fig. 8 on sheet 2). Subrounded to subangular large gneissic boulders derived from the Peña de Mora Formation, which crops out at higher elevations within the Sierra de Avila, were found in channels and alluvial fan deposits near the coast, in areas underlain by the Tacagua Formation. The underlying geology and in situ weathering characteristics suggest that these boulders have been transported at least several kilometers, probably by multiple episodes of flood/debris flow over a period of many thousands of years.

Figure 6.—Coalescing shallow landslides initiated on steep hillsides in soils developed over

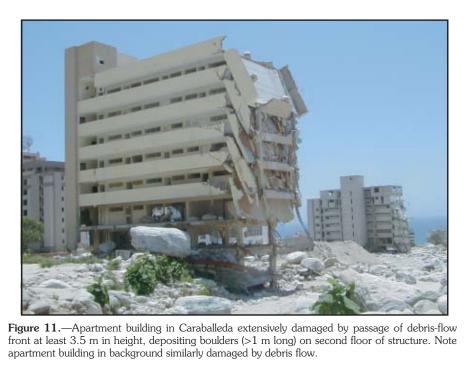
Figure 4.—Debris-flow and flooding deposit thickness determined by comparison of pre-event and post-event topography for the December 1999 storm on the Caraballeda fan.

Total depositional volume on the subaerial fan was calculated by using two different methods. In the field we measured deposit thickness, or if necessary, indications of the depth of flow where material had been removed by cleanup. Where material had been removed, mudlines on structures were used as an approximate measure of deposit thickness. Total depositional volume of 1.9 million m<sup>3</sup> was determined from field measurements by using Earth Vision Version 5.11 software for three-dimensional modeling. This volume is a minimum because it neglects the amount of material that remained in the main channel after the event, but was removed by the time of our visits. The same software also was used for comparison of pre-event and post-event topography on the fan derived from aerial photography, and the results show a depositional volume of 1.8 million m<sup>3</sup>. Figure 4 shows a plot of contoured thickness of deposits using the comparison of pre-event and post-event topography. The determination of volume by comparison of pre-event and post-event topography is the preferred method due to modifications on the fan by the time of our field visit in July of 2000, although both values vary by only about 10 percent.
