SAGO MINE EXPLOSION

JANUARY 2, 2006

INTERNATIONAL COAL GROUP
SAGO MINE

MSHA I.D. No. 46-08791

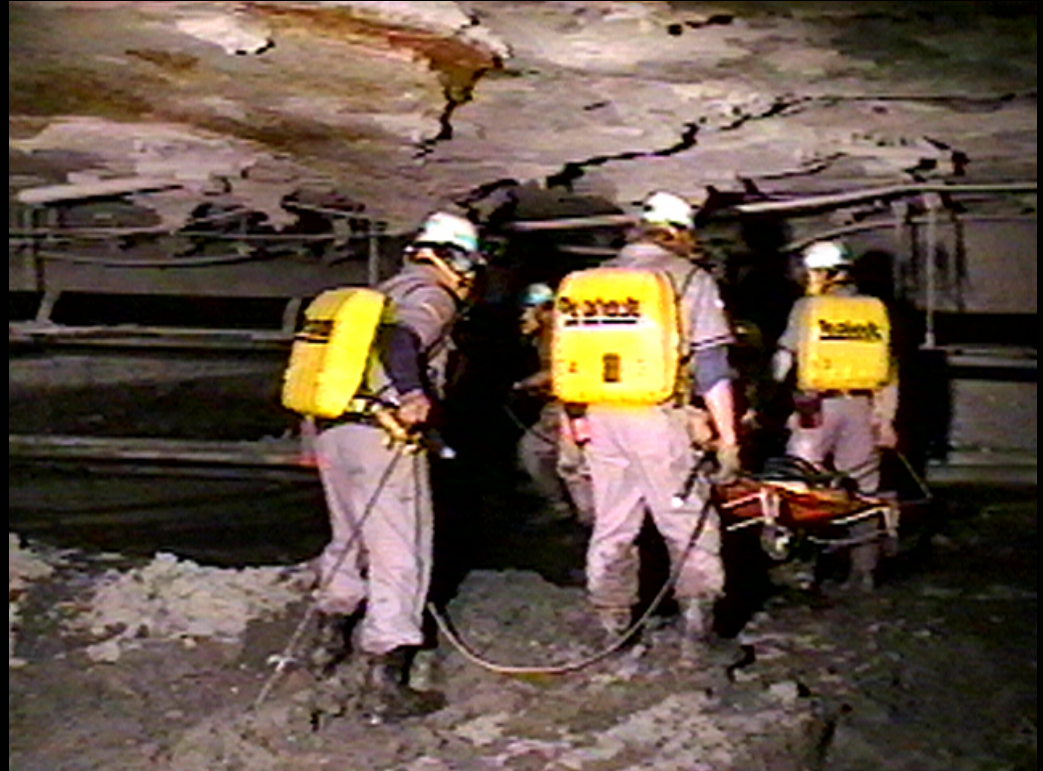
**Mine Rescue Teams
Wearing full
apparatus.**

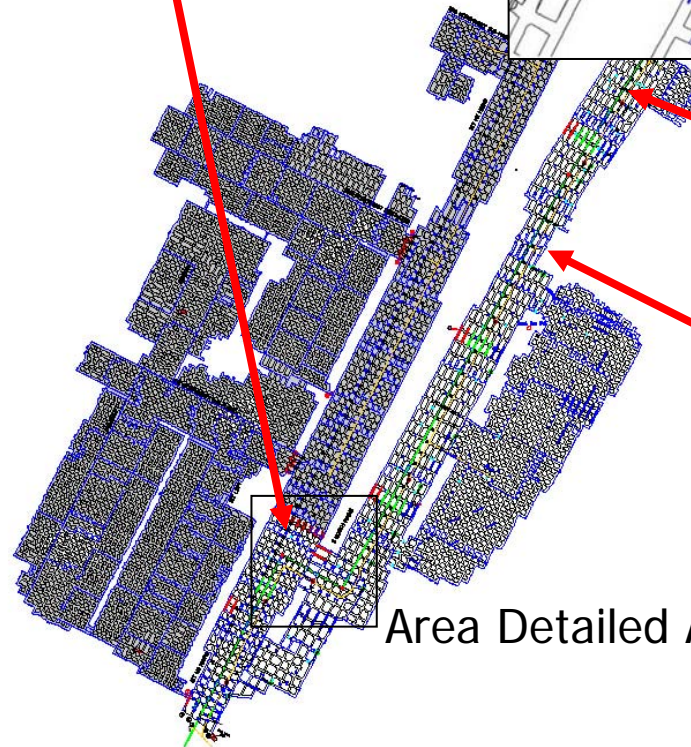
Midnight

January 3, 2006

Ventilation controls damaged.

Explored to X-8 of 4 Belt

8:50 p.m.

January 2, 2006

Explored to X-33 of 3 Belt

Area Detailed Above

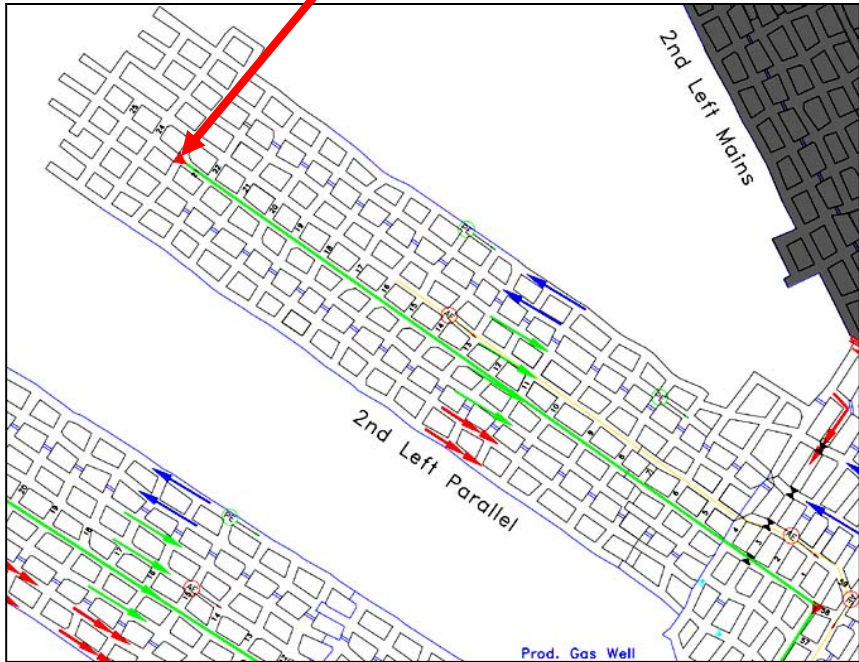
**2 Left Borehole punches
into mine. 1200 ppm CO
detected.**

- **6:22 a.m.** Teams re-enter mine.
- **6:35 a.m.** Camera is lowered into the 2-Left borehole. No indications of explosive forces are observed.
- **6:50 a.m.** 1 Left borehole started.

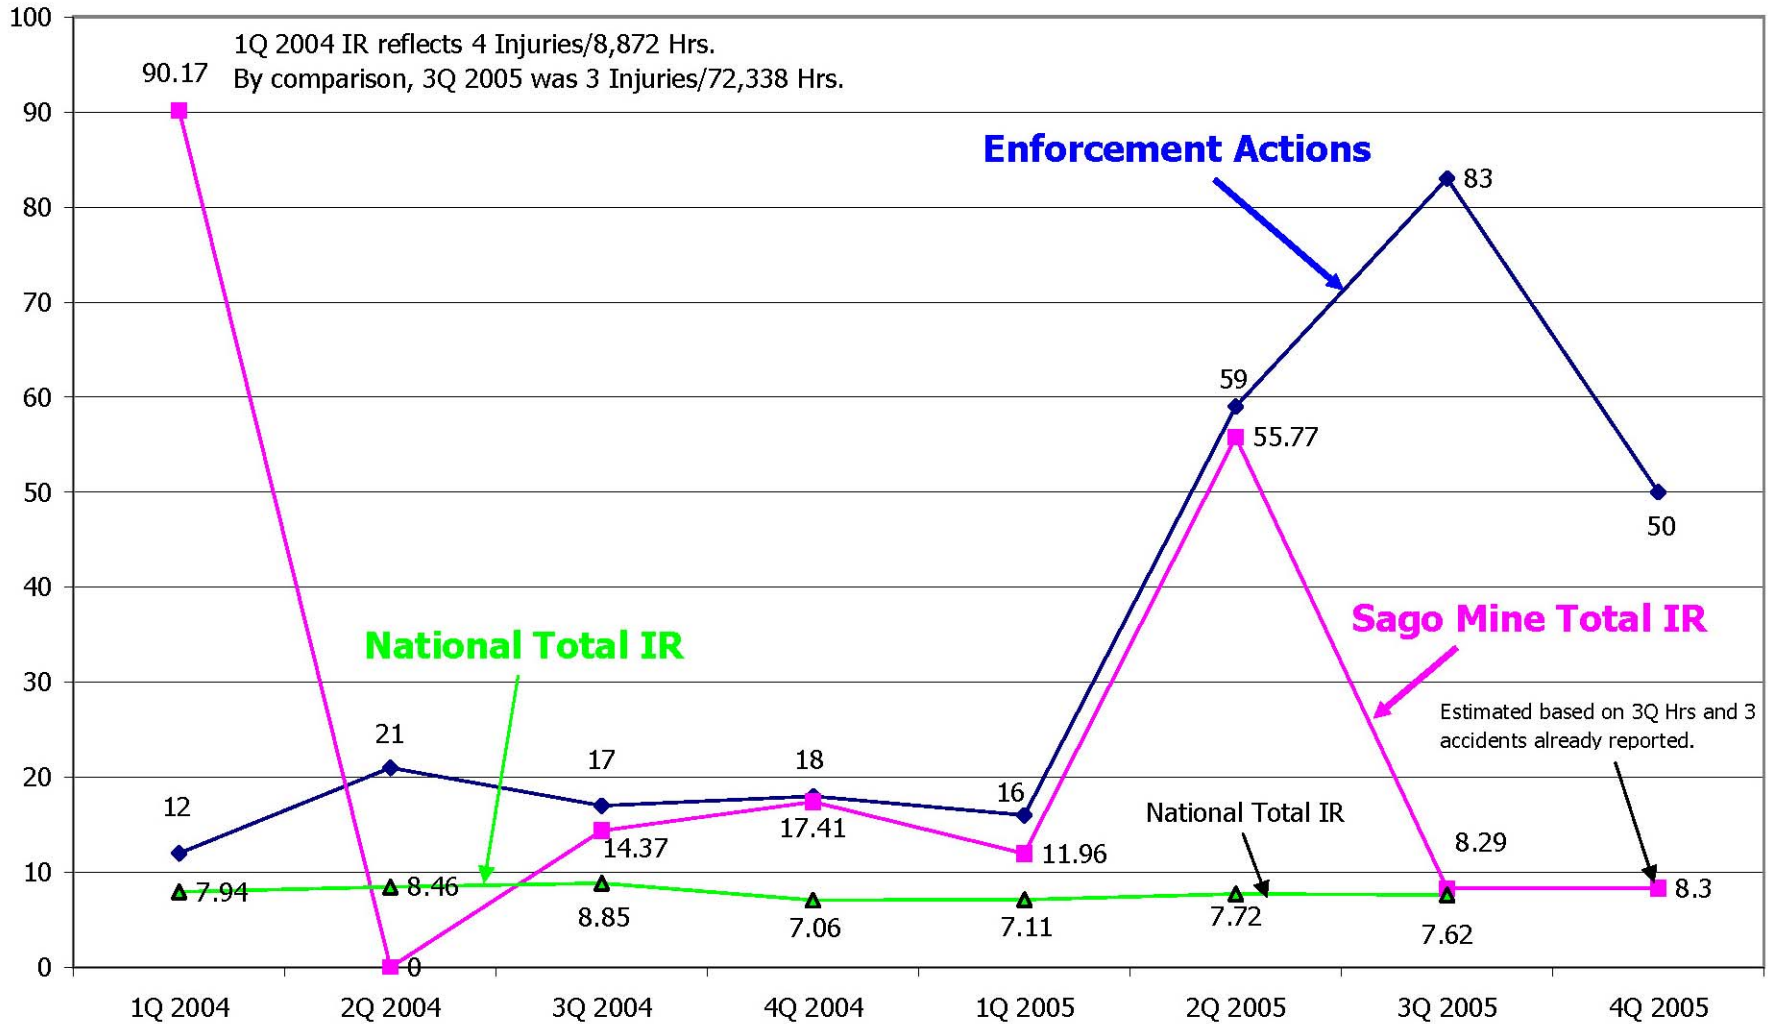
Quarterly Enforcement Actions vs Total Incident Rate

Sago Mine 2004 - 2005
