MSHA WEBCAST WITH STAKEHOLDERS

January 28, 2004

Remote Control CM Crushing Fatalities

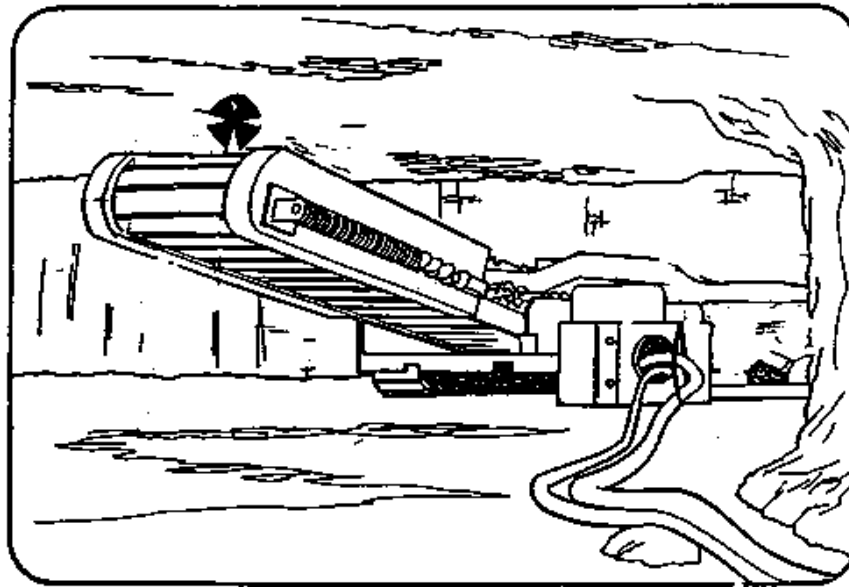
FATAL MACHINERY ACCIDENT
No. 1 Mine (ID No. 46-07430)
Daniel's Branch Coal Co., Inc.
Hampten, Mingo County, West Virginia

COAL MINE FATALITY - On Tuesday, April 18, 1995, at 2:10 a.m., an electrician helper was fatally injured while making repairs to a radio-remote controlled continuous mining machine. The electrician helper was positioned in the conveyor of the continuous miner during the installation of a hydraulic relief valve. The conveyor boom of the continuous miner was positioned against the roof and had been securely blocked. The helper remained in the conveyor to observe the relief valve for oil leaks while another miner energized the radio-remote. When the pan switch was engaged on the radio-remote control, the conveyor chain also started.

The electrician helper was forcibly pushed against the roof by the conveyor chain.

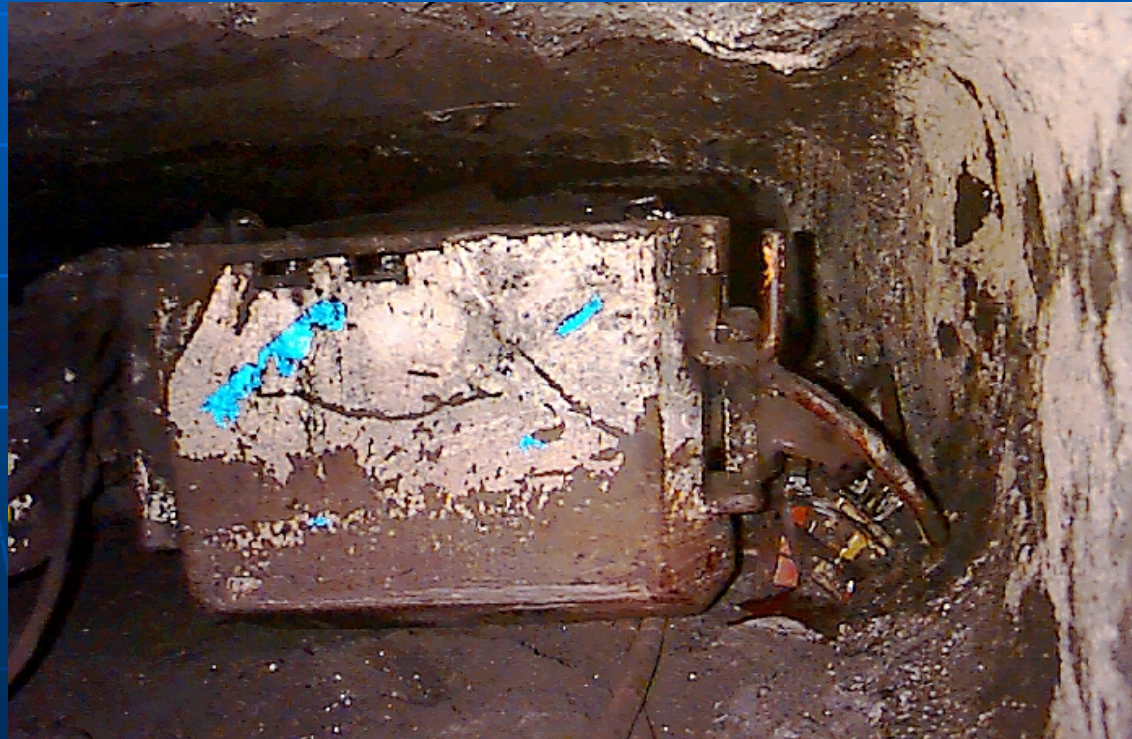
COAL MINE FATALITY - On Monday, October 21, 1996, a continuous mining machine operator, using a radio remote control, had backed the continuous mining machine away from the face. The mining machine operator crawled inby, dragging the remote control unit, to the rear corner of the mining machine. The continuous mining machine's trailing cable rolled out of the side cable hook and fell onto the remote control unit inadvertently activating the left tram reverse control. The rear portion of the mining machine moved suddenly toward the right rib, crushing the continuous mining machine operator. Investigators found the remote control unit's "slide" tram control safety-device, taped in the activated position.

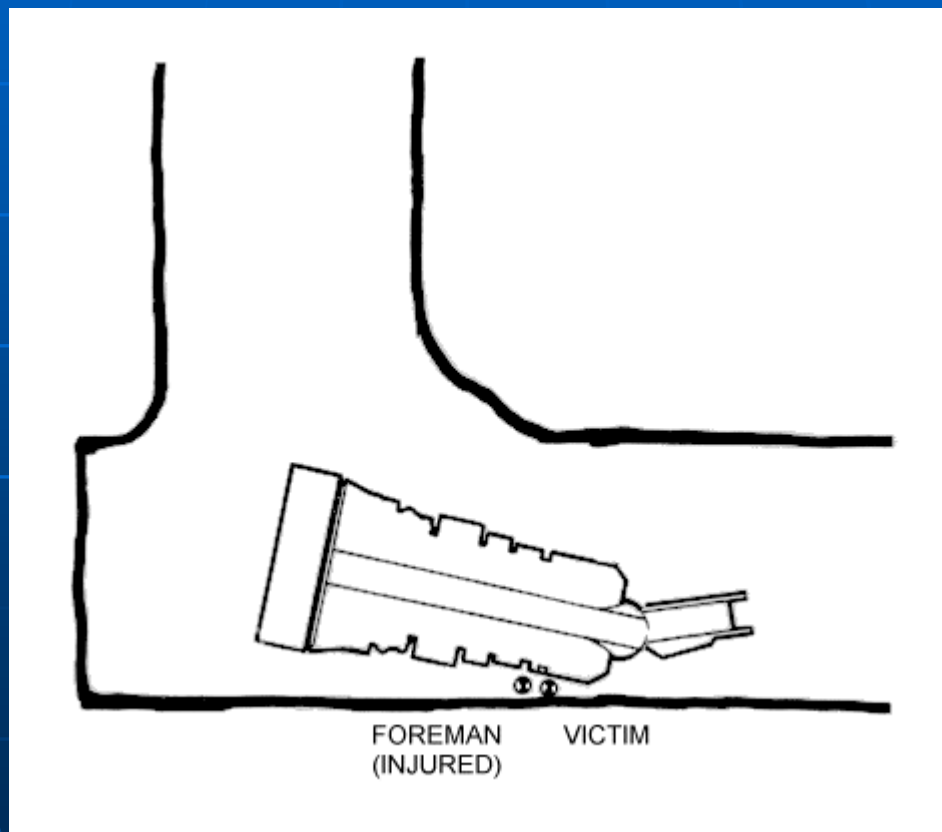
Plan View of the Accident Area

COAL MINE FATALITY - On Friday, March 28, 1997, in Eighty-Four, Pennsylvania, two mechanics and a maintenance foreman were troubleshooting a remote-controlled continuous mining machine. During mining operations, the continuous mining machine was not functioning properly and had unexpectedly stopped while tramping out of a working place. One of the mechanics was crouching between the machine and the coal rib peering through a sight glass to observe the operation of the diagnostic lights of the remote-controlled circuit. The continuous mining machine pivoted suddenly, pinning the maintenance foreman and the crouching mechanic against the coal rib. The mechanic was fatally injured but the foreman only received minor injured.

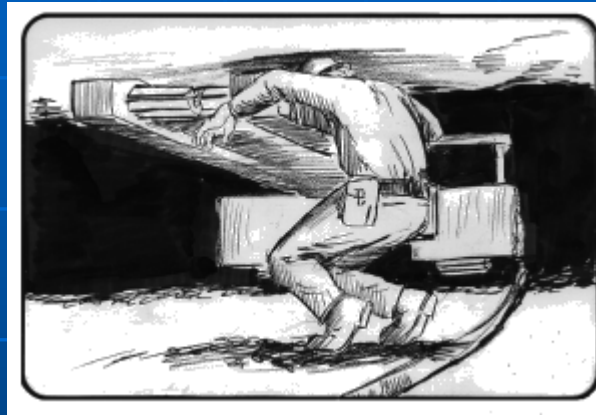
COAL MINE FATALITY-On Monday, July 26, 1999, a continuous miner helper was fatally injured in a machinery accident. The victim was attempting to drag the trailing cable out of the #3 entry when he apparently tripped or stumbled forward against the conveyor boom of the continuous miner which was being trammed across the intersection toward the #2 entry. The continuous miner trammed over road gob causing the conveyor boom end of the machine to tilt upward against the mine roof crushing the miner helper between the boom and mine roof resulting in fatal injuries. The miner operator reported that he was not aware that the victim had fallen against the boom of the machine.

- **All miners should be in a safe location while the continuous miner is being moved from one location to another.**
- **All mining equipment should be stopped while the trailing cable is being hung**
All personnel who operate a continuous miner should be instructed to make sure the conveyor boom and ripper head are lowered, as far as possible, prior to moving the miner from one location to another.
- **All miners should wear reflective material.**

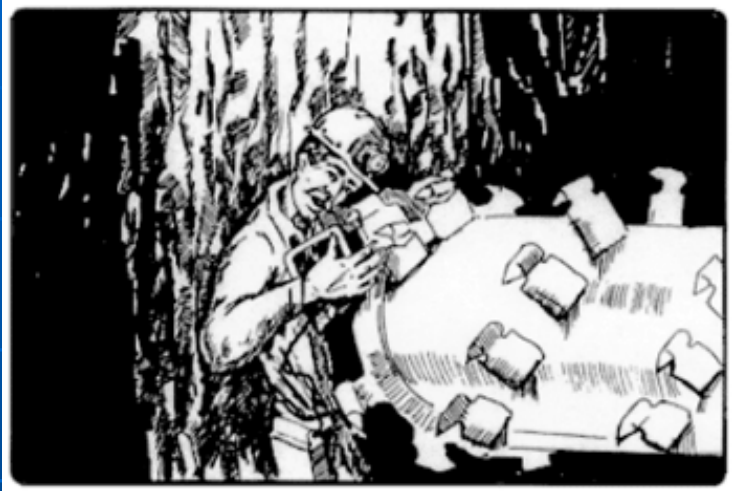
COAL MINE FATALITY - On Friday, January 21, 2000, a continuous mining machine operator was fatally injured when he came in contact with the ripper head of the continuous mining machine while it was in motion. While there were no eye witnesses to the accident, it was reported that the victim had positioned himself in front of the continuous mining machine in order to change bits. At the time of the accident the victim had the machine's remote control box in his possession.

- All power circuits and electrical equipment shall be de-energized before any work is done on such circuits and equipment.
- All areas where persons are required to work or travel should be kept free of tripping and stumbling hazards.
- Always make sure that all persons, including yourself, are in a safe location before energizing.

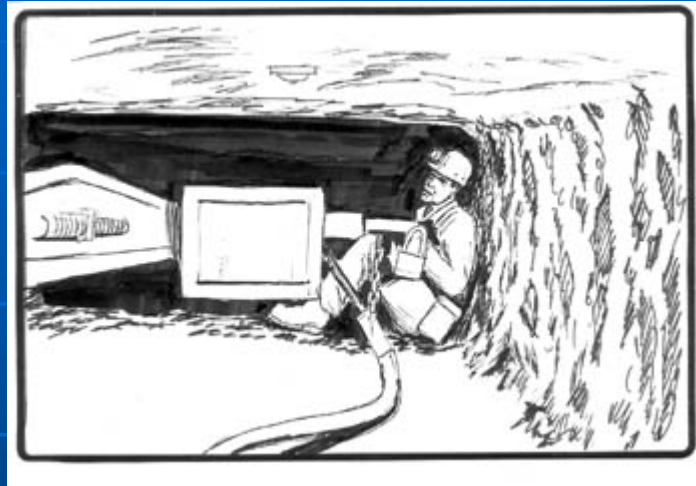
COAL MINE FATALITY - On Friday, May 12, 2000, a 29 year old continuous mining machine operator, using a radio remote control, positioned himself between the mining machine and right rib as he trammed the machine out of the working face. Fatal crushing injuries resulted when the victim was caught by the trailing cable support bracket, which protruded about 17 inches from the right rear side of the machine. The mining height at this location was 41 inches.

- When a continuous mining machine is being trammed by remote control, the continuous mining machine operator and all other persons must be outside the machine's turning radius and away from pinch points at all times.
- Adequate task training to assure safe operation of equipment requires training and observation of all tasks required to be performed by the equipment operator. Proper follow up is required to assure the training is understood and implemented.

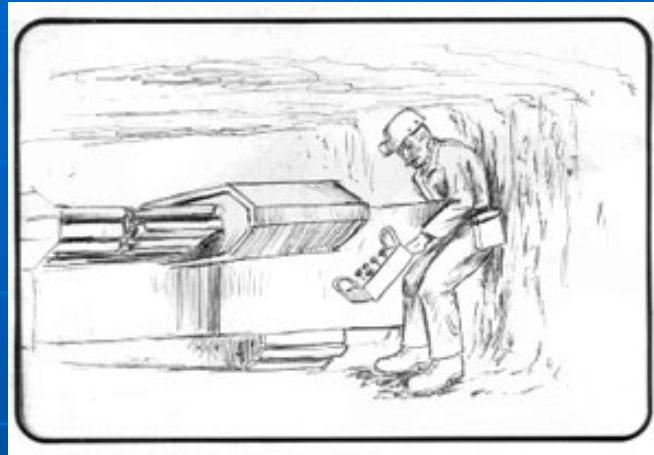
COAL MINE FATALITY - On Tuesday, August 15, 2000 a 40 year old continuous mining machine operator with 22 years experience received fatal crushing injuries while tramming a radio remote control mining machine. The victim was caught between the rear of the continuous mining machine and the coal rib.

- When a continuous mining machine is being trammed by remote control, the continuous mining machine operator and all other persons must be outside the machine's turning radius and away from pinch points at all times.
- All persons helping operators move mobile equipment should be positioned a safe distance from the equipment while it is in motion.
- Always be alert to your location when equipment is in motion.

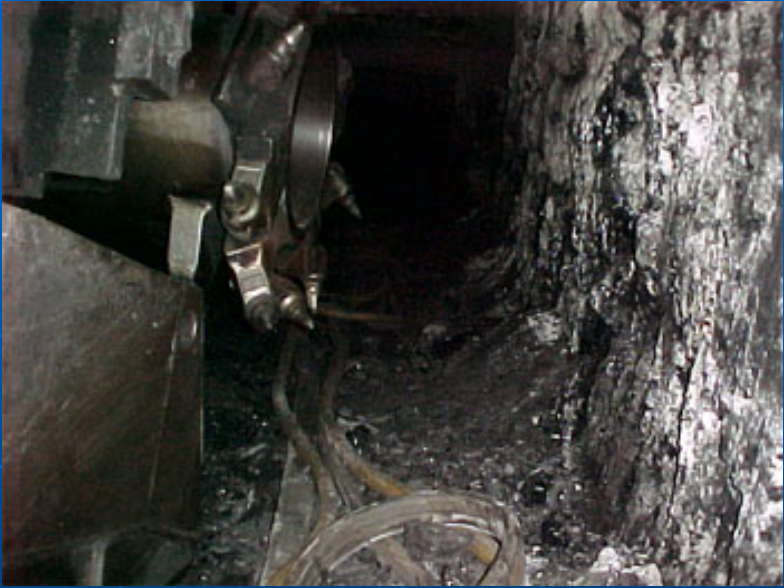
COAL MINE FATALITY - On Wednesday, November 21, 2001, a fatal machinery accident claimed the life of a 38 year old continuous mining machine operator. The operator had completed mining in a crosscut, and was backing the continuous miner from the No. 3 entry to the No. 4 entry, to allow roof bolting equipment access to the area which was mined. The operator was found pinned between the cutting head of the continuous mining machine and the out by coal rib.

- Always be sure that everyone is in a safe location when starting the equipment.
- Equipment should be deenergized before any work is done on the equipment.
- Do not position yourself anywhere beside the continuous miner during tramming operations.
- Ensure that persons are beyond the continuous miner's turning radius during remote control tramming.

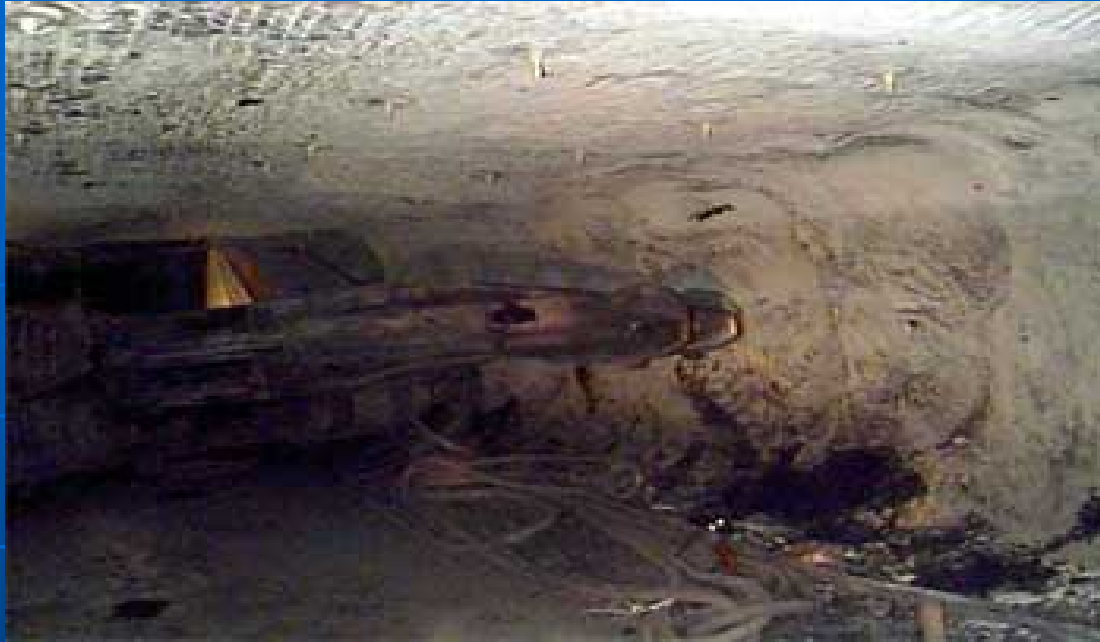
COAL MINE FATALITY - On March 22, 2002, a 33 year old section foreman was fatally injured when he was caught between the conveyor boom of a continuous mining machine and the coal rib. The victim was using a remote control unit to tram the machine when he was struck by the end of the conveyor boom.

- Continuous mining machine operators should never be located between the machine and the coal rib while the machine is being trammed from place to place by remote control.
- When moving continuous mining machines around corners, or in other instances where the left and right traction drives are operated independently, low tram speed should be used.
- The pump motor should be de-energized, and all machine motion stopped, when the trailing cable or water line has to be repositioned in close proximity to the continuous mining machine.

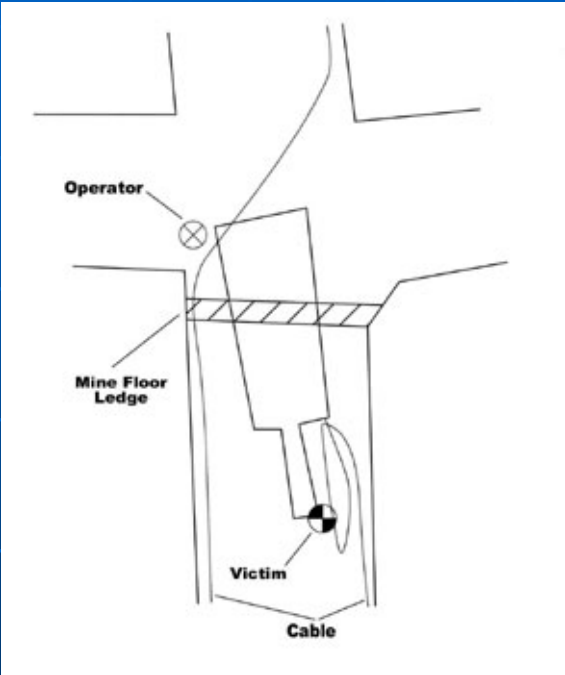
COAL MINE FATALITY - On Monday, August 12, 2002, at approximately 1:45 p.m., a 23 year old miner was killed when his head was caught between the conveyor boom of the continuous mining machine and the mine roof. The continuous mining machine operator and victim were moving the mining machine from the working section to the surface for repairs. About half way to the surface, the front of the machine dropped over a small ledge in the mine floor causing the conveyor boom to strike the roof. The victim, who had been assisting with the continuous miner cable, was caught between the boom and roof. The victim's regular job title was greaser. He had 6 months and 10 days of mining experience.

- Establish procedures for moving machinery and equipment.
- Assure that personnel do not position themselves in proximity to moving machinery.
- Maintain clear visibility with all personnel in the vicinity of moving equipment.
- Keep trailing cables on the operator's side of the machine when moving the machine.

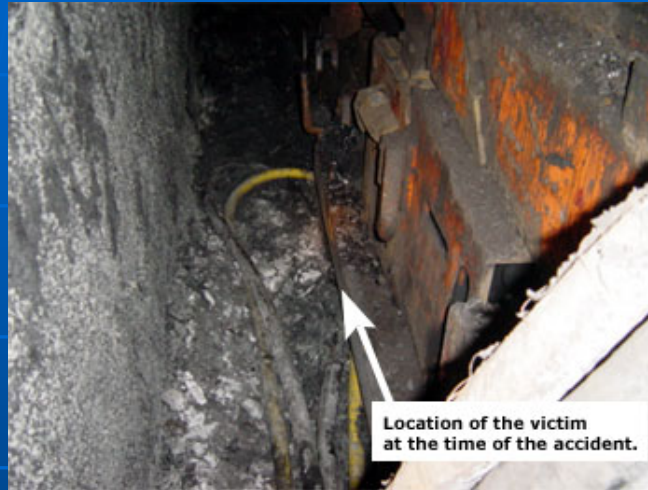
COAL MINE FATALITY - On Tuesday, April 15, 2003, a fatal machinery accident claimed the life of a 43-year-old continuous mining machine operator with 12 years of mining experience. The operator had completed mining in the face of No. 2 entry and was backing up the remote control continuous miner to clean up the left side of the cut. The operator was found behind the line curtain and was pinned between the left rear of the continuous mining machine and the left rib.

- Avoid pinch points between the rib and machinery during tramming operations.
- Ensure everyone is in a safe location when starting and moving the equipment.
- Avoid positioning yourself behind the line curtain while tramming machinery.
- Ensure that persons are beyond the machine's turning radius during remote control tramming.

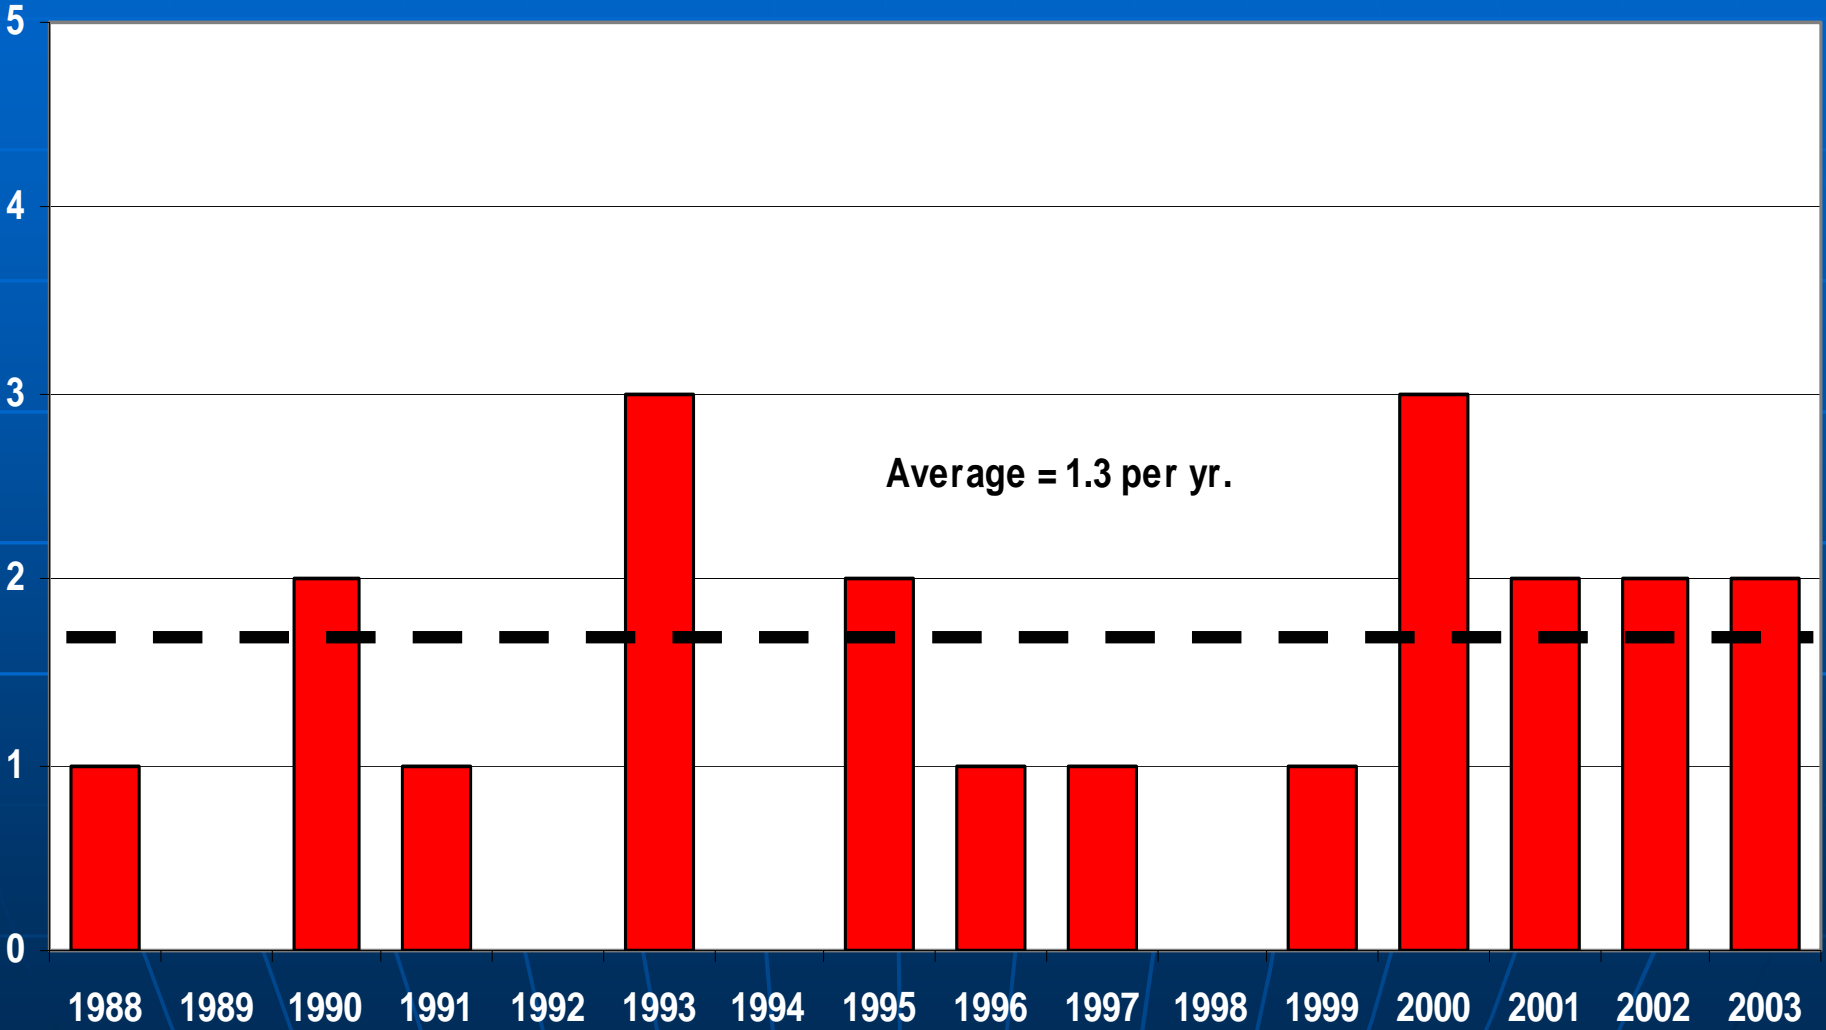
Average = 1.3 per yr.

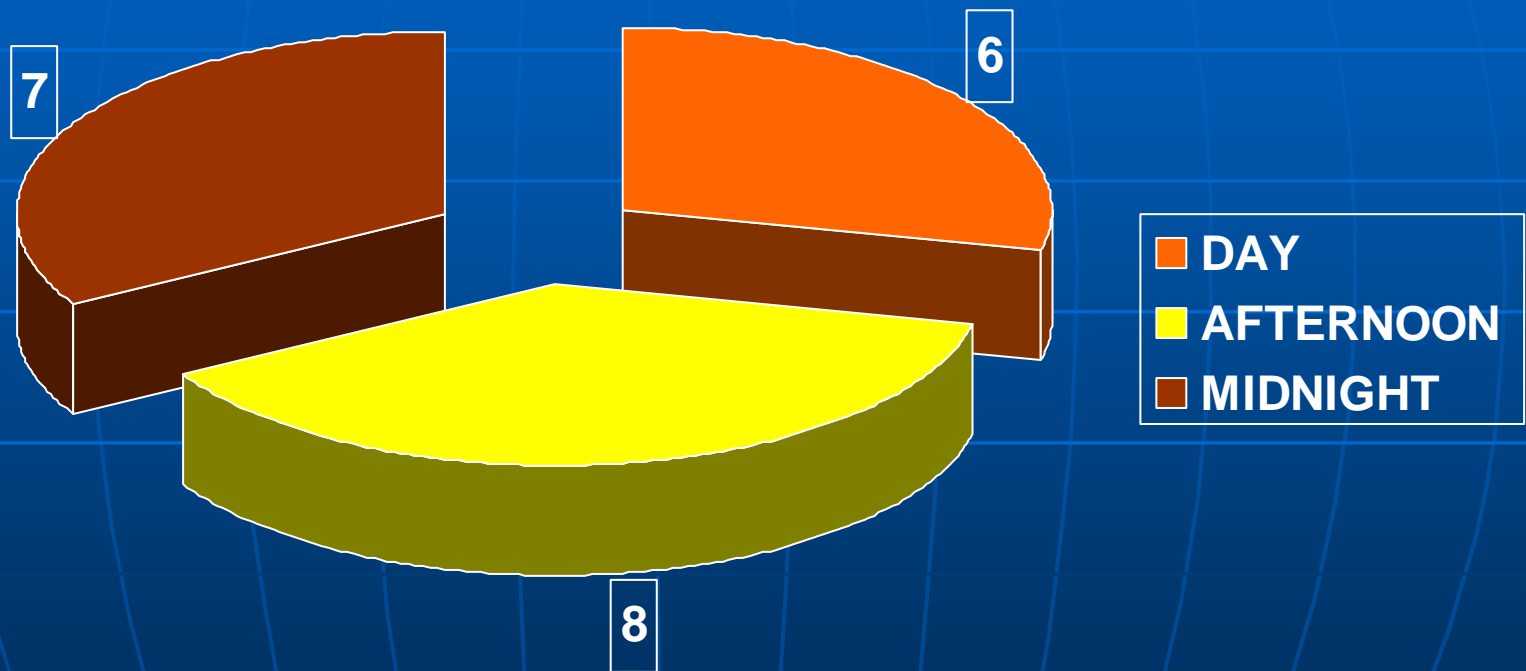
FATALITIES BY SHIFT

1988-2003

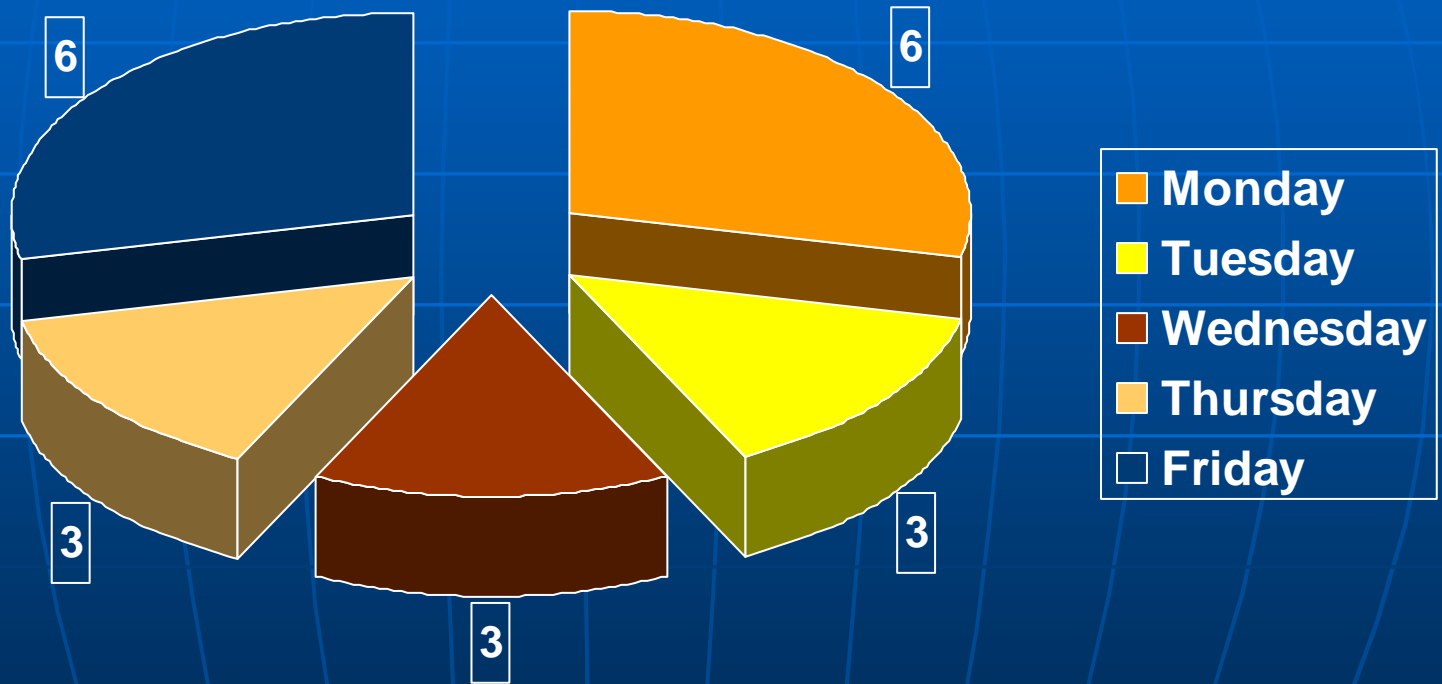
FATALS BY DAY OF WEEK

1988-2003

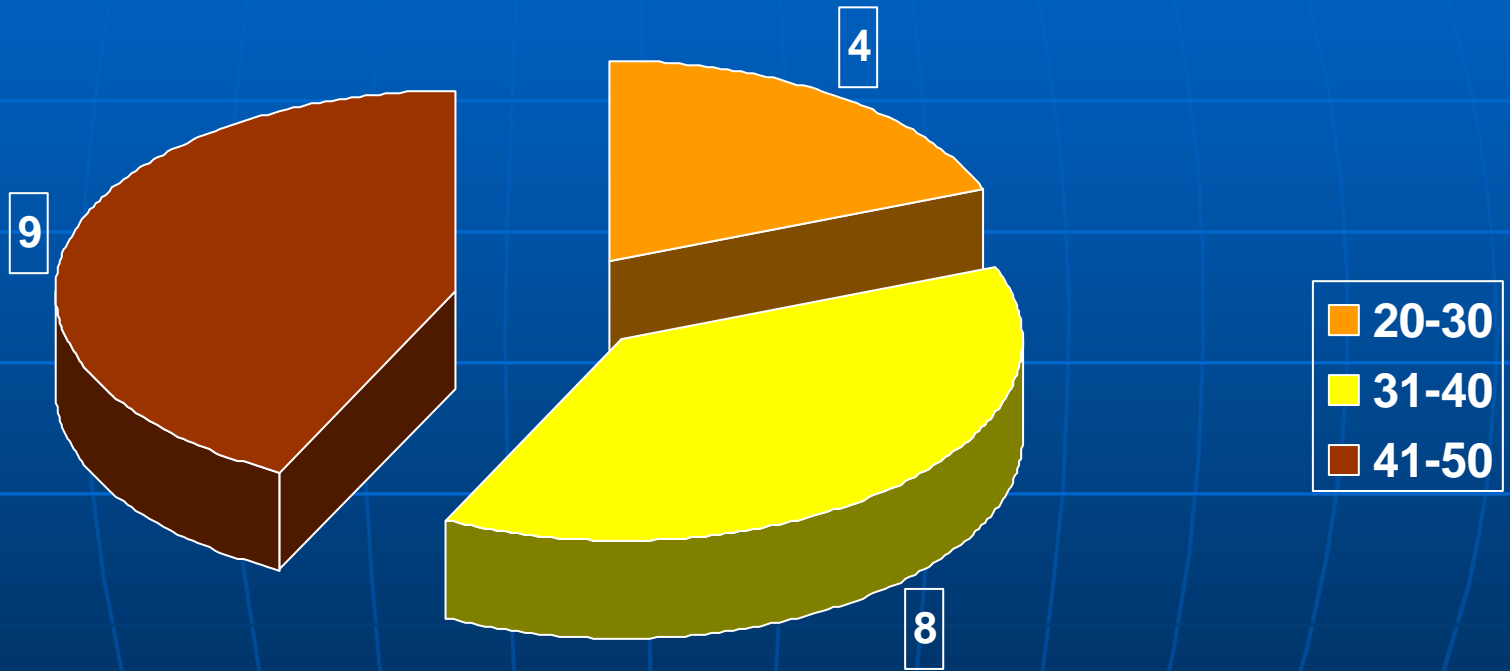
FATALITIES BY AGE

1988-2003

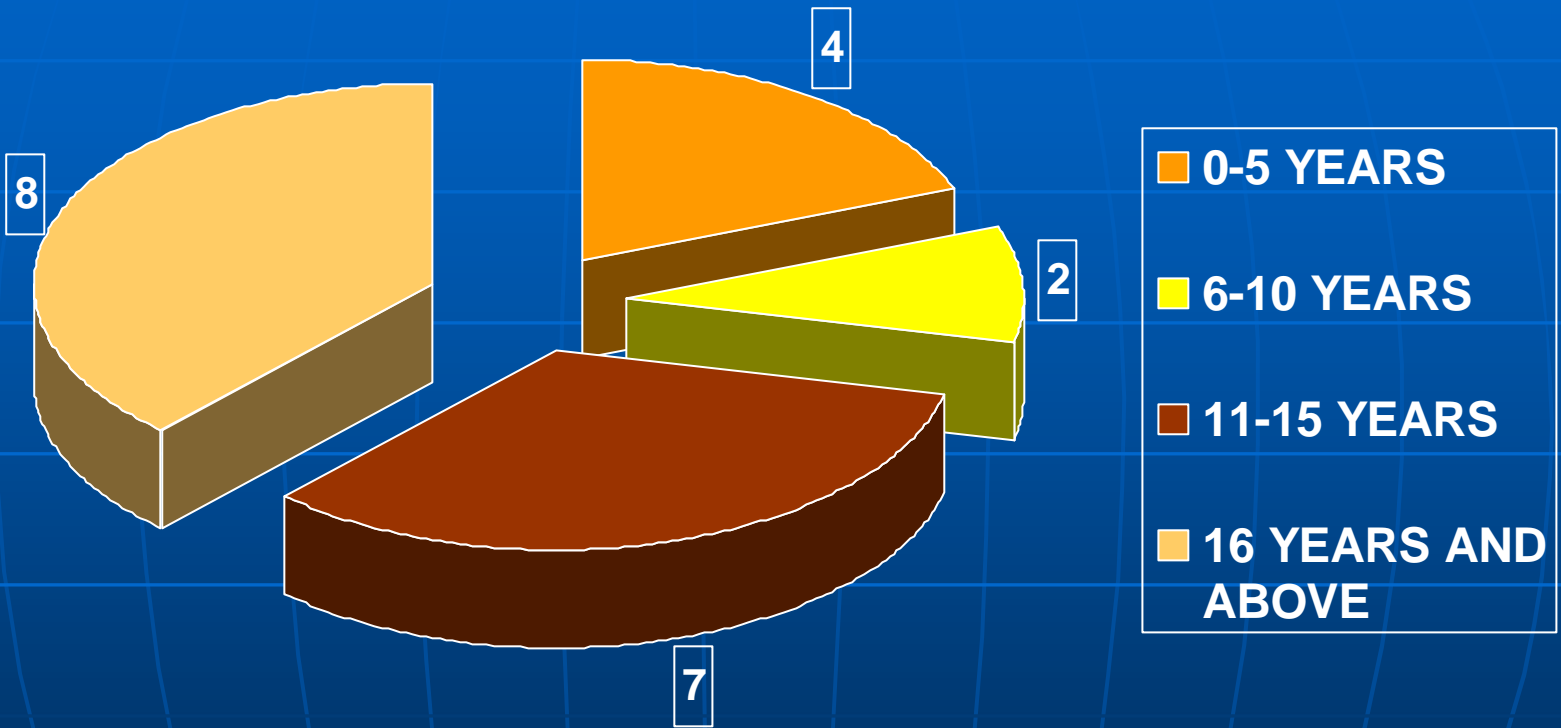
FATALS BY TOTAL EXPERIENCE

Experience rounded to nearest year

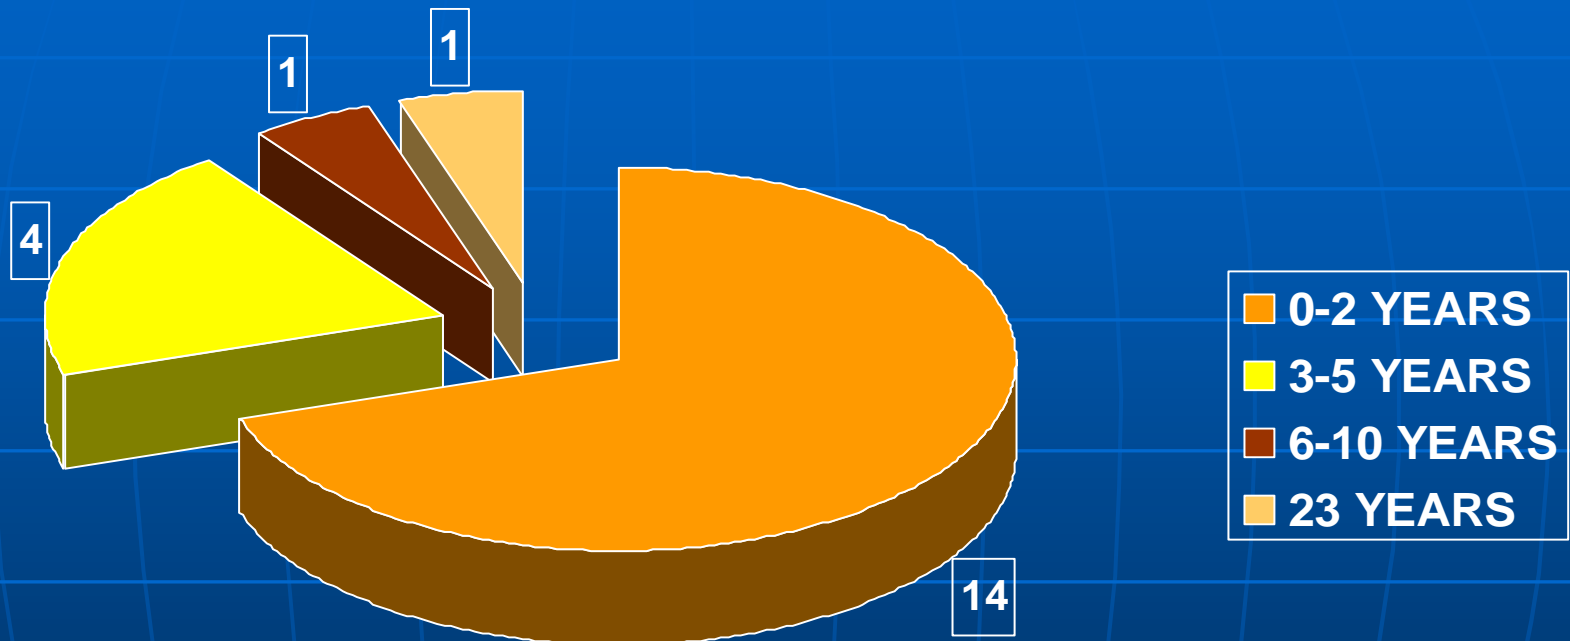
FATALS BY EXPERIENCE AT MINE

One fatality excluded-
incomplete data

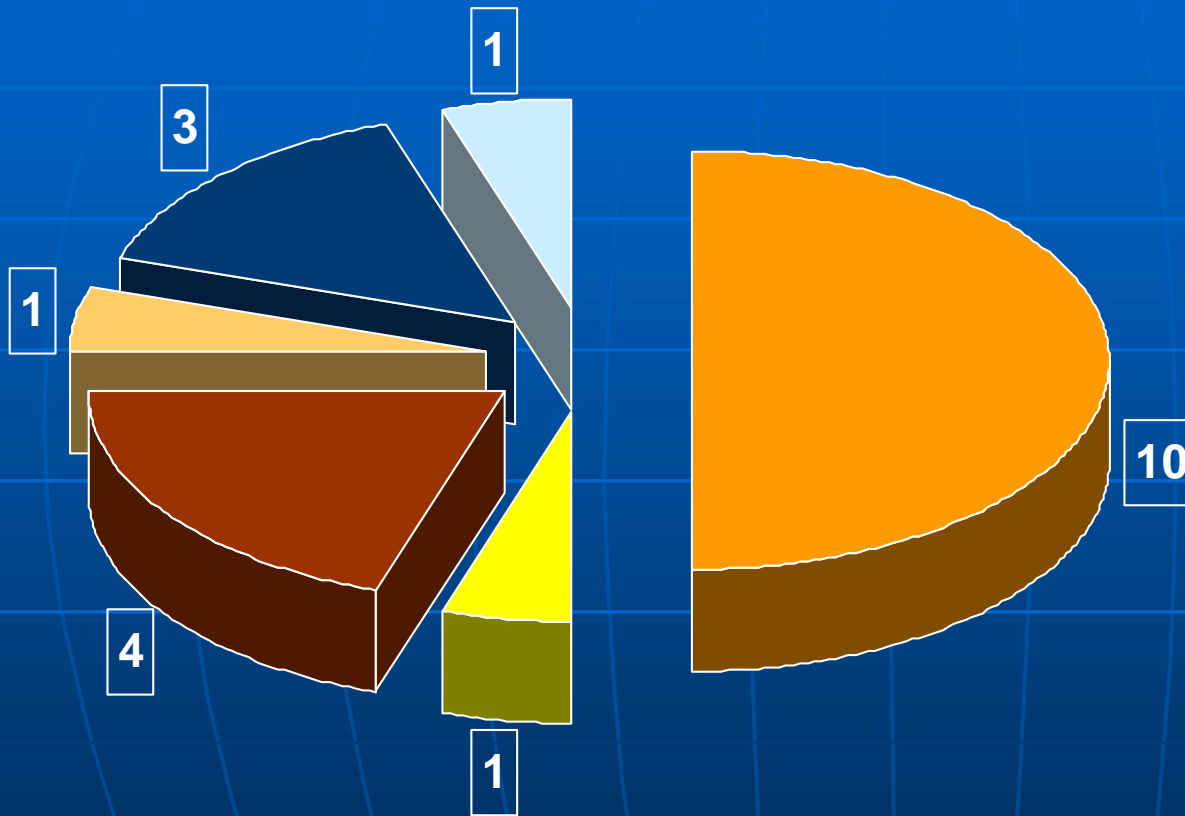
FATALS BY JOB CLASSIFICATION

1988-2003
