Appendix B

Field Data

B-2.0 ALTERNATIVE COVER DEPLOYMENTS AND FIELD DEMONSTRATIONS

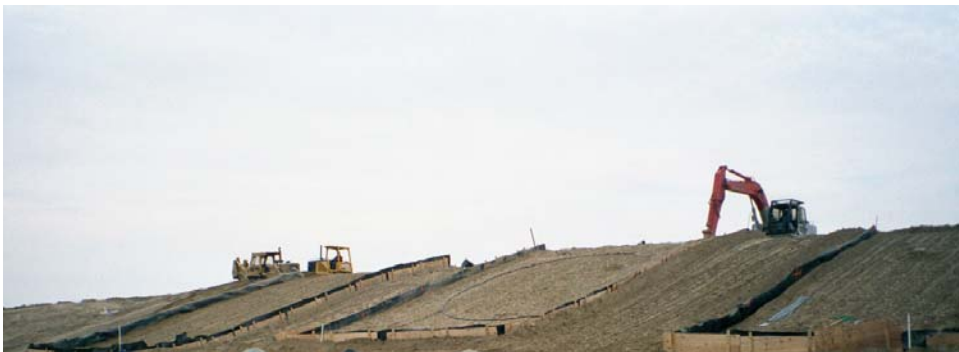
Figure B-2.1-2. Finley Buttes Regional Landfill test covers installation

1. Composite/GCL: 1 m of soil over a geomembrane over a GCL.
2. Thin ET cover: 1.2 m of soil.
3. Thick ET cover: 1.8 m of soil.

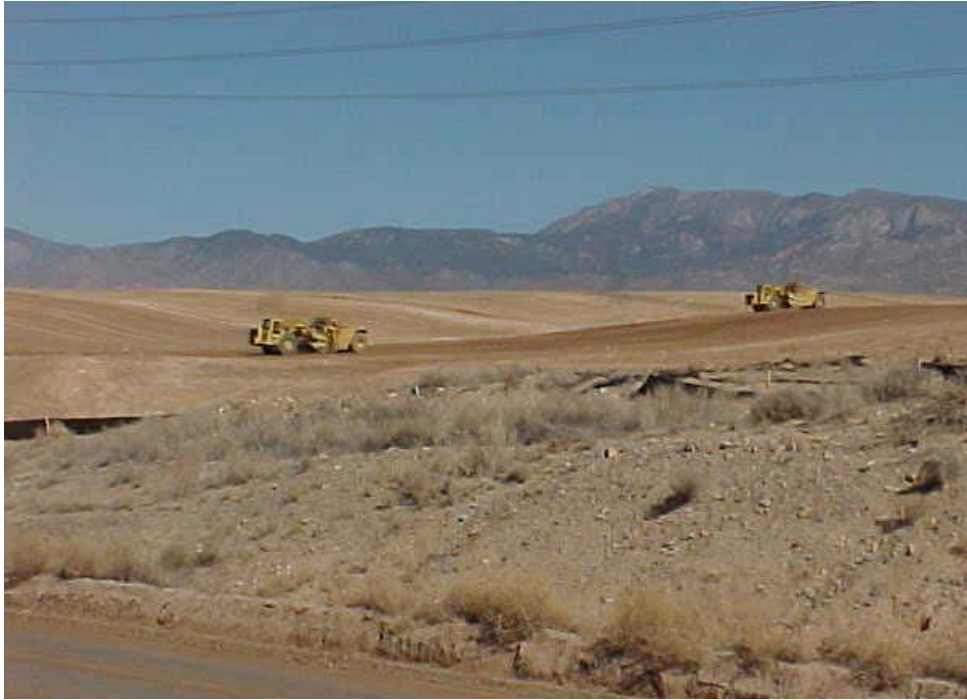
Figure B-2.2-1. ET cover installation on Kirtland Air Force Base

Kirtland Air Force Base has had three alternative final covers approved using an ET cover to close three separate solid waste facilities. Kirtland Air Force Base is located in the southwest portion of Albuquerque, NM near the Manzano Mountains. The landfills average about 40 acres each in size. The first cover was constructed and completed in 2003 (Figure B-2.2-1).

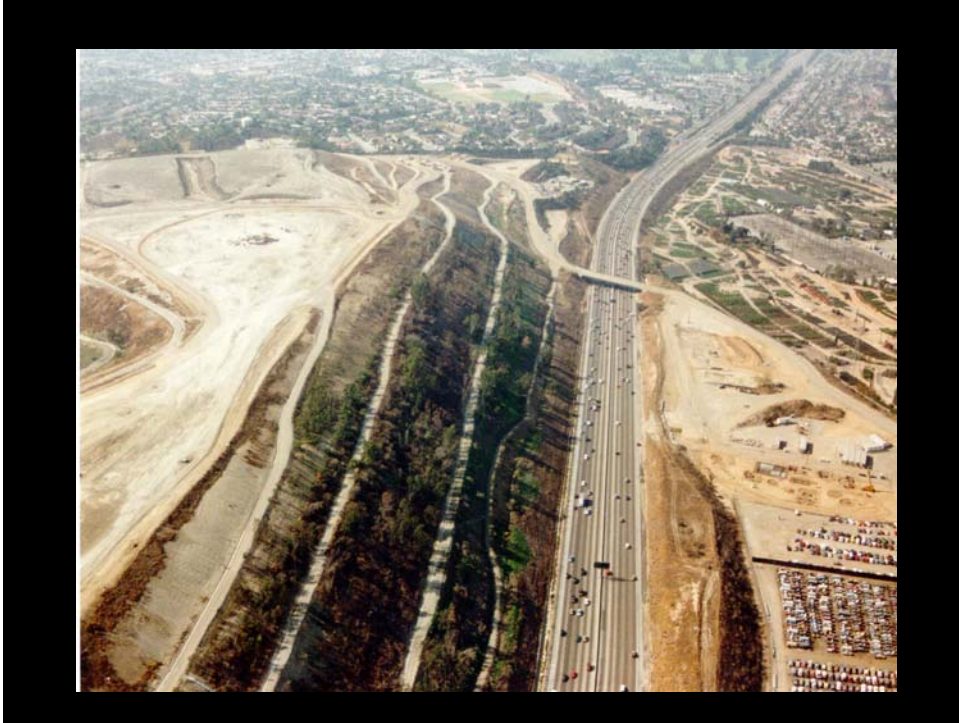
Figure B-2.3-1. OII Landfill

OII Superfund landfill in southern California closure constitutes the first ET cover approved by the EPA for construction at a Superfund site.

The selected baseline cover was a 1500-mm-thick single soil layer with a saturated hydraulic conductivity of 1027 m/s and moisture retention characteristics typical of silty soils. The average fines content reported for these soils is 54% and the plasticity index is 5% ~USCS designation ranges over CL to ML. Campbell's fitting parameters used for the baseline cover are listed in Table B-2.3-1. Weather data needed for the analyses includes daily precipitation and daily minimum and maximum air temperatures. Weather conditions generated for 30 years using data for southern California led to an average precipitation of 379 mm/year and an average evapotranspiration of 1015 mm/year.

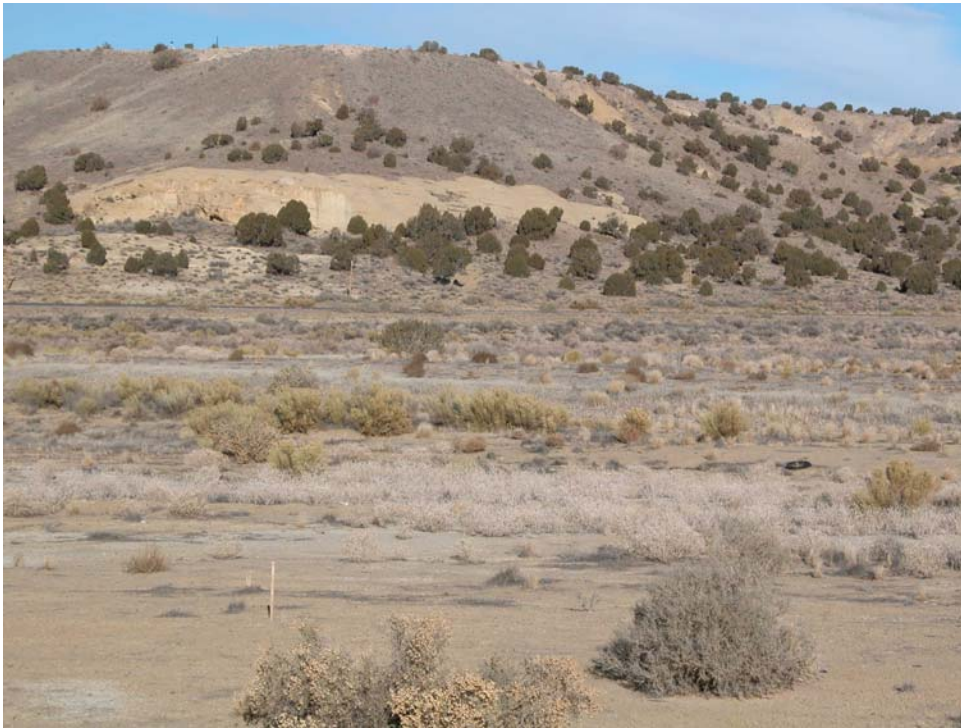
Figure B-2.3-2. Lee Acres Landfill, Farmington, NM

Monitoring over a multiple-year period indicated zero flux. Farmington, NM is located in the northeast corner of New Mexico near the four corners region of New Mexico, Arizona, Utah, and Colorado. The site was originally permitted as a municipal landfill in 1962. However, in 1980 it was expanded to include the disposal of liquid waste. Containment berms were built where liquid waste was dumped. Plumes formed that found their way to the groundwater that was used by a local community. This groundwater was contaminated. The landfill was closed to liquid waste disposal in 1985 and solid waste disposal in 1986. Lee Acres is listed on the EPA's National Superfund Database, identification number NMD980750020. The Record of Decision stated that the site will be covered with a capillary barrier. A test cover was placed and monitored at the site in 1997.
