## Fatalgrams and Fatal Reports

Fatality #1 - January 6, 2009
Falling/Sliding Material - California - Construction Sand and Gravel Matich Corporation- Redlands Rock Plant

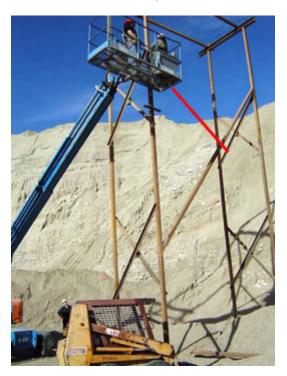
**METAL/NONMETAL MINE FATALITY -** On January 6, 2009, a 41 year-old laborer with 3 years of experience was injured at a sand and gravel operation. The victim was operating a skid steer loader underneath a belt conveyor that was being dismantled. Two coworkers were in an elevated manlift removing a 12-foot piece of 4-inch metal tubing from the leg supports of the belt conveyor frame. The tubing fell into the front of the skid steer loader as it approached the work area, striking the victim. He was hospitalized and died on January 9, 2009.

The red line shows the original location of the tubing.

- Establish and review procedures to ensure all possible hazards have been identified and appropriate controls are in place to protect persons before beginning work. Discuss procedures with all persons present in the work area.
- Establish policies to ensure that barricades or warning signs are installed to prohibit access and protect persons from falling object hazards.
- Remove all persons from beneath the area where overhead work is being performed.
