MNMM Fatal 2009-01

- Falling Material Accident
- January 6, 2009 (California)
- Sand & Gravel Operation
- Journeyman Heavy Equipment Operator
- 41 years old
- 3 years, 8 months of experience

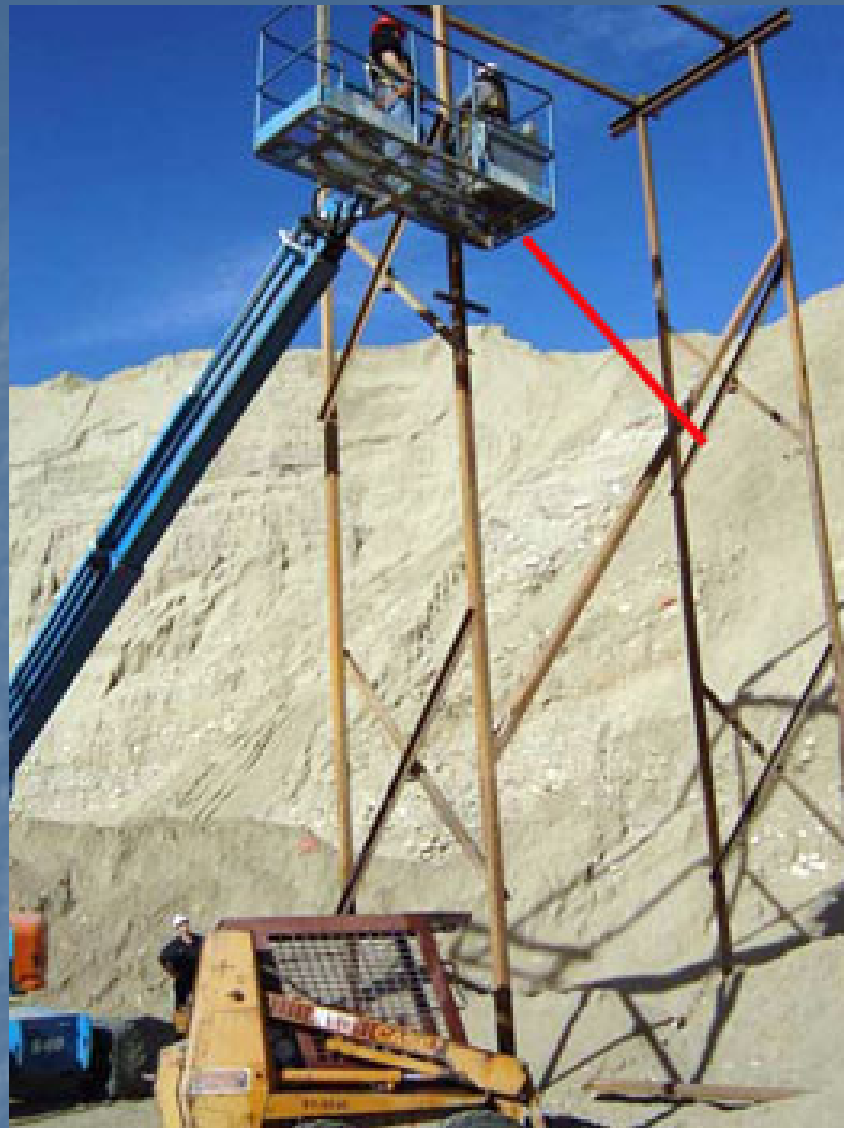
The victim was injured on January 6, 2009, while operating a skid steer loader underneath a belt conveyor that was being dismantled. Two coworkers were in an elevated man lift cutting braces from the leg supports of the belt conveyor support structure. A 12-foot by 4-inch piece of steel box tubing fell into the cab of the skid steer loader as it approached the work area, striking the victim. He was hospitalized and died on January 9, 2009.

The red line shows the original location of the tubing.

Management failed to establish policies and procedures to ensure that persons could safely dismantle the belt conveyor support system. A risk assessment to determine potential hazards and to establish safe work procedures was not conducted prior to performing the task.

- Establish and review procedures to ensure all possible hazards have been identified and appropriate controls are in place to protect persons before beginning work. Discuss procedures with all persons present in the work area.
- Establish policies to ensure that barricades or warning signs are installed to prohibit access and protect persons from falling object hazards.
- Remove all persons from beneath the area where overhead work is being performed.
