# Soiling Patterns on a Tall Limestone Building: Changes over 60 Years

Soiling of limestone caused by air pollution has been studied at the Cathedral of Learning on the University of Pittsburgh campus. The Cathedral was constructed in the 1930s during a period of heavy pollution in Pittsburgh, PA. Archival photographs show that the building became soiled while it was still under construction. Reductions in air pollutant concentrations began in the late 1940s and 1950s and have continued to the present day. Concurrent with decreasing pollution, soiled areas of the stone have been slowly washed by rain, leaving a white, eroded surface. The patterns of white areas in archival photographs of the building are consistent with computer modeling of rain impingement showing greater wash off rates at higher elevations and on the corners of the building. Winds during the rainstorms are predominantly from the quadrant SW to NW at this location, and wind speeds as well as rain intensities are greater when winds are from this quadrant as compared with other quadrants; the sides of the building facing these directions are much less soiled than the opposing sides. Overall, these results suggest t

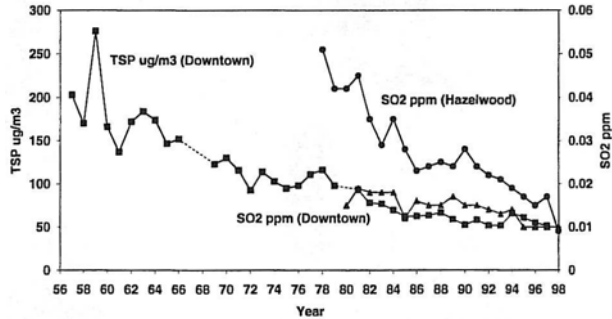
**Figure 1.** Annual arithmetic average concentrations of total suspended particles (TSP) and SO<sub>2</sub> in Pittsburgh. The TSP measurements were made with high-volume samplers at two downtown locations: the County Office Building (1957-1982) and Flag Plaza (1983-1997). The SO<sub>2</sub> measurements were made with continuous monitors at Flag Plaza downtown (1980-1998) and in the Hazelwood section of the city (1978-1998). These measurements were conducted as part of the National Air Sampling Network and the Air Quality Program of the Allegheny County Health Department. Reliable TSP data are not available for 1967, 1968, and 1980.

Figure 1 shows annual average concentrations over time for total suspended particles (TSP) and for SO<sub>2</sub> in Pittsburgh (13). The TSP data cover the years 1957-1997 and are for downtown, 3.2 km west of the Cathedral. The SO<sub>2</sub> data are for downtown (1980-1998) and for the industrial area of Hazelwood, 3.3 km south of the Cathedral (1978-1998). The data show steady decreases in concentration over time, mainly due to reductions in emissions from heavy industry and from mobile sources. Data on visibility reduction due to smoke from the early part of this century to the present suggest that average TSP levels were much greater than 200 µg/m<sup>3</sup> in the 1930s and 1940s before regular TSP monitoring began (14). This is confirmed by archived data on dustfall in downtown Pittsburgh that show values decreasing from 30 ton/km<sup>2</sup> month in 1938-39 to 14 ton/km<sup>2</sup> month in the mid-1950s (14). The dustfall values have continued to decrease and are now less than 5 ton/km<sup>2</sup> month.

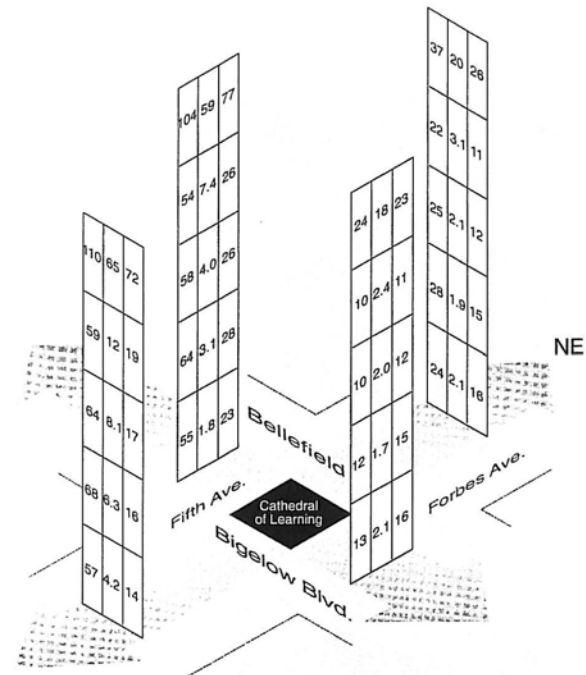
Figure 7. Computed rain fluxes in mm/year to the walls of a simple rectangular block with approximate dimensions of the Cathedral of Learning. The data suggest that much more rain strikes the Fifth and Bigelow faces of the building as compared with the Forbes and Bellefield faces.

these intervals, normalized to 1 year, is 1210 mm/year. This compares with the average rainfall in Pittsburgh of approximately 1000 mm/year, with May and June each receiving about 10% of the annual rainfall. Details of the modeling have been reported elsewhere (12). Resultant rain fluxes normalized to 1 year are shown in Figure 7.

The figure shows that calculated rain fluxes to the Fifth Avenue and Bigelow Boulevard sides are much greater than those to the Forbes and Bellefield Avenue sides. This is consistent with the greater amounts of soiling in Figure 5 for the Forbes and Bellefield faces. On all four sides, the fluxes at the top are considerably greater than those at lower heights. Furthermore, the fluxes on the sides are greater than those in the center sections. These results are in agreement with the observations of less soiling near the top and at the corners of the building. Comparing model results with the meteorological input data shows that the greater rain fluxes on the Fifth and Bigelow sides are due in part to the large fraction of time (0.50) when the wind is from the quadrant SW through NW. Furthermore, the rain intensities are high when the wind is from the SW, W, or NW (average 4.0 mm/h) as compared with all other directions (average 2.6 mm/h), and the wind speed is greatest when the wind is from these three directions (average 2.5 vs 1.7 m/s).
