## **Project Report**

# **Nondestructive Method for Hardness Evaluation of Mortars**

Rocky Mountain Masonry Institute  
1780 South Bellaire Suite 402  
Denver, CO 80222

National Center for Preservation Technology and Training  
United States Department of the Interior  
National Park Service  
P.O. Box 37127  
Washington, D.C. 20013-7127

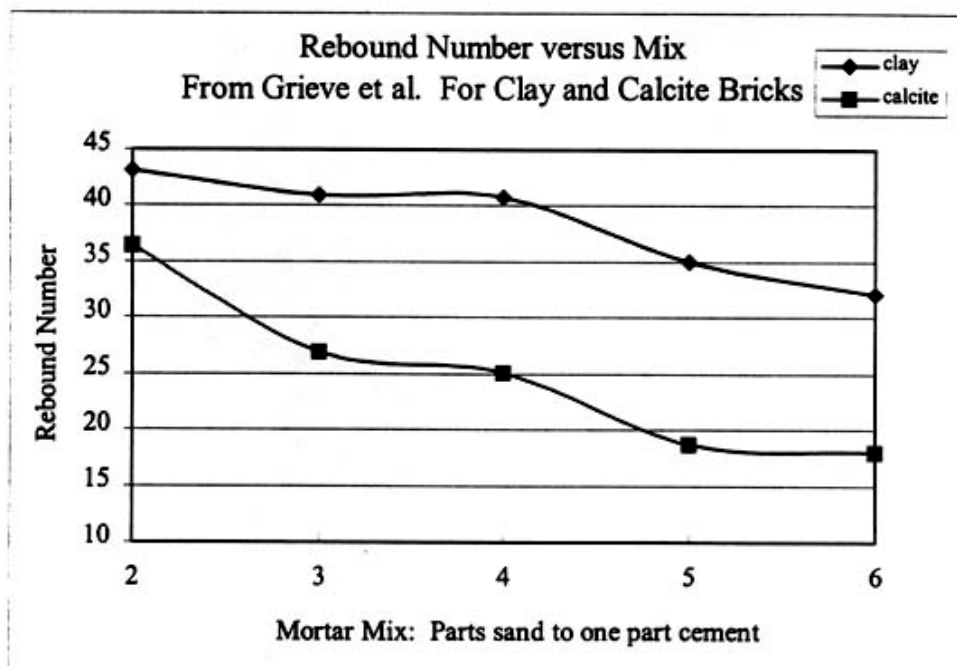
Figure 2.7. Rebound numbers from various mortar mixes in laboratory walls of clay bricks and calcite bricks (Grieve et al.).

The Windsor Penetrometer was found to be difficult to use, unreliable, and dangerous for mortar testing. The Schmidt hammer was found to be convenient to use and to give reasonable results. However, the rebound numbers were found to be more affected by brick type than mortar mix proportions. Figure 2.7 shows the rebound numbers recorded for test walls of clay and calcite bricks. Notice that the values for the calcite bricks are consistently lower yet show the same trend for the different mortar mixes.

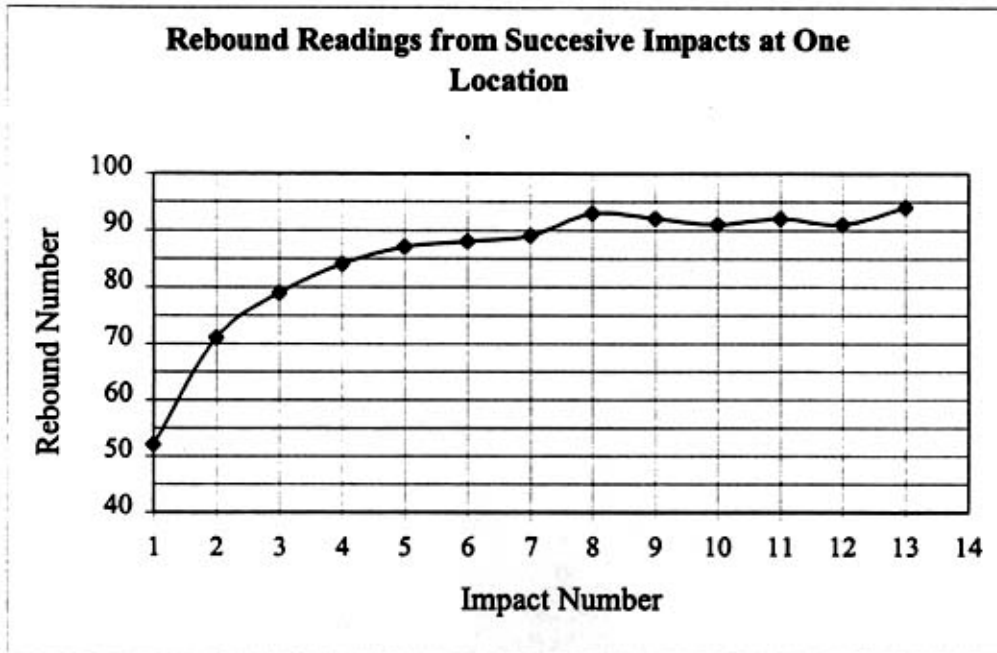
Figure 5.9. Rebound readings for a series of successive impacts taken from a test wall at the University of Colorado Structural Engineering Laboratory.

Existing masonry test walls at the University of Colorado Structural Engineering Laboratory and at the Atkinson-Noland & Associates Laboratory were used as preliminary test specimens. Grid patterns were established on the faces of the test walls and pendulum hammer rebound data was taken from 50 or more locations on each wall. A series of successive rebounds were recorded at each location without moving the hammer. Analysis of the preliminary data revealed that at all individual locations the rebound number increased significantly with successive impacts for the first 3 to 5 impacts, and then settled down to a narrow range. Figure 5.9 is a plot of a typical series of successive rebound readings from one location.

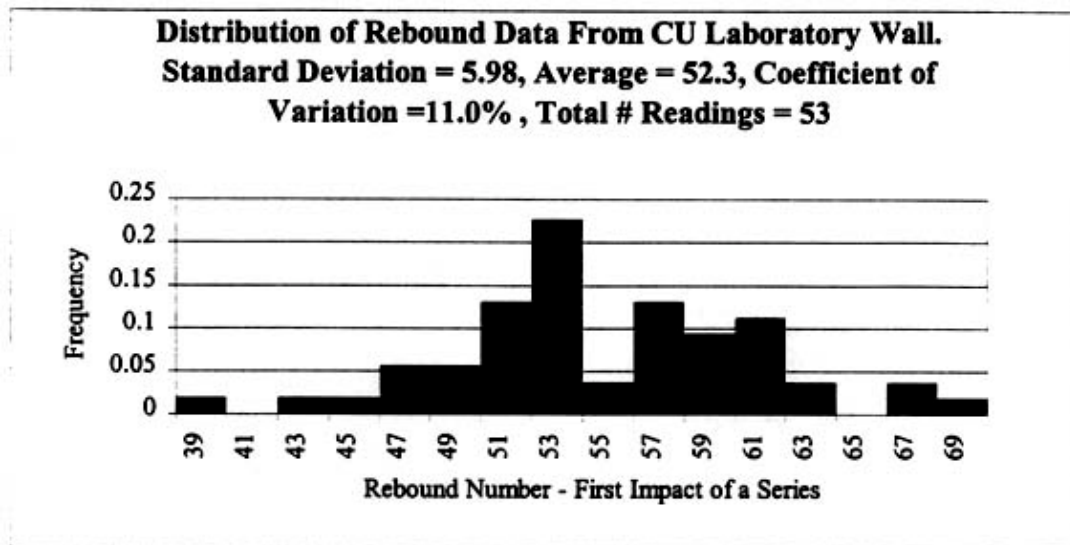
Figure 5.10. Results of a statistical analysis of preliminary rebound number data (rebound number as the average of the last 5 of a series of 10 impacts).

The coefficient of variation for the first case (using the average of the last 5 of a series of 10 impacts) is 4.6 percent, while the coefficient of variation for the second case (using the first impact) is 11.0 percent. This reduction of variation of the data by more than half is motivation for using a series of impacts to measure the hardness at one location.

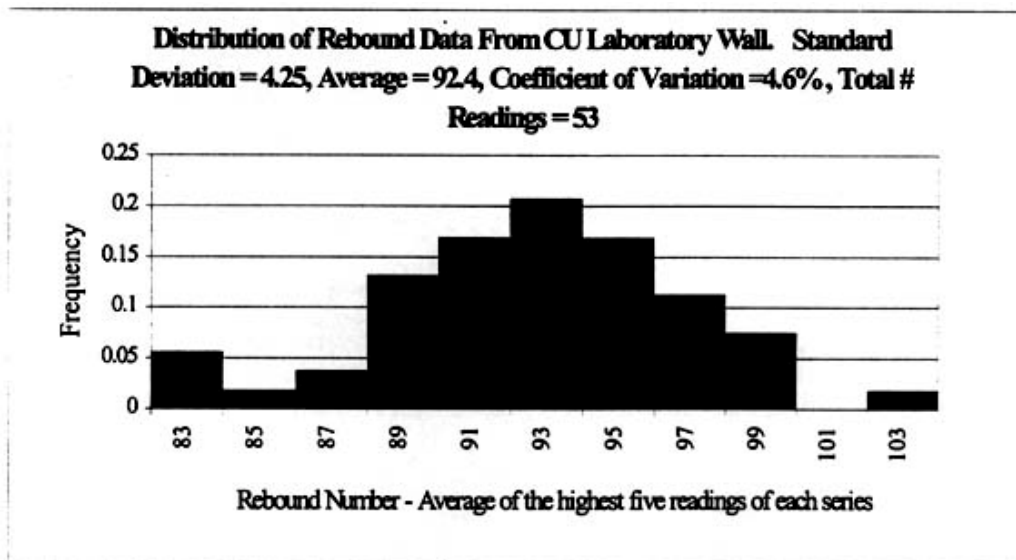
Figure 5.11. Results of a statistical analysis of preliminary rebound number data (rebound number as the first impact of a series).

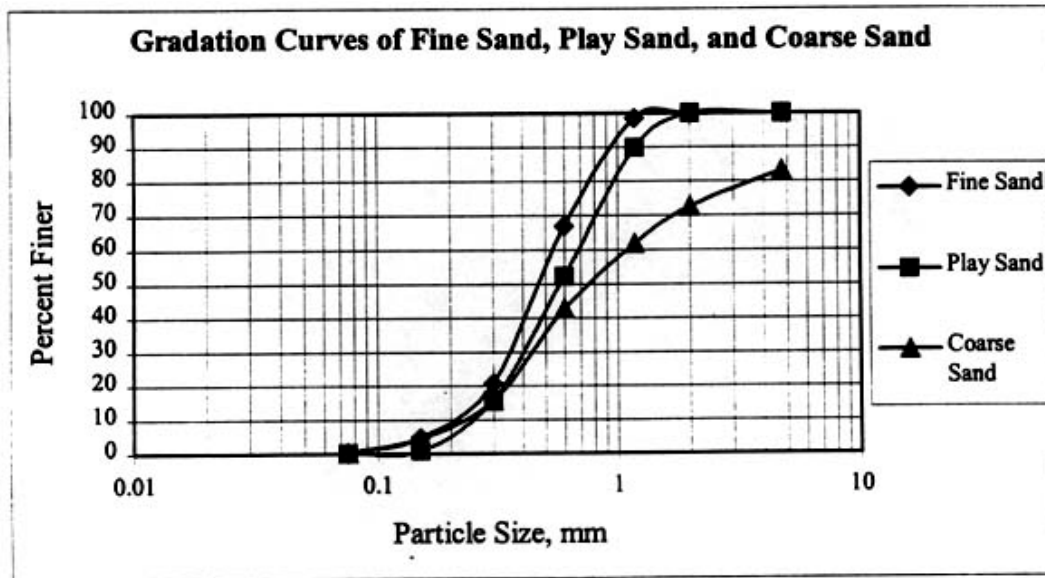
Figure 6.1. Sand gradation curves.

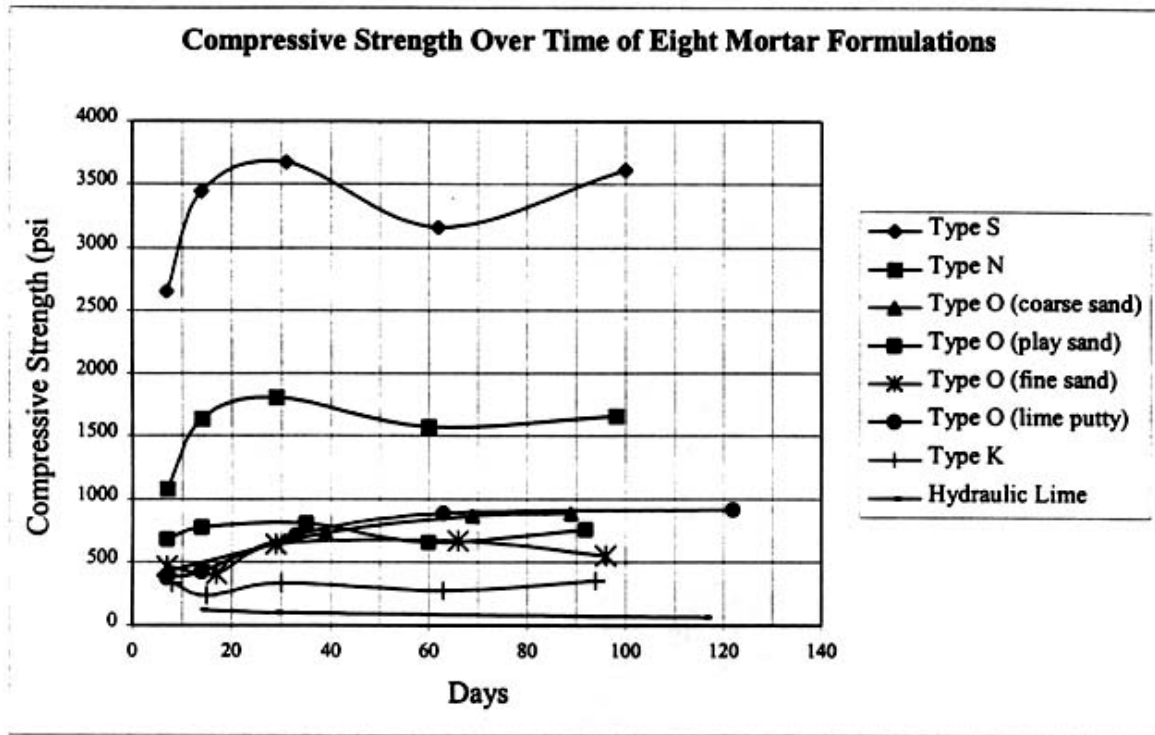
Figure 6.2. Compressive strength of mortars over time.

The compressive strength of the eight mortar types over time is plotted in Figure 6.2. Each test result is the average of the measured compressive strength of 3 specimens. Table 6.3 shows the 90-day and later strengths of the eight mortars.

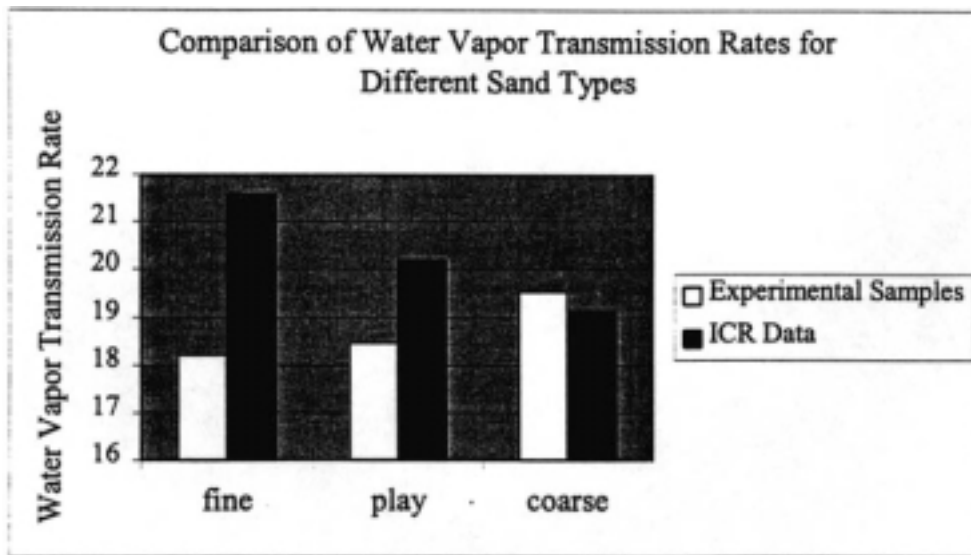
Figure 6.3. Comparison of water vapor transmission rates of type O mortars with different sand types.

High water vapor transmission rate (WVTR) values indicate high relative permeability of the material and conversely, low relative WVTR values indicate lower permeability. Notice that the WVTR values for the 3 type 0 mortars follow a trend. The fine sand is the least permeable, followed by the play sand with a higher WVTR, and then the coarse sand with the highest relative WVTR of the three. Integrated Conservation Resources Inc. (ICR) compared these results to data in their company database. Using sands similar to the fine, play and coarse sands used in this study, ICR has noted an inverse trend in type 0 mortars. ICR data shows that fine sand is the most permeable and the coarse sand is the least permeable. Figure 6.3 shows these opposing trends graphically.

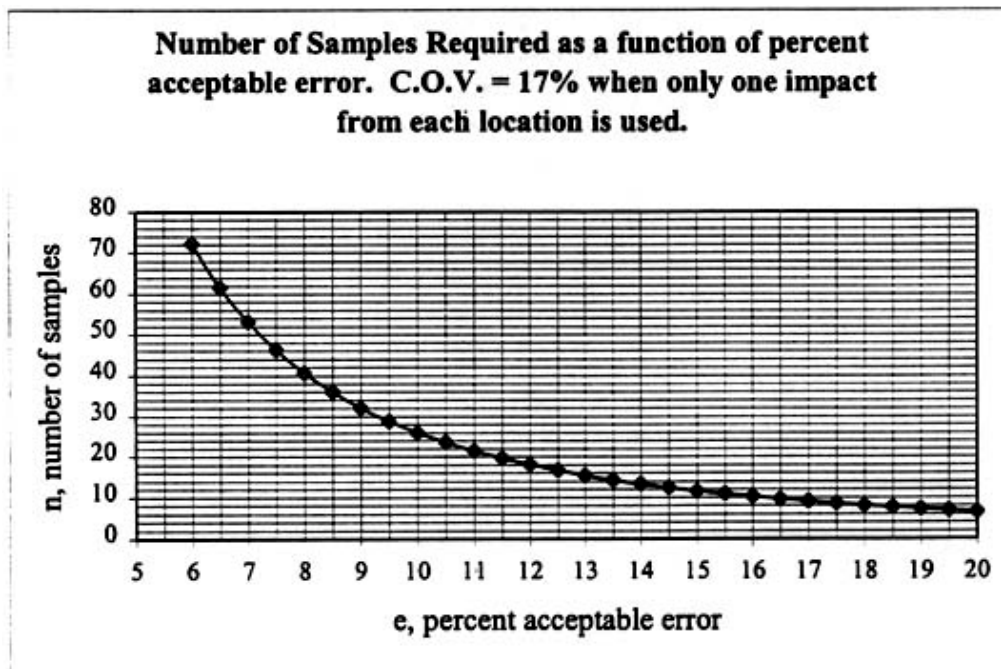
Figure 6.4. Number of samples required when only one rebound is measured from each location.

The number of samples required was then calculated for a range of acceptable errors for each interpretation of the rebound number. The results of these calculations are presented in Figures 6.4 and 6.5.

Choosing an acceptable error ( $e$ ) of 10 percent, the number of measurements required using only one rebound is twenty-six. The number of measurements required when the last 5 of a series of 10 impacts are used is nine.

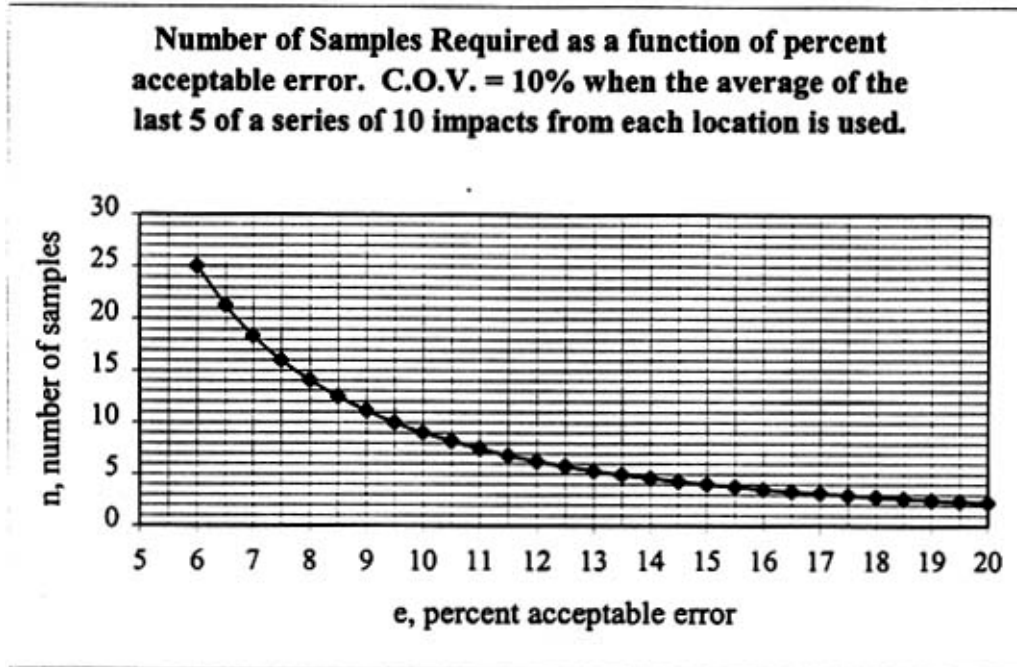
Figure 6.5. Number of samples required when the average of the last 5 of a series of 10 impacts from each location is used.

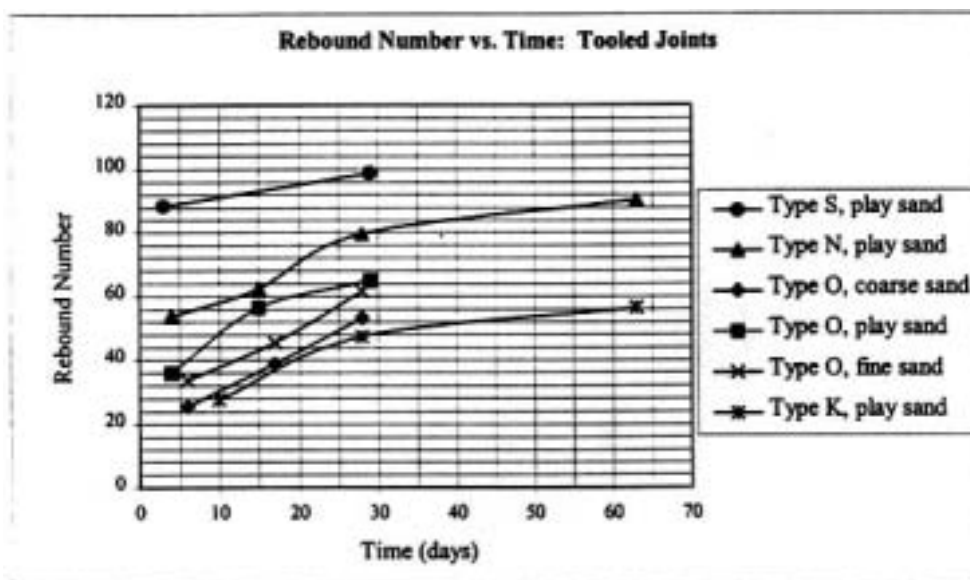
Figure 6.6. Rebound number versus time for selected mortars.

The rebound number results for selected mortar types over time are shown in Figure 6.6. This data was taken early in the study during a time period when the pendulum hammer was new and calibration problems had not yet manifested. Later data is unreliable for comparison overtime. These results are of data taken from tooled joints, using the procedure described in Section 5.4.2.

In all cases, the hardness of the mortar increased as it cured, as would be expected. However, the increase in hardness does not mirror the increase in compressive strength. For example, the compressive strength of the type N mortar increased by 67 percent from 7 to 28 days of age, while hardness of the type N mortar increased by 47 percent from 4 to 28 days. This mortar exhibited larger increases in strength than in hardness during its initial cure. However, the weaker type O and K mortars demonstrate an opposing trend. These mortars exhibit larger increases in hardness than in compressive strength during the initial cure. For example, the type O mortar with fine sand increased in strength by 37 percent from 7 to 28 days, while its hardness increased by 82 percent. Table 6.5 presents the relative increases in compressive strength and in rebound hardness of mortars from the first week to the fourth week of curing.

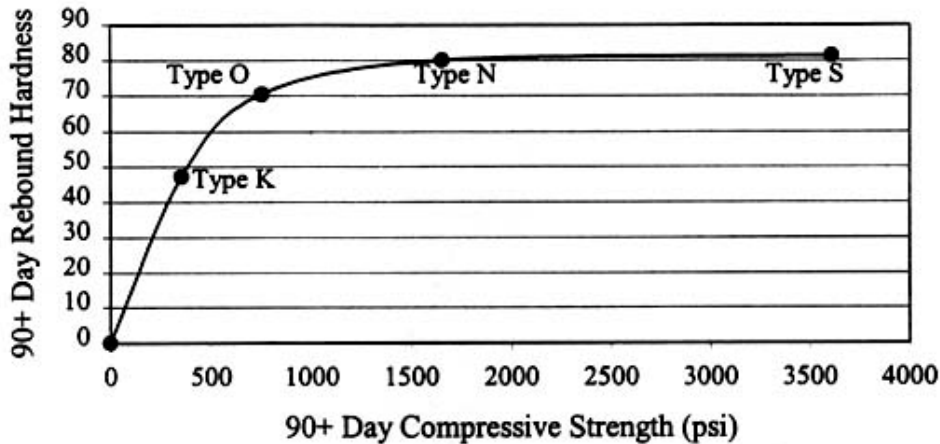
**Rebound Hardness vs. Compressive Strength: All mortars contain the same sand, lime and cement. Point (0,0) is artificial.**

Figure 6.7. Rebound hardness versus compressive strength for mortars made with the same sand, lime and cement.

Figure 6.7 is a plot of the rebound hardness results for the mortars containing the type S lime, cement, and play sand plotted versus the compressive strength of these mortars. This data is in tabular form in Table 6.6.

Notice that there is little difference in the rebound hardness of the type N and type S mortars although the compressive strength of the type S mortar is more than double that of the type N mortar. Conversely, there is a significant difference in hardness between the type K and type O mortars with a similar difference in compressive strength. Again, the rebound number appears to be more sensitive to changes in compressive strength in the lower range of mortar compressive strength (type O and weaker) and less sensitive to strength differences in the higher range of mortar compressive strength (type N and stronger). However, this observation should be tempered by the fact that the data for the type S mortar was taken from a pier with an empty cavity, while the data for the other 3 mortars were taken from piers with full cavities. The empty cavity could cause the type S rebound hardness to be less than if the cavity were full.

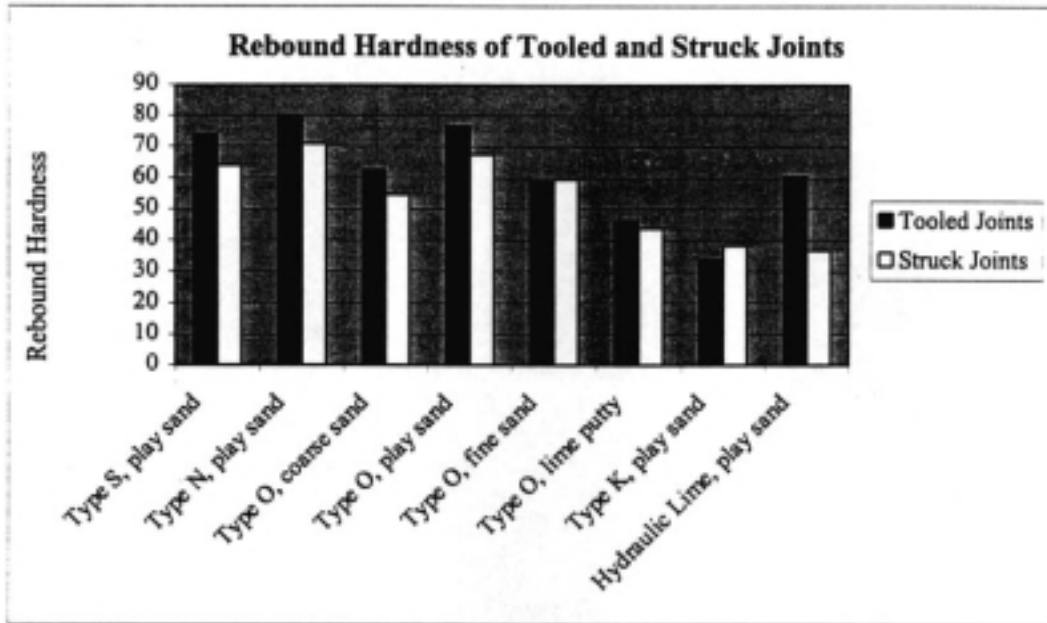
Figure 6.8. Rebound hardness versus compressive strength for all mortars.

Figure 6.8 is a plot of the rebound hardness results for all of the mortar types used. This data is in tabular form in Table 6.7.

Overall the tooled joints were harder than the struck joints. This result is sensible given that the tooling process compacts the mortar and thus the joint presents a denser surface for testing. The type K mortar and the type O mortar with fine sand were exceptions to this pattern. These exceptions are likely due to differences in the workmanship of these piers.

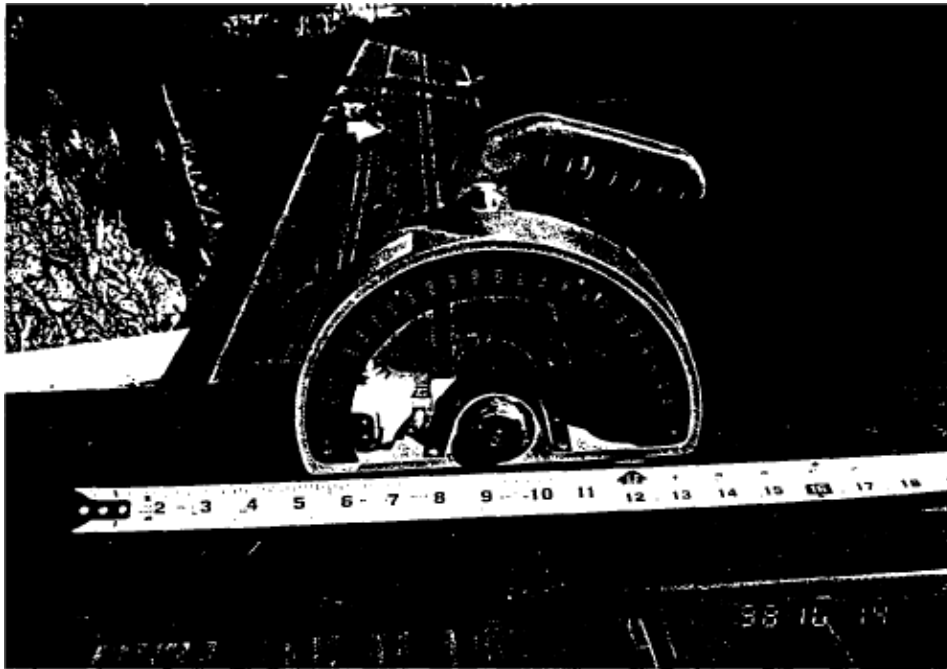
Fig. 1 Pendulum Rebound Hammer

4.2 Calibrate the pendulum rebound hammer using a steel anvil of the type available from the manufacturer or another such mass that gives consistent rebound numbers. It is recommended that the pendulum hammer be calibrated after 1000 impacts. The maximum allowable deviation from the calibrated reference value is  $+1-2$  units. The rebound values are sensitive to temperature variations of the calibration mass and the rebound hammer.

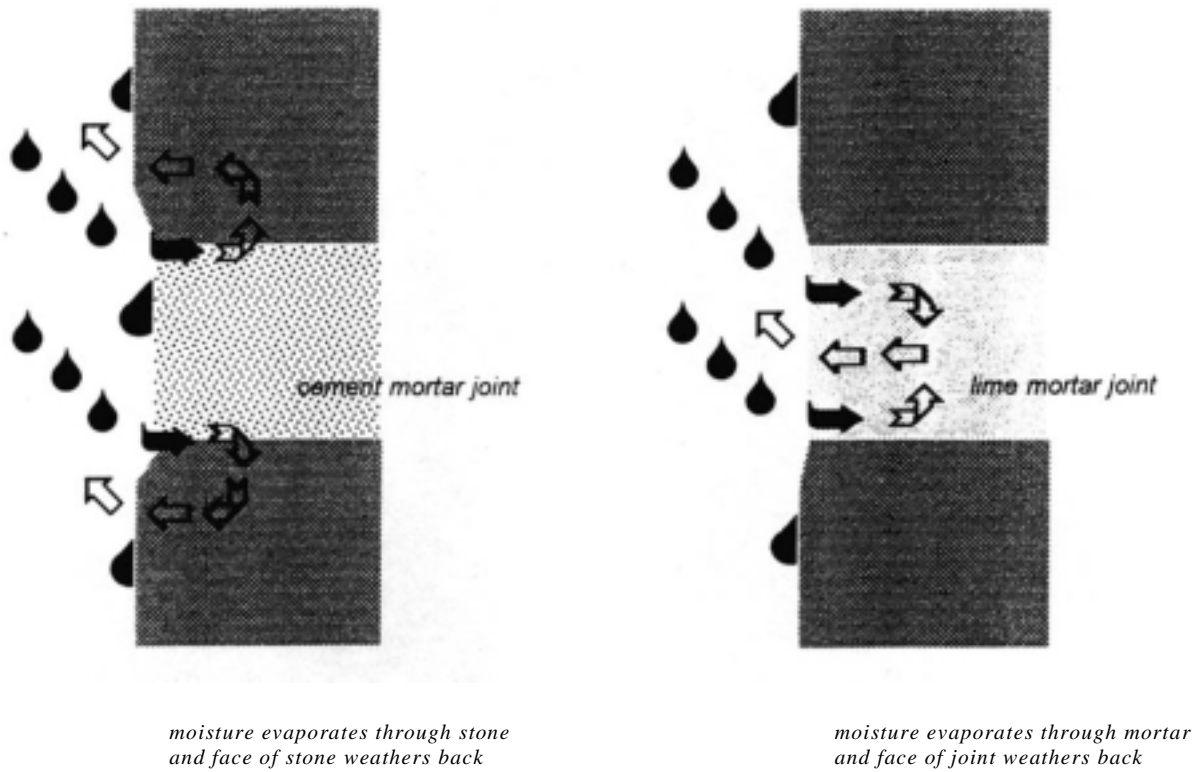
Figure 2.1 Moisture transmission through cement and lime mortar joints (from Gibbons, 1995).

A further problem that can be caused by repointing with cement mortar is a change in the migration paths of water through masonry. Lime mortars are porous and allow moisture ingress and egress, while cement mortars are much less porous (Williams, 1979; Speweik, 1997). Non-porous mortars can force moisture transmission through bricks and thus cause the bricks to deteriorate rapidly (Gibbons, 1995). Figure 2.1 illustrates the migration of moisture in cement and lime mortar joints. Moisture transmission through bricks is also encouraged by cement mortars because cement mortars can shrink upon setting, and can thus leave spaces for water to penetrate a wall at the mortar-brick interface (Speweik, 1997).

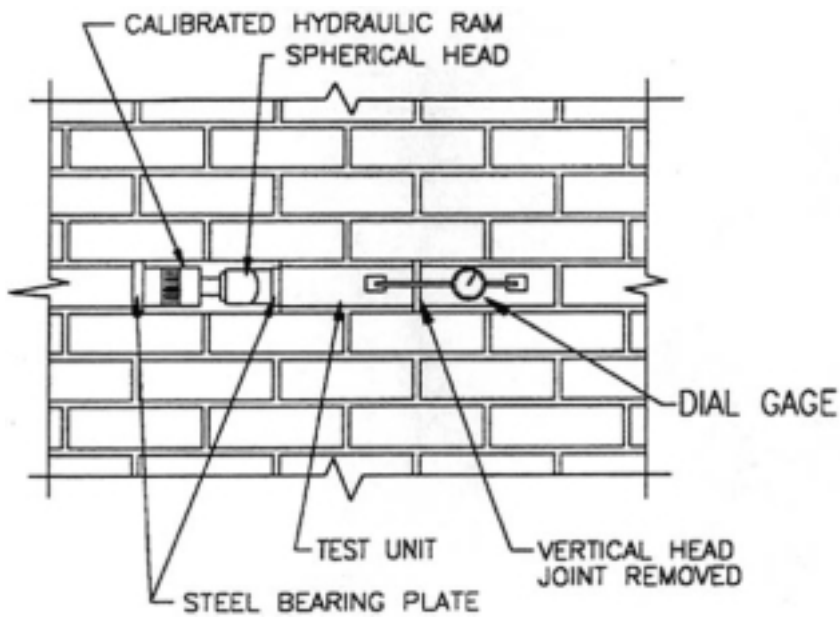
Figure 2.2. Schematic of the in-place push test (from Suprenant and Schuller, 1994).

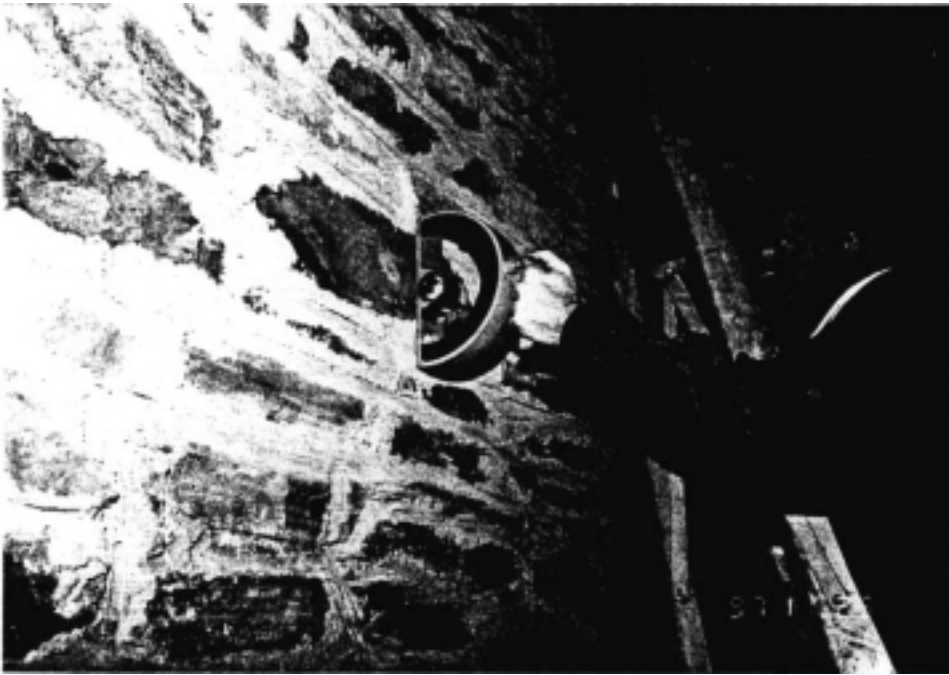
Figure 2.3. The Schmidt type PM pendulum hammer in use.

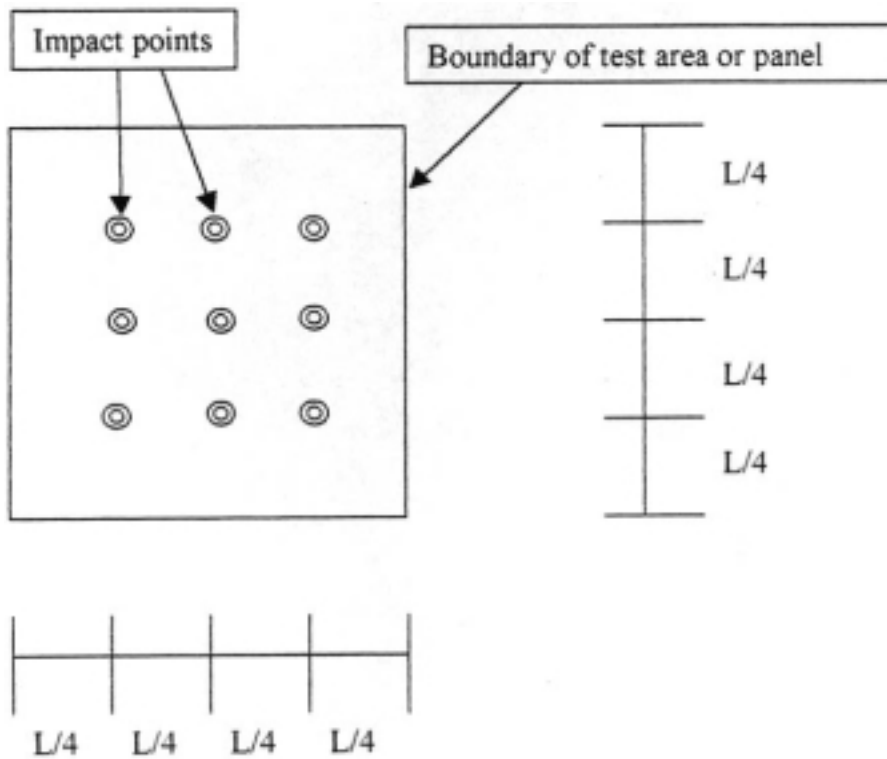
Figure 2.4 Example of the spacing of impact points for determining the rebound value in accordance with RILEM MS.D.7.

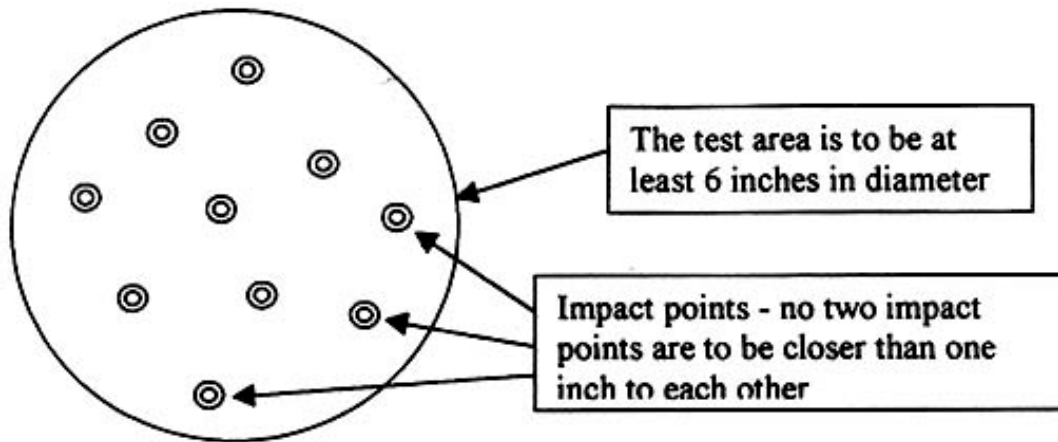
Figure 2.5. Example of the spacing of impact points for determining the rebound value in accordance with ASTM C 805.

ASTM C 805 specifies that 10 individual hits are to be made in a test area, and the average of these (less the outliers) is taken as the rebound number. The test area is to be at least six inches in diameter, and the concrete is to be at least four inches thick and fixed within a structure. Figure 2.5 shows an example of the spacing of impact points for ASTM C 805. This method is intended to identify regions of poor quality or deteriorated concrete in a structure by testing several areas (ASTM C 805).

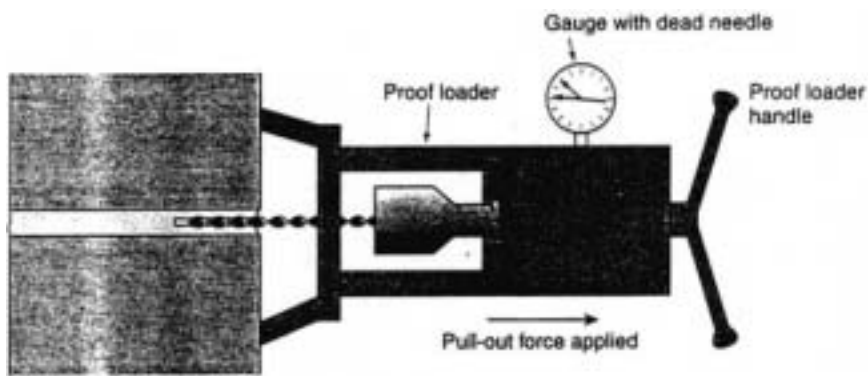
Figure 2.6. The screw pullout test (from BRE Digest 421).

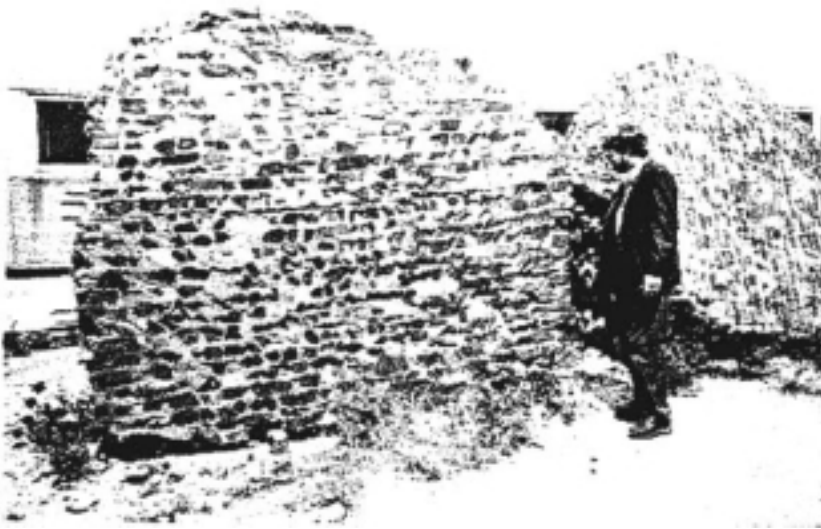
Figure 2.8. Cross-section of a wall from the Pavia Tower.

The collapse of the Civic Tower of Pavia in 1989 prompted the researchers to study the degradation of the mortar of this medieval construction (Baronio and Binda, 1991). It was suspected that mortar deterioration due to pollution had caused the collapse. Construction of the tower began in the eleventh century and a belfry of granite and brick masonry was added in the sixteenth century.

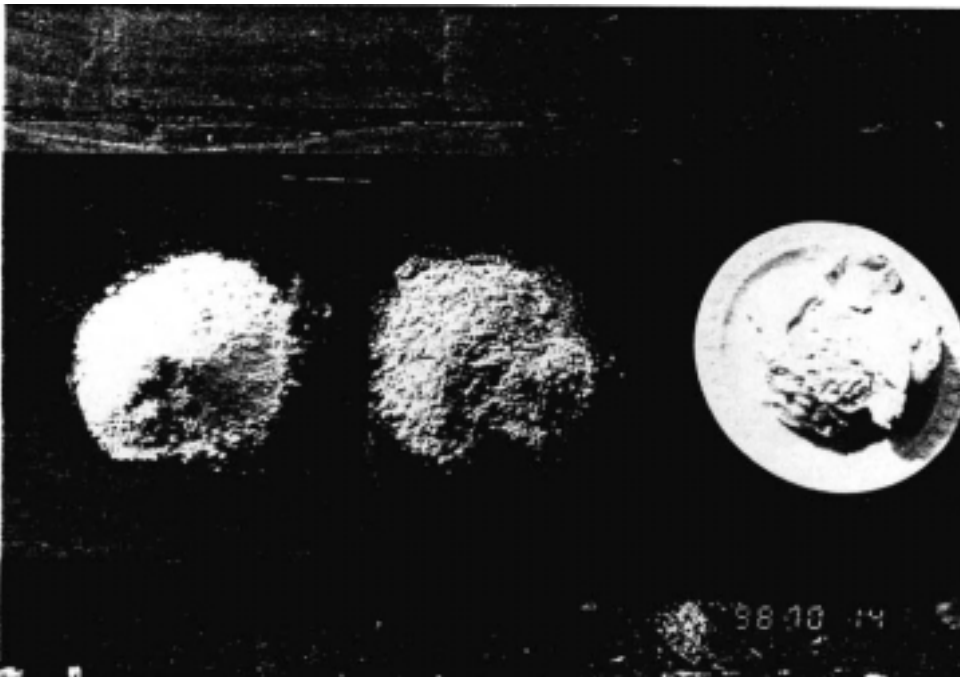
Figure 3.1. From left to right: type S hydrated lime, hydraulic lime, and lime putty.

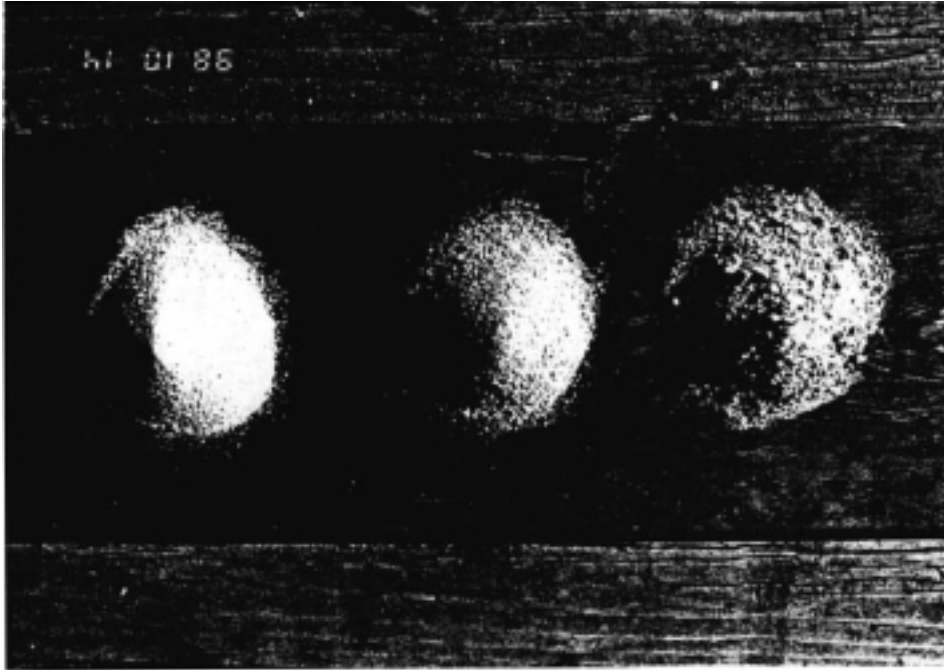
Figure 3.2. From left to right: fine sand, play sand, and coarse sand.

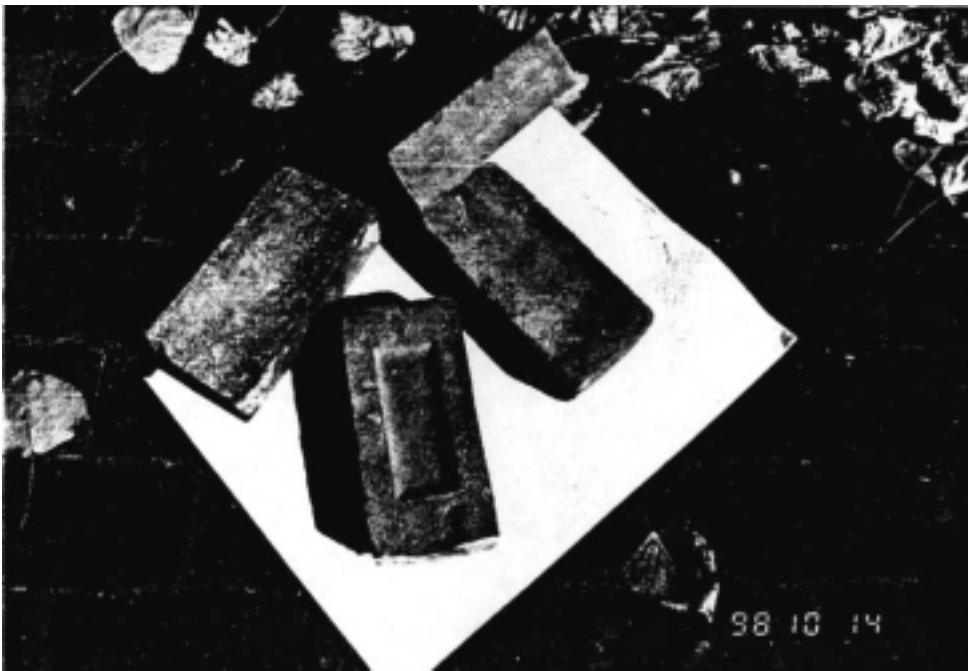
Figure 3.3. Hydraulically pressed molded bricks circa 1900.

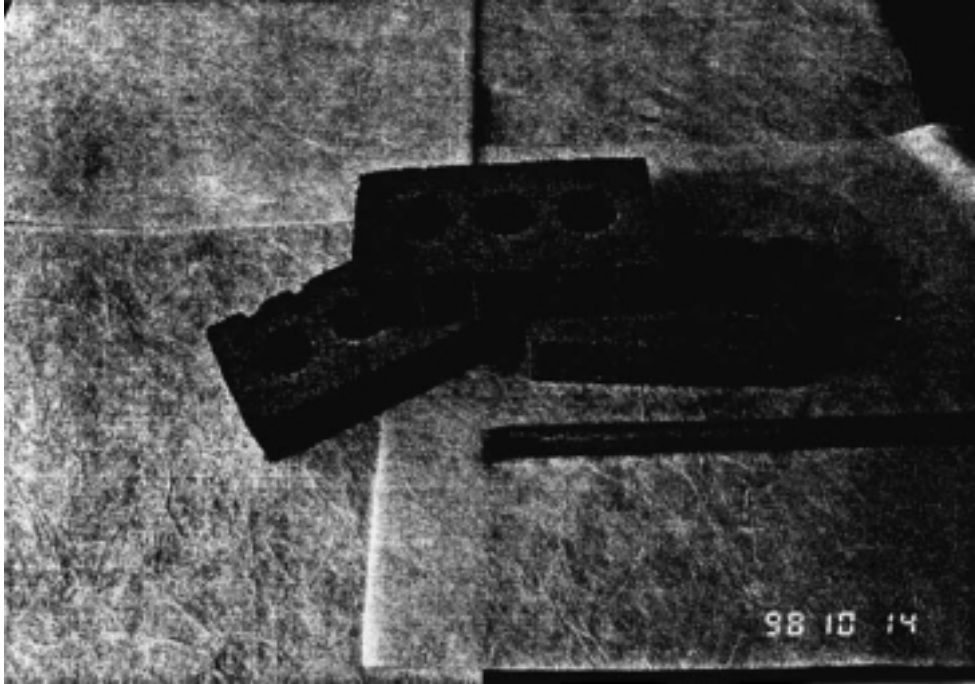
Figure 3.4. Modern extruded, cored, clay bricks.

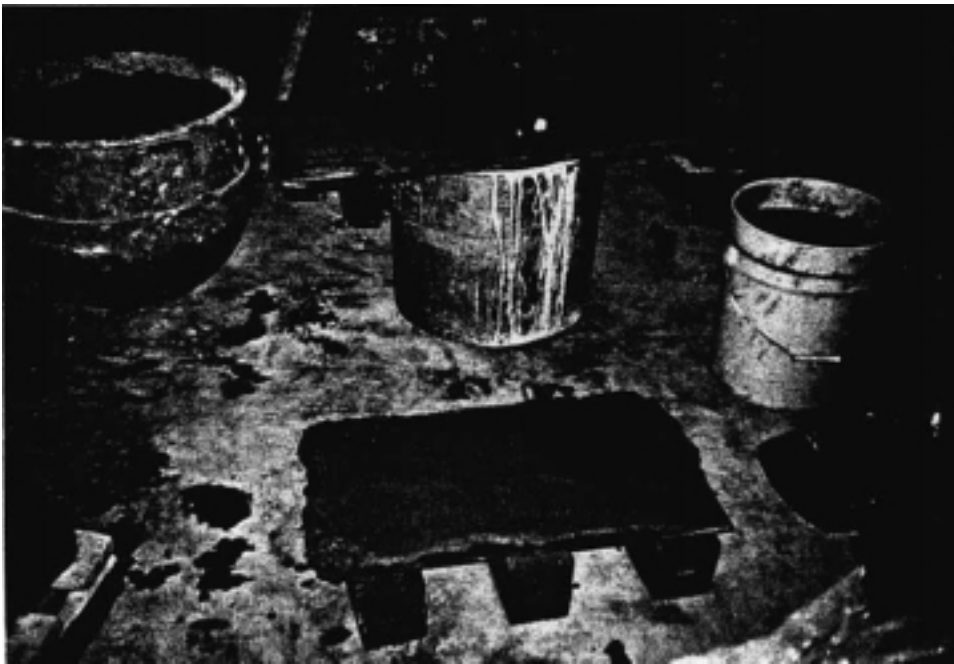
Figure 4.1. Steel plate with mortar base prepared for pier construction.

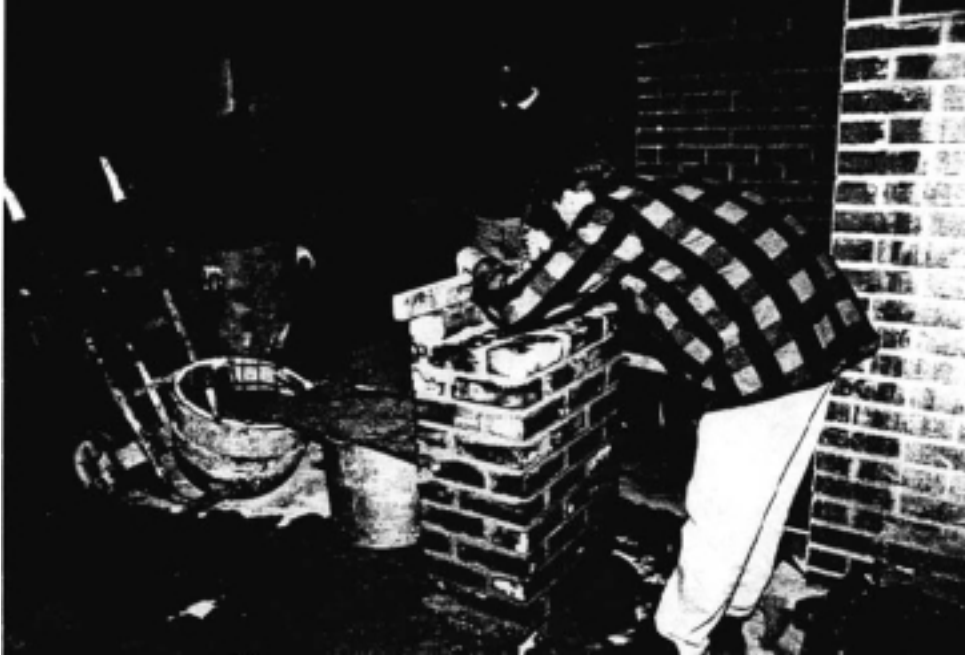
Figure 4.2. Checking for horizontal level during pier construction.

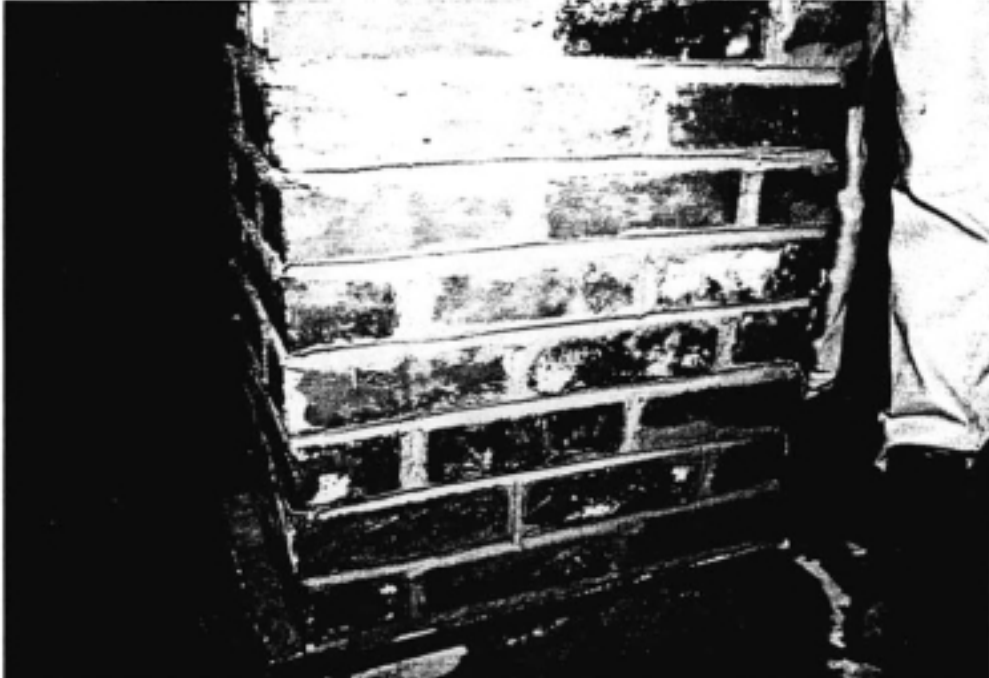
Figure 4.4. The tooled joints of a pier.

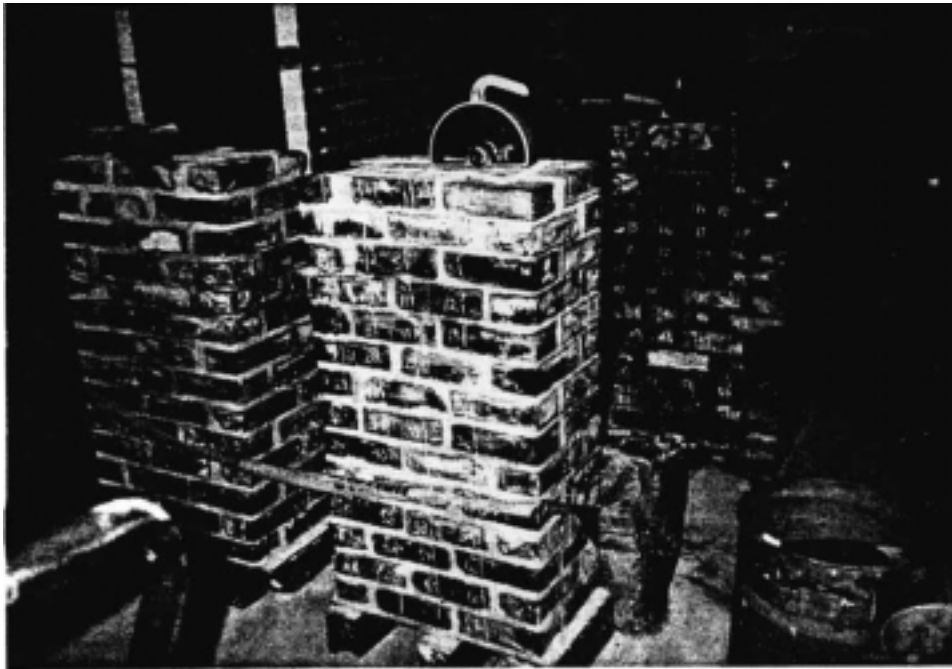
Figure 4.5. Completed piers in the laboratory.

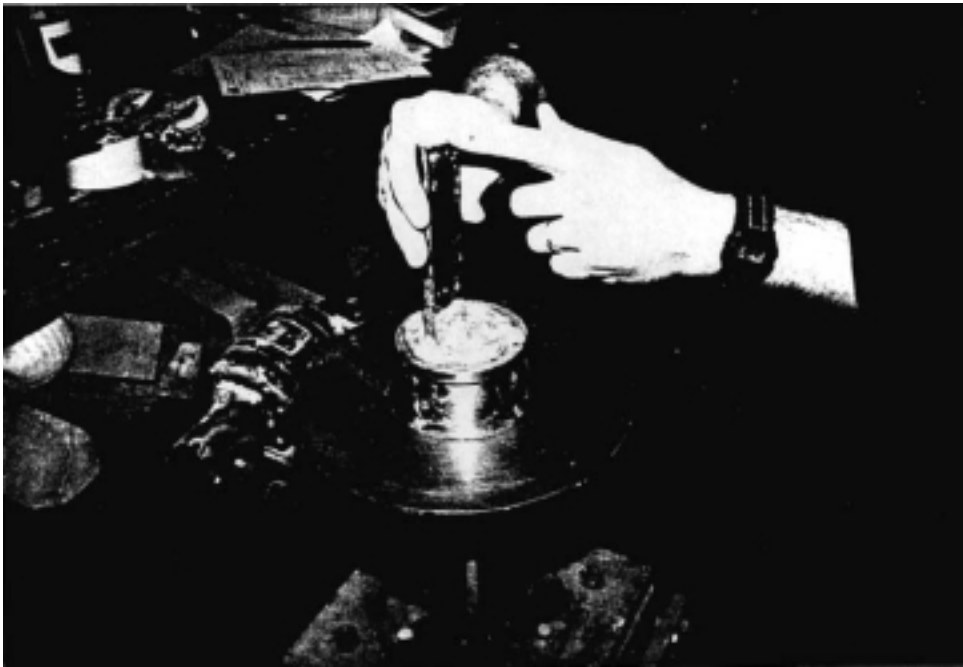
Figure 5.1. Mortar is tamped in the brass mold on the flow table.

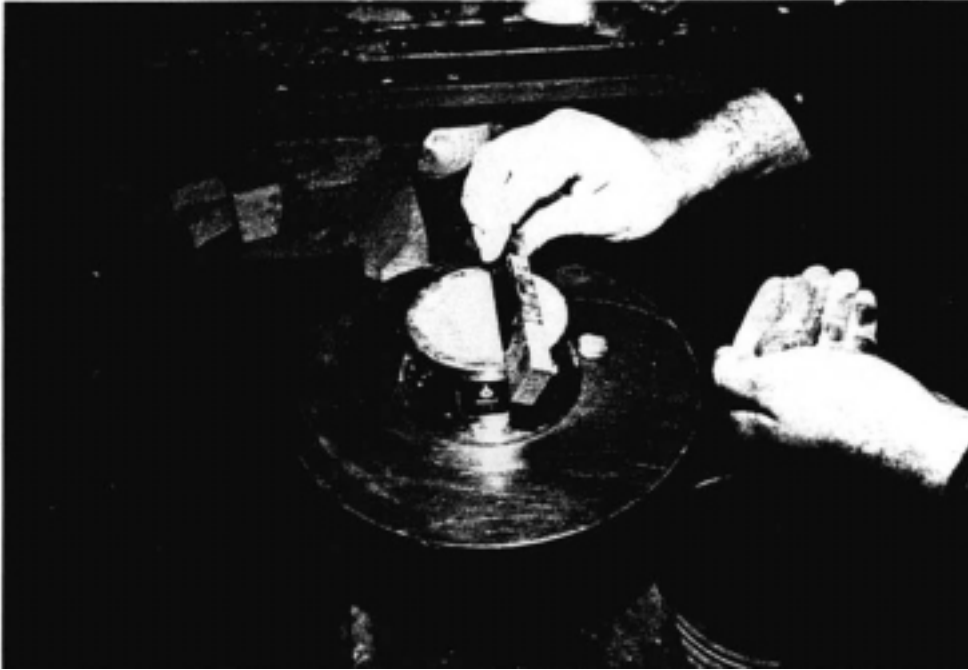
Figure 5.2. Excess mortar is scraped from the top of the mold to leave a level surface.

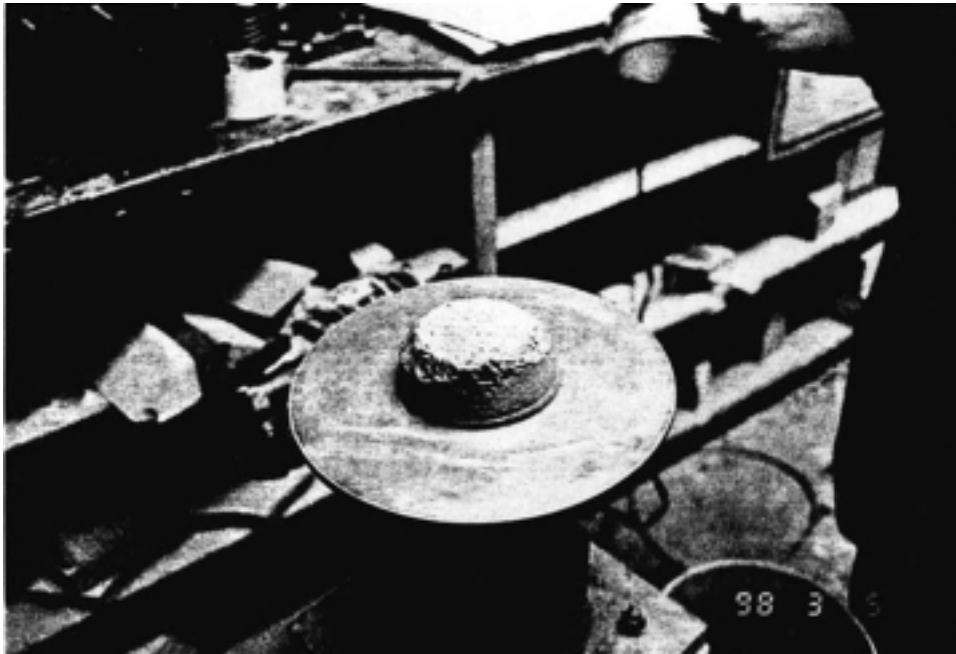
Figure 5.3. The brass mold has been removed from the mortar on the flow table.

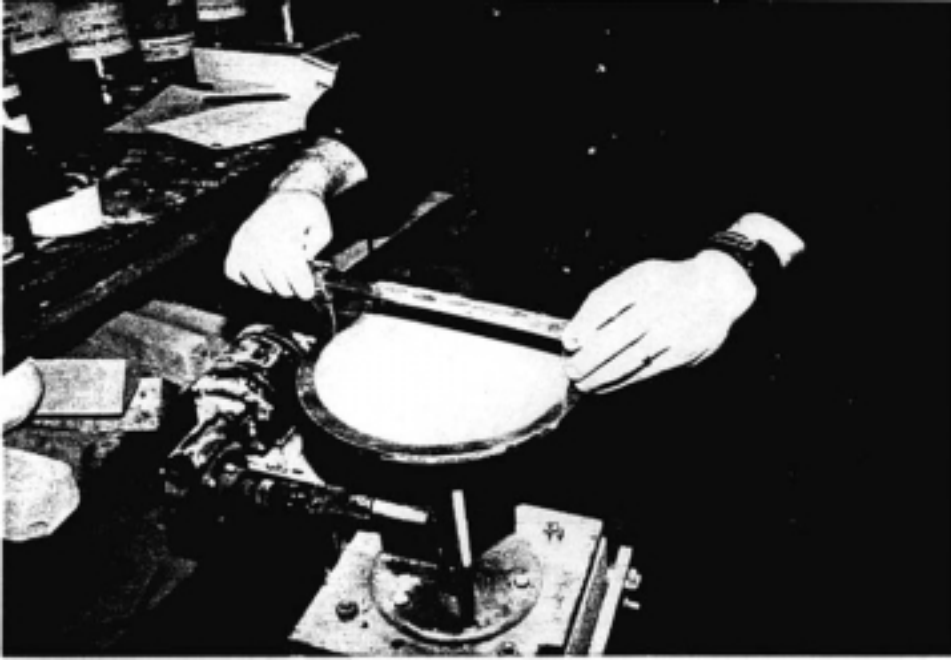
Figure 5.4. The diameter of the mortar pancake is measured with calipers.
