## **Project Report**

# **Nondestructive Method for Hardness Evaluation of Mortars**

Rocky Mountain Masonry Institute  
1780 South Bellaire Suite 402  
Denver, CO 80222

National Center for Preservation Technology and Training  
United States Department of the Interior  
National Park Service  
P.O. Box 37127  
Washington, D.C. 20013-7127

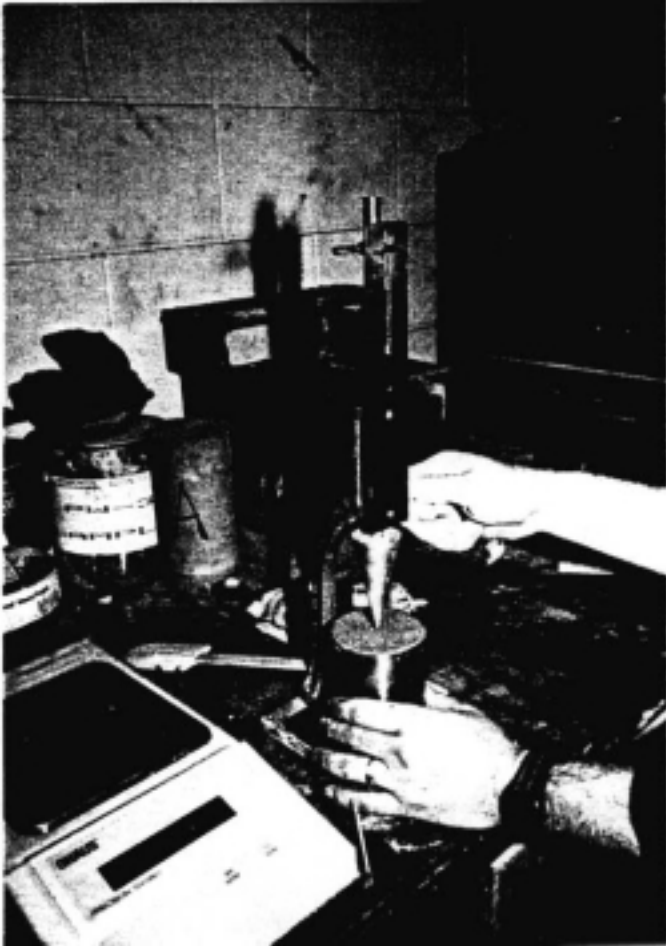
Figure 5.5. Modified Vicat cone penetration apparatus.

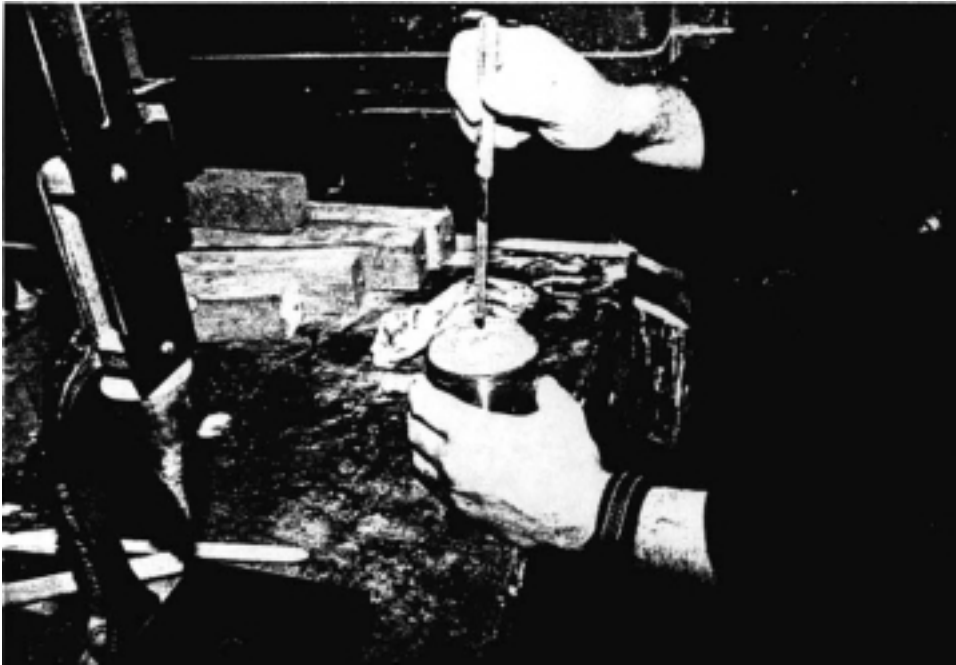
Figure 5.6. The last of three lifts of mortar is tamped with the steel spatula.

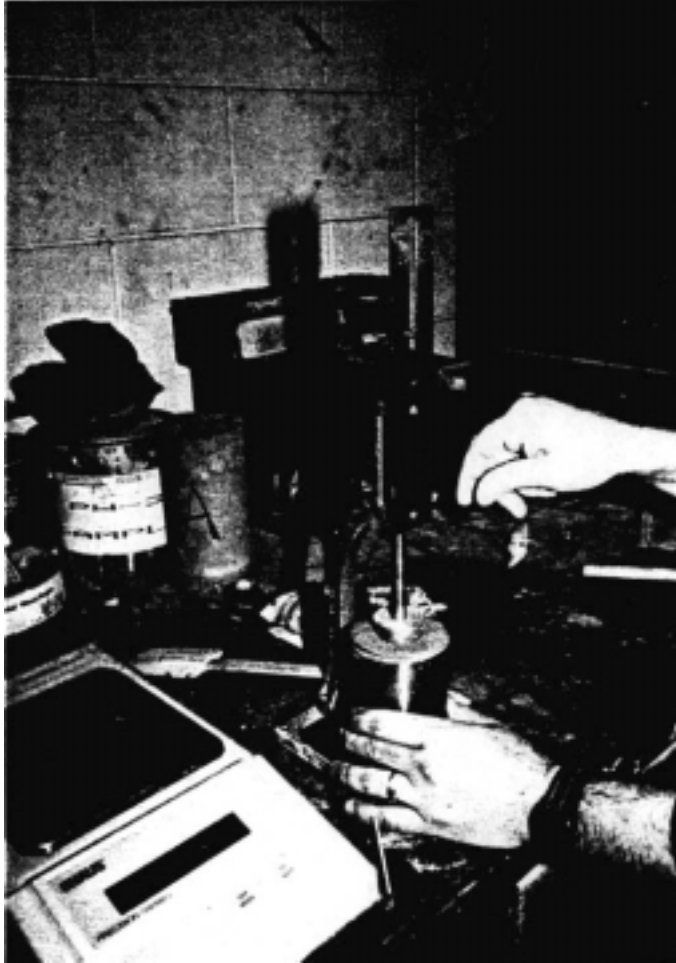
Figure 5.7. The Vicat cone has been released and has fallen into the cup of mortar.

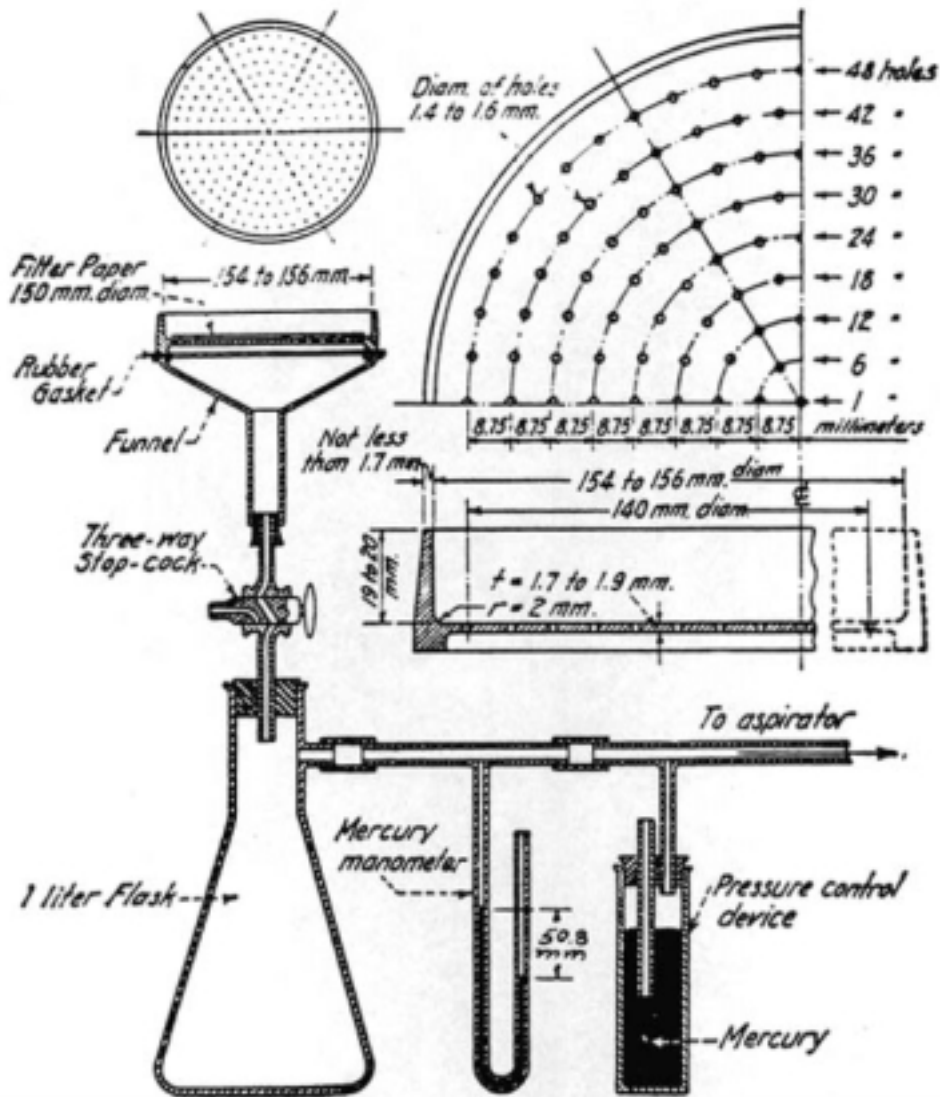
ASTM C 110

Figure 5.8. Apparatus Assembly for the Water Retention Test (figure taken from ASTM C 110).

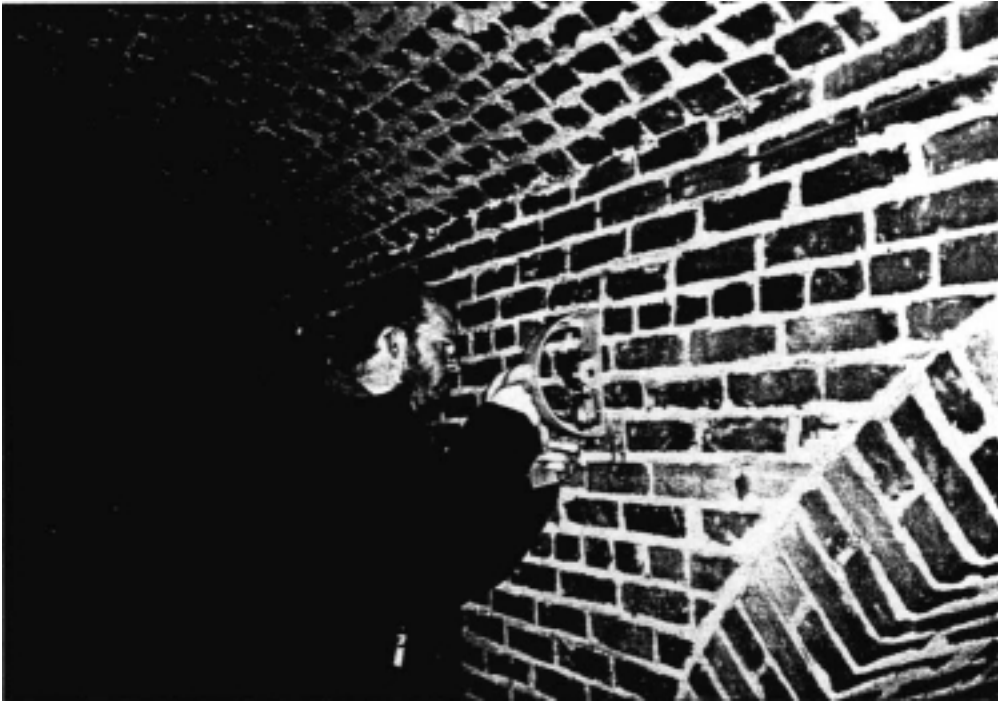
Figure 7.1. Pendulum hammer testing in the undercroft of the Basilica of the Assumption.

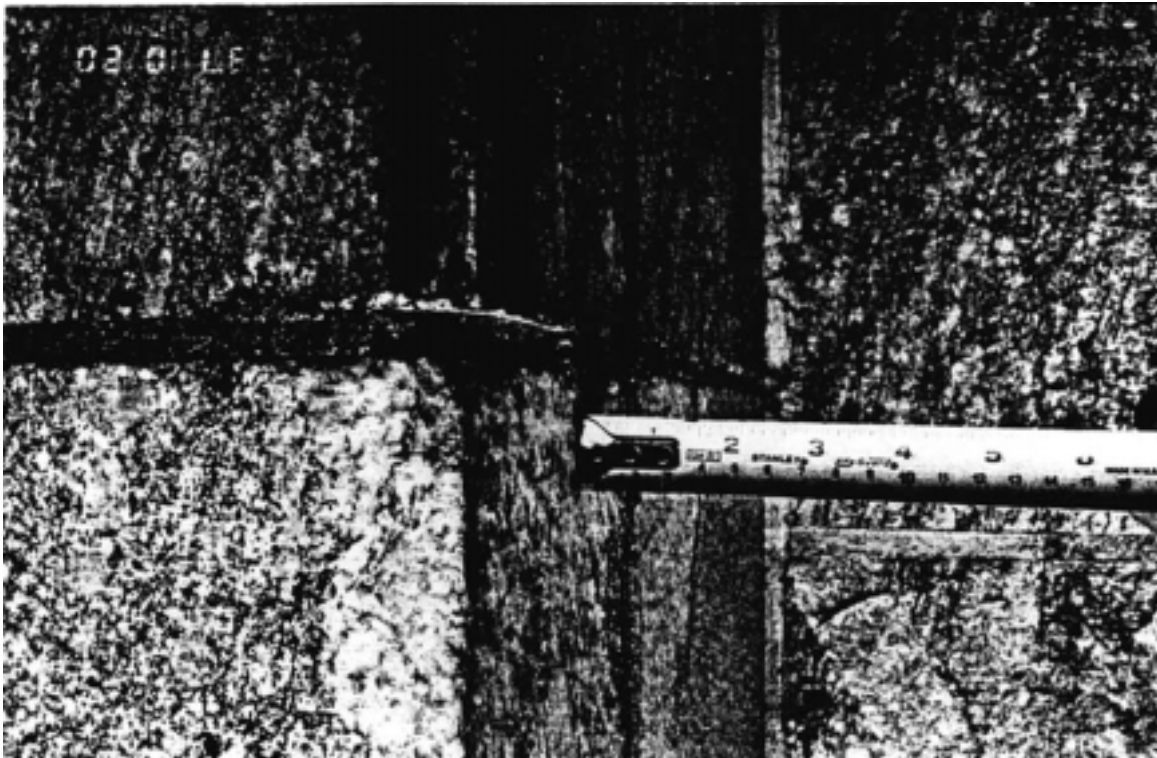
Figure 7.3. Poorly bonded pointing mortar at Mahan Hall.

The exterior mortar joints are cracked and delaminated from the surrounding stonework. The original construction documents specified that the mortar joints were to be raked back to 3/4 inch deep and pointed with a hard, cement-sand mortar. This pointing mortar was not well compacted into the joints, resulting in a poor bond to the setting mortar and prevalent voids between the two mortars. The pointing mortar is debonded and in many cases has fallen out of the joints. Figure 7.3 shows a joint with both poorly bonded and absent pointing mortar.
