CASE HISTORY 25: PUNCH PRESS
(OSHA Noise Problem)

CASE HISTORY 26: PUNCH PRESS
(OSHA Noise Problem)

CASE HISTORY 27: BRAIDING MACHINE
(OSHA Noise Problem)

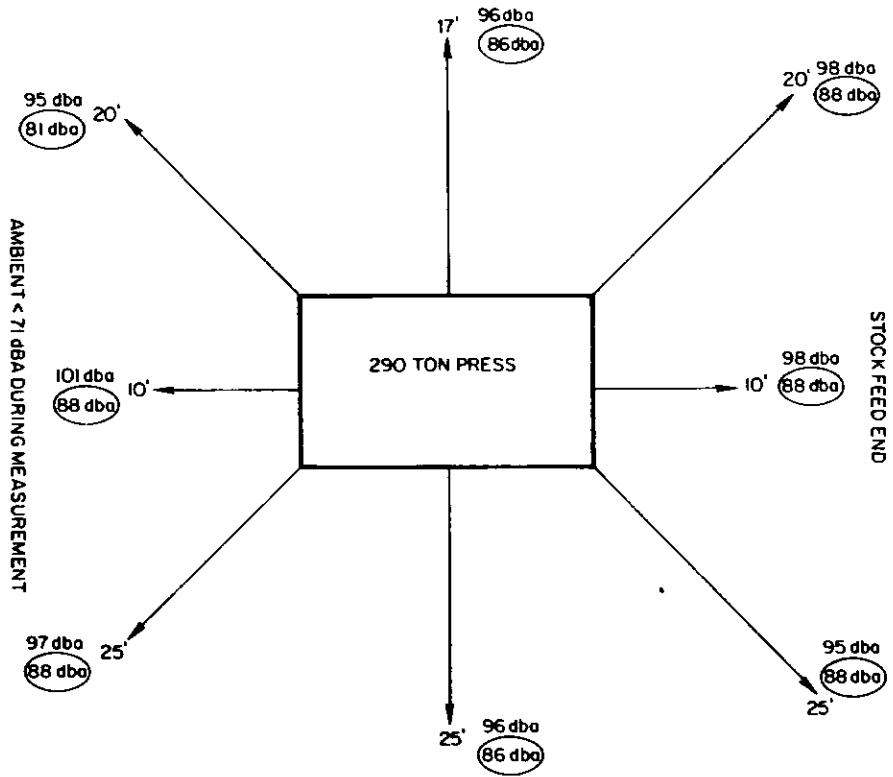
Figure 6.26.1. Sound levels at the original measurement locations, which were reduced to a maximum of 88 dBA.

Sound levels at the original measurement locations were reduced by 7 to 14 dB to a maximum of 88 dBA at those locations. (See Figure 6.26.1.) Enclosure systems need not always be elaborate

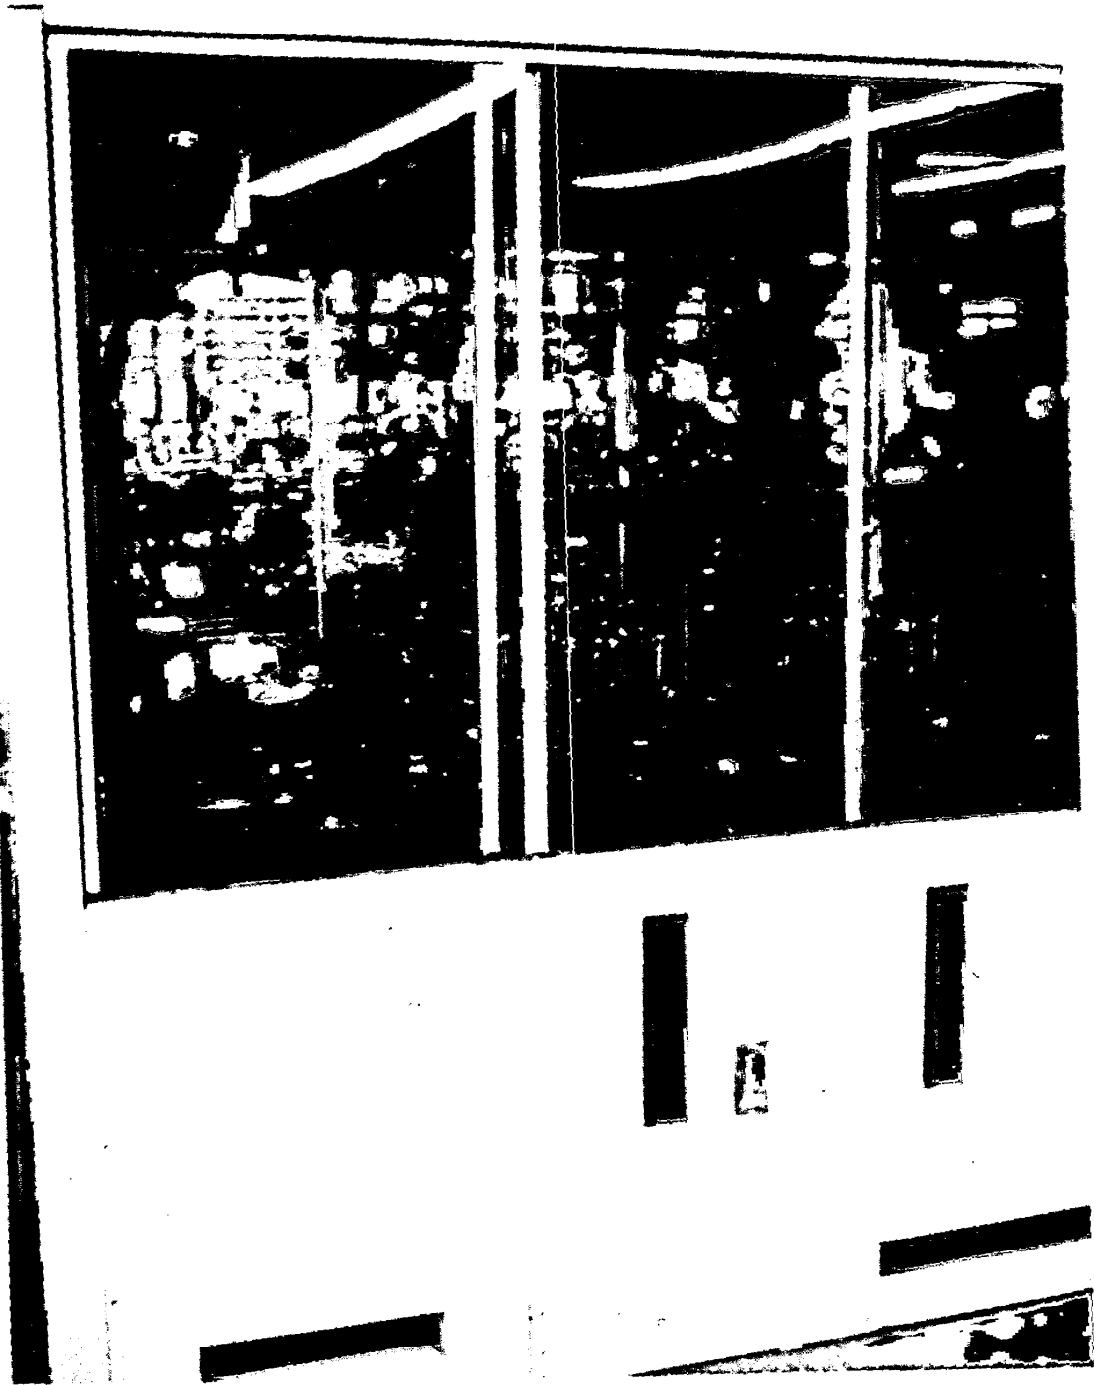
Figure 6.27.1. Braider enclosure.

The custom-designed I.D.E. enclosure constructed for this problem is shown in Figures 6.27.1 and 6.27.2. From the photographs, it is easy to see that the operators retain good visibility of their machines. Several aspects are not revealed by the pictures: The windows slide on roller bearing, making worker accessibility relatively easy and fast. Panels on the bottom of the enclosure also slide. All windows and the bottom panels are removable for maintenance. Gravity ventilation sufficient for these machines is furnished via the silenced vent openings visible below the bottom panels. The outer skin of the enclosure panels is made of corrosion-resistant steel. The inner skin of the panels is of perforated sheet metal that covers an acoustical fill material, thereby making the inner surface acoustically absorbent and thereby minimizing any build-up of sound inside the enclosure. A layer of woven glass fiber fabric protects the inner fill from working out of the perforated sheet metal.

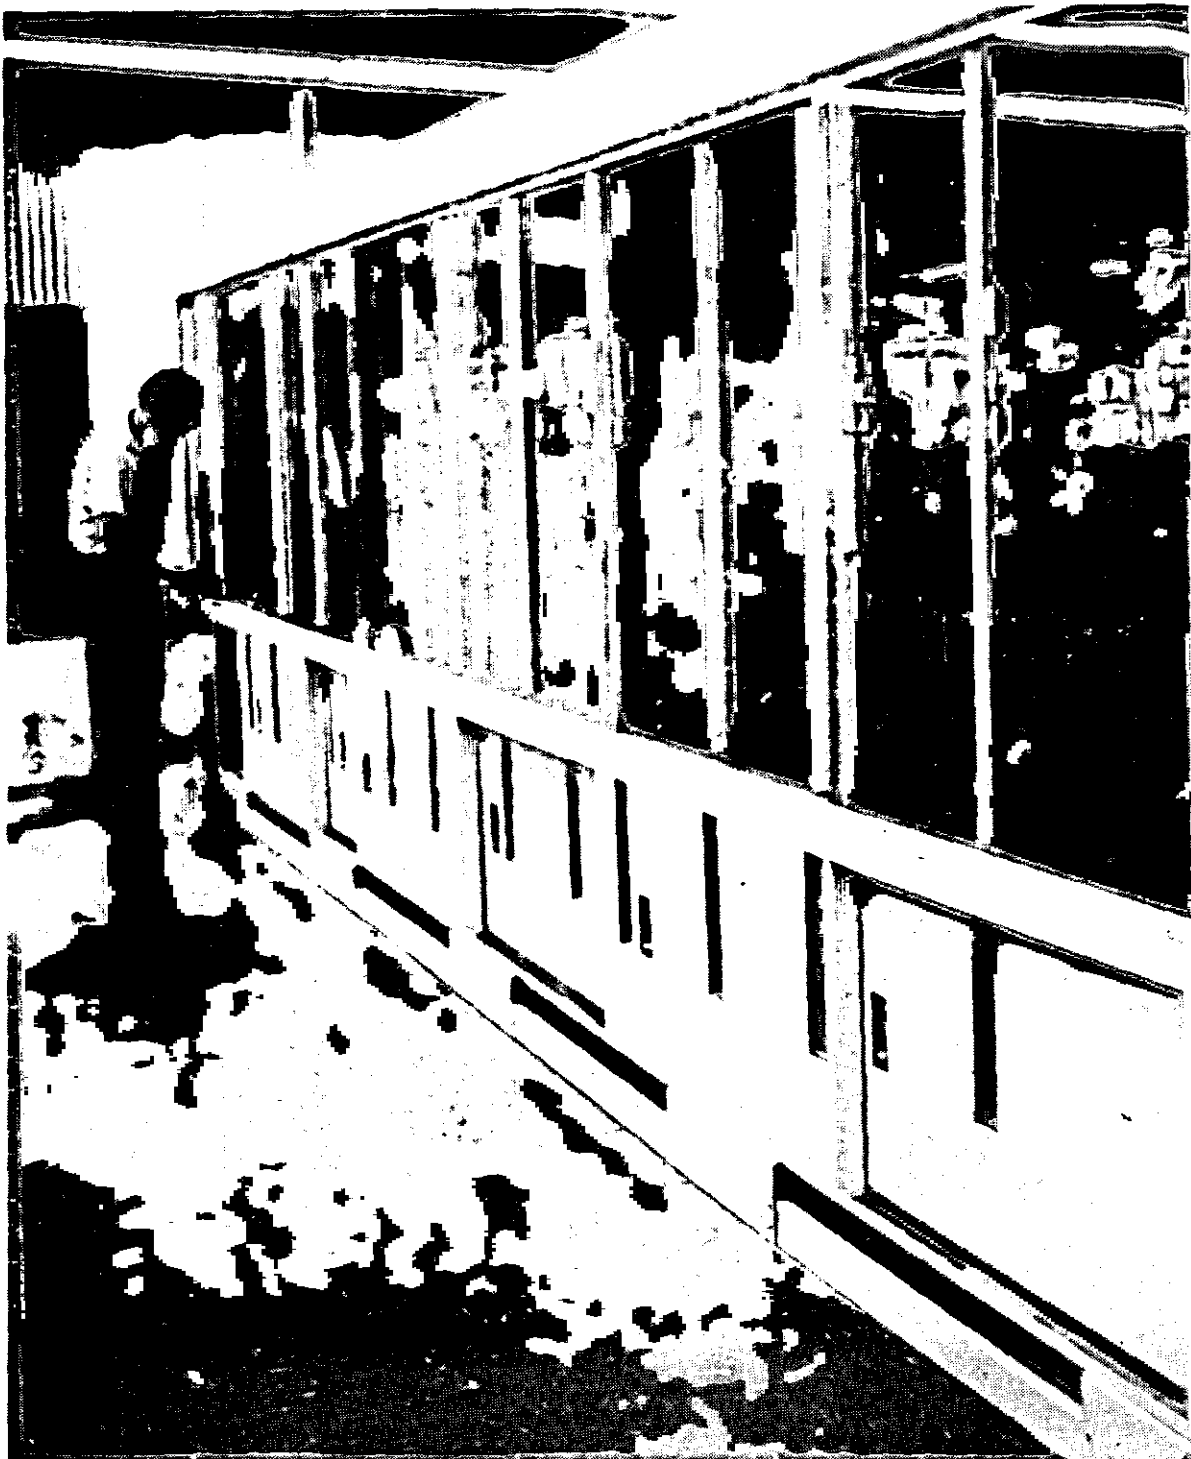
Figure 6.27.2. Braider enclosure, another view.
